# Davidson County Sheriff's Office

## Master Plan

**April 14, 2015**

## **FACILITY ASSESSMENT SUMMARY**

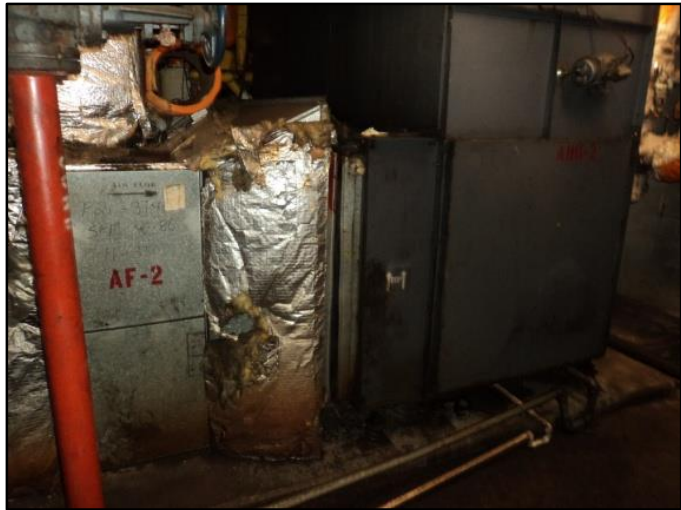
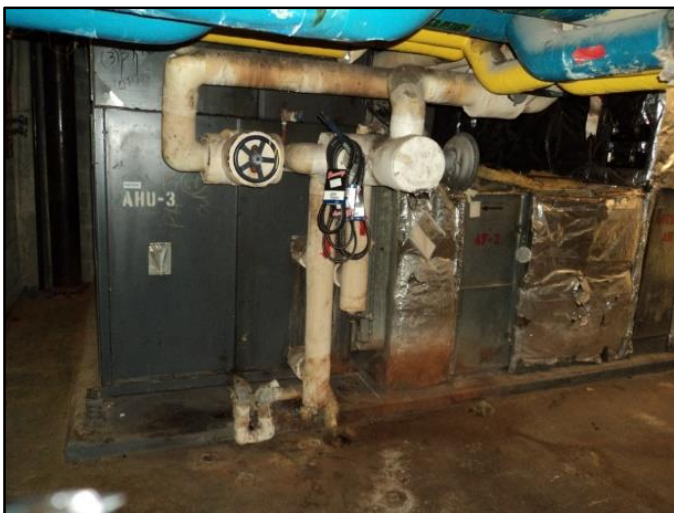
### Air Handling Systems

The existing air handlers and fans not replaced in the 2004 renovation are past the end of their anticipated 25-30 year life expectancy according to the American Society of Heating, Refrigeration, and Air-Conditioning Engineers (ASHRAE). While these units are currently operating, their replacement should be considered in the near future to prevent outages due to ongoing maintenance issues. Additionally, several of the systems currently operate with thermostatically controlled dampers that allow supply air to completely be shut off to the space served. This arrangement violates the code required ventilation for occupied spaces and needs to be addressed in a future renovation.

The existing duct systems are past their life expectancy as detailed by ASHRAE and the leakage rate may exceed current standards. New duct systems are recommended to provide improved energy efficiency and required temperature control.

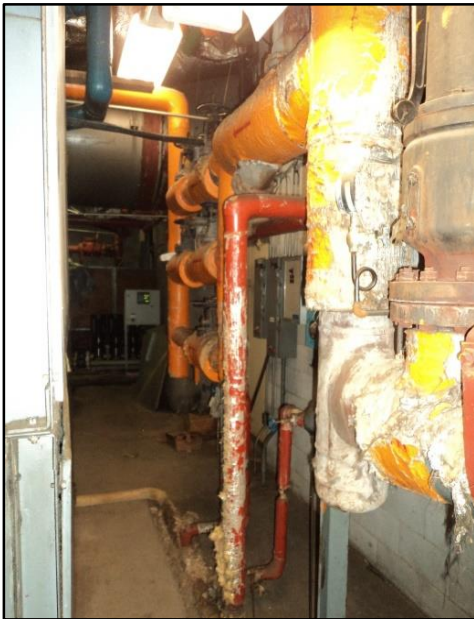
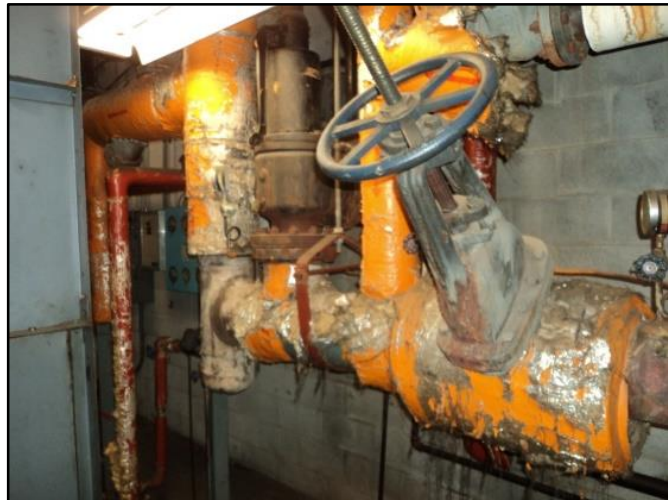
## **Steam and Hot Water Systems**

The steam-to-hot water heat exchangers are beyond their anticipated 24 year life expectancy according to ASHRAE and should be replaced in the near term.

ASHRAE lists the anticipated life expectancy for an end suction or split case pump to be 20 years. Due to the age of all four hot water pumps, replacement is necessary. Each new end suction pump should be provided with the associated valves, differential pressure switch, pressure gauges, and variable frequency drive. The existing hot water piping may be reused, but should be flushed and chemically cleaned. The hot water piping insulation should also be checked and repaired as necessary in the mechanical rooms.

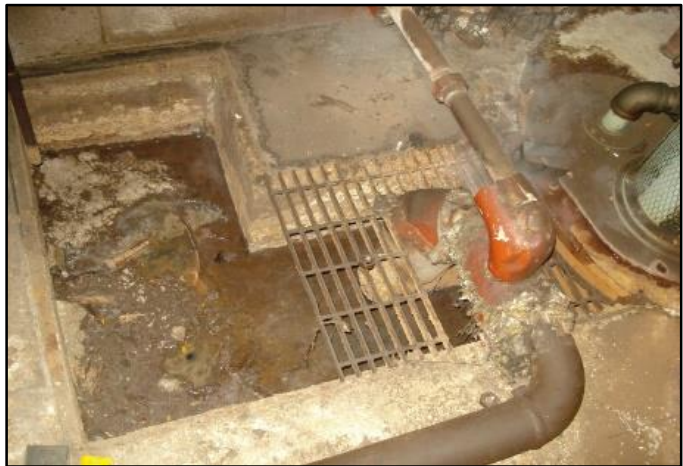
The original buildings waste and vent piping is 33 years old. Repairs or patch areas have been made. The cast iron is at the end of its life expectancy and needs to be replaced in the next couple of years.

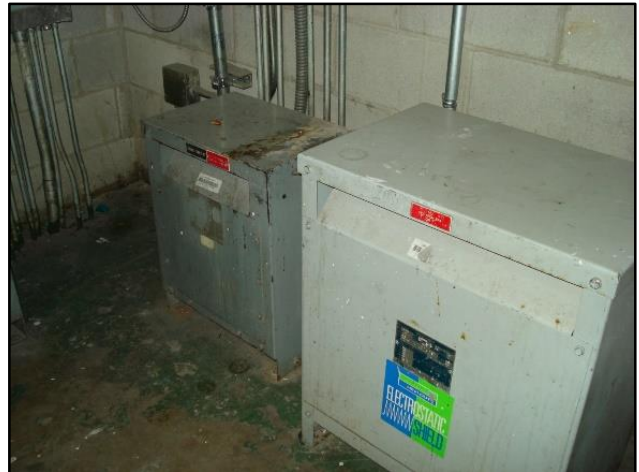
### Power Distribution

It is recommended to replace main switchgear, distribution panels, transformers, transfer switches, and branch circuit panels serving lighting, receptacles, etc. due to the age of the equipment and difficulty obtaining parts for the equipment.

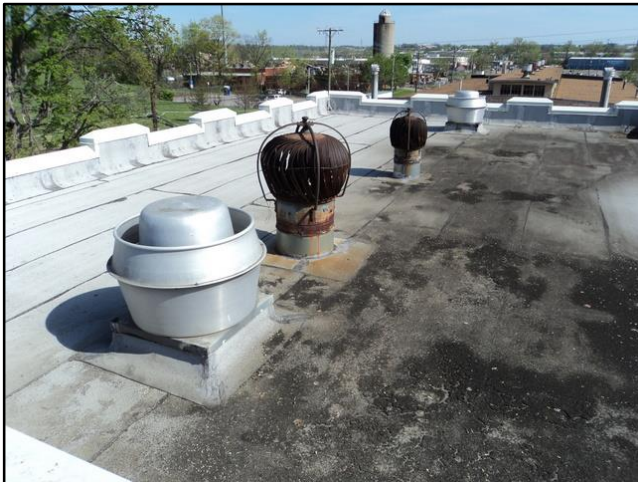
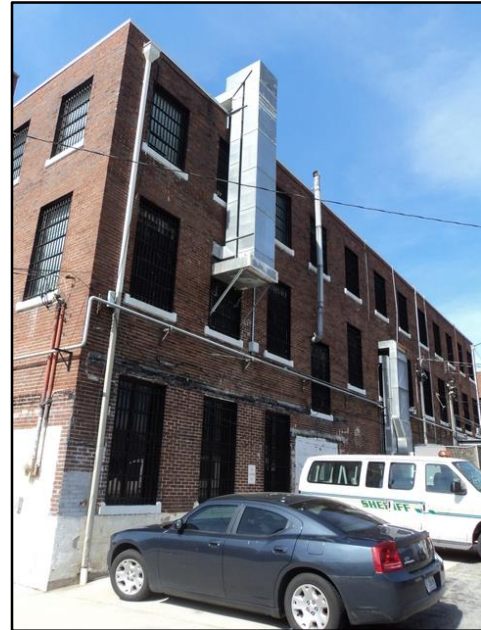
### Roofing and Exterior Weather Protection

Exterior masonry is relatively poor condition requiring moderate repointing and water proofing provisions.

Windows are aged, and should be replaced for increased weather tight conditions.

Roofing materials are in poor condition and at end of life requiring need replacement

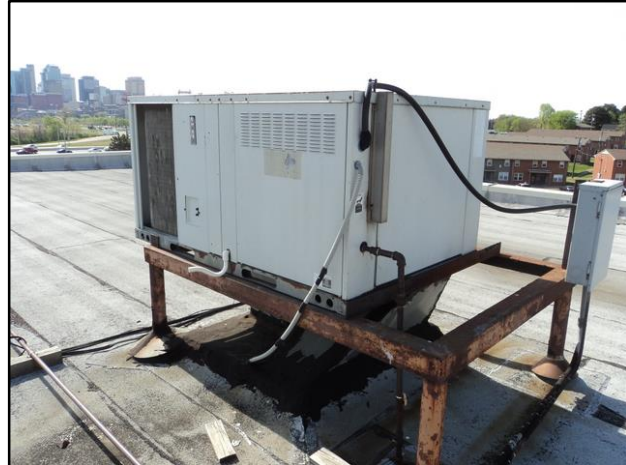
### **Heating and Air Conditioning Equipment**

Most of the 10 packaged rooftop units serving the facility are in poor condition and past their anticipated 15-20 year life expectancy according to ASHRAE. Replacement of these units with equipment of like capacity should be considered in the near term to prevent outages and ongoing maintenance issues.

Where equipment replacement is recommended, the system type should be changed to a Variable Refrigerant Volume (VRV) system with a dedicated outdoor air system (DOAS). This system type would provide a more energy efficient solution.
