HISTORIC STRUCTURE REPORT
FORT NEGLEY
Nashville, Tennessee

FINAL REPORT (CORRECTED)
January 31, 2014

CHAPTER I.3 – CONDITION ASSESSMENT

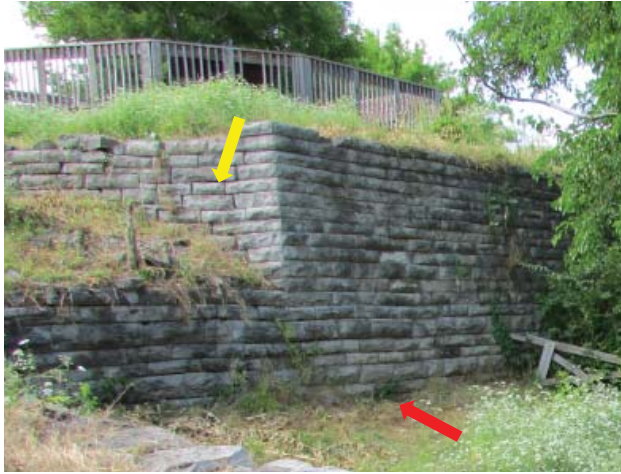
Figure 59. Slight batter—0.03 horizontal to vertical—observed at scarp of South Main Works (1200 AE, 2013).

This location exhibiting out-of-plane displacement due to sliding as indicated by stepped open horizontal and vertical joints (yellow arrow) and measurements at the base of wall reporting a 4-inch change in outward displacement between grade and two feet above grade (red arrow)

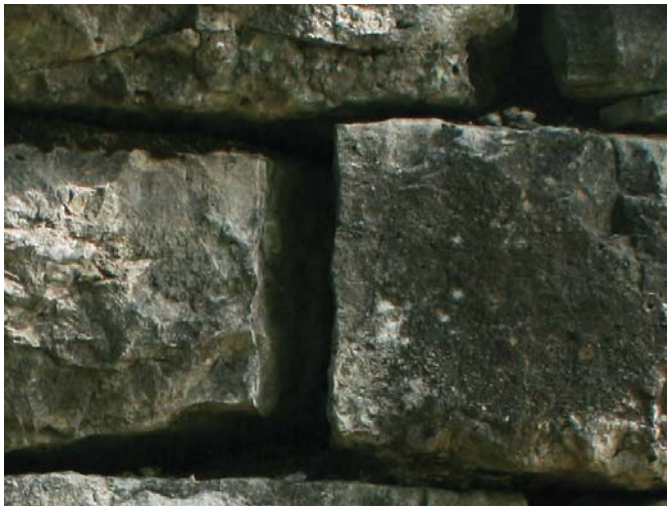
Figure 80. Open head joints (JMA, 2013).

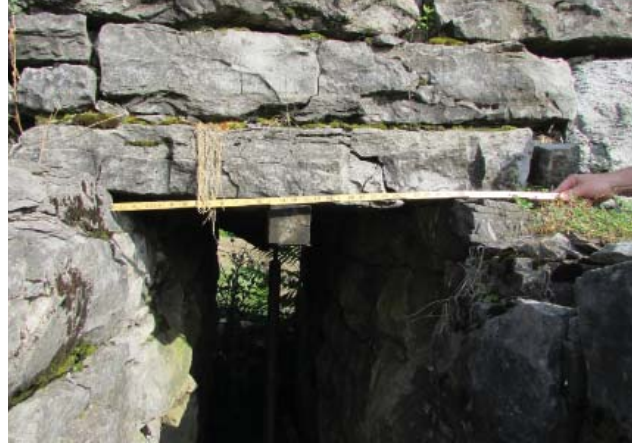
Figure 91. West Bastion tunnel with flexure cracks in stone lintels (1200AE, 2013).

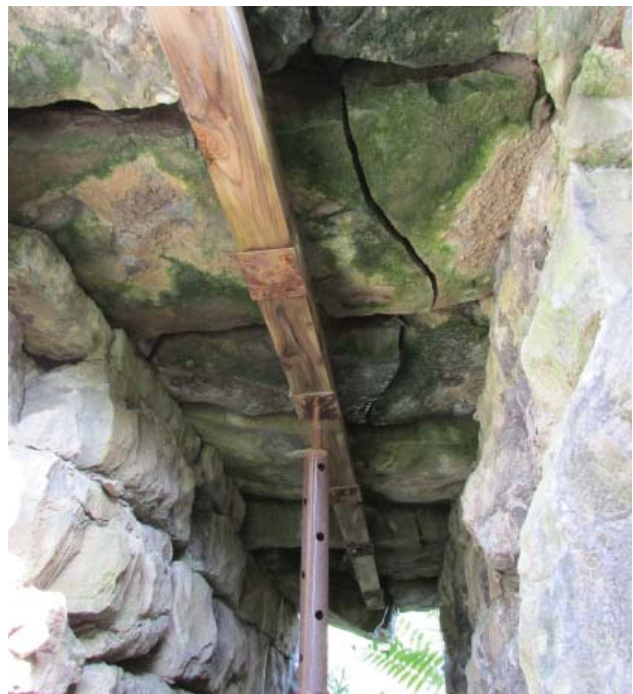
Figure 92. West Bastion tunnel with shoring installed and loss of post shores (1200AE, 2013).

Note locations of steel post caps steel anchored to beam and significant cracks in each of the stone lintels throughout length of tunnel.

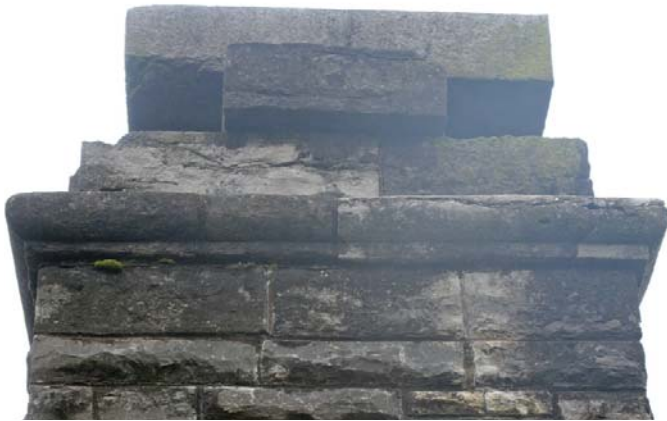
Figure 94. Open joints at top of north pylon at entrance gate with accompanying efflorescence, biological growth including moss, and erosion of natural cracks in two limestone units (JMA, 2013).

One upper unit has also spalled from water intrusion into stone.

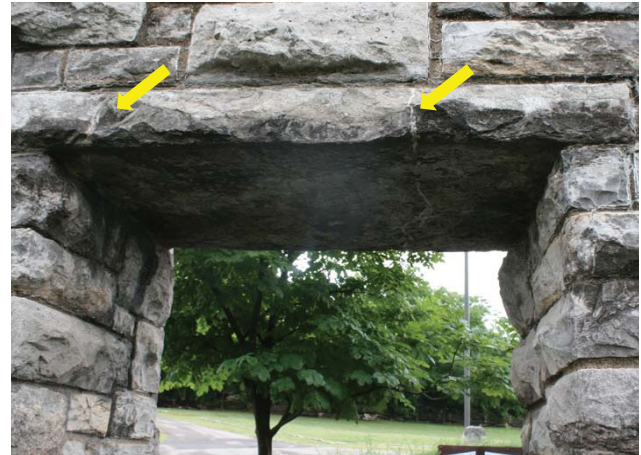
Figure 98. Cracked and broken mortar skim coat on limestone platforms at openings in entrance gate central screen wall, completely missing in some places (JMA, 2013).

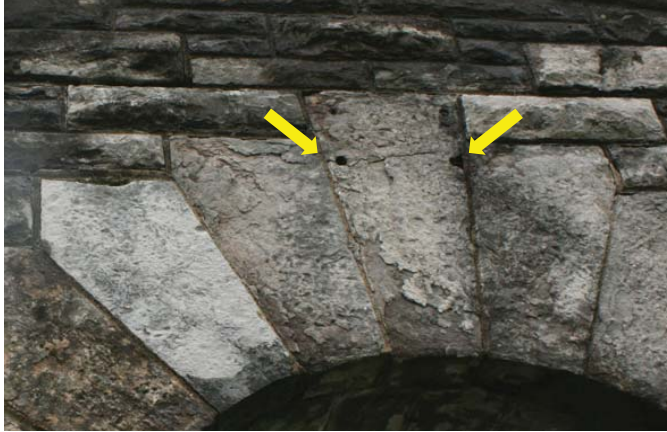
Figure 99. Drilled holes in face of stone in central arch of the entrance gateway (JMA, 2013).

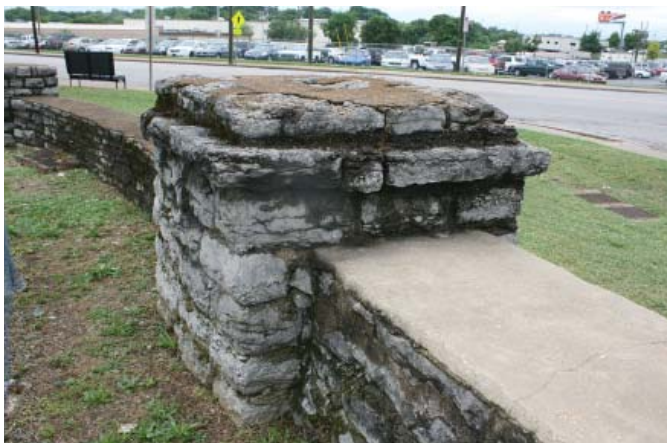
Figure 100. End pier of original wing wall extending from south end of gateway (JMA, 2013).

Mortar cap is cracking.

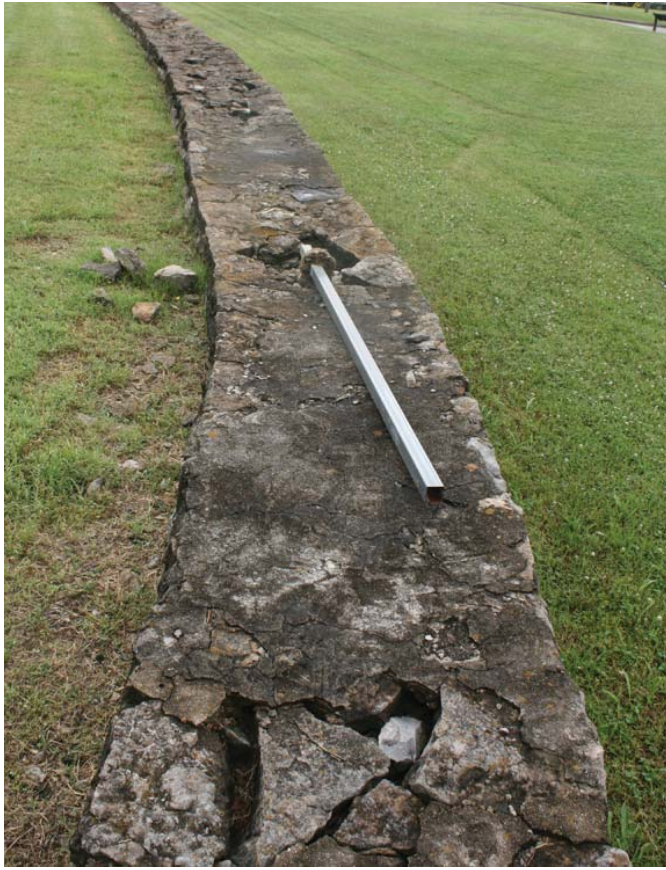
Figure 105. Damage to top surface of northwest wing wall of entrance gate structure caused by water infiltration and failure of post previously mounted into top of wall (JMA, 2013).

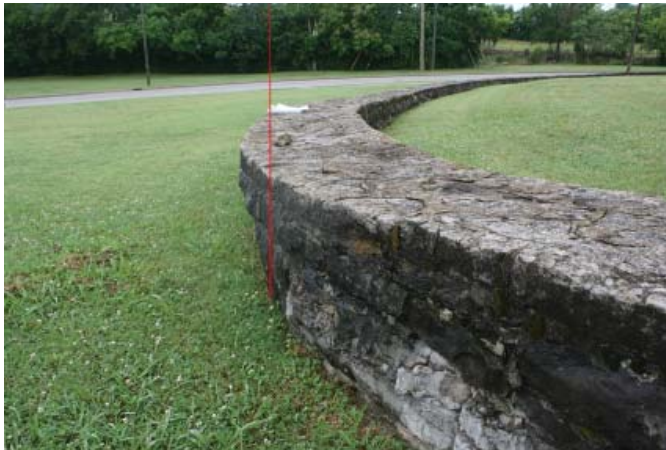
Figure 106. Section of northwest wing wall of entrance gate structure exhibits bowing resulting from either vehicular damage or an underlying structural problem (JMA, 2013).

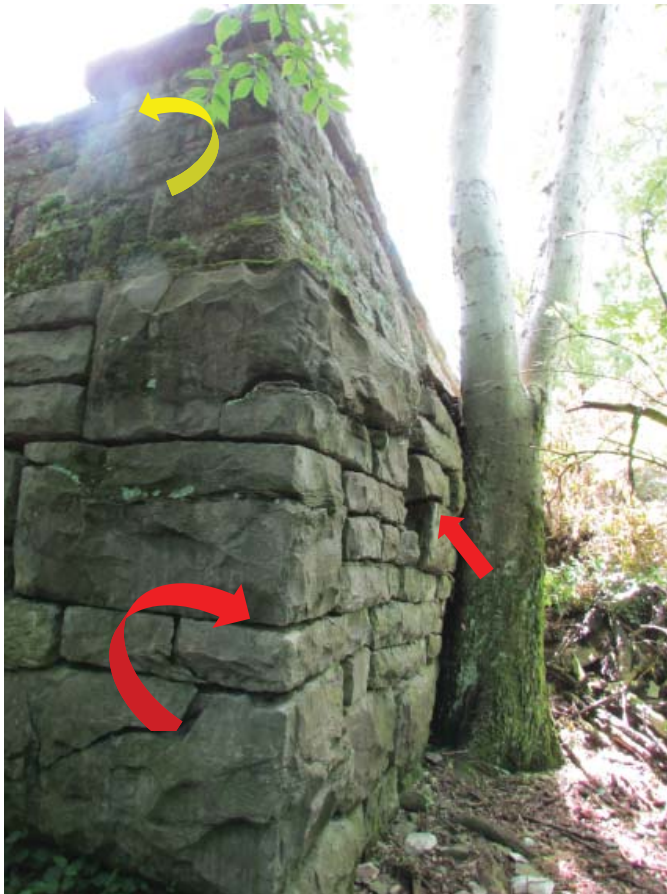
Figure 113. Typical wall conditions at parking area retaining wall. Note bulging and out-of-plane rotation in the dry-stacked retaining wall (red arrows) and out-of-plane rotation of parapet towards interior (yellow arrow). Note position of tree and restricting additional lateral movement. (1200AE, 2013).

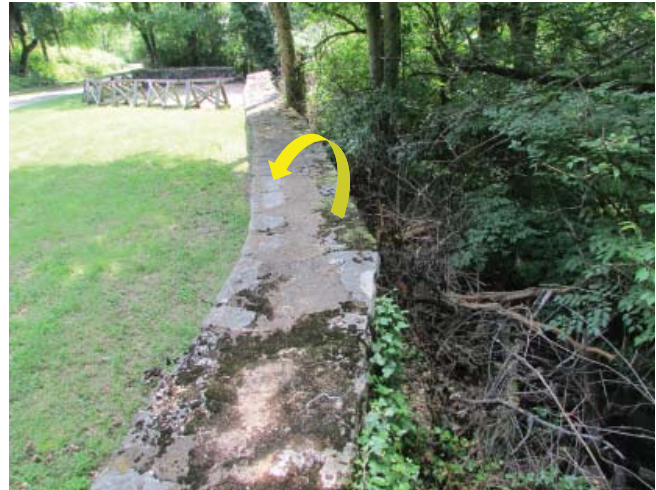
Figure 114. Rotation of parapet towards the interior (1200AE, 2013).

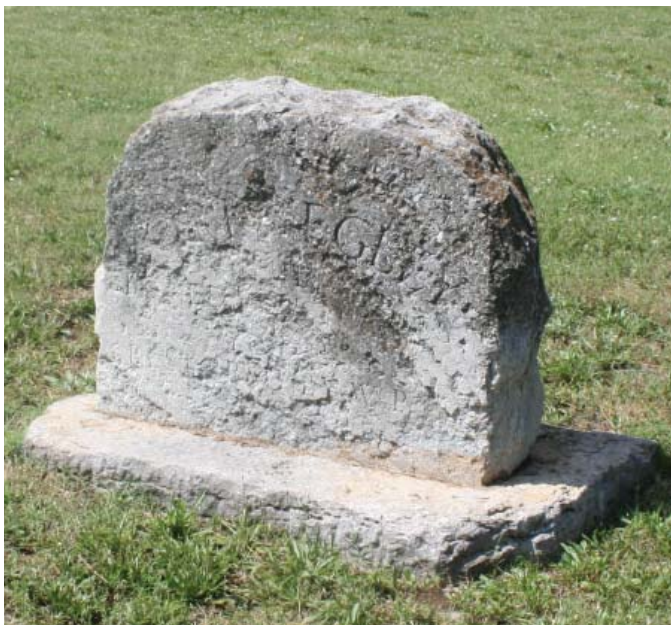
Figure 119. Deterioration of WPA dedication monument (JMA, 2013).
