METROPOLITAN GOVERNMENT OF NASHVILLE AND DAVIDSON COUNTY

STAFF RECOMMENDATION
1830 5th Avenue North
January 20, 2021

Application: Demolition
District: Salemtown Neighborhood Conservation Zoning Overlay
Council District: 19
Map and Parcel Number: 081 08 0M 002.00
Applicant: Jeff Zeitlin
Project Lead: Paul Hoffman, paul.hoffman@nashville.gov

SUBJECT: Feasibility Opinion Letter
1830 5th Avenue N, Nashville, TN
SE&I Project No: 20-1316

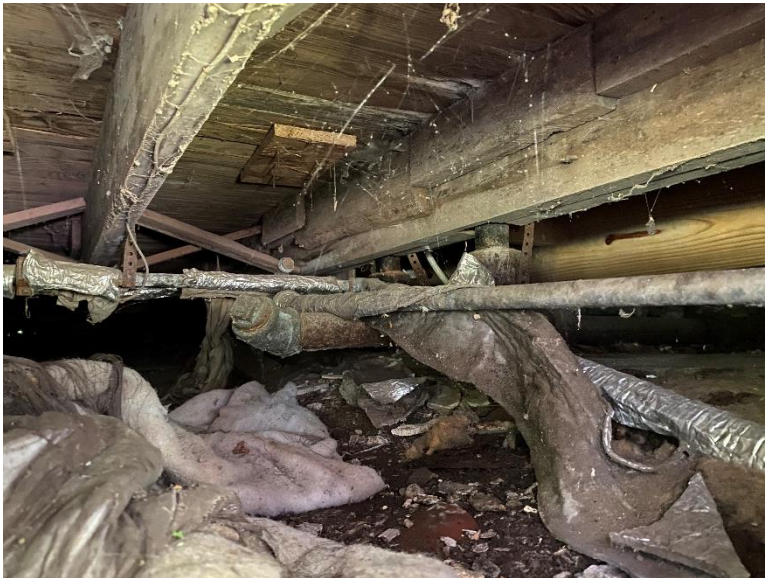
Foundation & Floors: Access underneath the structure is limited. The perimeter foundation is in good condition. The block foundation was laid with two blocks, but the lower block is mostly below grade, resulting in the wooden support elements being as close as six inches (6”) from the ground. The visible portion of the floor support structure exhibits water damage, termite tracks and has been cut through in places either for repairs or for installation of mechanical work. Although only a portion of the crawl space is visible, staff and the engineer reports estimate deterioration, water intrusion and termite damage to a significant percentage of the beams and joists that would likely require replacement, based on what can be seen on the interior. The engineer’s report notes the floor slopes half an inch (½”) over a four-foot (4’) length toward the center of the building. Floors that have fallen out of level are common in an historic structure, but typically, this much drop is considered problematic over a length of twenty feet (20’), essentially the entire width of the building.

Figure 3. Damaged/deteriorated structural components underneath.

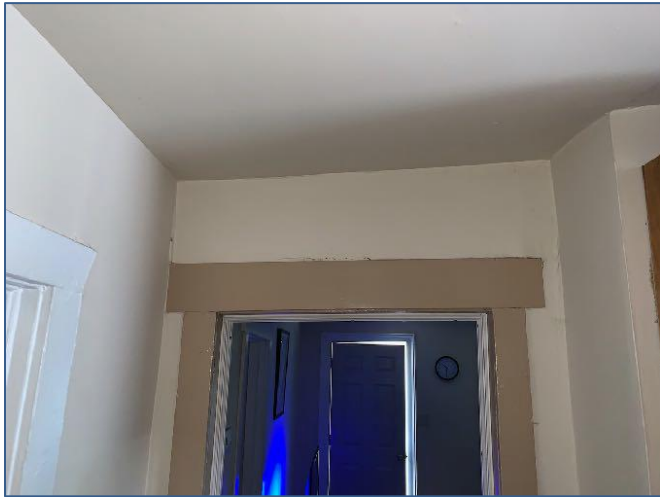
Framing/Siding: The wall framing is not visible. The interior framing exhibits the same sagging visible in the floors, between half an inch (1/2“) to an inch (1”) over the span of a door frame. In one location, Mr. Sandhu observed horizontal framing where it should be diagonal and he states that all ceiling joists need to be replaced, just to place mechanicals in the attic space.

Figure 4. Sagging is evident in the interior framing.

The home would need to be supported in order to place the new foundation and the existing framing may not be strong enough to withstand that effort. The framing could not be reconstructed or repaired until after the foundation has been relayed.

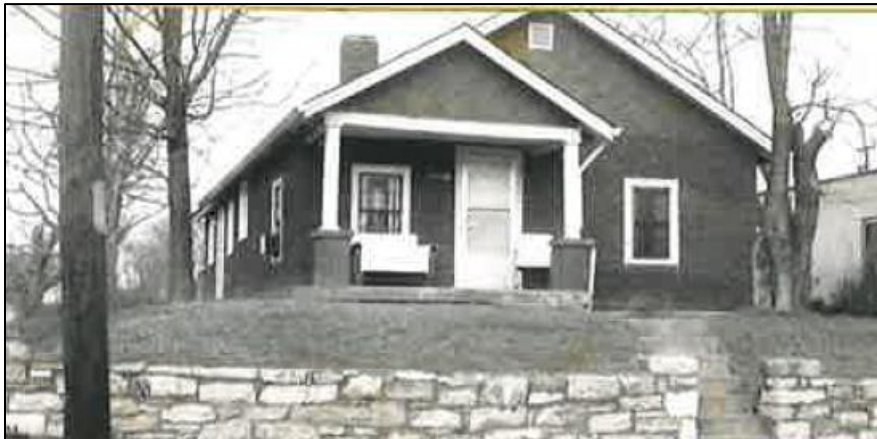
The building likely was originally clad in tar paper shingles, which remain underneath the T1-11 and faux brick siding. T1-11 does not meet the guidelines and tar paper shingles would not be repairable. Neither material would be desirable in this district at this point in its history.

Figure 5. Subject property c. 1968. Tar paper siding is likely the original cladding.

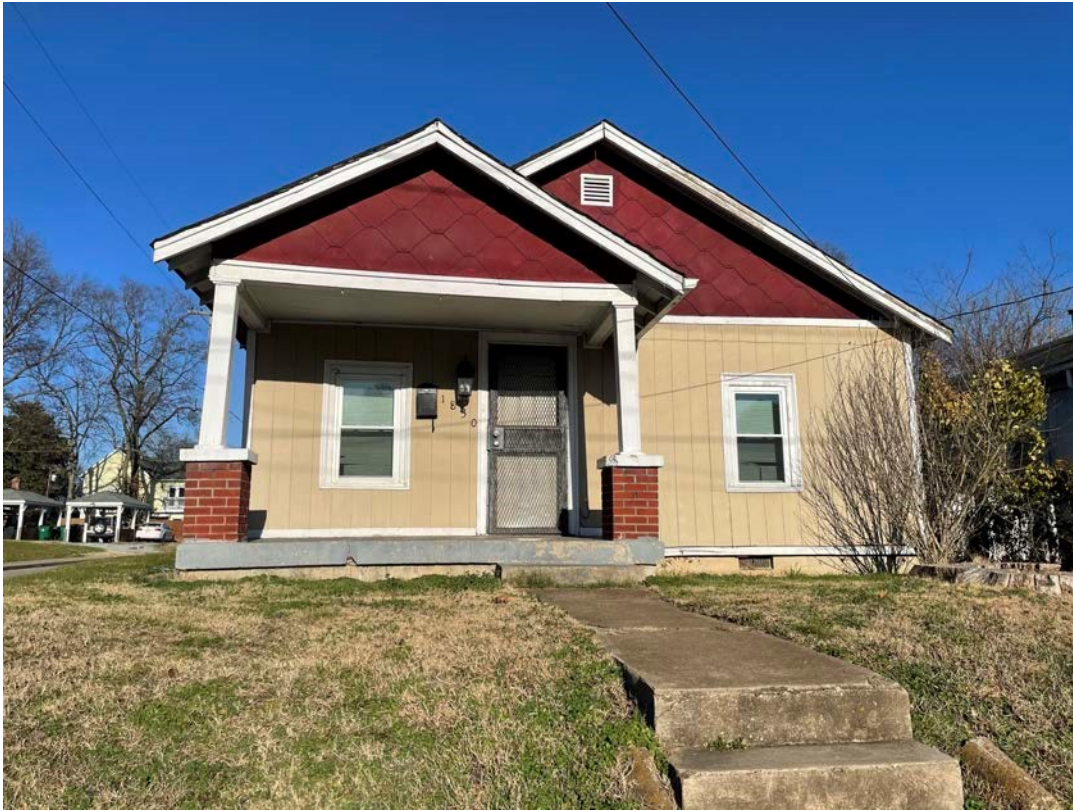
**View of Front of House
(Note Wood Panel Siding and Asphaltic Shingle Siding; Partial porch)**

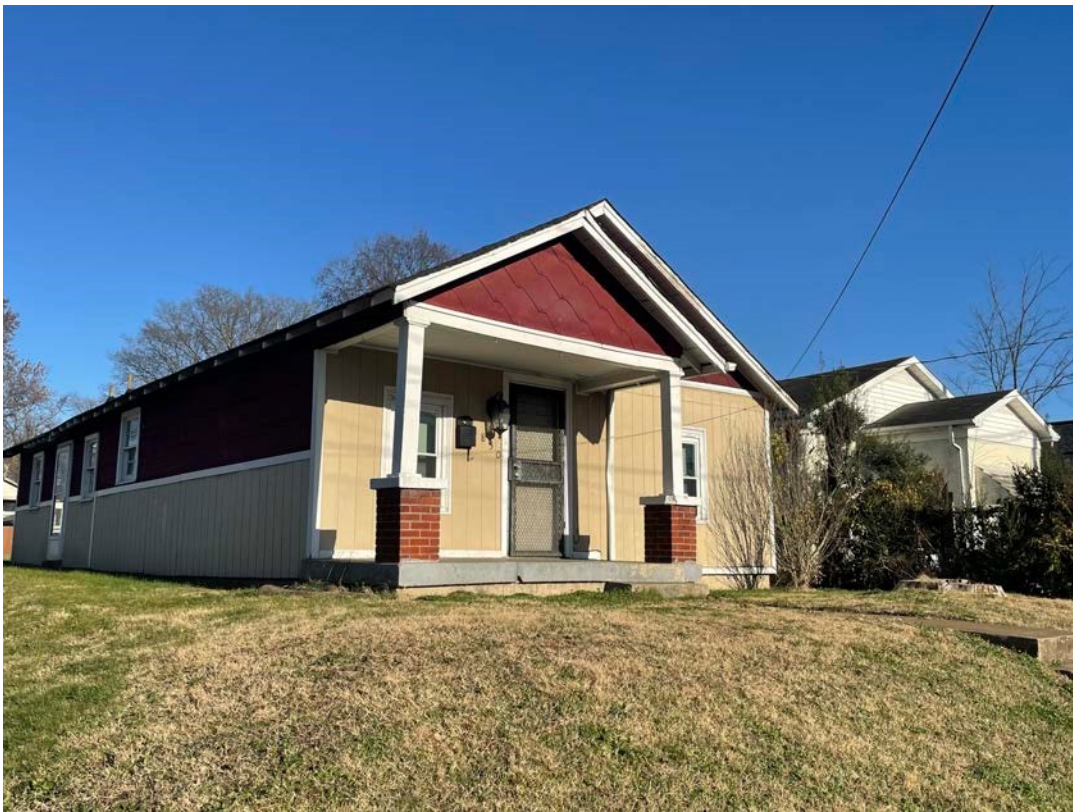
**View of Front and North Side
(Porch slab is cracked and heaves in middle)**

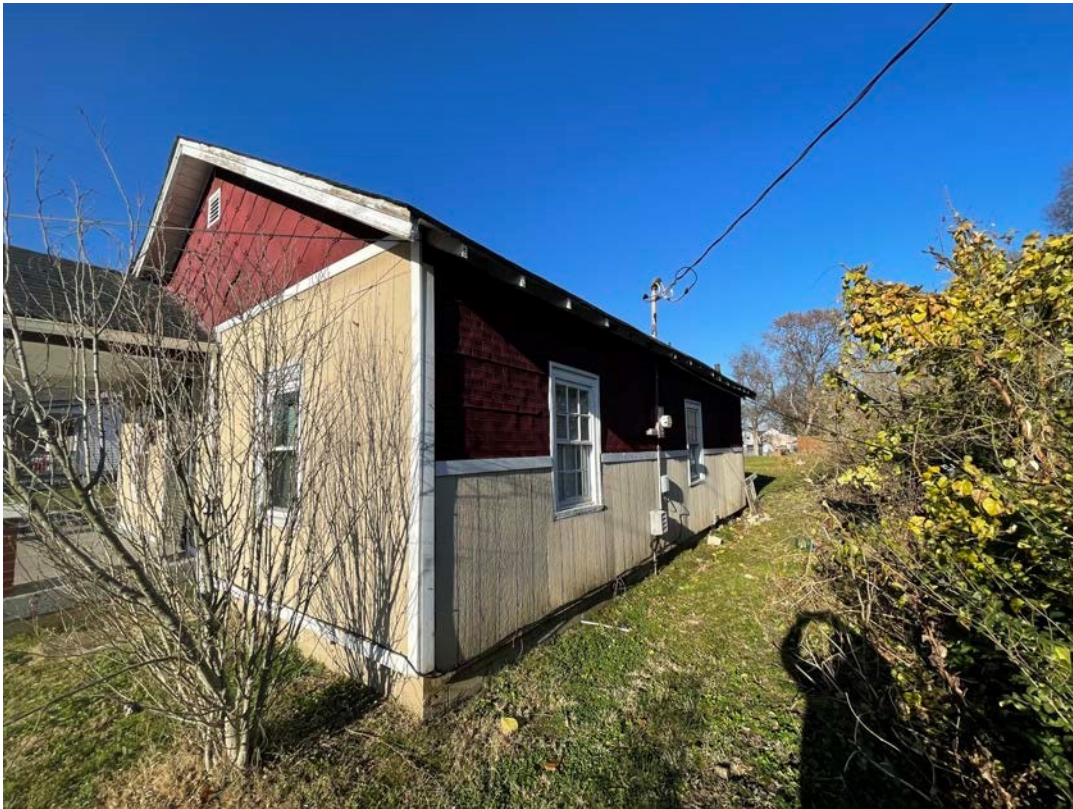
**View of South Side from Front Corner
(Note poorly attached wood panel siding- wavy;)**

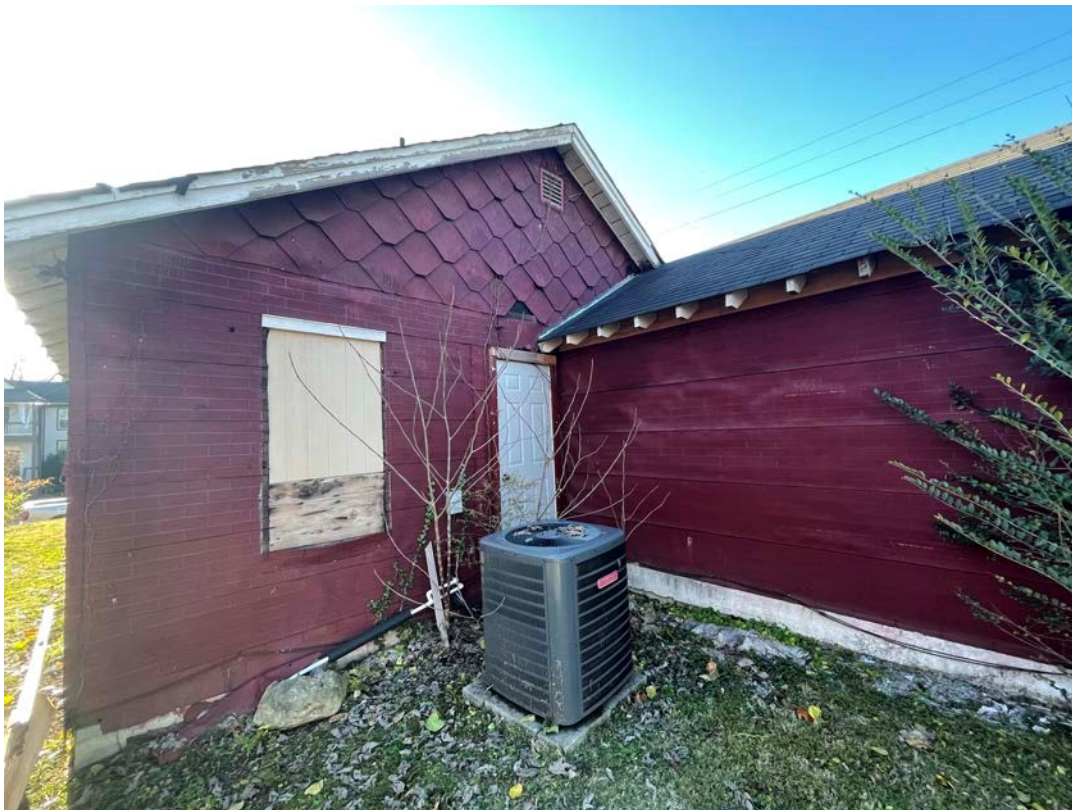
**View of East Corner (Rear) of House next to addition
(Note: Poor installation of siding – wrinkles and waves)**

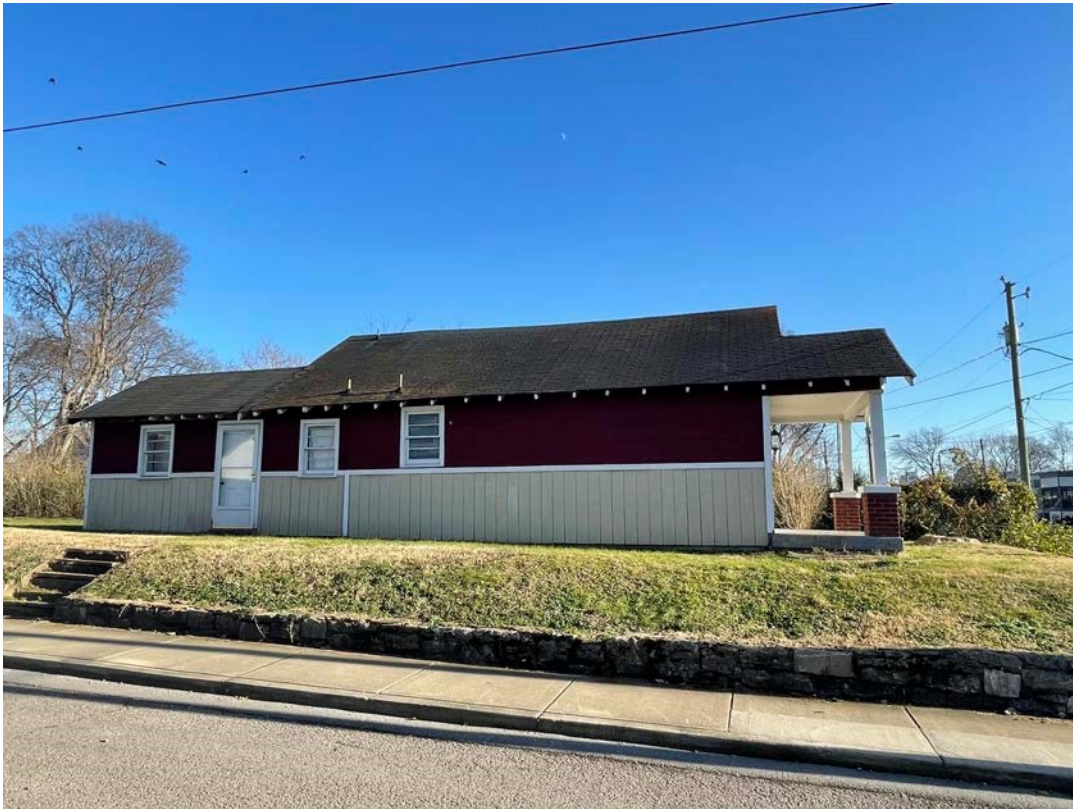
**View of North Side of House from Coffee Street
(Note the long “shot-gun” characteristic; proximity to ground)**

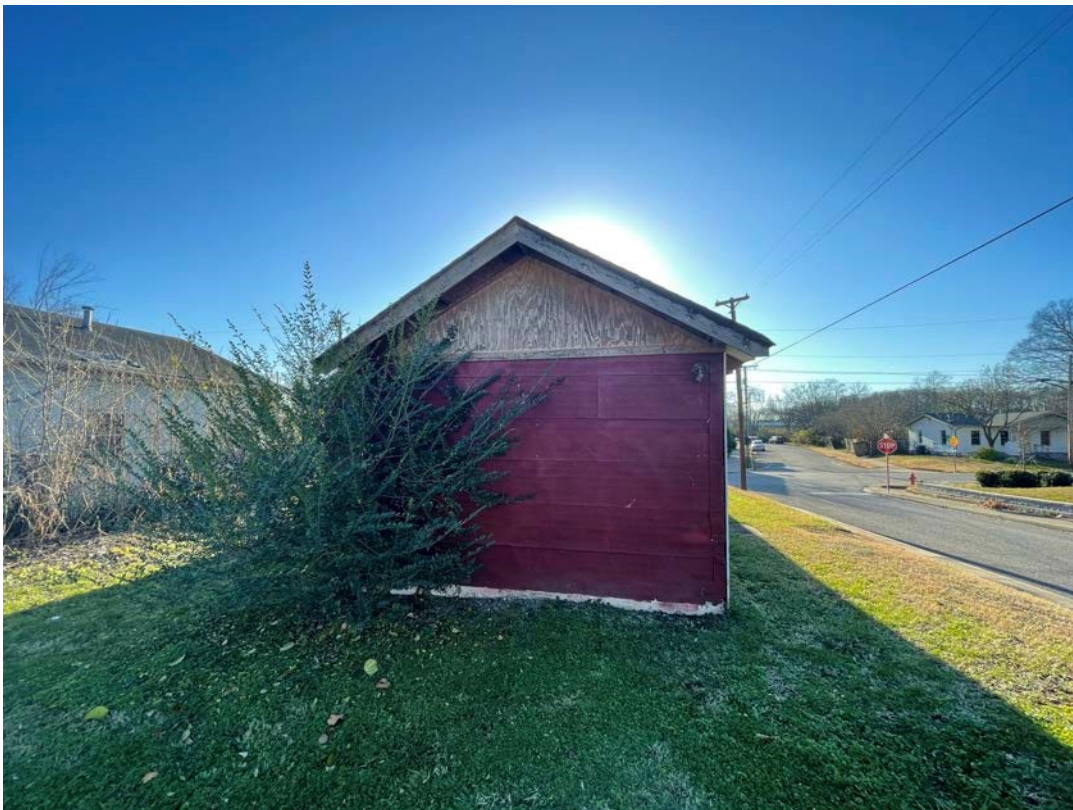
Rear of Rear Addition (No character; Just a box)

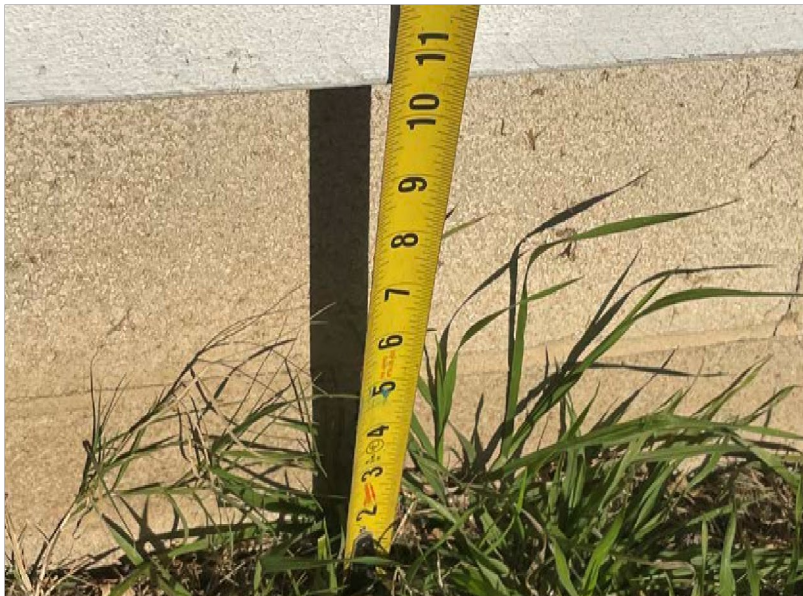
1. There is a stepped concrete footing at a depth of about 6 to 8 inches below the ground.
2. Foundation for the main house consists of one to two CMU block placed on the footing, but the first block is completely or partially below ground.
3. The foundation is in satisfactory condition and has vents.
4. The addition in the back is constructed on a concrete slab.
5. It could not be determined if this is a turn down slab.
6. Access to the crawl space is 9"x18" and not adequate for easy passage.
7. Clear height of the crawl space is less than 10"
8. The framing members are less than 6" from the ground and leave them susceptible to wood destroying insects (termites, etc.) and mold.

CMU Block Foundation Height less than 12"

1. The structure will need to be raised to obtain the allowable minimum 24" clearance for access to the crawl space.
2. At least two and three courses of CMU will need to be added to existing foundation wall.
3. The piers for the main girder will need to be likewise raised.
4. The crawl space will need to be graded to obtain positive drainage and competent vapor barrier added.

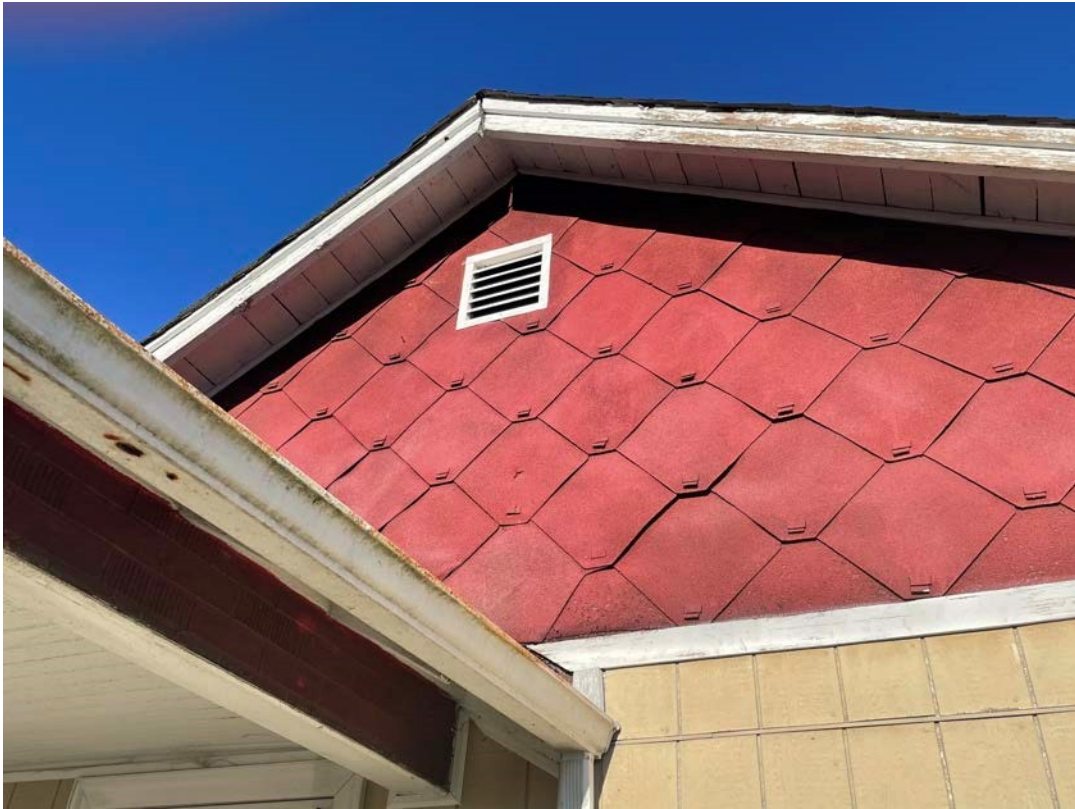
1. The only gutter and downspout are on the right part of the front porch.
2. Gutters and downspouts on the rest of the house are missing.

**View of somewhat fancy asphalt siding shingles
(Note the only gutter on the house on the porch)**

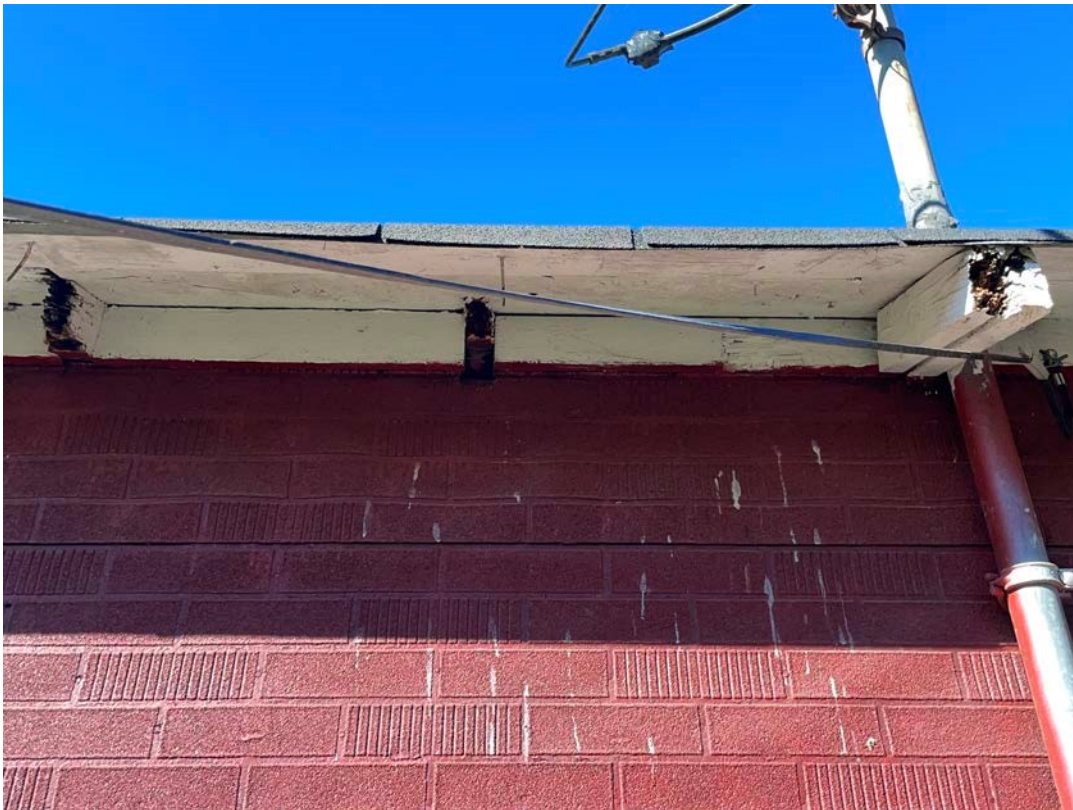
1. Roof rafters are 2x4 and 20" o.c.c with many rafter tails damaged or missing.
2. Collar ties and diagonal bracing provide additional support for the roof.
3. Despite the additional support, the roof ridge is sagging
4. The roof on the sides has a depression.
5. Roof decking is 1x boards.

View of broken and rotten rafters on South Side

1. For roof rafters attached to ceiling joists with 20 psf roof LL and 10 psf DL, minimum 2x6 SFP or SYP
2. Collar ties and diagonal bracing may still be needed
3. Replace roof decking this thermal shield decking.

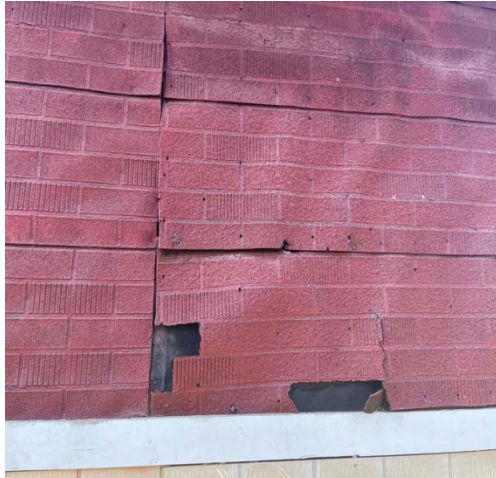
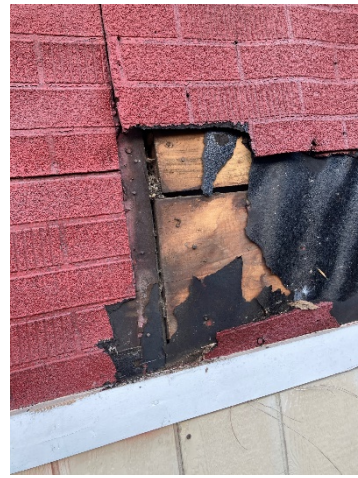
View of Damaged Siding Along **South Wall**

1. Remove siding and sheathing
2. Check wall plate and studs for termite damage. Replace as needed.
3. Install continuous plywood sheathing to meet braced wall panel requirements or acceptable option.
4. Install house wrap

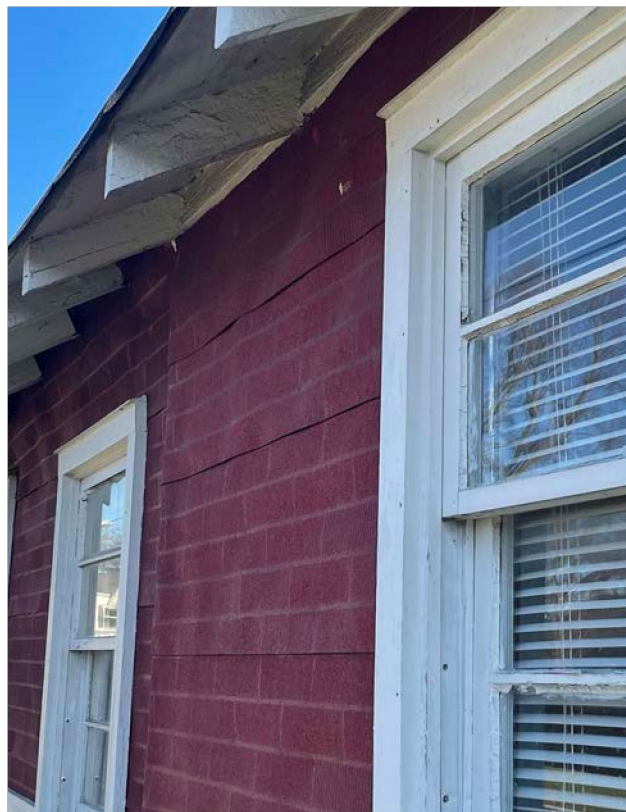
View of rafters, siding, and windows along North wall

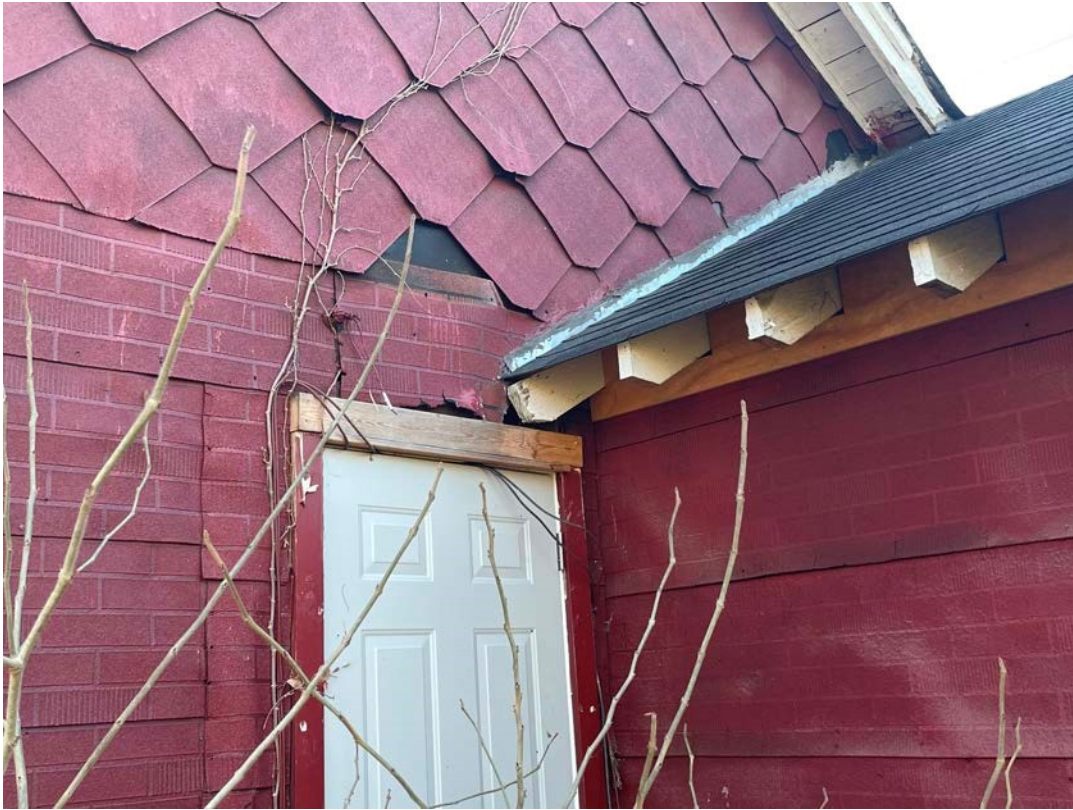
Closeup of Transition between original house and addition at the rear

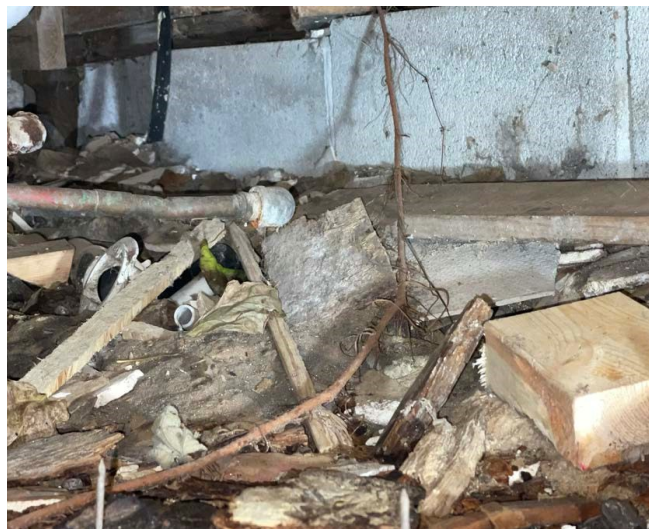
**View of Debris in Crawl Space
(Note CMU foundation wall)**

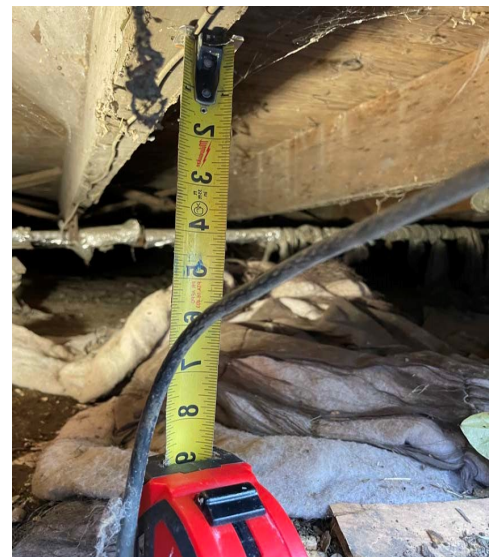
Head Space in Crawl Space Less than 12"

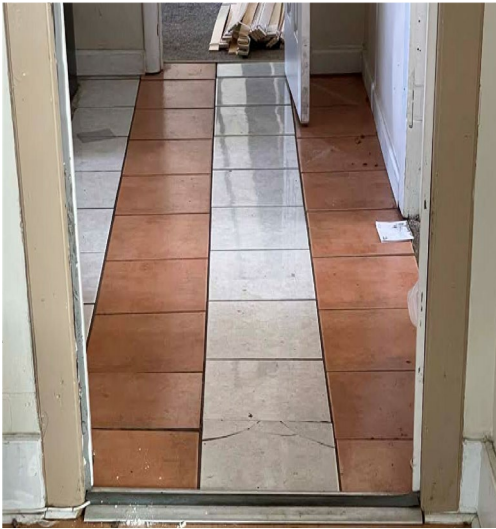
1. The flooring in the house consist of carpet, laminate flooring and tile.
2. None of the flooring is level; sags in many areas; slope is 1/2" or more from level in other areas.
3. Tile floor in the kitchen is cracked.
4. There is a hump in the middle of the floor along the central girder.

Cracked Uneven Tile Floor

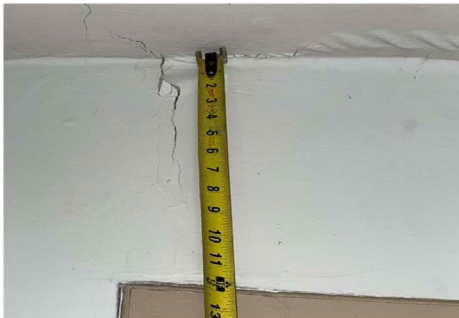
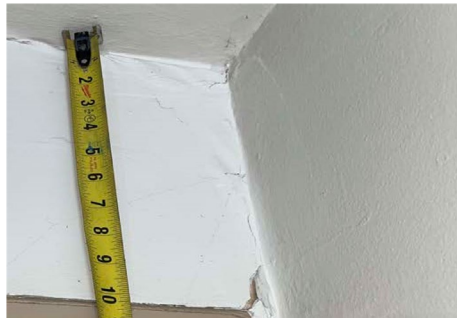
1. Most of the doors stick and do not close properly.
2. The alignment of the at least two doors in 1-2" out of level.
3. Windows are wood casement type and show some signs of rot.
4. The multiple layers of siding are installed around the windows and exterior door frames with proper flashing or waterproofing. This allows moisture to get trapped and cause damage

1-inch difference in door frame below

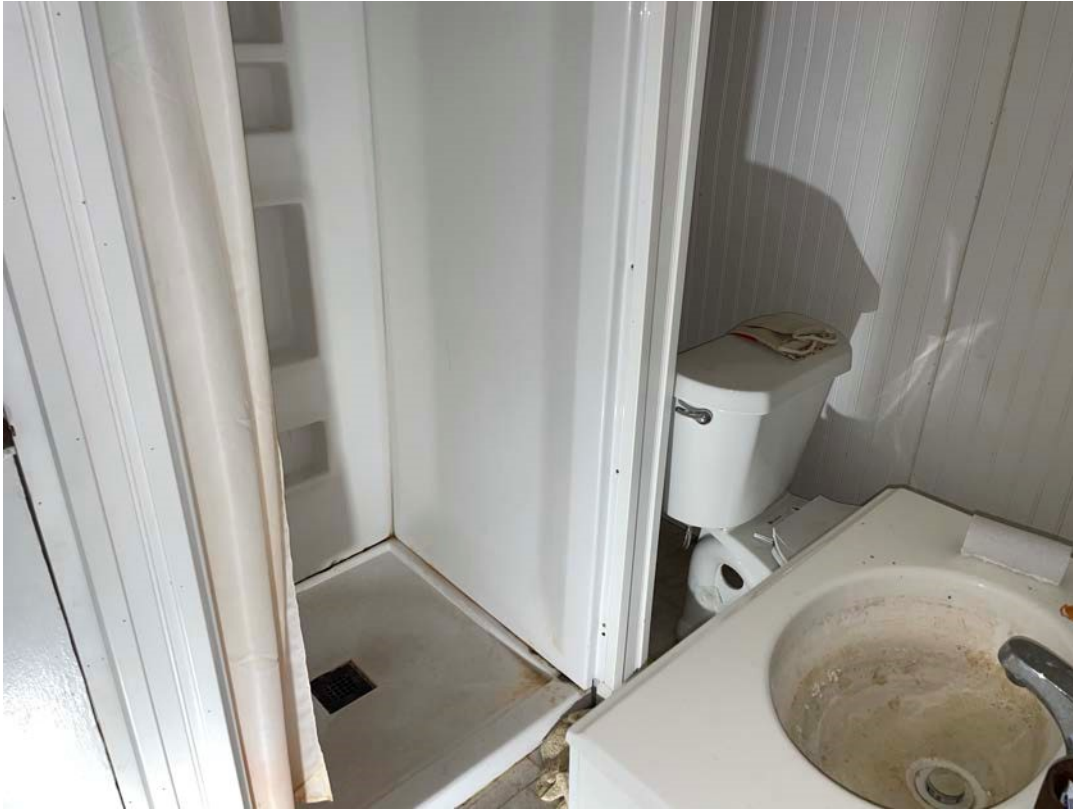
View of Bathroom – Not compliant with codes

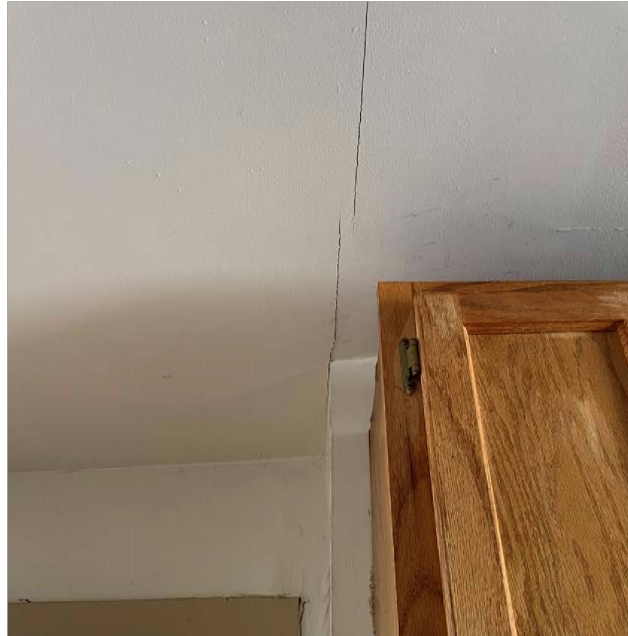
1. Interior walls show cracks in nearly every room, especially at ceiling/wall junctions.
2. The ceiling in the kitchen is sagging.

Separation crack in kitchen ceiling

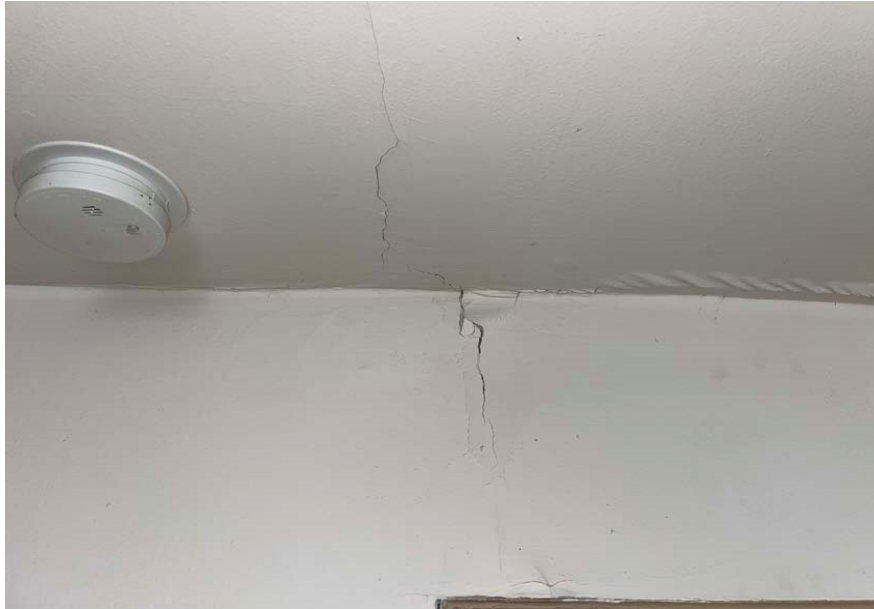
Typical cracks in drywall throughout
