METROPOLITAN GOVERNMENT OF NASHVILLE AND DAVIDSON COUNTY

STAFF RECOMMENDATION
1204 Russell Street
March 17, 2021

Description of Project: The applicant requests demolition of a contributing building, arguing for economic hardship.

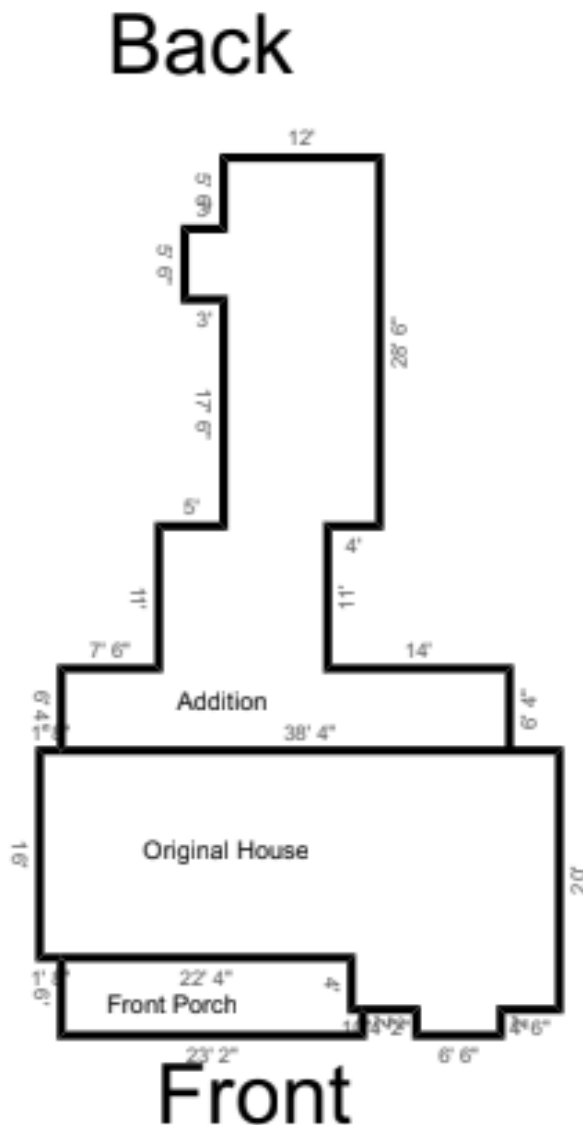
It is unknown when the footprint of the building changed, but a kitchen was added with the first addition and one more room was added with the second addition. It was observed that the additions did not have proper foundations allowing a crawlspace

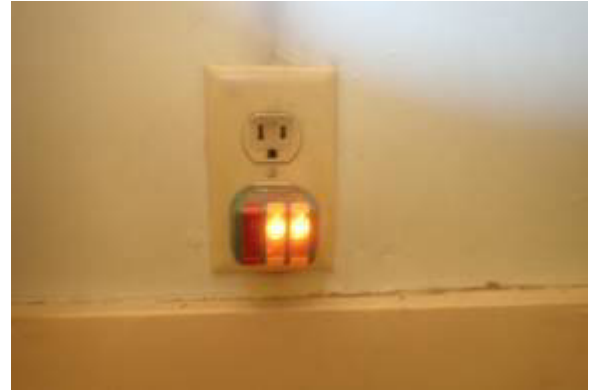
18. No GFCI protection was noted at the bathroom and kitchen sink counters or exterior wall receptacles. GFCI protection is recommended at all wet areas. Further investigation is recommended by a licensed electrical contractor with corrections made as needed.
