STAFF RECOMMENDATION 1609 Franklin Ave March 17, 2021

Application: Demolition
District: Eastwood Neighborhood Conservation Zoning Overlay
Council District: 06
Base Zoning: R8
Map and Parcel Number: 08306005000
Applicant: Micheal Klamann
Project Lead: Robin Zeigler, robin.zeigler@nashville.gov

I am writing to summarize the condition of 1609 Franklin Avenue in Nashville, Tennessee based on visual structural observations on August 6, 2020. My observations represent an opinion of the condition of the house structure and remediation recommendations.

STRUCTURAL EVALUATION OF RESIDENCE
1609 Franklin Avenue
Nashville, Tennessee
Project #220368

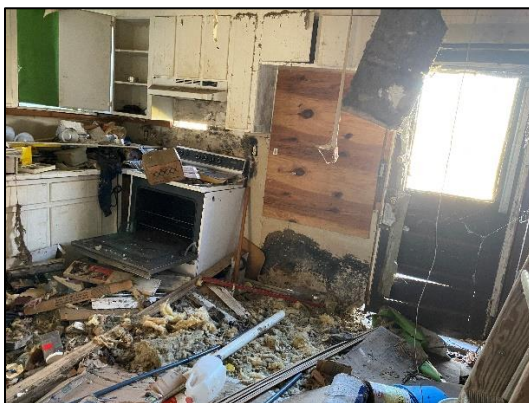
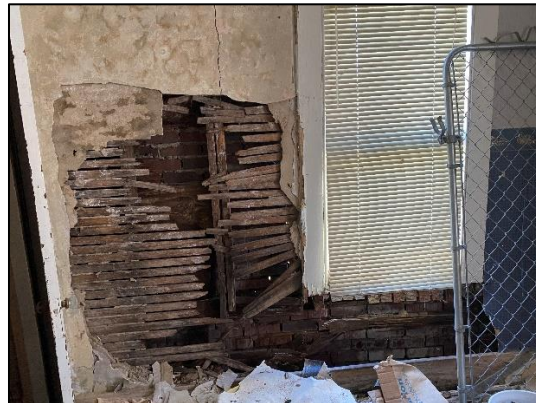
Figures 2 and 3: Interior views of 1609 Franklin Avenue.

The building has been primarily unoccupied since 1993. The 1998 tornado damaged the roof, which was never properly repaired. Water damage, debris, animal incursion and decaying trash have deteriorated the floor and walls.

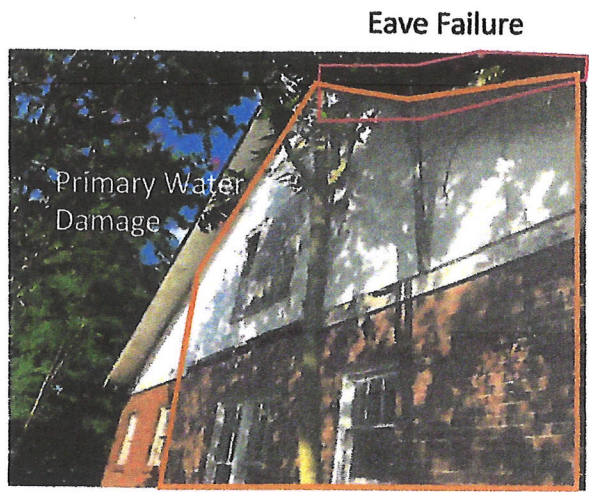
West Facade

Eave Failure

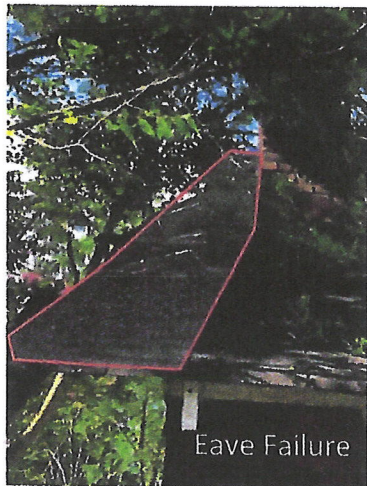
At the time of my observations, the structure showed significant water damage on the west and north exterior walls. The primary water infiltration along the west wall occurs from the ridge of the roof with a concentration at the chimney and fireplace. The north wall water infiltration extends the majority of the length of the wall.

Roof Damage – West Wall/Roof

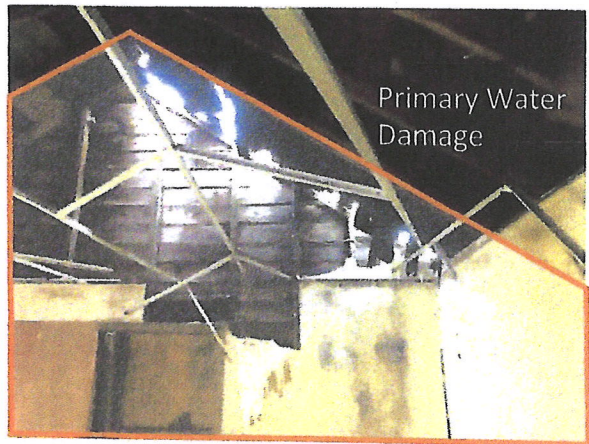
Water Damage – West Wall/Roof

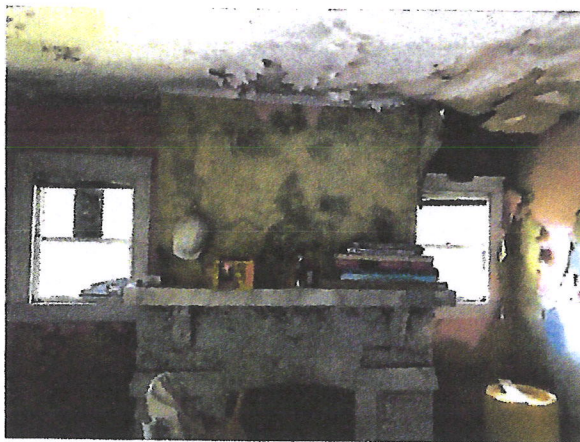
Water Damage – West Wall/Fireplace

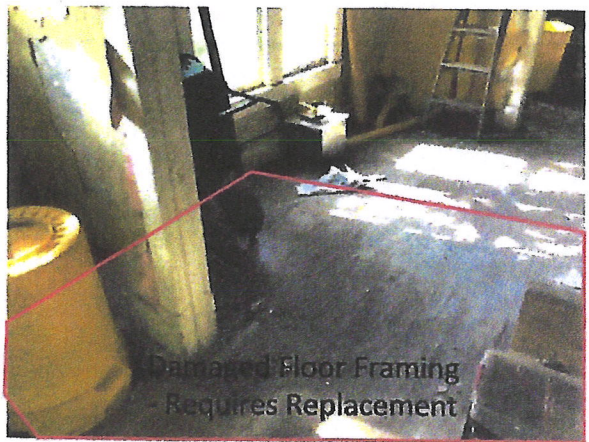
Water Damage – West Wall/Floor

Settlement/Deformation

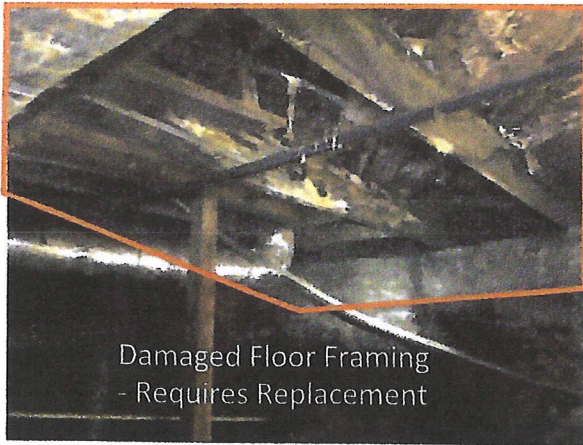
The water infiltration along the west wall has contributed to significant structural deficiency along the length of the wall. The west wall damage extends from the ridge of the roof, down the first level wall, and into the floor joists surrounding the fireplace. It is my opinion that the water damage will require deconstruction and replacement of approximately 60 percent of the west wall. The water damage at the floor joists will require the removal and replacement of approximately eight floor joists and an interior wall supported by the floor joists. The floor joists supporting the second level were not visible at the time of my observations. Replacement of second level joists should be reviewed once the framing is visible.

Damaged Floor Framing - Requires Replacement
Water Damage – West Wall/Floor Joists

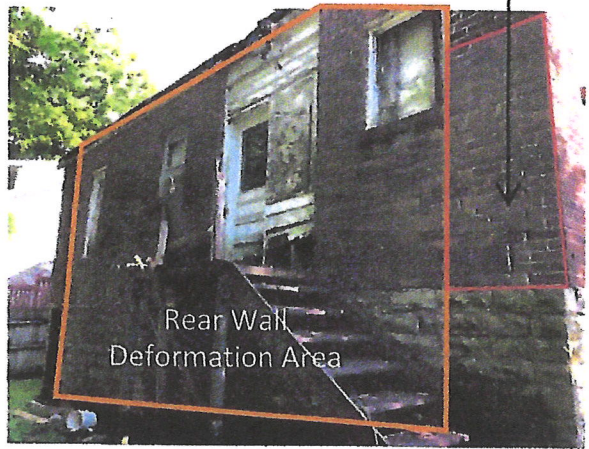
The north exterior wall is load bearing (second level and roof loading) and structurally deficient. It is unclear if the structural damage occurred prior to the water damage or if the water damage is a result of structural deterioration. The exterior of the north wall has significant and permanent out-of-plane deflection. The deflection is apparent in the brick and foundation wall. From the interior of the structure, walls and wall framing are deteriorated to the extent that the inside face of the brick façade is fully visible for approximately 40 percent of the north wall. The length of the wall will require demolition and replacement to restore the integrity of the wall.

Rear Wall Deformation Area
North (Rear) Facade

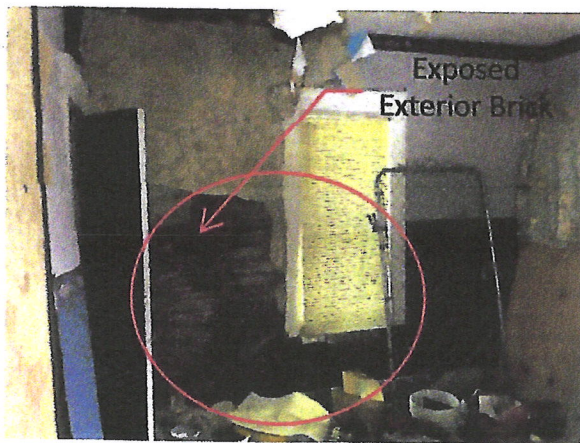
Exposed Exterior Brick
Water Damage – North Wall

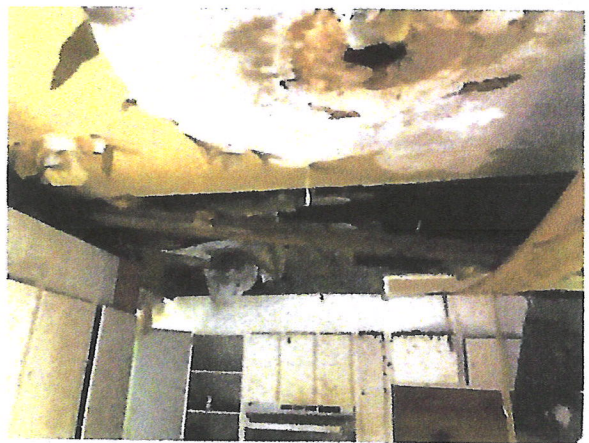
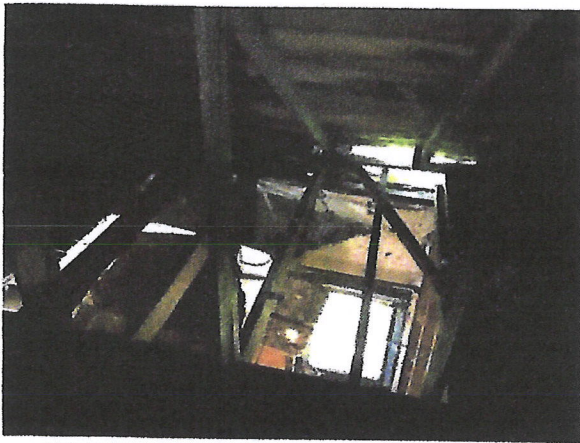
Ceiling Framing at Kitchen: At the time of my observations, the ceiling of the kitchen had collapsed. The collapse appears to be a result of the water infiltration from the north wall. Following the replacement of the north wall, the ceiling framing will require replacement.

Water Damage – Kitchen Ceiling Collapse

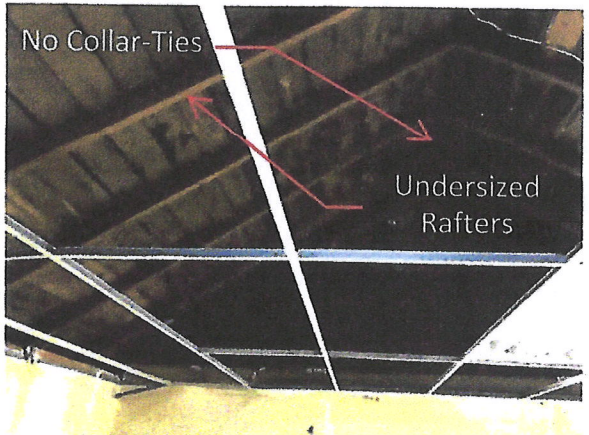
No Collar-Ties
Undersized Rafters
Rafters

Rafters: The framing of the roof consists of 2x4 timber rafters. The rafters exceed permissible span limits of 2x4 rafter framing and require scabbing 2x8 or 2x10 framing onto the rafters. Additionally, collar ties are recommended for additional stability of the roof system.
