JOHN COOPER
MAYOR

METROPOLITAN GOVERNMENT OF NASHVILLE AND DAVIDSON COUNTY

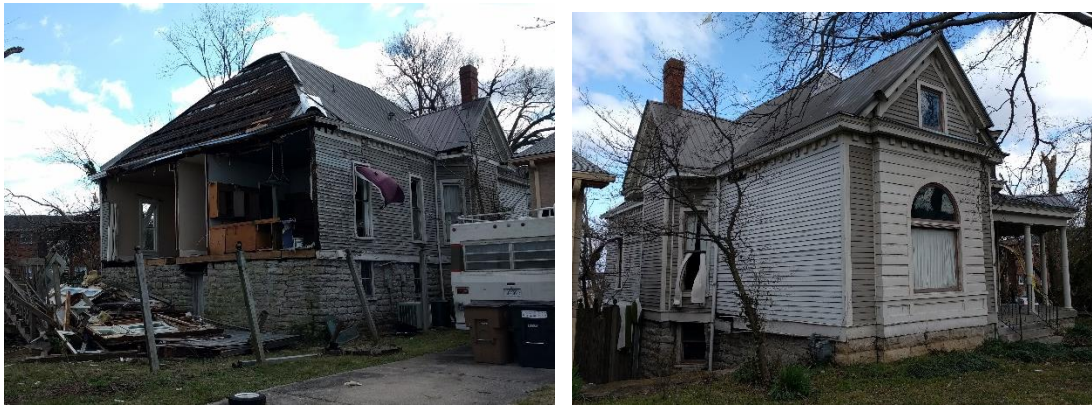
Figures 5 and 6: The house as seen after the storm on March 6, 2020.

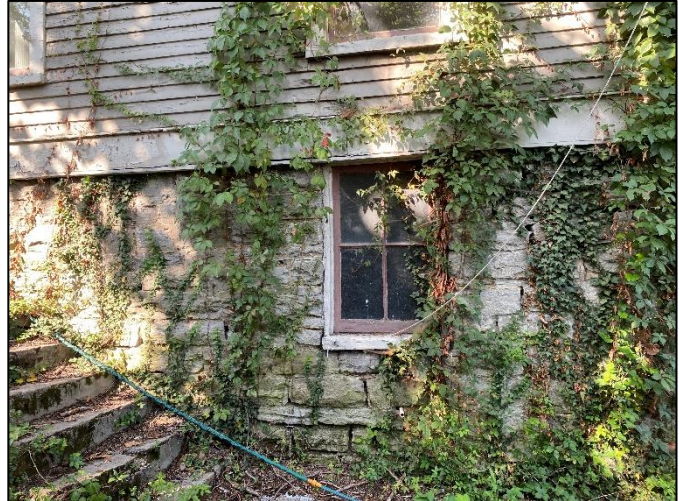
Figure 7: Foundation wall on the east side shows mortar joints that have deteriorated but is overall in good condition.

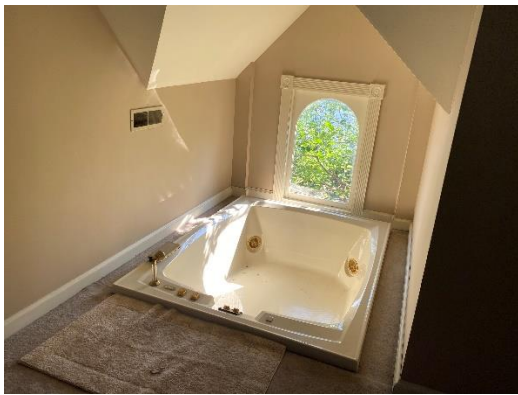
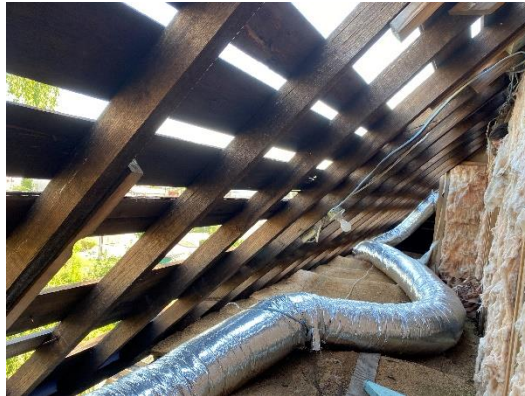
Figures 8 and 9: The house as seen after the storm on March 6, 2020.

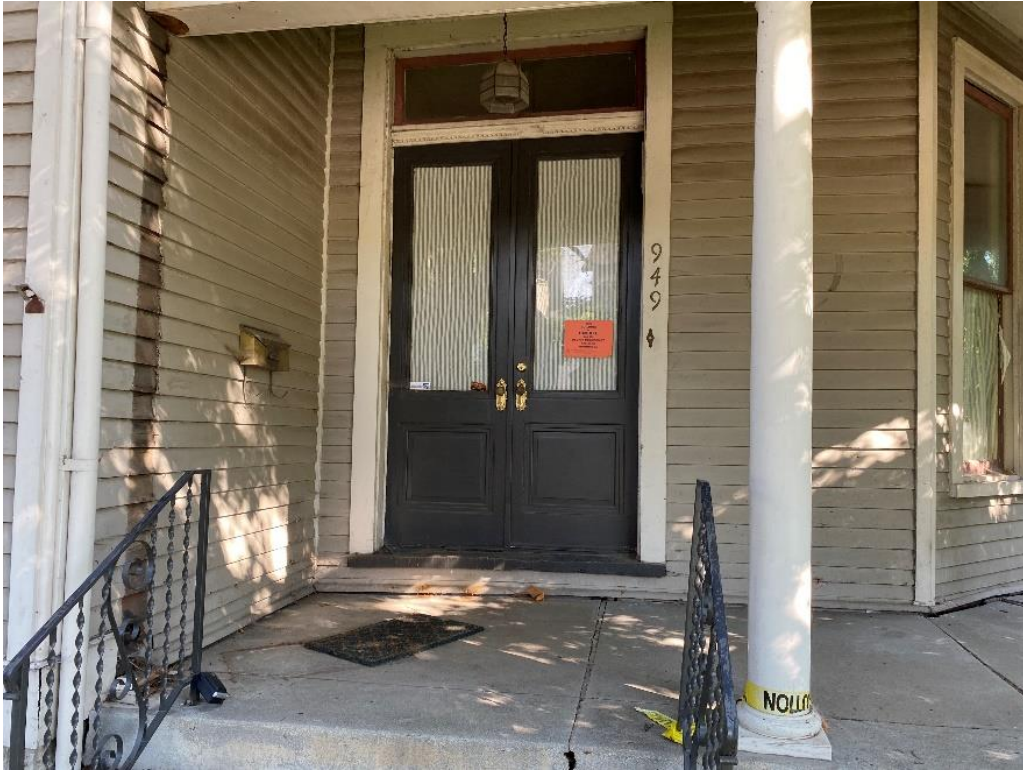
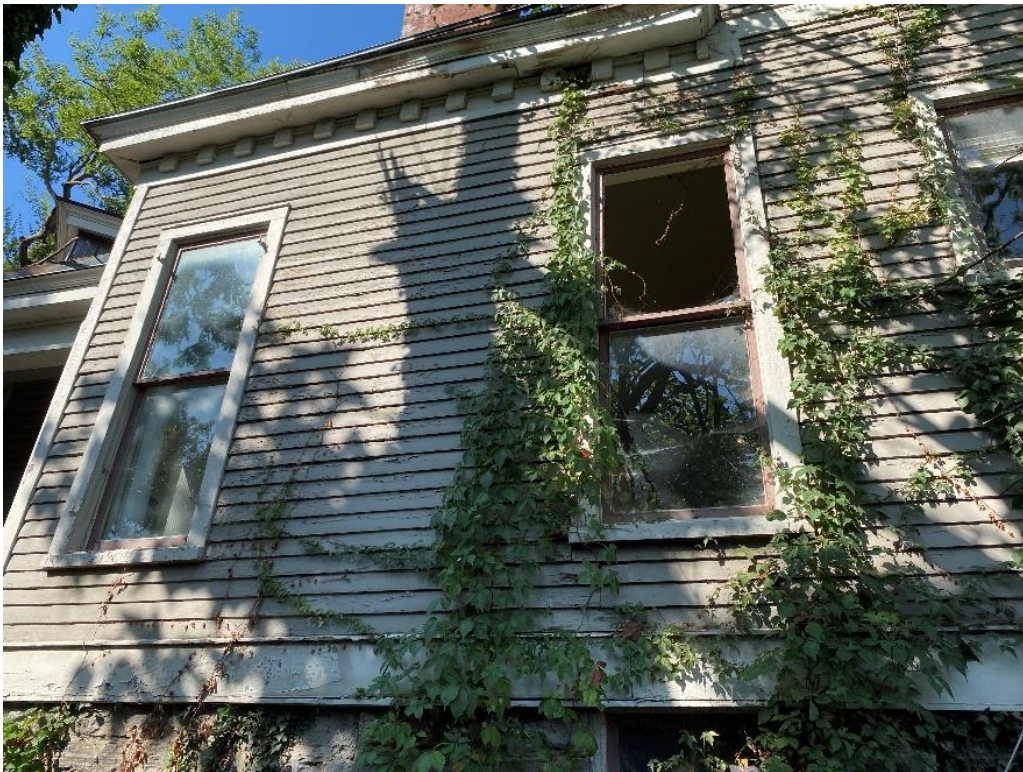
ATTACHMENT B: PHOTOGRAPHS

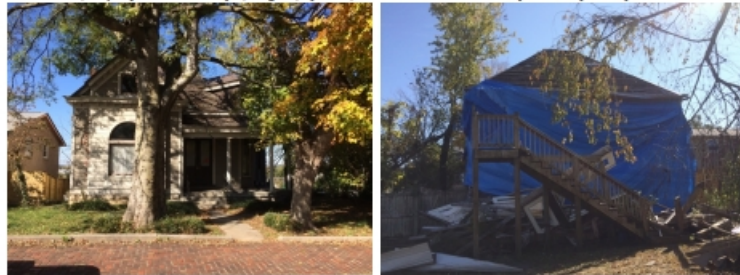
Note, any references to "left", "right", "front", or "back" are as viewed from the front of the home.

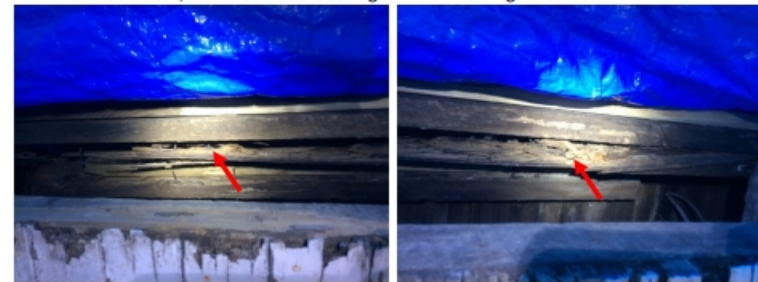
DailyEngineering@yahoo.com - (615) 450-8364 - P.O. Box 331865 - Murfreesboro, TN 37133

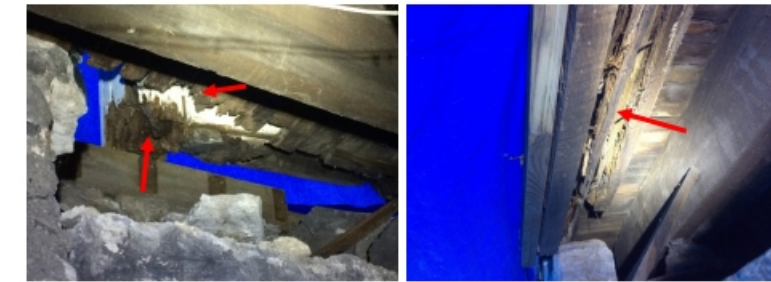
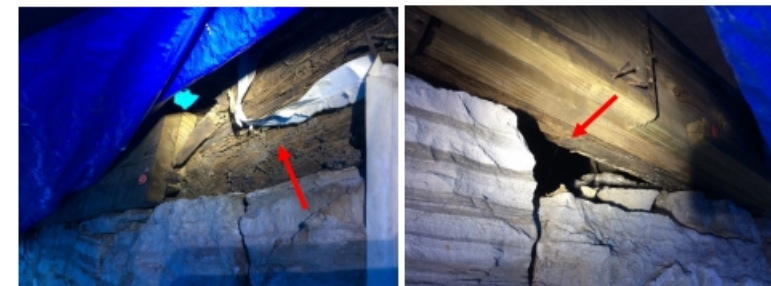
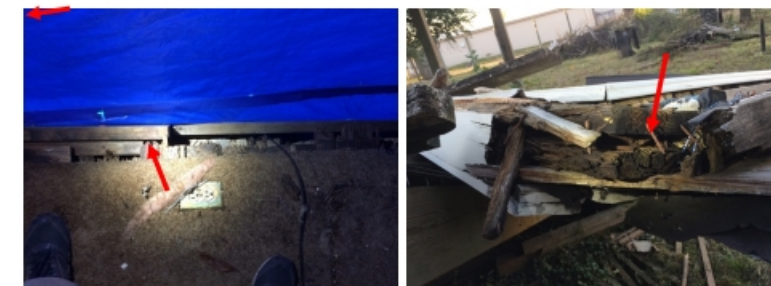
2. The wall from the left front corner of the home to the corner of the bay window in the dining room has broken free at the base and rolled outwards. Examination of the rim joists at this location determined that they have been damaged by water infiltration of the wall causing the wood to rot. The bases of the vertical 2x4 studs were also rotten.

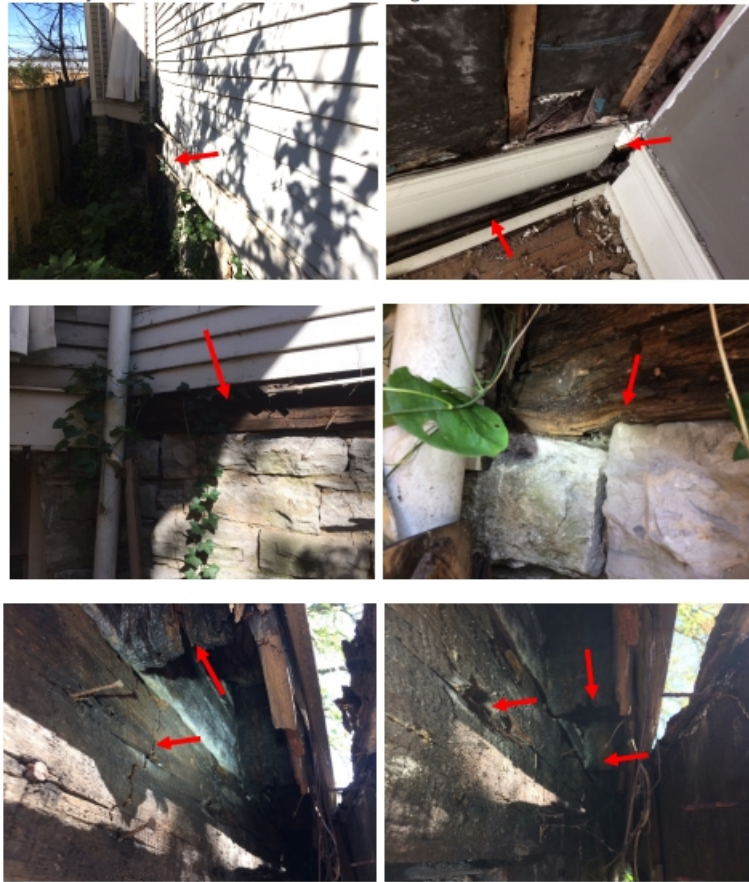
DailyEngineering@yahoo.com - (615) 450-8364 - P.O. Box 331865 - Murfreesboro, TN 37133

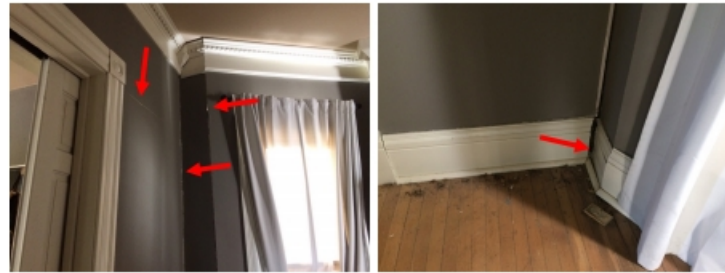
3. The walls of the front rooms of the home are leaning to the right, indicating that the wall framing has racked. The front to back walls along the hallway are 1/2" out of plumb in a 4' vertical level near the front wall tapering back to plumb at the stairwell. The racking has caused cracks to appear in the drywall around the doors and tapered gaps to open in the door trim. As the rear half of the home is plumb, the racking in the front half is apparently a function of structural weakness developing over time or the effect of the tornado's initial impact on the left front corner of the home.

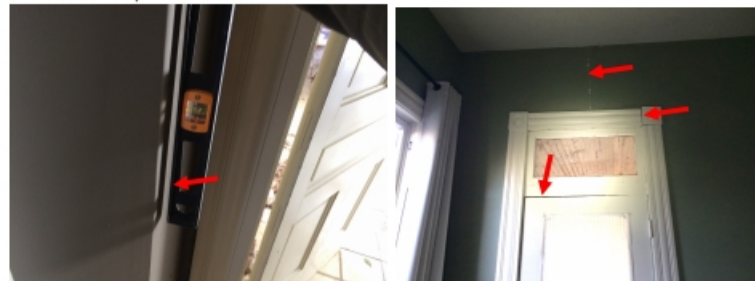
4. Where exterior window in the kitchen was blown in by the storm, the underlying wood framing could be observed. Evidence of wood rot in the framing could be observed due to years of water leaking in around the window. Less severe damage was also noted in the side jamb of the window in the dining room to the left of the fireplace. No other window frames were removed in their entirety, so the full extent of this type of damage is unknown.

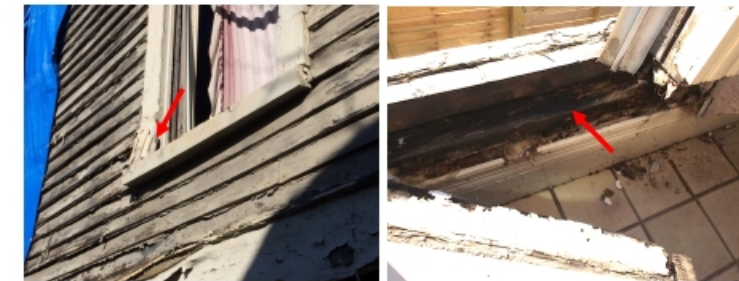
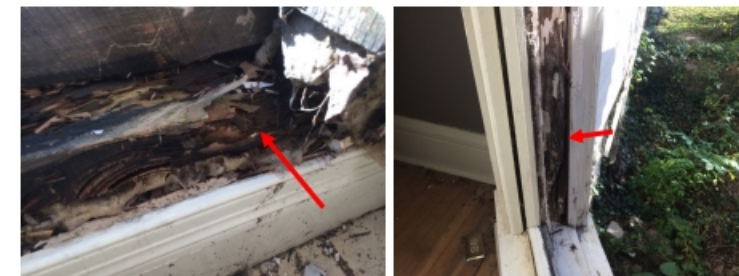
5. Damaged original hardwood floors were noted throughout the first floor. Gaps have developed between most of the tongue and groove planks, some approaching 1/4" wide. Soft spots in the flooring were also noted in the front rooms where water, wood destroying insects, or furniture weight have affected the wood's structural integrity.

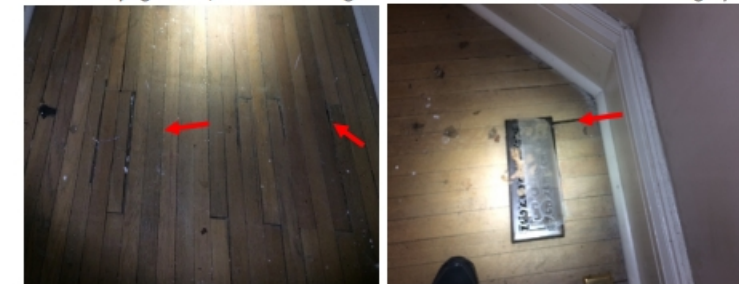
DailyEngineering@yahoo.com - (615) 450-8364 - P.O. Box 331865 - Murfreesboro, TN 37133

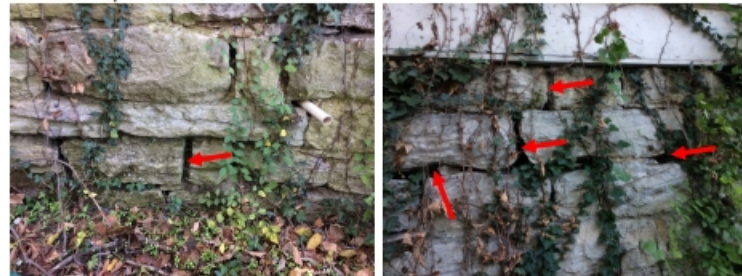
DailyEngineering@yahoo.com - (615) 450-8364 - P.O. Box 331865 - Murfreesboro, TN 37133

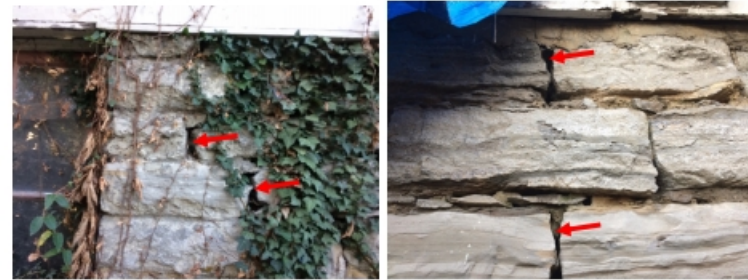
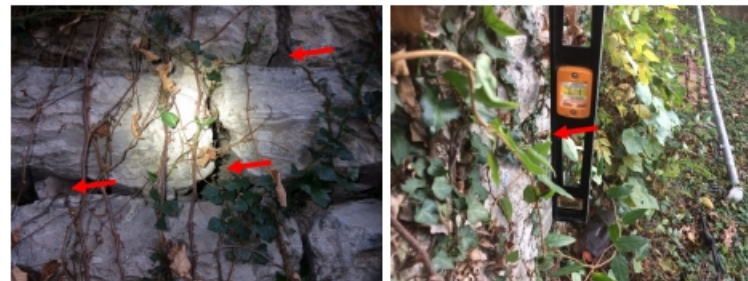
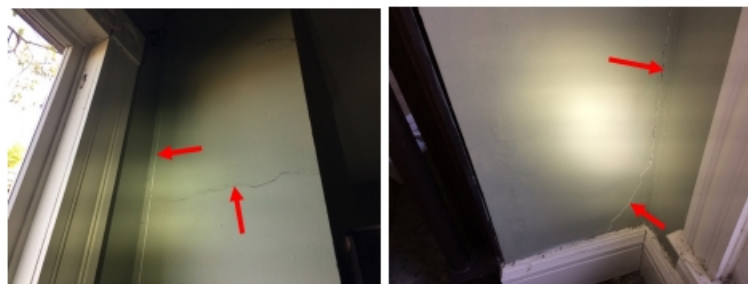
7. The weakened mortar has most likely contributed to movement in the foundation wall at the left rear corner of the home as well. A vertical crack is present in the rear face of the foundation wall at this corner indicating that the load bearing outer layer is leaning towards the left at this corner.

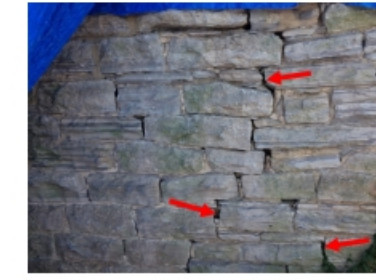
8. Sections of the rear foundation wall in the right corner are missing at the top, leaving the rim joist to support the exterior walls above across three gaps of up to three feet each.

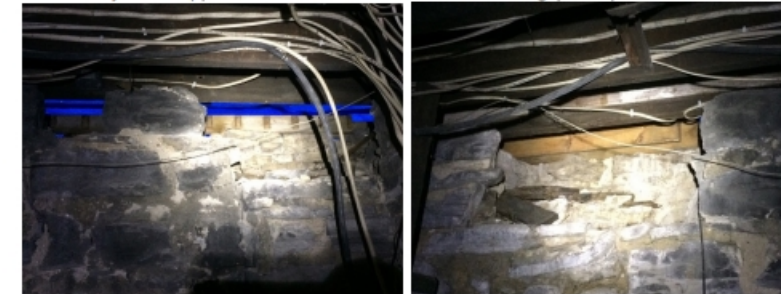
9. The interior side of the foundation wall beneath one of these gaps has 1/2" wide vertical crack running the full height of the wall.

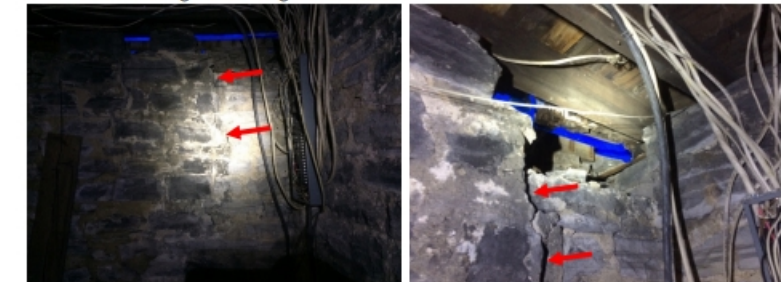
DailyEngineering@yahoo.com - (615) 450-8364 - P.O. Box 331865 - Murfreesboro, TN 37133

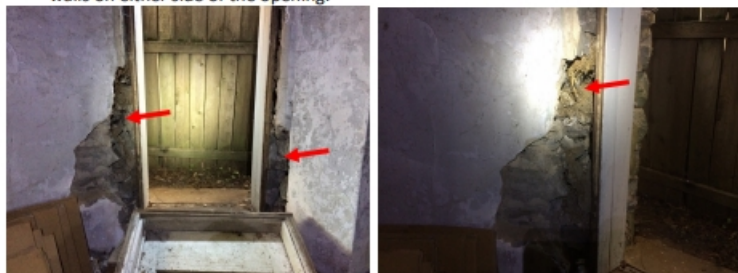
11. Damaged foundation walls were also noted under a window on the right hand side of the basement, in the wall adjacent to that window, and where the HVAC condensate lines were run through the wall.

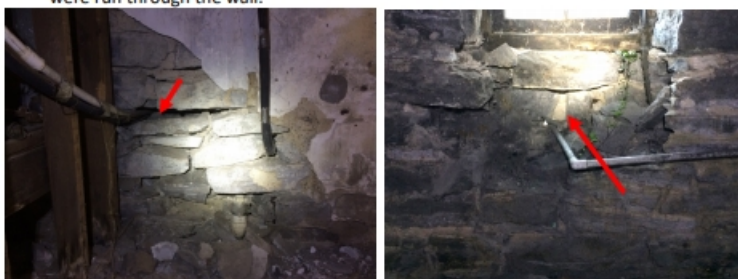
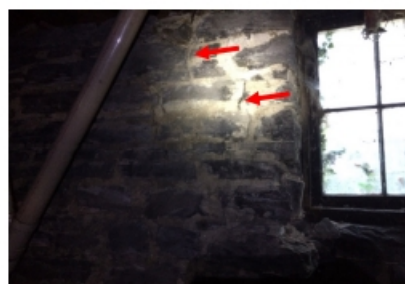
DailyEngineering@yahoo.com - (615) 450-8364 - P.O. Box 331865 - Murfreesboro, TN 37133

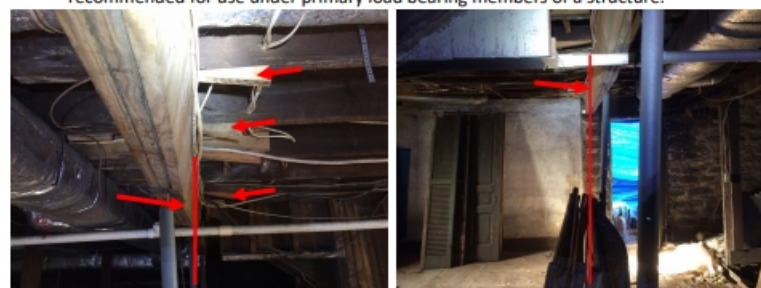
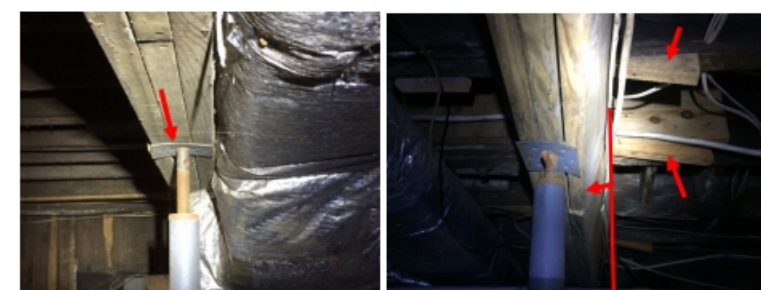
DailyEngineering@yahoo.com - (615) 450-8364 - P.O. Box 331865 - Murfreesboro, TN 37133

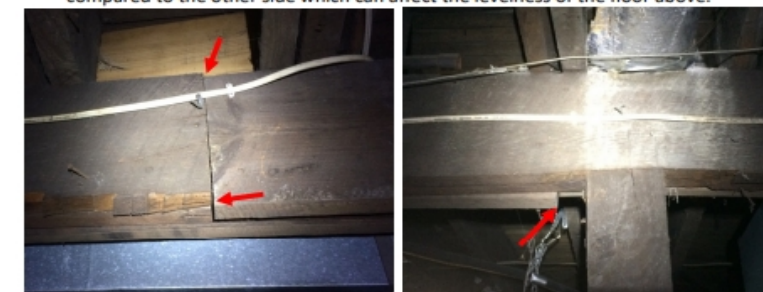
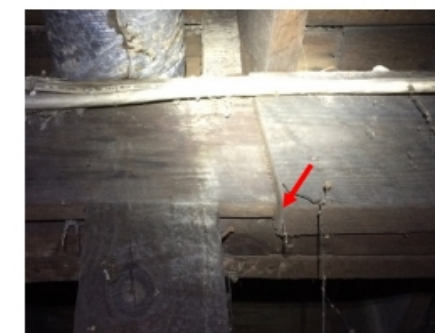
14. The wood destroying insect damage was not limited to the left hand beam only. Thirty one of the floor joists under the left half and central hallway of the home were also damaged. Some attempts were made to supplement the damaged members through the installation of short sections of 2x10's and 2x12's beside the damaged ends of the joists. These supplements were not attached to the original joists, so the damaged members are still supporting the majority of their original structural load. In one location, the flooring beneath the wall cavity was also damaged, greatly reducing the support available for the wall framing.

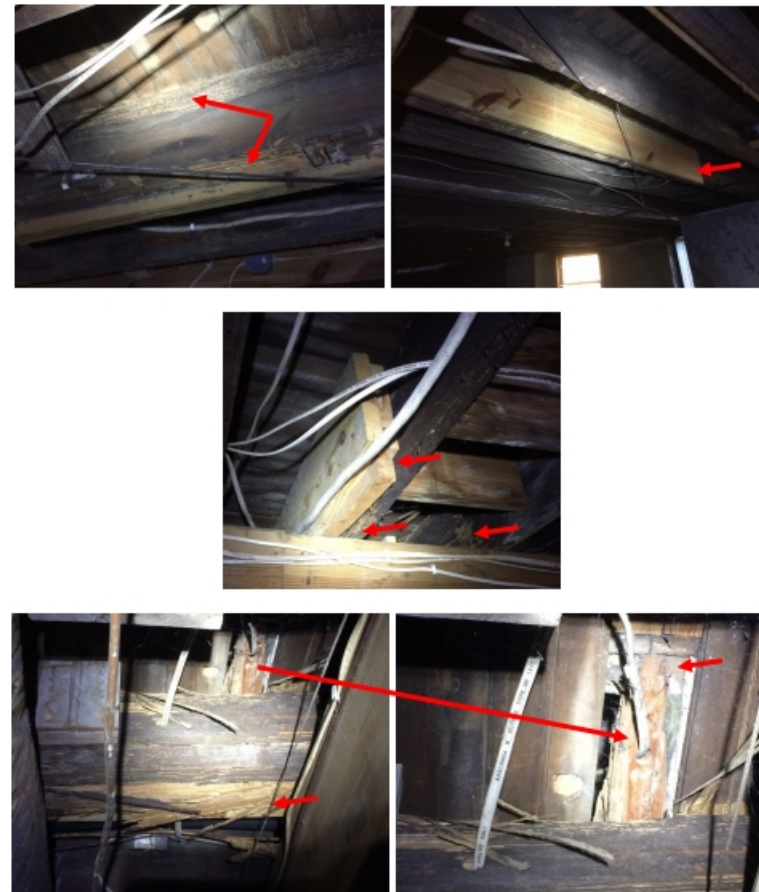
Undermined wall framing due to insect damaged floor

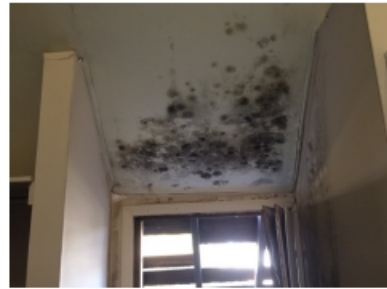
16. Historic evidence of water damage was also noted in the floor framing of the first floor bathroom. The end of one floor joist has completely rotted away and been re-supported by a 2x6 extension nailed to its end. This is not structurally sound.

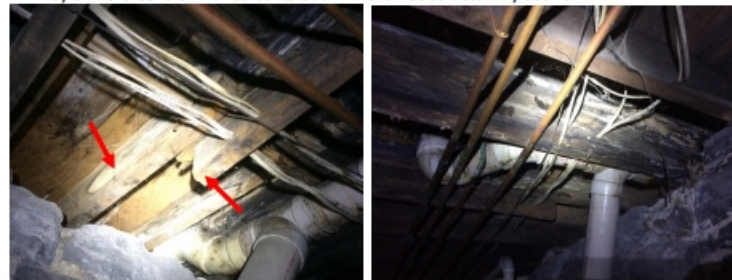
17. One floor joist under the front left living room of the home was cut to provide clearance for a HVAC duct. It was "headered-off" with a smaller 1x that is insufficient to transfer the cut joist's structural load to the adjacent members.

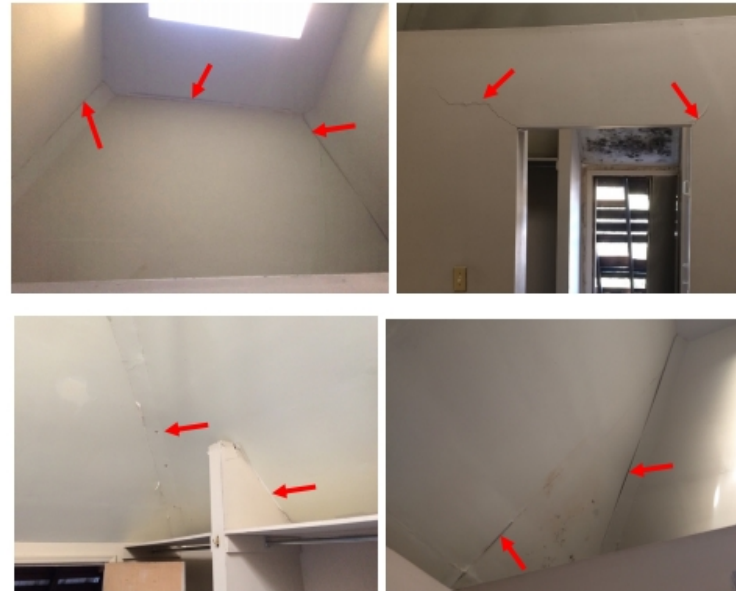
DailyEngineering@yahoo.com - (615) 450-8364 - P.O. Box 331865 - Murfreesboro, TN 37133

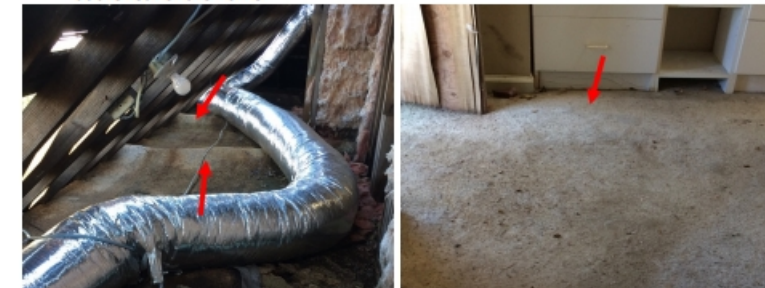
21. The front porch of the home is a concrete slab with a mortared stone foundation wall on the outside perimeter. The porch deck supports the framing for the shed roof above it through wooden columns. The foundation wall apparently does not have a sufficient footing because several of the blocks have broken free from the wall and the slab has cracked into large sections at the expansion joints. The cracks are up to 1" wide. The slab sections have dropped and pulled away from the house by more than 1". The movement is significant enough to tilt the columns out of plumb.

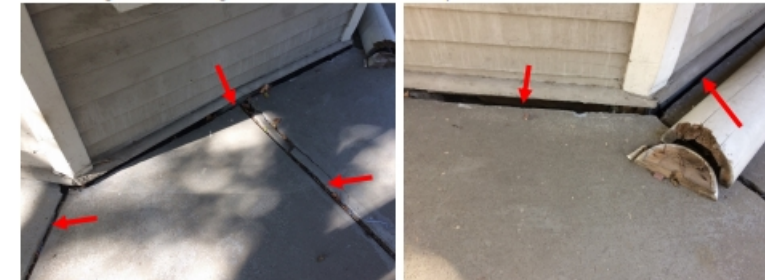
DailyEngineering@yahoo.com - (615) 450-8364 - P.O. Box 331865 - Murfreesboro, TN 37133

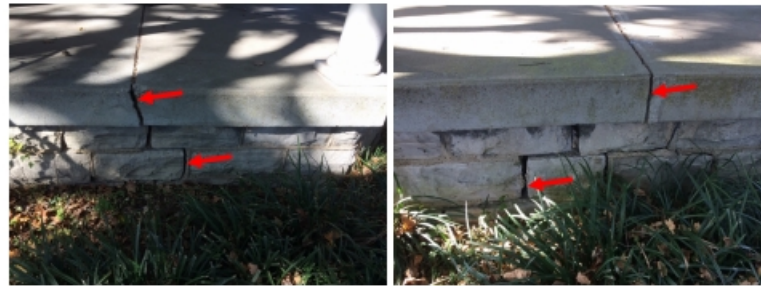
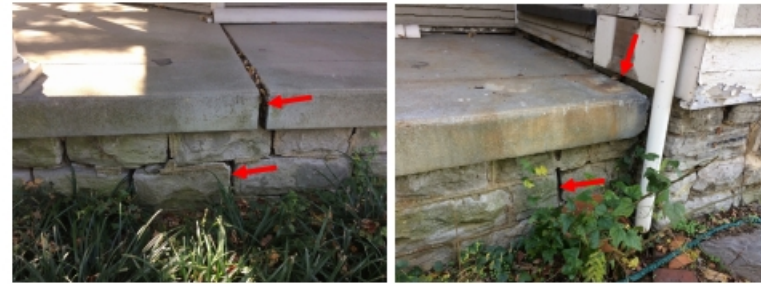
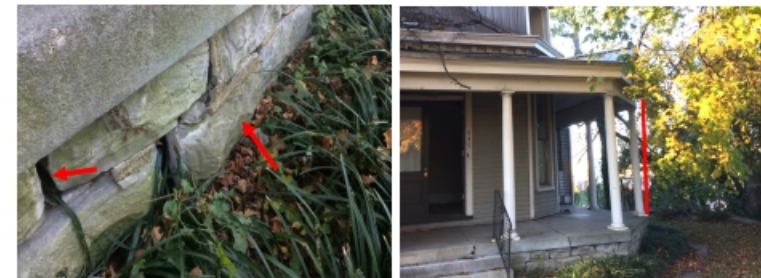
22. The porch section at the front door is cracked in the center and sloping towards the left, directing any water that blows onto the porch surface towards the right side wall of the front living room.

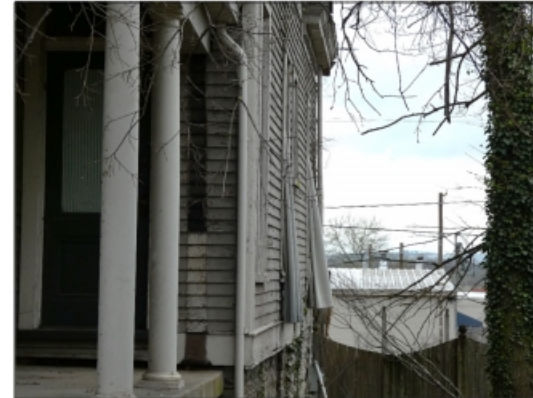
Photograph 7
Debris from the north wall resting on the failed deck.

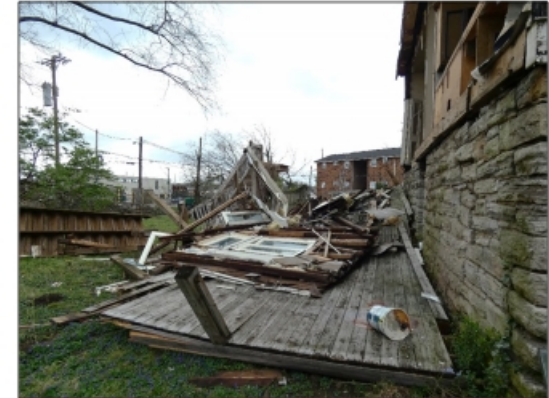
Photograph 2
East elevation of the residence.

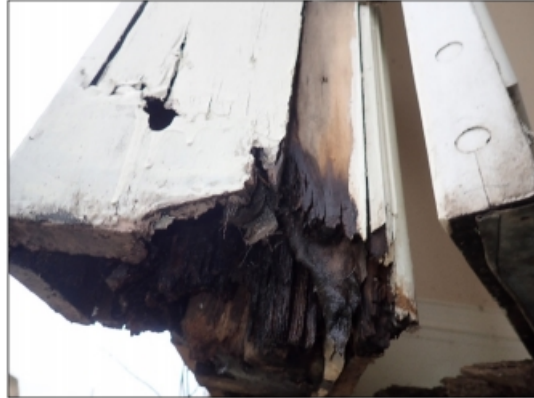
Photograph 11
Typical deterioration of the floor framing near the perimeter.

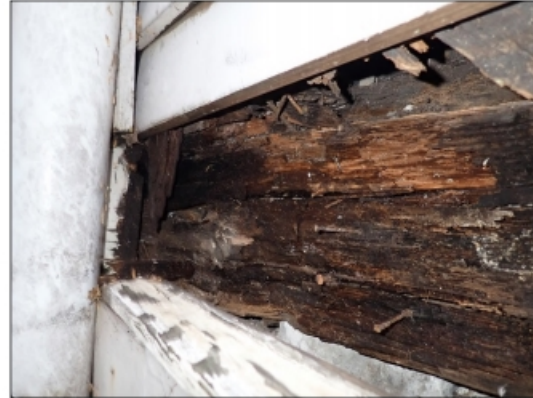
Photograph 13
Close-up view of the exposed wood planks on the north slope of the roof.

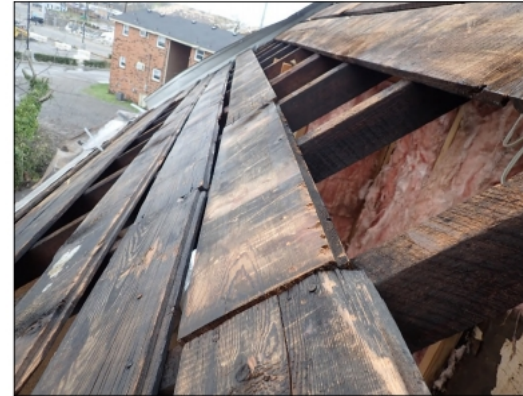
Photograph 15
Close-up view of the open mortar joints in the stone foundation wall.

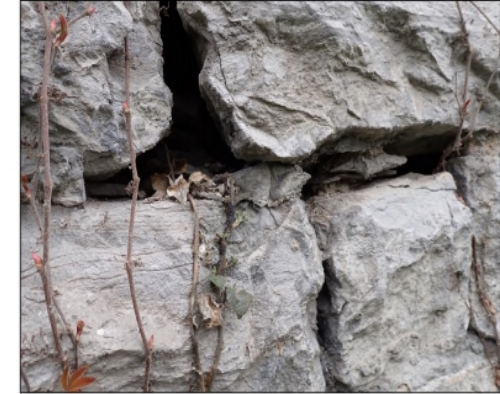
Photograph 10
Deterioration and a former repair along the bottom of the north elevation.

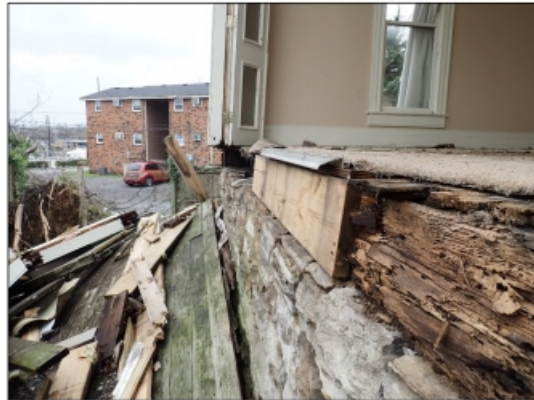
Photograph 12
Roof covering and a portion of the wood planks were missing on the north slope.

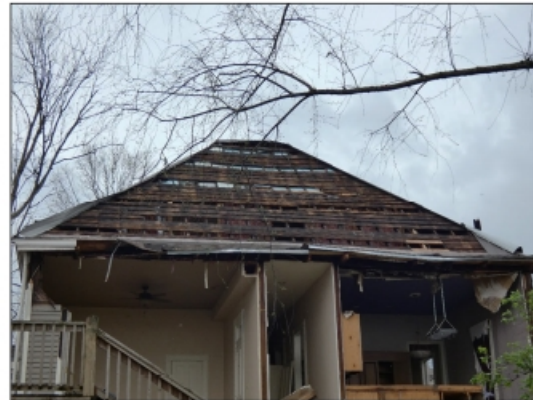
Photograph 14
Cracks and deterioration in the mortar joints and organic growth on the foundation wall.

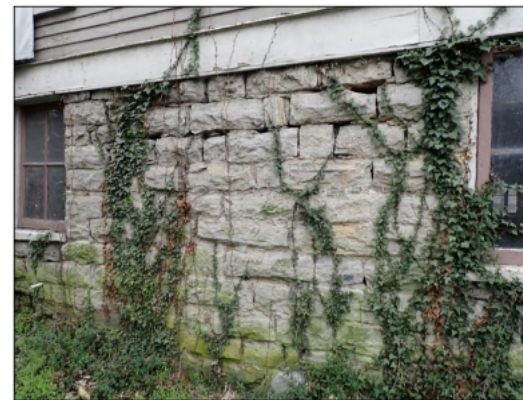
Photograph 16
Cracks in the stone foundation wall near the northwest corner of the residence (red arrow).

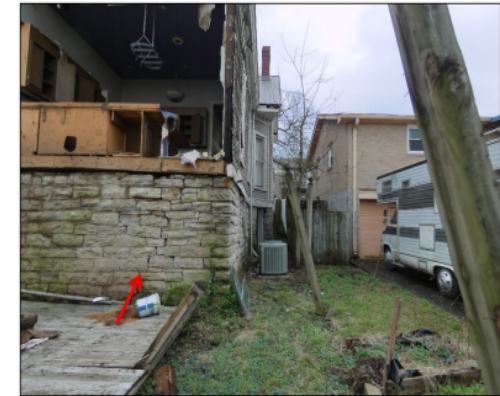
April 27, 2020
Rimkus File No. 100030156

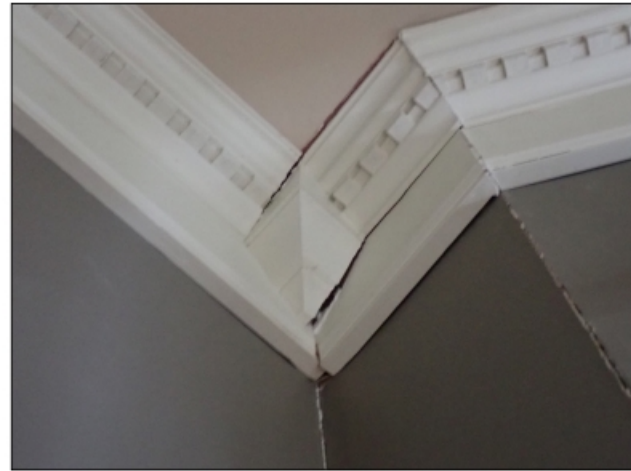
Photograph 24
Typical cracks in the ceiling and upper wall areas on the second story.

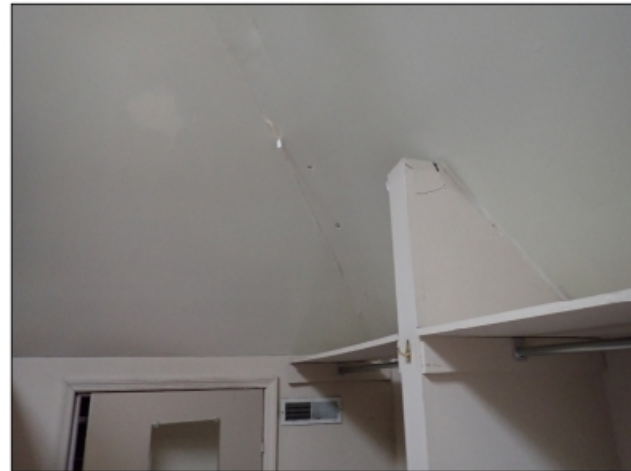
April 27, 2020
Rimkus File No. 100030156

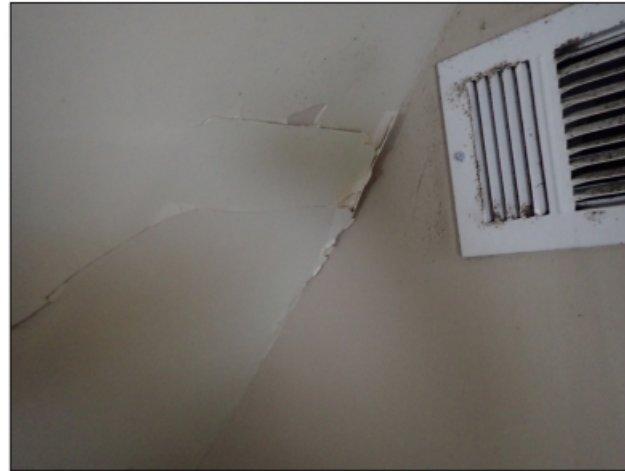
Photograph 26
Overview of the basement.

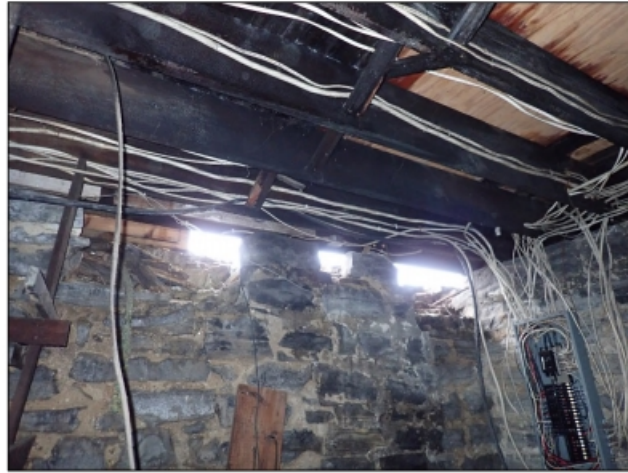
Photograph 30
View along the previously spliced and repaired beam in the basement, facing north. Note deflection at the north end, indicated by the red line.

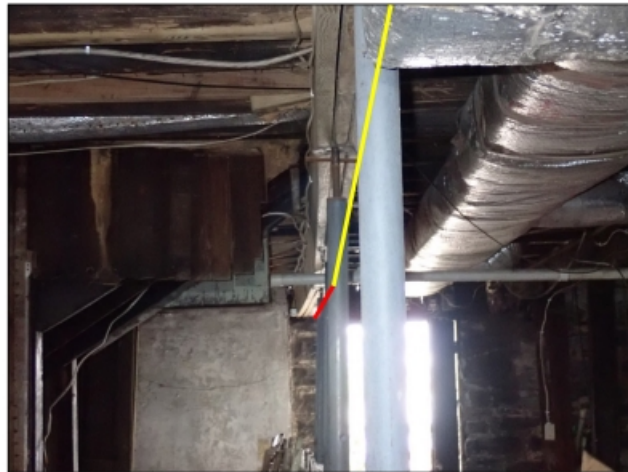
April 27, 2020
Rimkus File No. 100030156

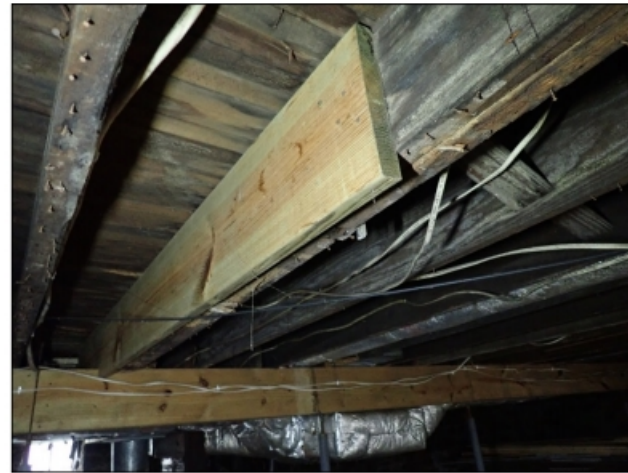
Photograph 32
Damage from wood-boring insects.

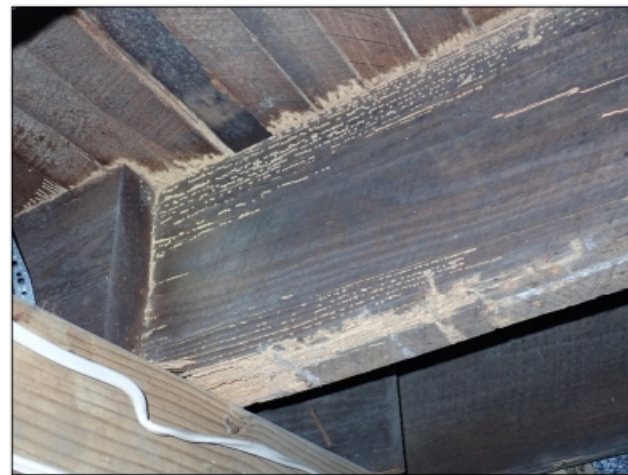
April 27, 2020
Rimkus File No. 100030156

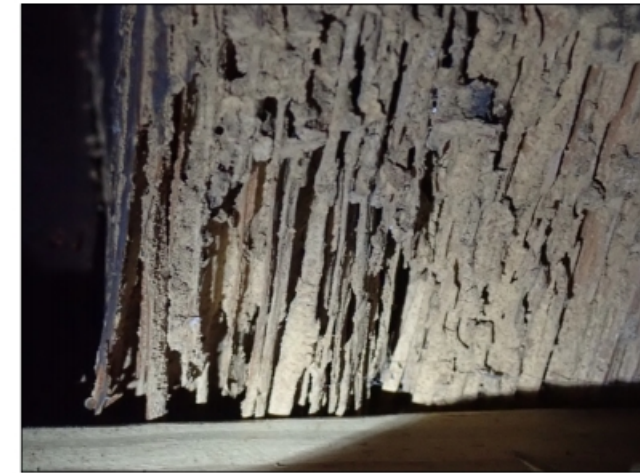
Photograph 34
Extensive wood boring insect activity and deteriorated wood.

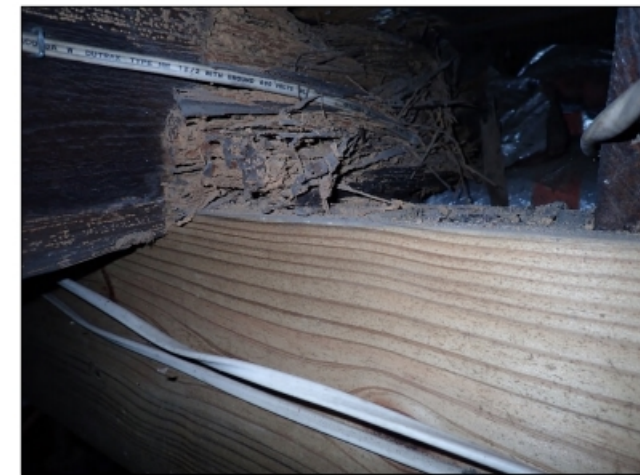
April 27, 2020
Rimkus File No. 100030156
