# HISTORIC STRUCTURE REPORT

## **FORT NEGLEY**

### **Nashville, Tennessee**

FINAL REPORT (CORRECTED)  
January 31, 2014

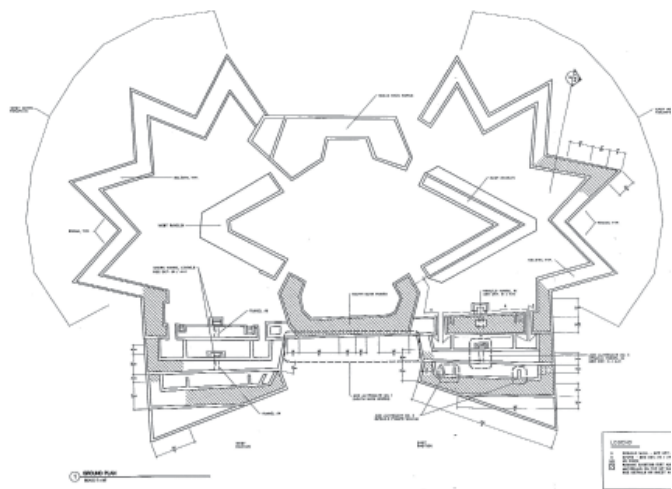
**Figure 83.** 1999 structural repair plan. Hickerson Fowlkes, Inc. Architects (FNVC). Hatched areas represent areas of repair.

Project meeting minutes and inspection reports indicate these structural repairs began to fail in localized areas as construction neared completion in 1999. GEC, a geotechnical consultant, was retained in early 2000 to perform an investigation of the collapses. The reported findings of the geotechnical investigation appear to be comprehensive and sound. Investigators concluded that the primary factor of wall collapse was tie pull-out failure due to the limited embedment lengths of geogrid ties beyond the soil failure plane and their lack of connection to the face stones. This lack of tension reinforcement and/or wall ties to the internal rubble substrate beyond provided minimal restraint against lateral earth pressure and forced the relatively narrow facing stones along the exterior wythe to serve as a gravity retaining wall.

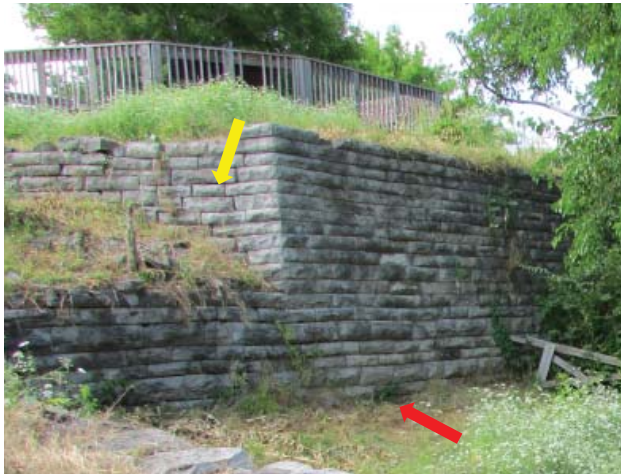
**Figure 59.** Slight batter—0.03 horizontal to vertical—observed at scarp of South Main Works (1200 AE, 2013).

This location exhibiting out-of-plane displacement due to sliding as indicated by stepped open horizontal and vertical joints (yellow arrow) and measurements at the base of wall reporting a 4-inch change in outward displacement between grade and two feet above grade (red arrow)

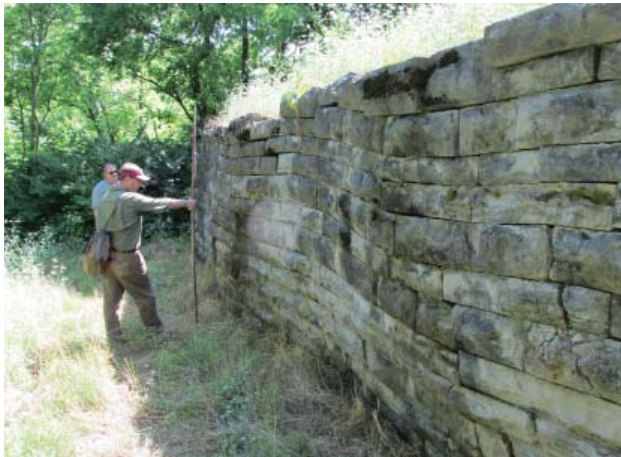
**Figure 60.** Bulging and out-of-plane rotation along east elevation of West Bastion (center and left), vertical cracking of stones to right, and dislodged and lost capstones (1200AE, 2013).

This wall area appears to date to WPA reconstruction efforts.

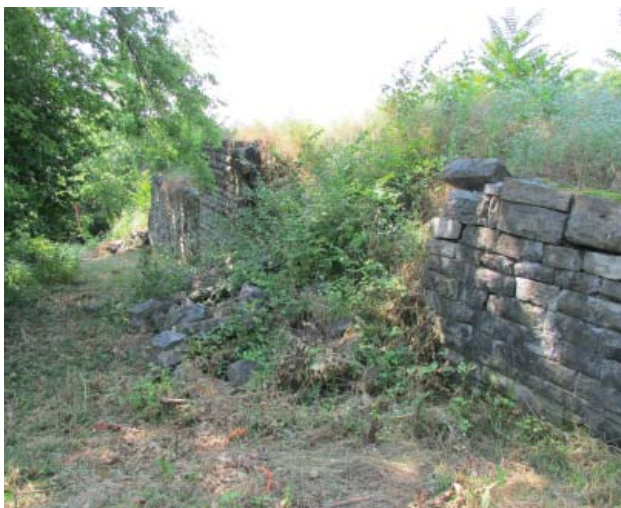
**Figure 61.** Collapse area at East Bastion retaining wall — reinforced earth retrofit (1200AE, 2013).

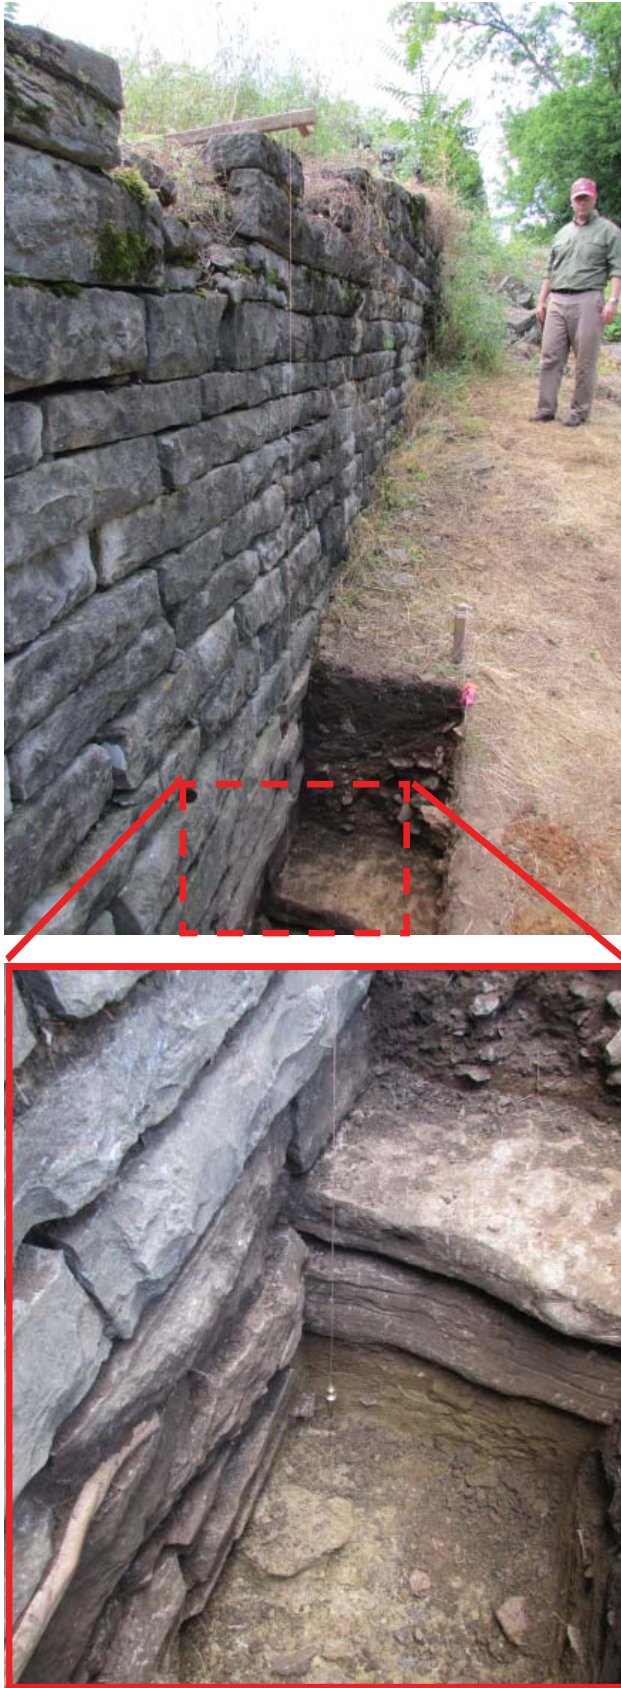
**Figure 64.** Wall conditions above and below grade at Test Pit 2 (1200AE, 2013).

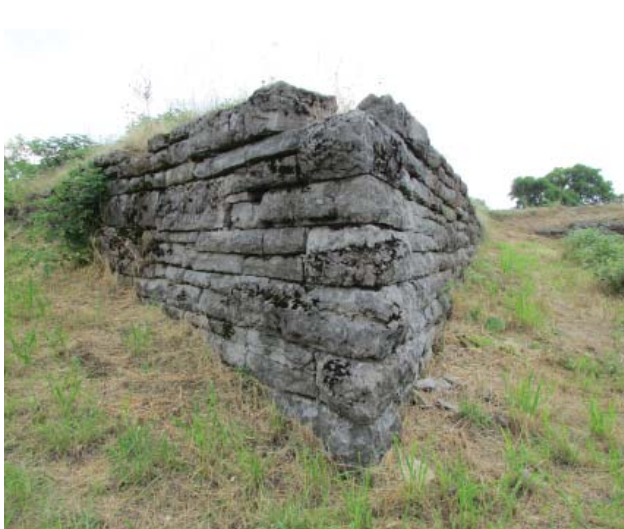
**Figure 70.** Loss of capstone units and delamination of exterior surface of stones (1200AE, 2013).

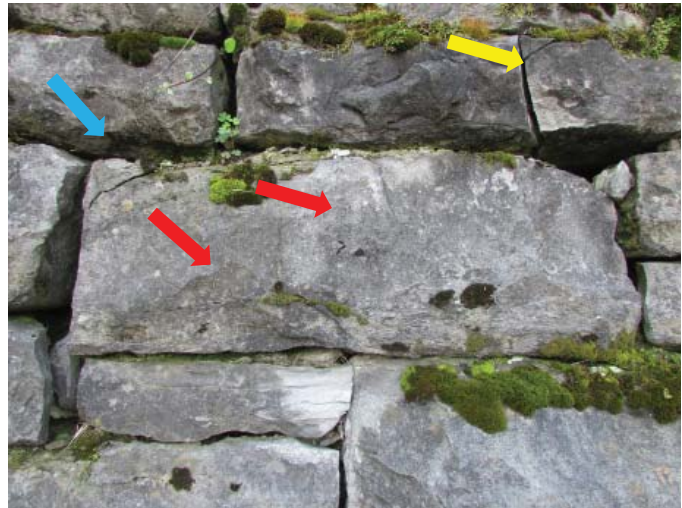
**Figure 72.** Loss of stone due to spalling and vertical flexural cracks above and below (1200 AE, 2013).

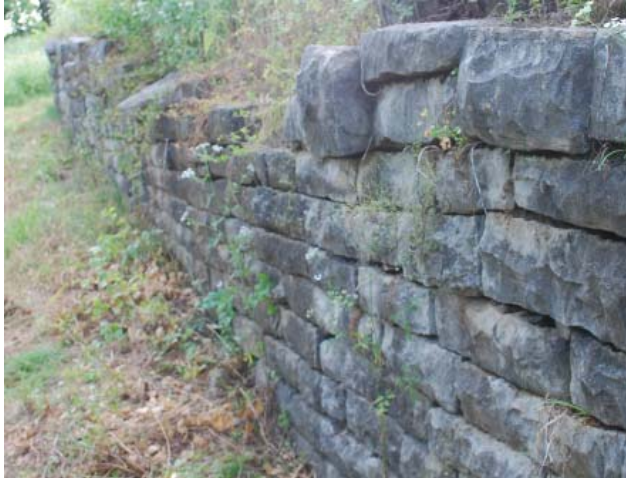
**Figure 74.** Localized wall displacement and missing capstones (JMA, 2013).

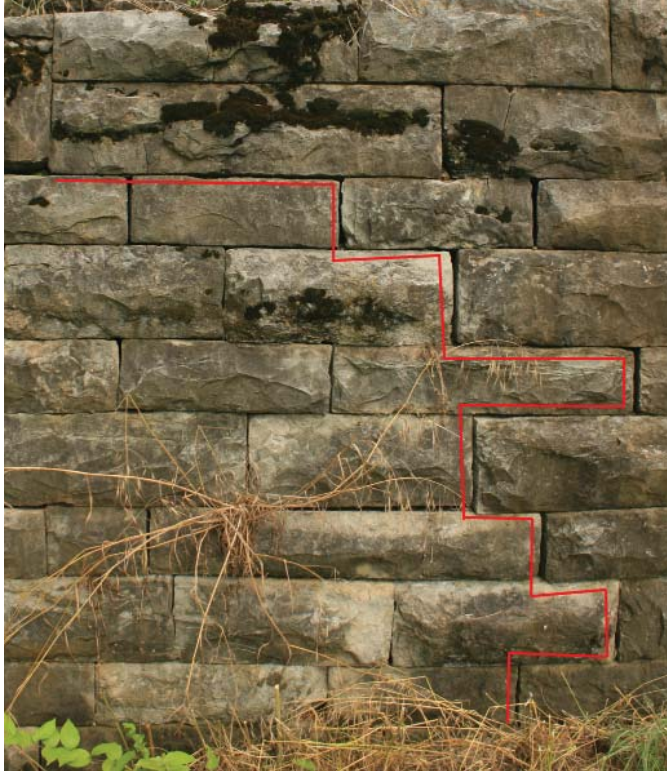
**Figure 79.** Step cracking indicating movement or “cold joint” between earlier construction and area of repair (JMA, 2013).

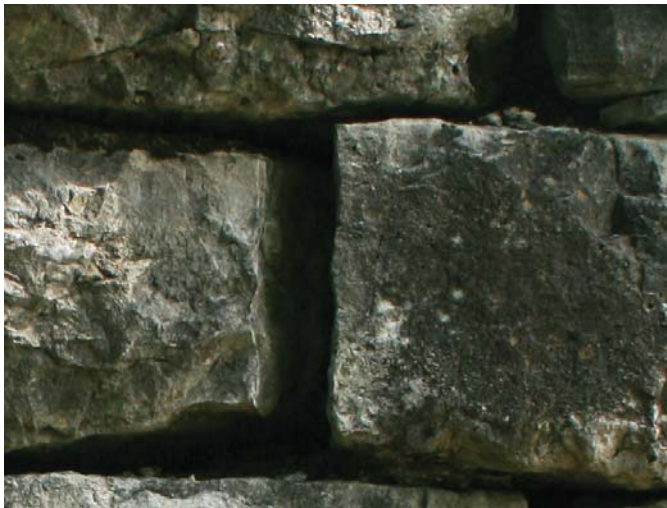
**Figure 80.** Open head joints (JMA, 2013).

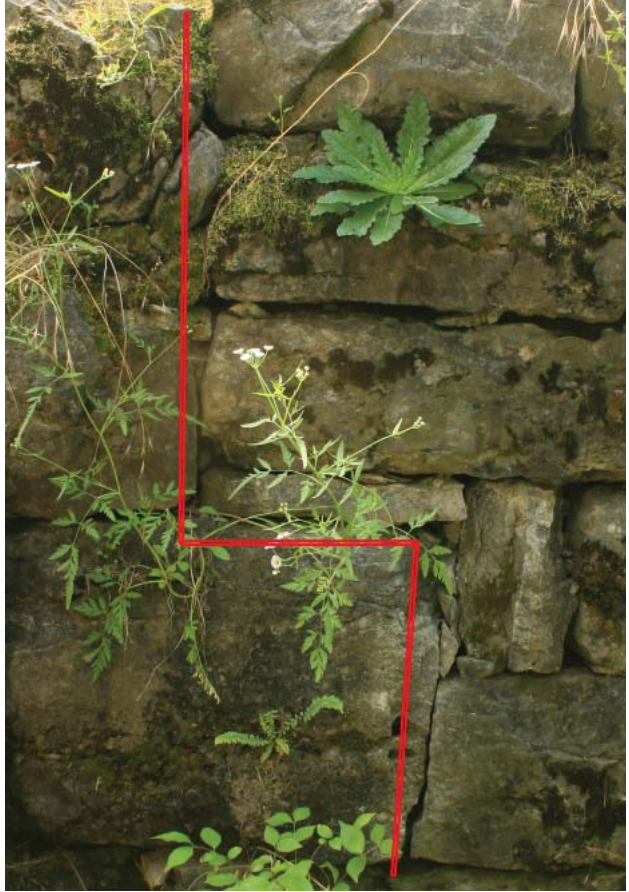
**Figure 81.** Vertical joints aligned and plant growth in cracks (JMA, 2013).

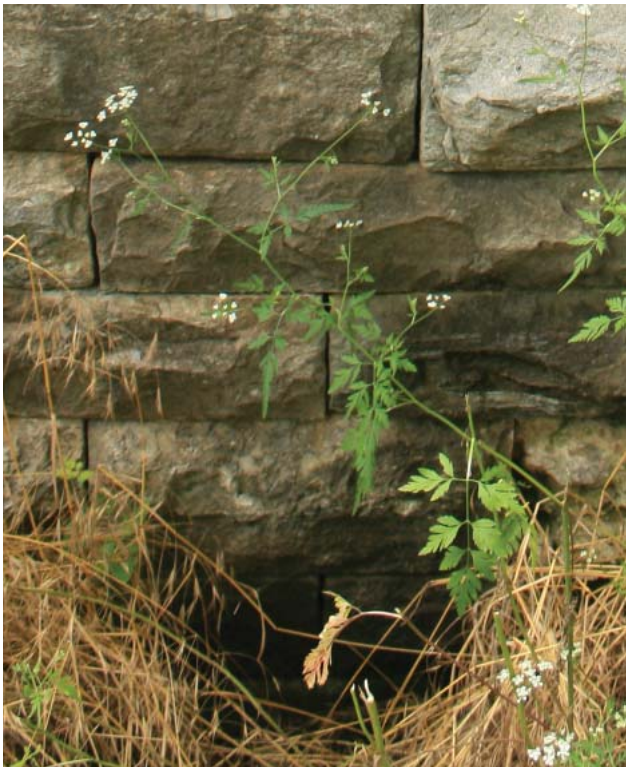
**Figure 82.** Animal burrow at base of wall (JMA, 2013).

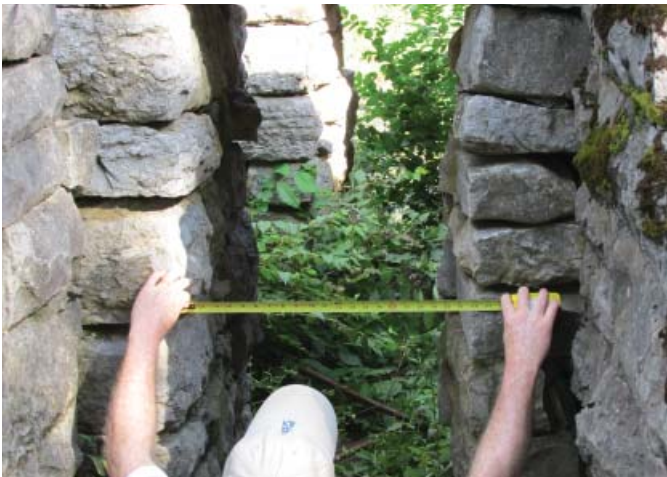
**Figure 88.** East Bastion tunnel with bulging walls (1200AE, 2013).

Maximum bulging was observed at mid-height of wall.

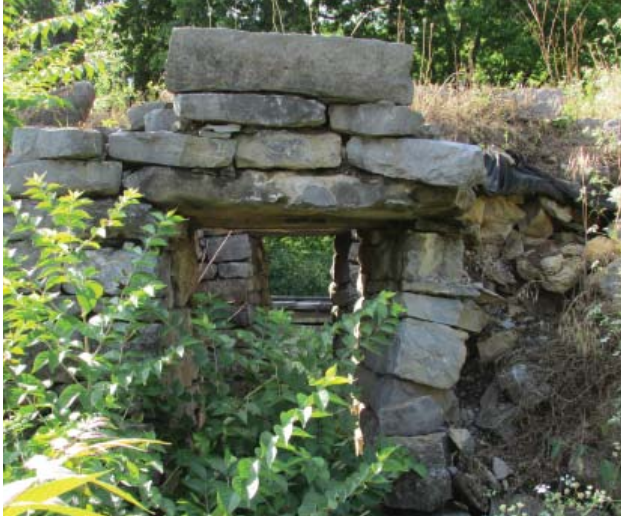
**Figure 89 (above).** East Bastion tunnel (east end) with partial collapse and instability in masonry above (1200 AE, 2013).

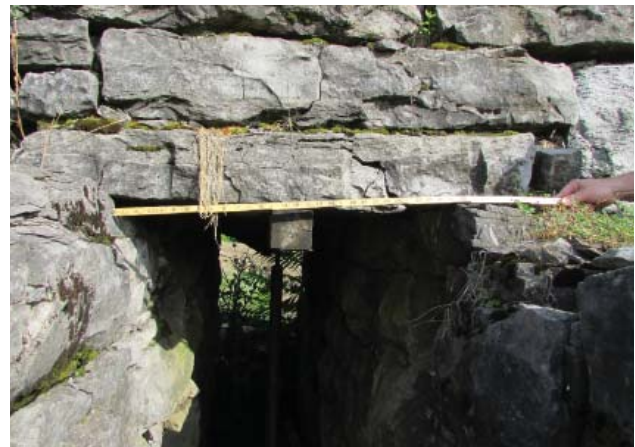
**Figure 91.** West Bastion tunnel with flexure cracks in stone lintels (1200AE, 2013).

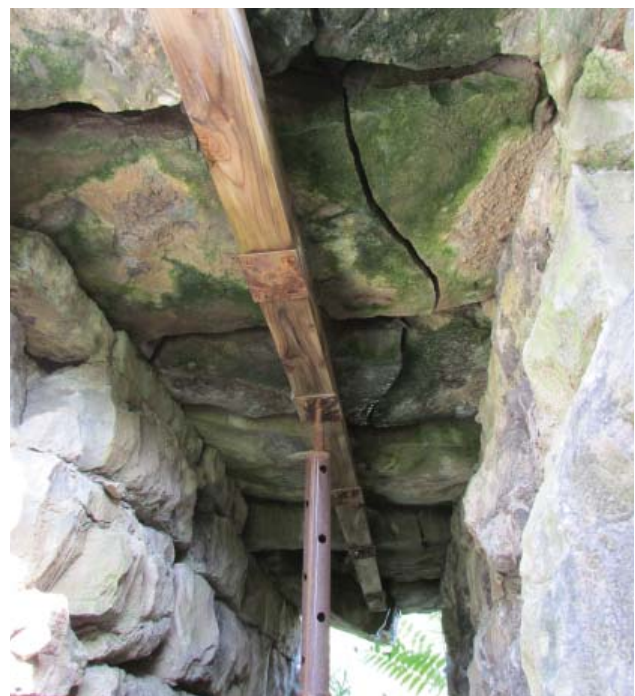
**Figure 92.** West Bastion tunnel with shoring installed and loss of post shores (1200AE, 2013).

Note locations of steel post caps steel anchored to beam and significant cracks in each of the stone lintels throughout length of tunnel.

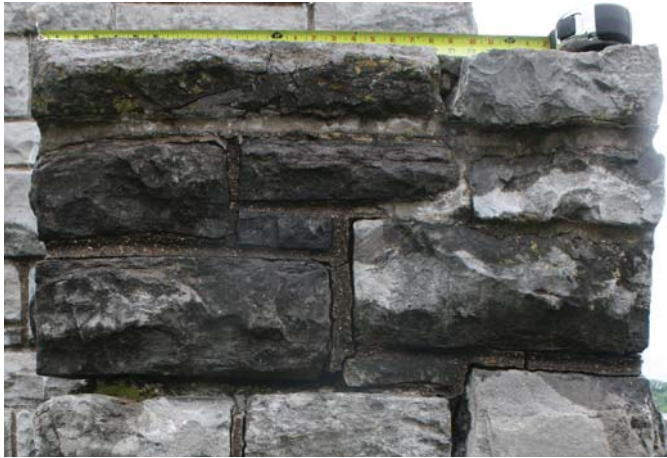
**Figure 93.** Entrance gate pier exhibits hairline-to-minor cracking in mortar joints, some open joints, and inappropriate repair in joint below cap (JMA, 2013).

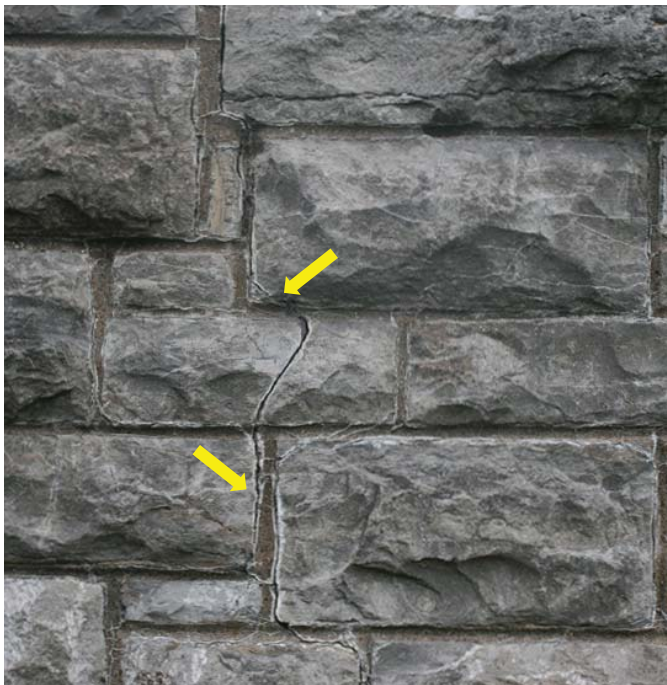
**Figure 95.** Cracking in east face of north pylon at entrance gate (JMA, 2013).

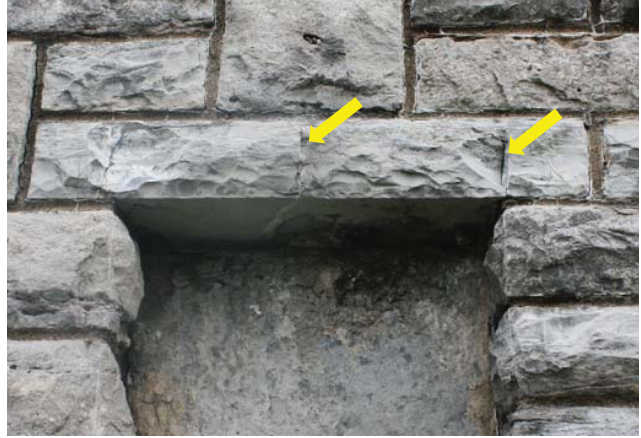
**Figure 97.** Lintel over wall opening at entrance gate cracked in two places (JMA, 2013).

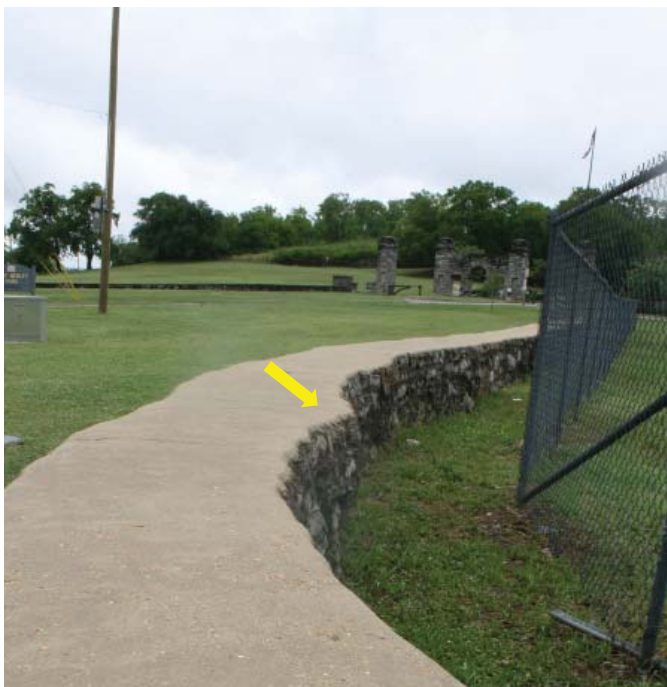
**Figure 101.** Bowing and displacement of southern wing wall, rear view (JMA, 2013).

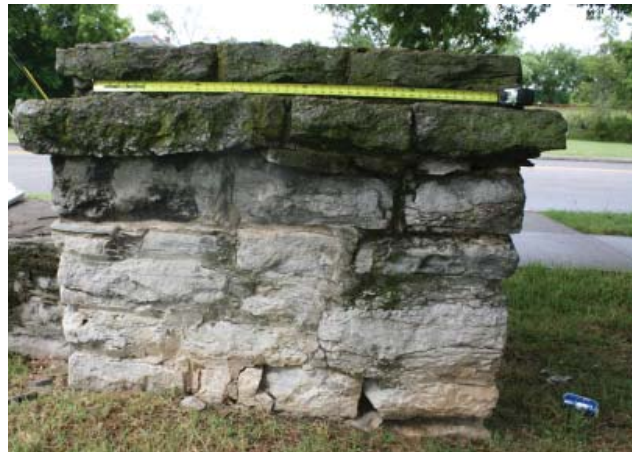
**Figure 104.** Water infiltration damage due to cracked or missing mortar joints at top of a portion of northwest wing wall of entrance gate structure (JMA, 2013).

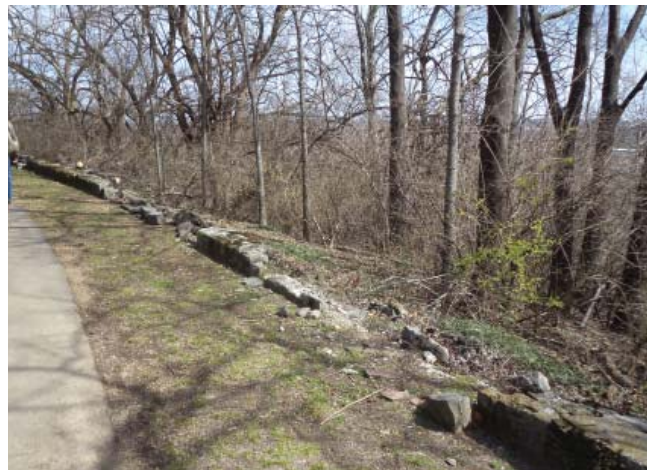
**Figure 110.** Drainage outlets built into the parapet. To the left, the wall is sagging due to structural instability (JMA, 2013).

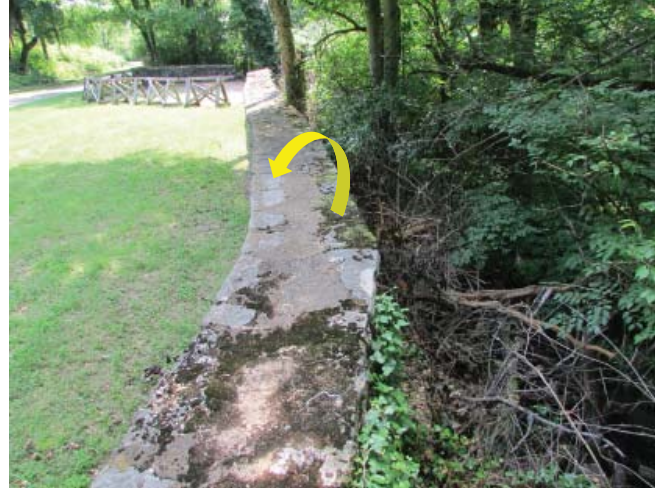
**Figure 114.** Rotation of parapet towards the interior (1200AE, 2013).

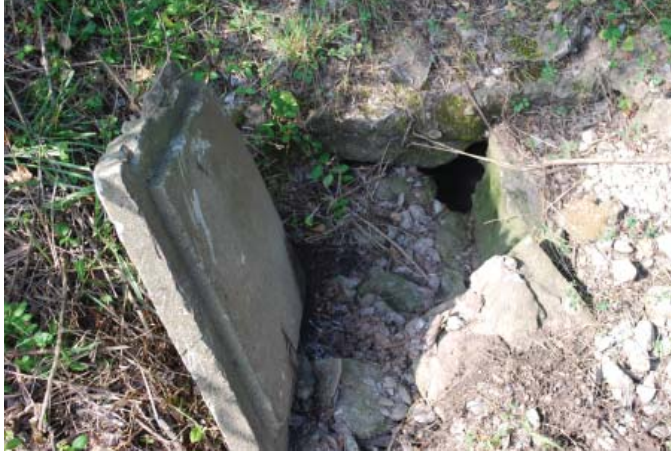
**Figure 117.** WPA drainage inlet: stone cover replaced with precast concrete cap and culvert filled with sediment and debris (JMA, 2013).

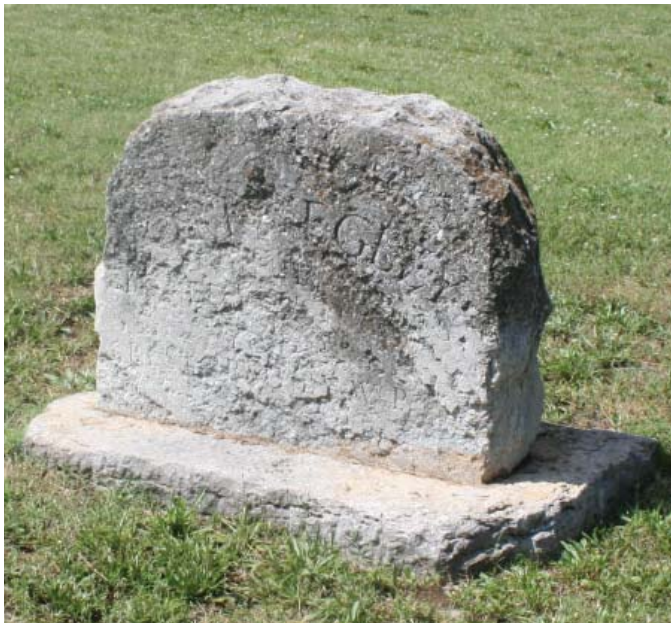
**Figure 119.** Deterioration of WPA dedication monument (JMA, 2013).
