**STAFF RECOMMENDATION**  
**2121 Westwood Avenue**  
**March 17, 2021**

**Application:** New Construction-Addition Revision  
**District:** Hillsboro-West End Neighborhood Conservation Zoning Overlay  
**Council District:** 18  
**Base Zoning:** RS7.5  
**Map and Parcel Number:** 10415039900  
**Applicant:** Blaine Bonadies  
**Project Lead:** Robin Zeigler, robin.zeigler@nashville.gov

Re: Structural Observations of Framing  
Residence, 2121 Westwood Ave., Nashville

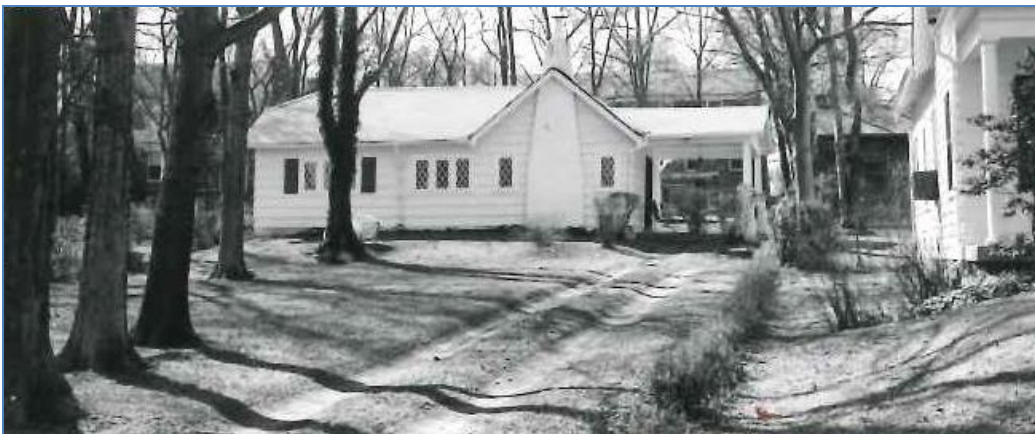
Figure 1. c. 1968 Property Assessor photo of 2121 Westwood

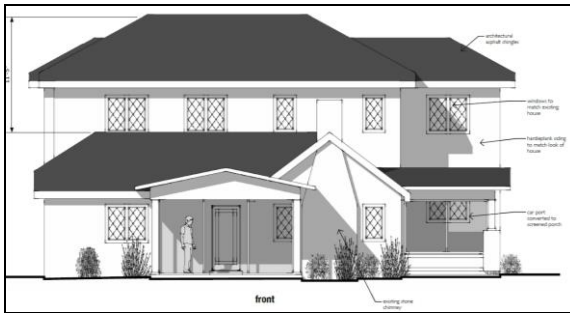
Figures 2:2019 addition and front porch.

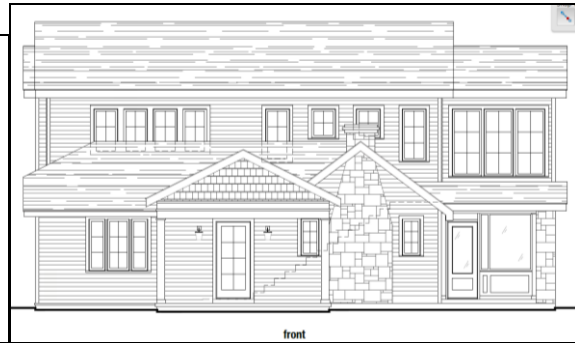
Figure 3: 2020 rear addition and front porch.

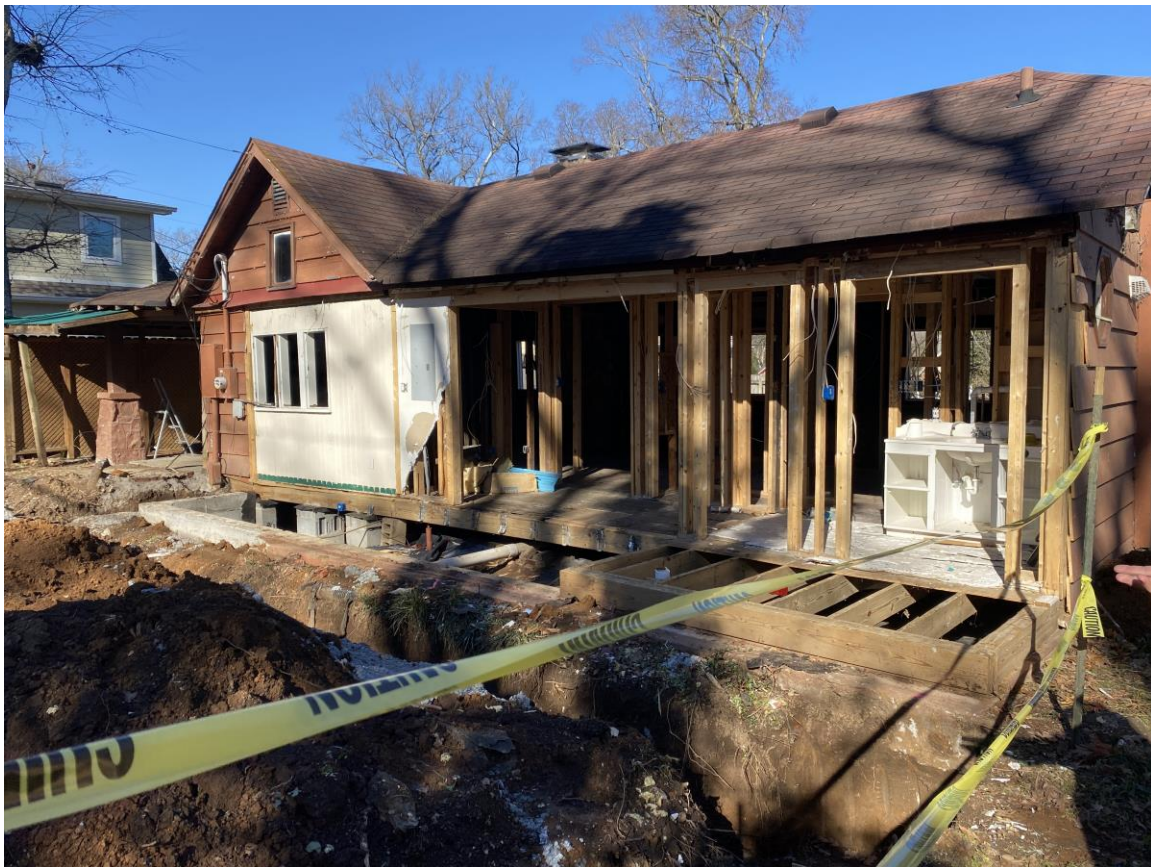
Figure 4: Rear of home in December 2020, after rear wall was removed for demolition.

In January 2021 the applicant contacted the office with concerns about the foundation and floor framing of the historic house, evident after the rear wall was removed for the addition.

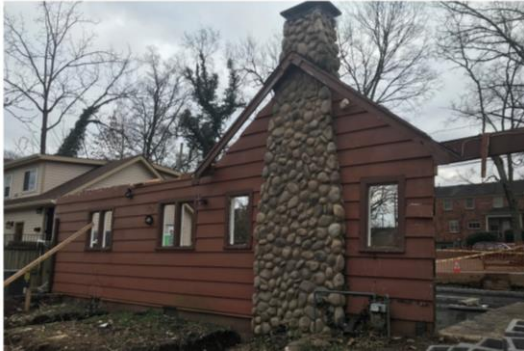
Figure 5: Exterior of preserved wall

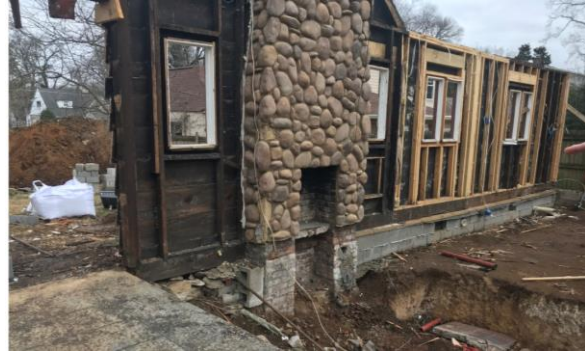
Figure 6: Interior of preserved wall.

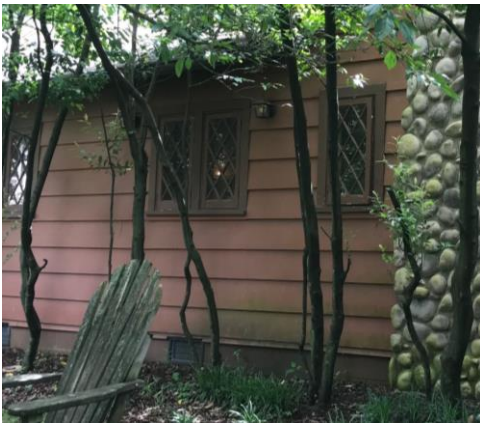
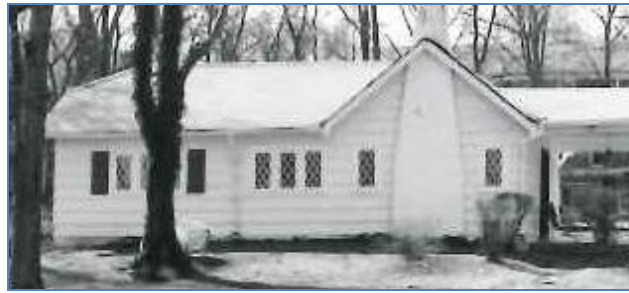
Figures 7 and 8: The diamond-lites originally on the building were an integral part of its historic character.

- Lap siding shall have mitered corners as it did originally
- Front windows shall be diamond fixed or casement windows, as document in earlier photographs.
- Chimney may be reconstructed with the round rock or the earlier brick with masonry to be approved administratively.
