## **Operations Monitoring Report**

**Second Quarter FY21**

**Prepared by:**

**Thermal Engineering Group, Inc.  
105 Hazel Path Court, Ste 2  
Hendersonville, TN 37075**

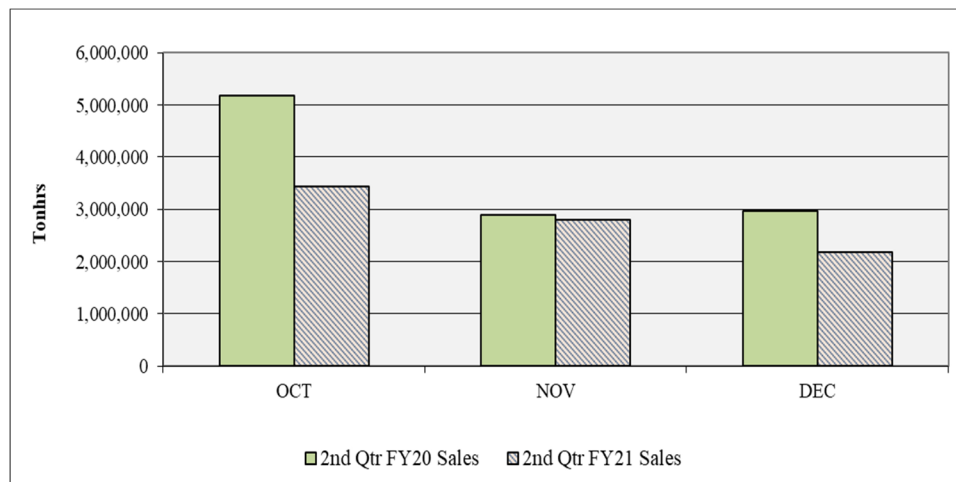
**Figure 1. Chilled Water Sales Comparison**

A comparison for the Second Quarter chilled water sales is shown in Figure 1. This data reflects a 23.9% decrease in sales for the current quarter over the same quarter of the previous fiscal year.

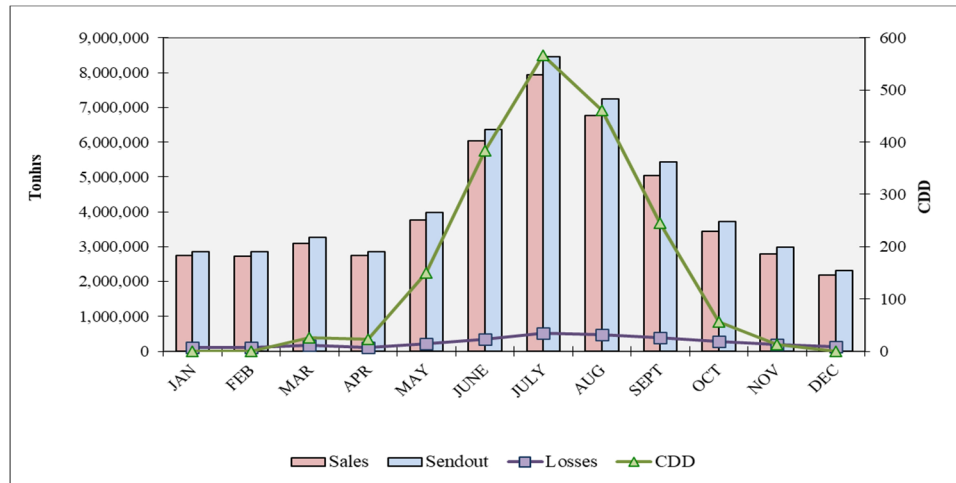
**Figure 2. Chilled Water Sales, Sendout, Losses and CDD for the Previous Twelve Months**

Figure 2 shows the chilled water sales, sendout and losses for the previous twelve months. The losses on this figure are defined as the difference in tonhrs per month between the recorded sendout and sales values and represent the total energy loss for chilled water in the EDS. The number of cooling degree days per month are also tracked for comparison.

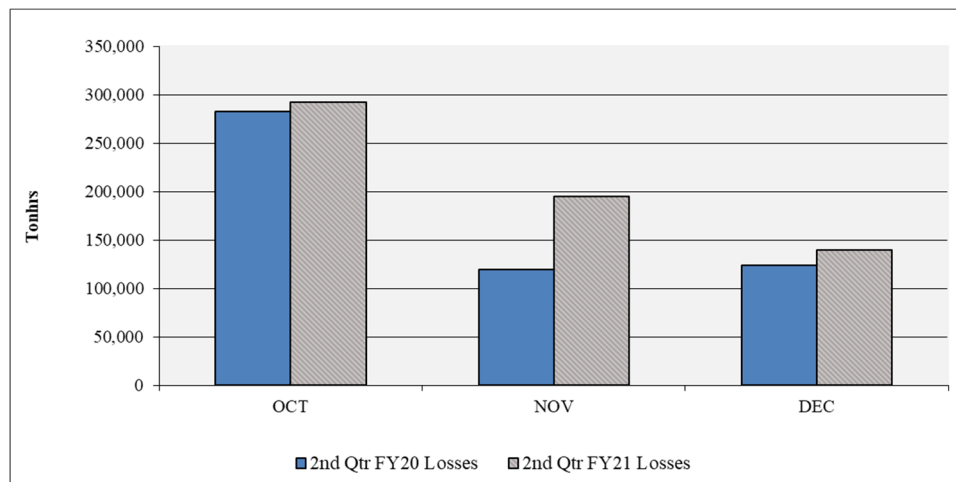
**Figure 3. Chilled Water System Loss Comparison**

A comparison of the total, chilled water energy losses in the EDS for the Second Quarter is shown in Figure 3. These losses are the difference in chilled water sendout and sales.

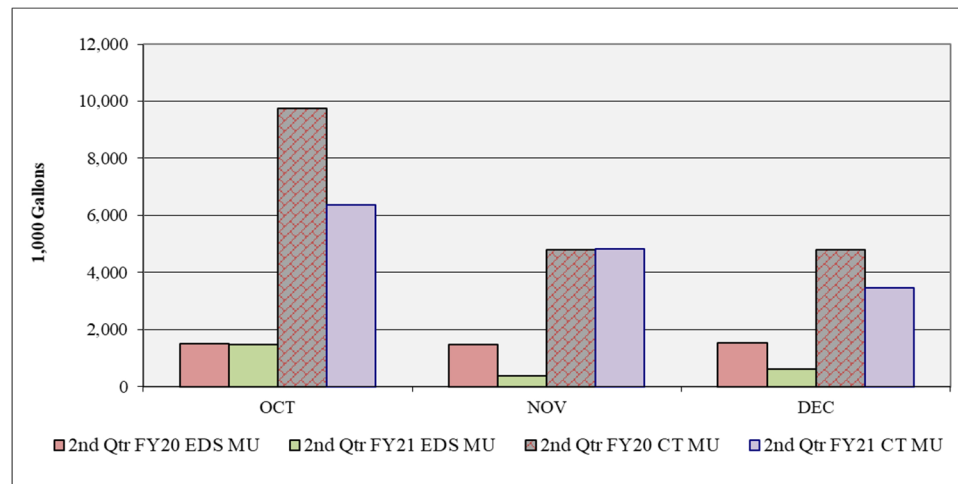
**Figure 4. Chilled Water System City Water Usage Comparison**

The make-up to the cooling towers decreased 24.3% over the previous Second Quarter. The water usage in the cooling towers is largely due to the consumption of chilled water and should vary with chilled water sales. The number of cycles of concentration in the condensing water circuit decreased 18.4%. The total chiller plant water use decreased 11.8% over the Second Quarter FY20. The overall city water make-up comparison for the chilled water system Second Quarter is shown in Figure 4.

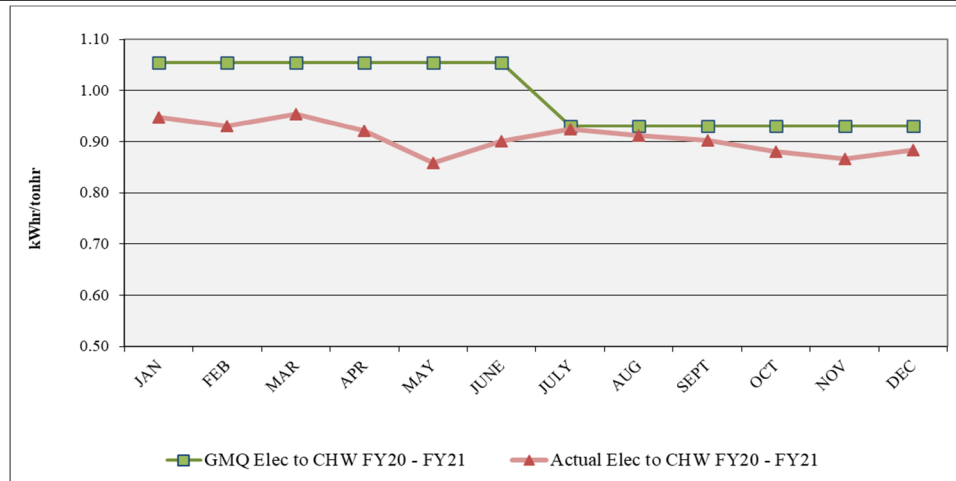
**Figure 5. Chiller Plant Electric Performance Guarantee Comparison for the Previous Twelve Months**

The performance of the chilled water aspect of the EGF is presented by the following two charts, Figures 5 and 6, for the previous twelve months. The System Performance Guarantee levels as described in Amendment 2 of the ARMA were not achieved for the chilled water-water conversion for one month of the quarter and four months out of the six months in FY21.

The chilled water allocation of the electric consumption falls under the GMQ limit of 0.93 kWhr per tonhr for the current quarter, and no excursion is reported for the current fiscal year. The electric usage per unit of sales decreased 4.9% over the previous Second Quarter.

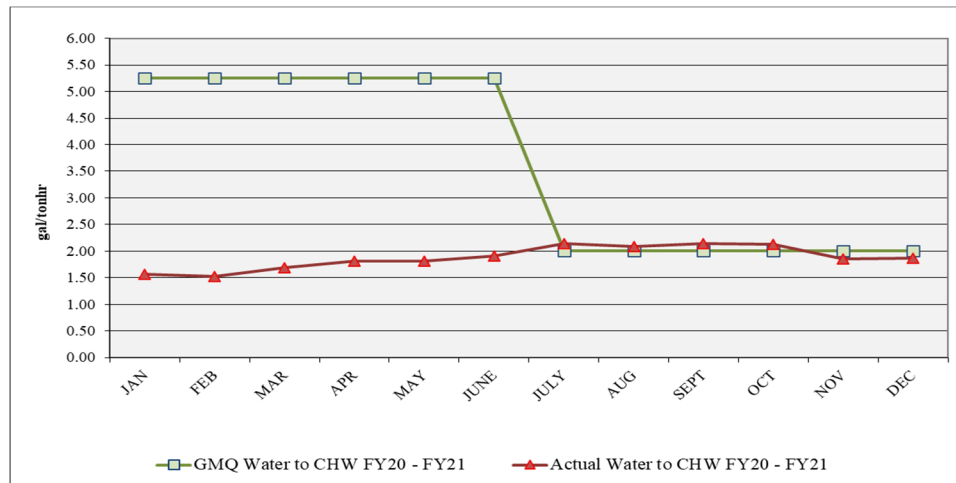
**Figure 6. Chiller Plant Water Consumption Performance Guarantee Comparison for the Previous Twelve Months**

13.5% over the previous Second Quarter. However, a new equation for calculating the chilled water-water conversion factor came into use with the implementation of Amendment 2. When a month-to-month comparison is made for the months of FY21, this conversion factor appears consistent and decreased below the guarantee only after the cooler months arrived and the EDS leak was found and repaired.

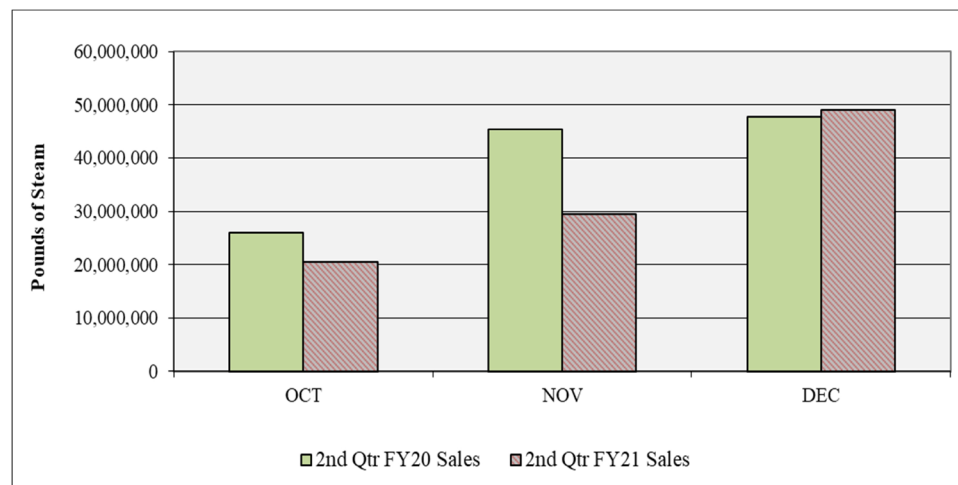
**Figure 7. Steam Sales Comparison**

The steam sendout decreased by approximately 14.3% over the previous Second Quarter (FY20), and the sales also decreased by approximately 17.1%. The Quarter experienced a 3.5% decrease in the number of heating degree days. The steam system losses increased 8.4%, and the relative amount of condensate return decreased 34.3% due to the dumping of condensate on 4<sup>th</sup> Ave N during a portion of the quarter. A comparison for the Second Quarter steam sales is shown in Figure 7.

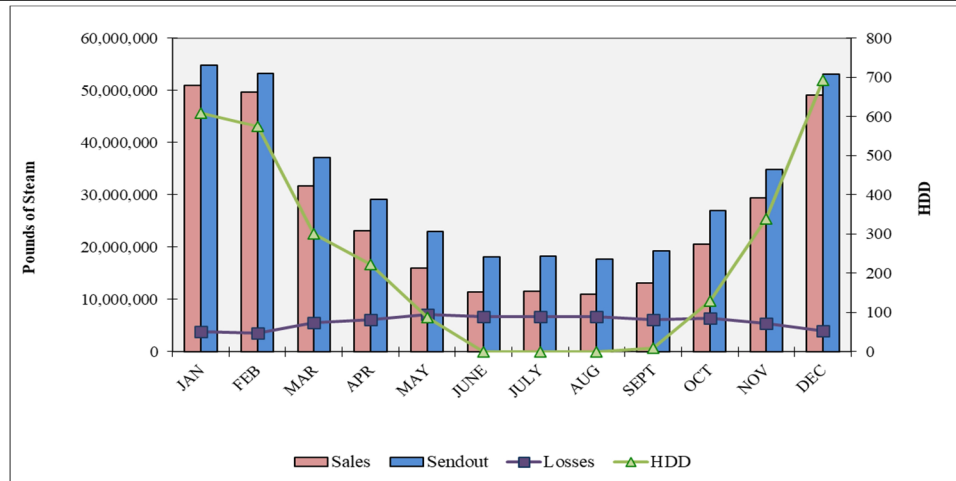
**Figure 8. Steam Sales, Sendout, Losses and HDD for the Previous Twelve Months**

Figure 8 shows the steam sales, sendout and losses for the previous twelve months. The losses on this figure are defined as the difference in pounds per month between the recorded sendout and sales values and represent the total mass loss in the EDS between the EGF and the customer meters.

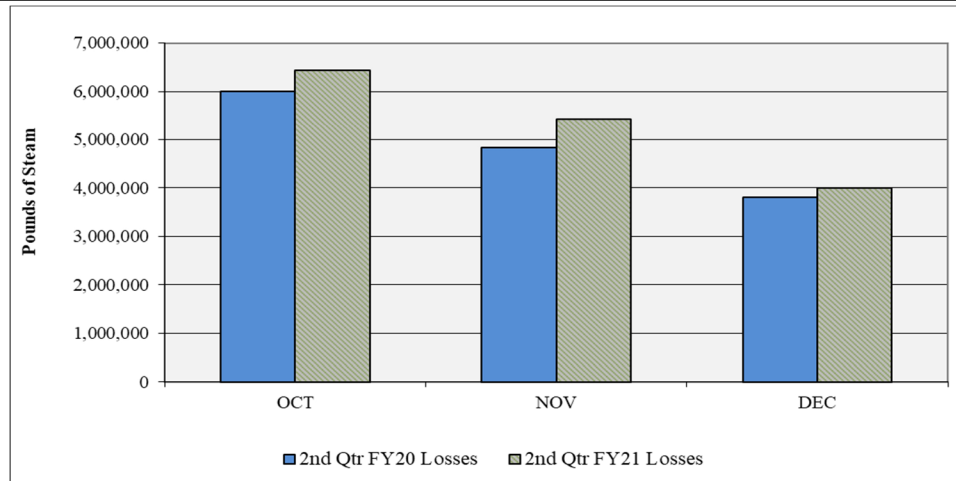
**Figure 9. Steam System Losses**

A comparison of the total steam mass losses in the EDS for the Second Quarter is shown in Figure 9. The mass loss is caused by the heat loss in the EDS between the EGF and the customer meters, resulting in a mass loss at steam traps. Faulty traps, steam leaks or meter error could also be a contributing cause of these losses. Whenever steam sales decrease from the previous quarter, the percent of system losses can be expected to increase since most of these losses are based on a near constant heat loss of the system.

The increase in the losses and make-up shown in Figures 9 and 10 was largely due to a leak in the condensate system near MH-9 on Deaderick St and the repair of an additional leak near MH-D on 3<sup>rd</sup> Ave N. The Deaderick St leak was repaired in the First Quarter, but CNE continued to record high hardness levels in the condensate return from this area through the Second Quarter. Additional tests performed by CNE at customer buildings also revealed additional sources of hardness. Therefore, a significant portion of the condensate return was dumped in the 4<sup>th</sup> Ave tunnel to prevent the hard water from returning to the EGF. CNE is continuing to monitor the hardness levels of the condensate return throughout the EDS.

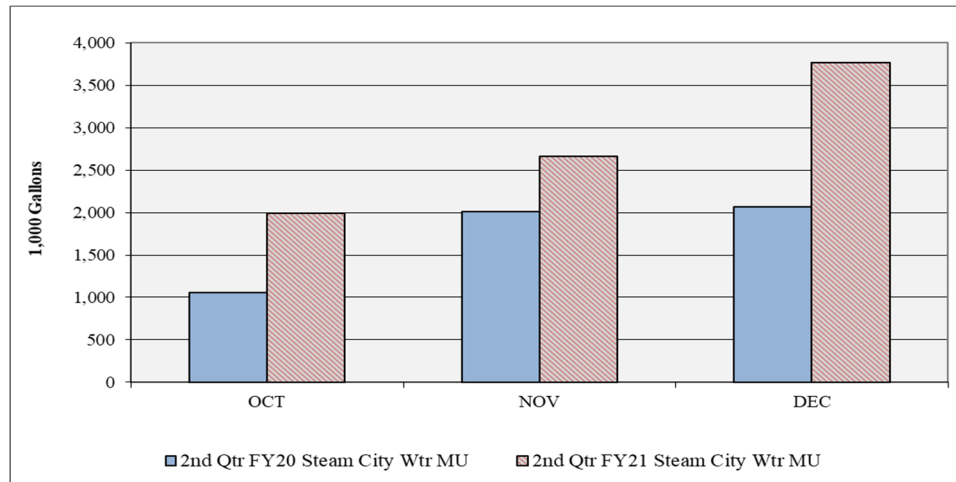
**Figure 10. Steam System City Water Make-up Comparison**

The amount of city water make-up (MU) to the steam system consists of the loss in mass between the EGF and the customers, in the condensate return from the customers to the EGF and losses at the EGF. The corresponding data for steam system make-up is shown in the comparison of Second Quarter data in Figure 10.

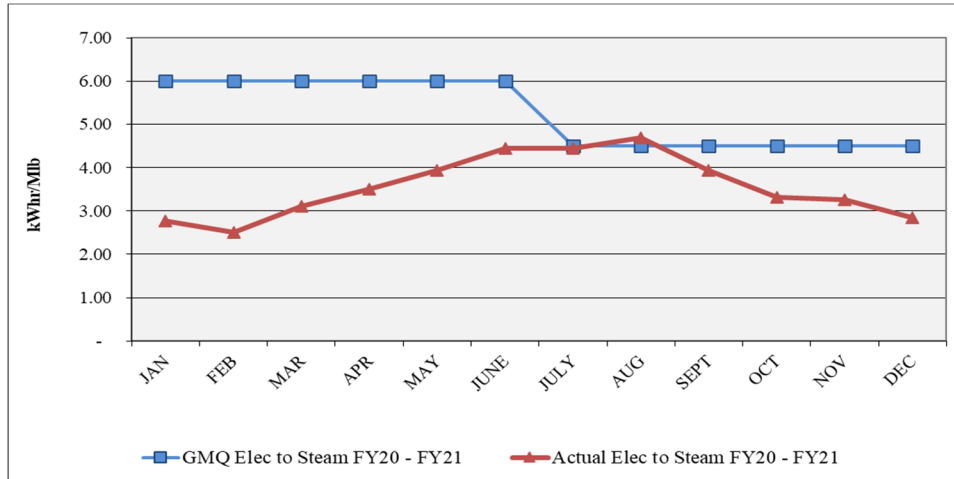
**Figure 11. Steam Plant Electric Performance Guarantee for the Previous Twelve Months**

The performance of the steam system of the EGF is presented by the following three charts, Figures 11, 12 and 13. The steam fuel conversion factor exceeded the guaranteed values in October, November, and December 2020. The steam electric conversion factor was exceeded in July and August (First Quarter) but there was no excursion during the Second Quarter. TEG monitors CNE’s performance regularly and will continue to report any non-compliance in the EGF’s operation.

The current quarter experienced a 10.2% decrease in the steam plant electric consumption while experiencing a 7.8% increase in the electric conversion factor. The water consumption for the steam plant increased 64.4% this quarter as compared to the previous Second Quarter due largely to the condensate leak and the dumping of condensate due to hardness levels.
