Operations Monitoring Report

First Quarter FY13

**Thermal Engineering Group, Inc.
105 Hazel Path Court, Ste 2
Hendersonville, TN 37075**

November 1, 2012

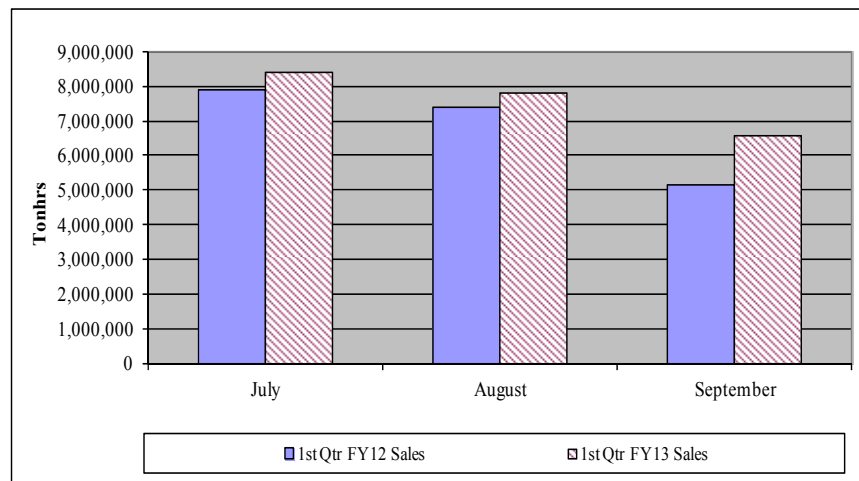
Figure 1. First Quarter FY13 Sales Comparison

A comparison for the First Quarter chilled water sales is shown in Figure 1. This data reflects an 11% increase in sales for the current quarter over the same quarter of the previous fiscal year. The quarter also experienced a 1.9% decrease in the number of cooling degree days. The majority of the increase in sales is a result of the MCCC beginning to take service.

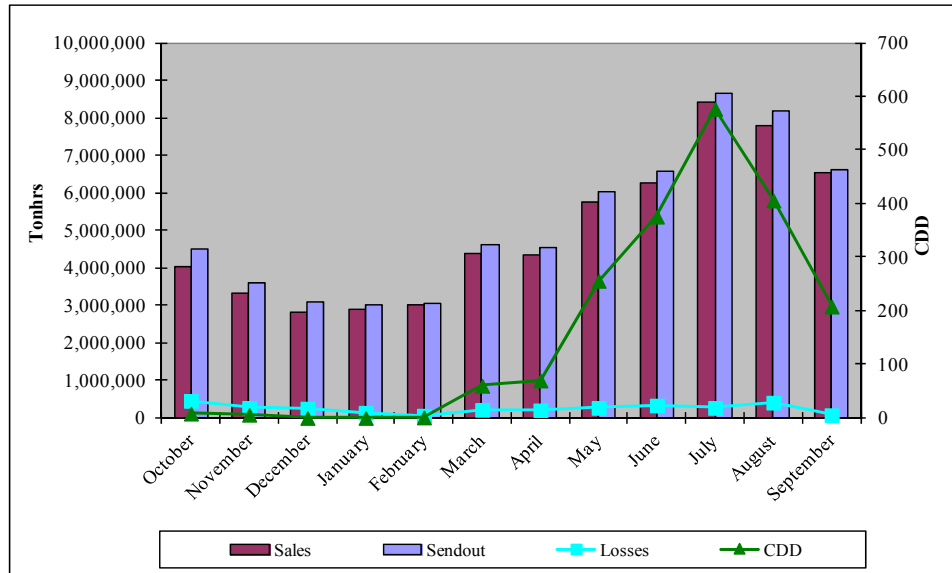
Figure 2. Chilled Water Sales, Sendout, Losses and CDD for the Previous Twelve Months

Figure 2 shows the chilled water sales, sendout and losses for the previous twelve months. The losses on this figure are defined as the difference in tonhrs per month between the recorded sendout and sales values and represent the total energy loss for chilled water in the EDS. The number of cooling degree days per month are also tracked for comparison.

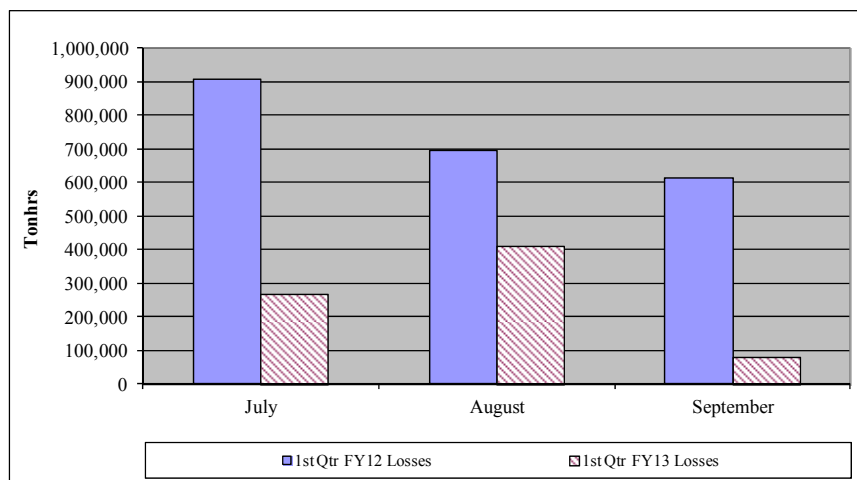
Figure 3. Chilled Water System Loss Comparison for the First Quarter FY13

A comparison of the total, chilled water energy losses in the EDS for the First Quarter is shown in Figure 3. These losses are the difference in chilled water sendout and sales. During the quarter, the new flow meter in the EGF chilled water line began being used to measure the total chilled water sendout. The use of this more accurate meter contributes to the significant decrease in recorded losses for the quarter.

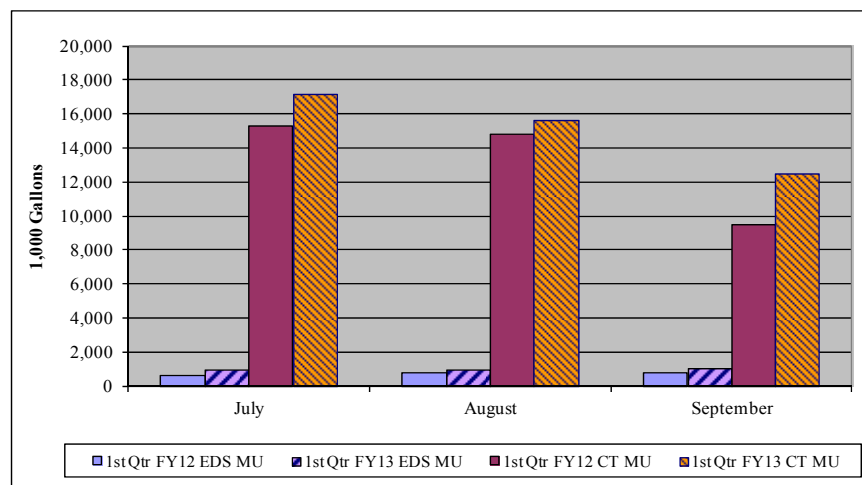
Figure 4. Chilled Water System City Water Usage Comparison

The EDS make-up increased by approximately 31.5% over the previous First Quarter even though recent months have experienced a decline in water usage. However, the total EDS water usage represents only 0.6% of the total EGF water usage for the quarter. The total energy losses have decreased by approximately 66% over the previous First Quarter due to improvements in the EGF sendout metering equipment. The make-up to the cooling towers increased by approximately 14% (due to an increase in chilled water sales and ambient relative humidity). The number of cycles of concentration in the condensing water circuit experienced a 12% decrease during the current First Quarter. The overall city water make-up comparison for the chilled water system is shown in Figure 4.

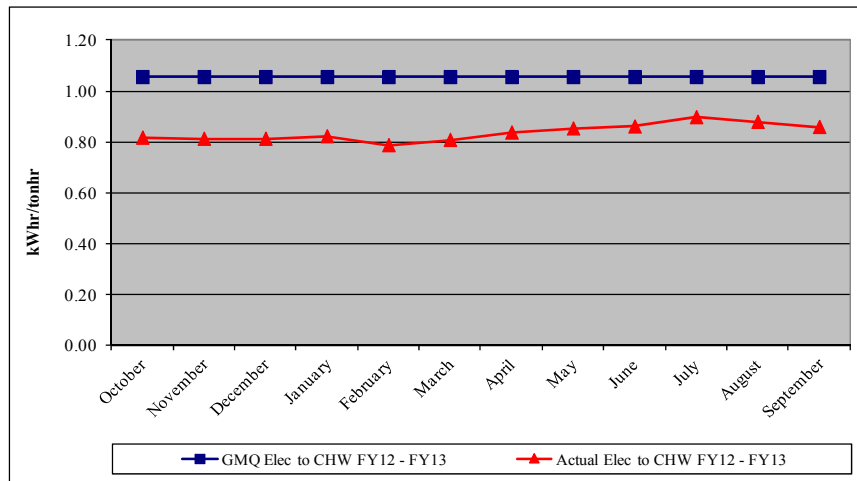
Figure 5. Chiller Plant Electric Performance Guarantee Comparison for the Previous Twelve Months

The performance of the chilled water aspect of the EGF is presented by the following two charts, Figures 5 and 6, for the previous twelve months. Under the management of CNE, the System Performance Guarantee levels as described in the ARMA are being achieved quite satisfactorily.

The chilled water allocation of the electric consumption falls under the GMQ limit of 1.055 kWhr per tonhr for the current quarter, and no excursion is reported for the current fiscal year. The chiller plant electric usage for the current quarter increased approximately 13.5% over the First Quarter for FY12. The actual electric conversion factor increased 2.3% in the quarter.

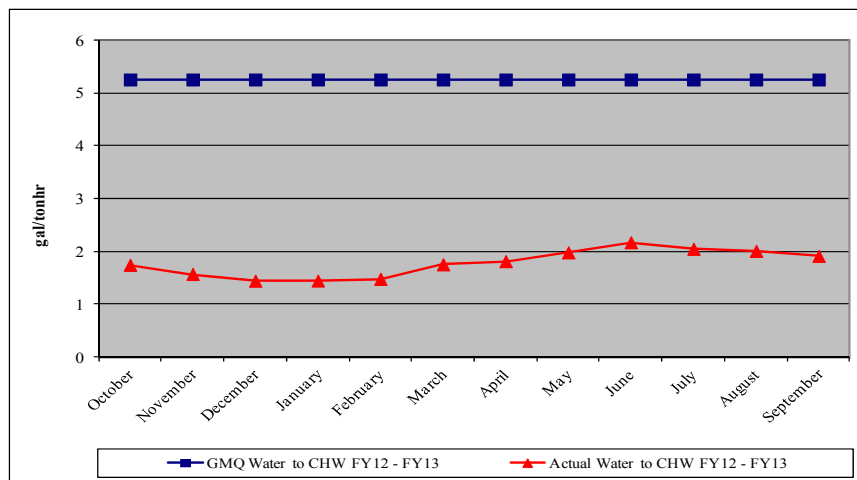
Figure 6. Chiller Plant Water Consumption Performance Guarantee Comparison for the Previous Twelve Months

The actual chilled water plant water conversion factor increased approximately 3.6% over the previous First Quarter. The total consumption of city water for the chiller plant for the current quarter is approximately 15% higher than that for the previous First Quarter.

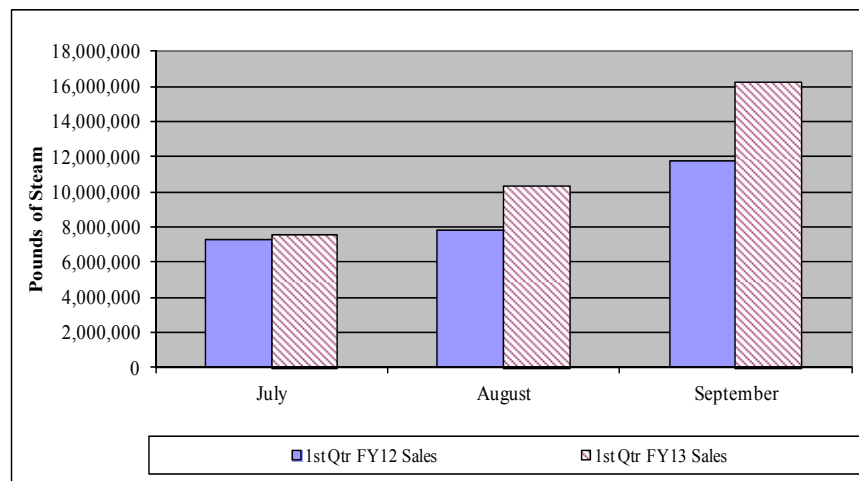
Figure 7. Steam Sales Comparison for the First Quarter FY13

The steam sendout increased by approximately 21.5% over the previous First Quarter (FY12), and the sales increased by approximately 26.9%. The steam system losses increased approximately 13% relative to sendout, due in part to a natural decrease in meter accuracy at relatively load steam demands at the customer buildings. The number of heating degree days have decreased by 31% over the previous First Quarter. A comparison for the First Quarter steam sales is shown in Figure 7.

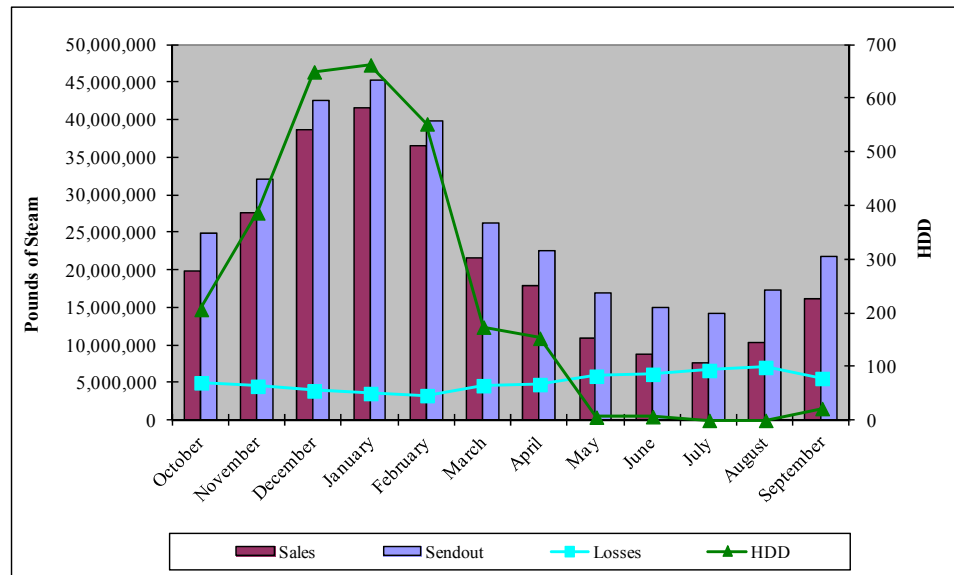
Figure 8. Steam Sales, Sendout, Losses and HDD for the Previous Twelve Months

Figure 8 shows the steam sales, sendout and losses for the previous twelve months. The losses on this figure are defined as the difference in pounds per month between the recorded sendout and sales values and represent the total mass loss in the EDS between the EGF and the customer meters.

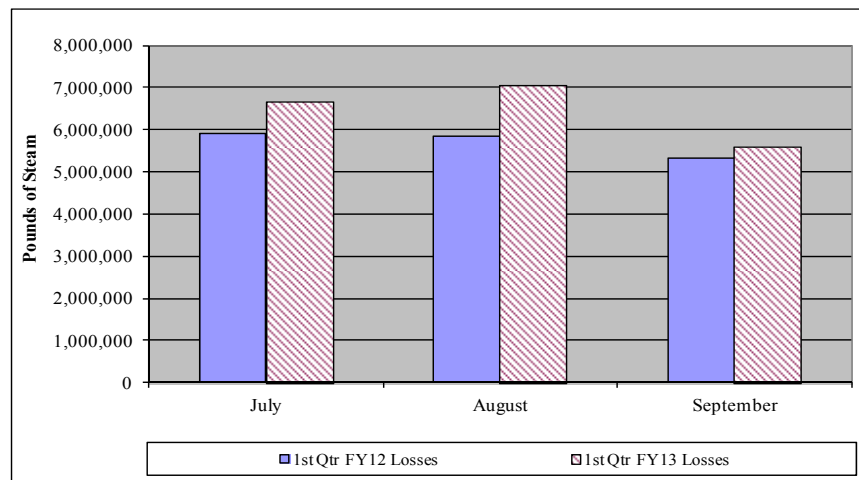
Figure 9. First Quarter FY13 Steam System Losses

A comparison of the total steam mass losses in the EDS for the First Quarter is shown in Figure 9. The mass loss is caused by the heat loss in the EDS between the EGF and the customer meters, resulting in a mass loss at steam traps. Faulty traps, steam leaks or meter error could also be a contributing cause of these losses.

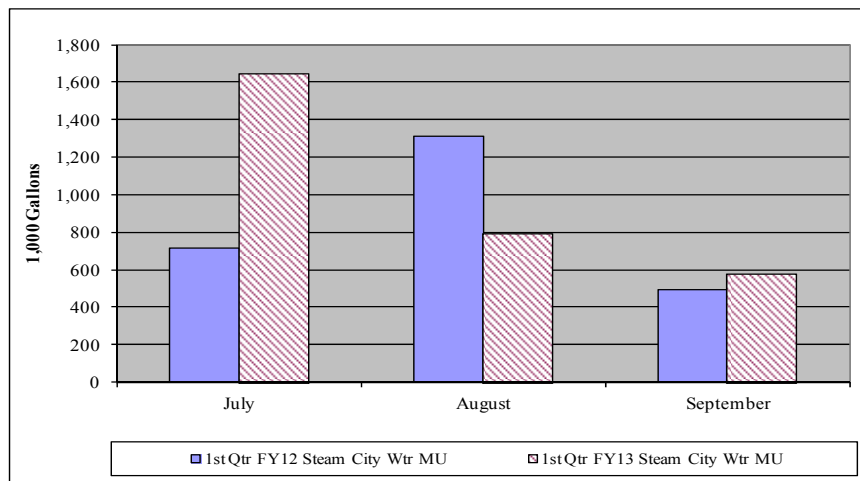
Figure 10. First Quarter FY13 Steam System City Water Make-up Comparison

The amount of city water make-up (MU) to the steam system consists of the loss in mass between the EGF and the customers, in the condensate return from the customers to the EGF and losses at the EGF. This data is shown in the comparison of First Quarter data in Figure 10. Figure 10 depicts a significant

increase in city water make-up to the steam system of approximately 19% for the current quarter due to the dumping of condensate in the early part of the quarter for high iron content and hardness. CNE investigated the source of the iron and hardness and have since determined the source and isolated it from the rest of the EDS.

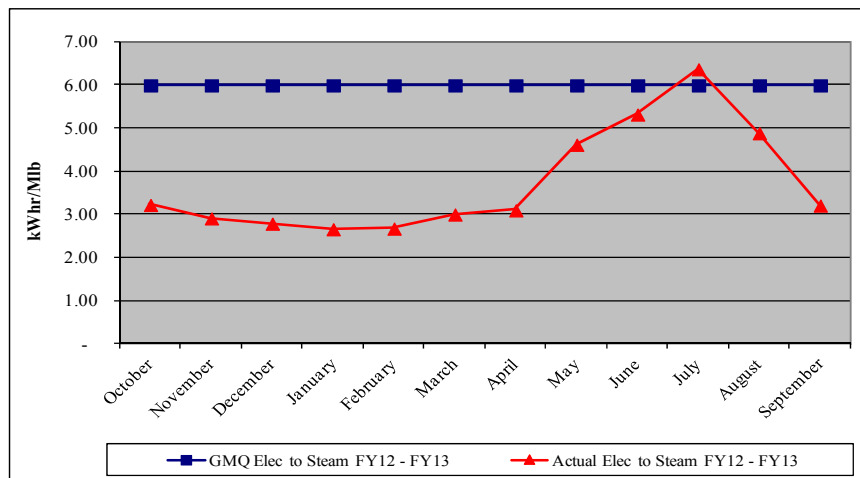
Figure 11. Steam Plant Electric Performance Guarantee for the Previous Twelve Months

The performance of the steam system aspect of the EGF is presented by the following three charts, Figures 11, 12 and 13. Under the management of CNE, the System Performance Guarantee levels as described in the ARMA are being achieved satisfactorily.

The current quarter experienced a 4.5% increase in the steam plant electric consumption while experiencing a 17.6% increase in the electric conversion factor. The water consumption for the steam plant increased 19% this quarter as compared to the previous First Quarter. The fuel consumption per unit of steam sales is relatively constant throughout the year and when compared to the historic data. The boiler plant fuel efficiency increased slightly for the current quarter.
