## **Operations Monitoring Report**

**First Quarter FY14**

**Prepared by:**

**Thermal Engineering Group, Inc.  
105 Hazel Path Court, Ste 2  
Hendersonville, TN 37075**

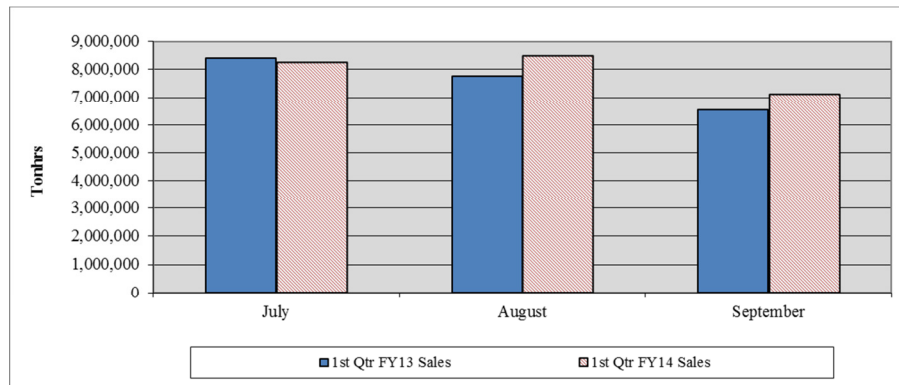
**Figure 1. First Quarter FY14 Sales Comparison**

A comparison for the First Quarter chilled water sales is shown in Figure 1. This data reflects a 4.8% increase in sales for the current quarter over the same quarter of the previous fiscal year. The quarter also experienced a 10.4% decrease in the number of cooling degree days.

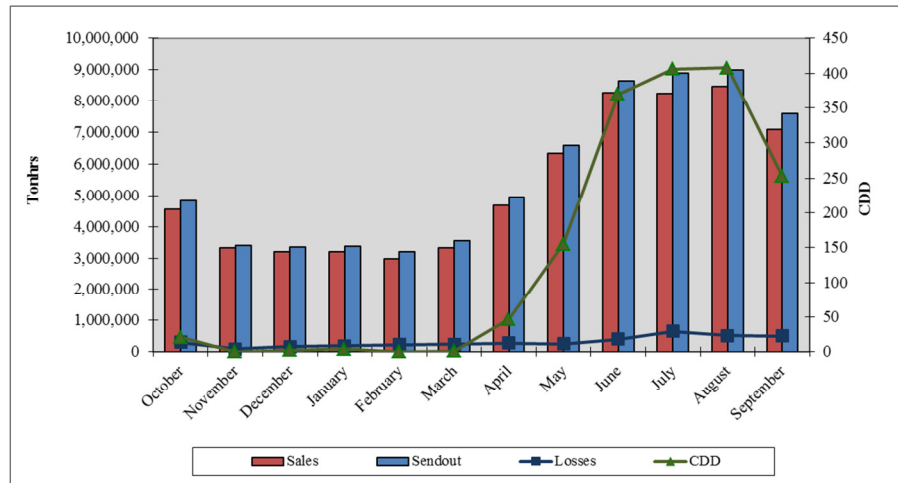
**Figure 2. Chilled Water Sales, Sendout, Losses and CDD for the Previous Twelve Months**

Figure 2 shows the chilled water sales, sendout and losses for the previous twelve months. The losses on this figure are defined as the difference in tonhrs per month between the recorded sendout and sales values and represent the total energy loss for chilled water in the EDS. The number of cooling degree days per month are also tracked for comparison.

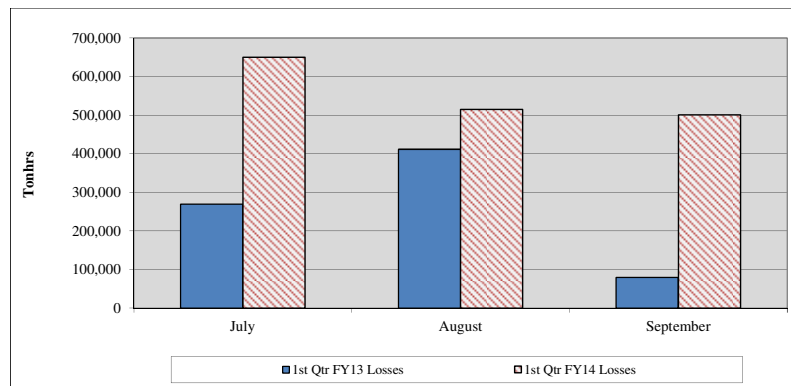
**Figure 3. Chilled Water System Loss Comparison for the First Quarter FY14**

A comparison of the total, chilled water energy losses in the EDS for the First Quarter is shown in Figure 3. These losses are the difference in chilled water sendout and sales.

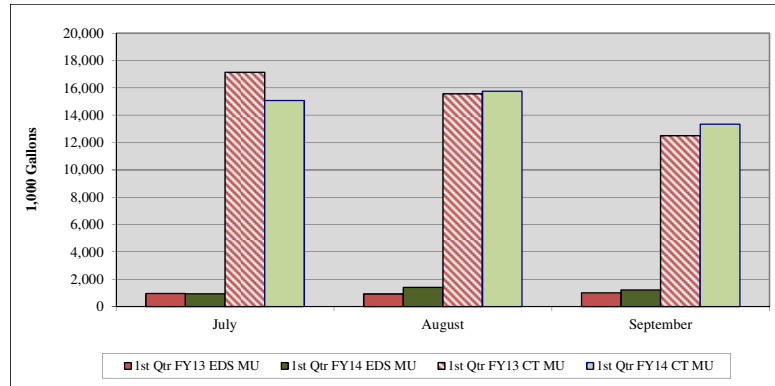
**Figure 4. Chilled Water System City Water Usage Comparison**

The EDS make-up increased by approximately 23% over the previous First Quarter. However, the total EDS water usage represents only a small part of the total EGF water usage for the quarter. The total energy losses have increased by approximately 120% over the previous First Quarter, but the percent of losses as a function of sales has decreased by approximately 24%. The make-up to the cooling towers decreased by approximately 2% due to a milder than normal summer. The number of cycles of concentration in the condensing water circuit experienced a 40% increase during the current First Quarter due to improved

water chemistry in the cooling towers. The overall city water make-up comparison for the chilled water system is shown in Figure 4.

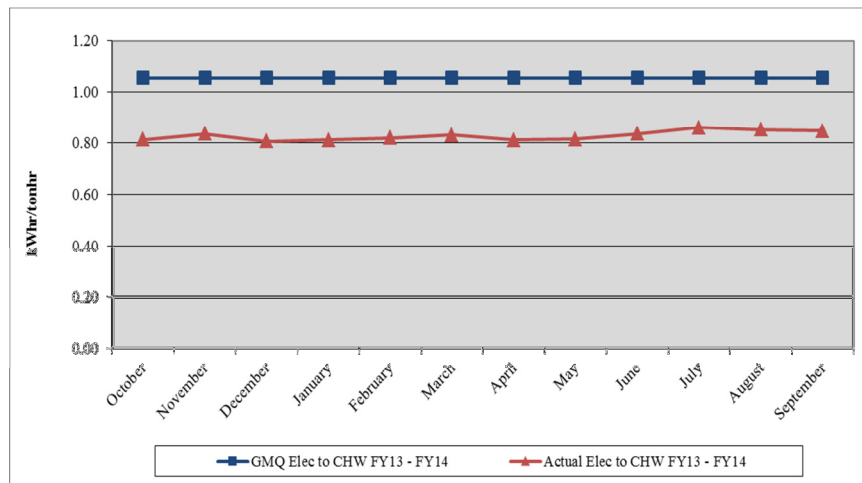
**Figure 5. Chiller Plant Electric Performance Guarantee Comparison for the Previous Twelve Months**

The performance of the chilled water aspect of the EGF is presented by the following two charts, Figures 5 and 6, for the previous twelve months. Under the management of CNE, the System Performance Guarantee levels as described in the ARMA are being achieved quite satisfactorily.

The chilled water allocation of the electric consumption falls under the GMQ limit of 1.055 kWhr per tonhr for the current quarter, and no excursion is reported for the current fiscal year. The chiller plant electric usage for the current quarter increased approximately 1.6% over the First Quarter for FY13. The actual electric conversion factor decreased 3.0% in the quarter to 0.853 kWhr per tonhr.

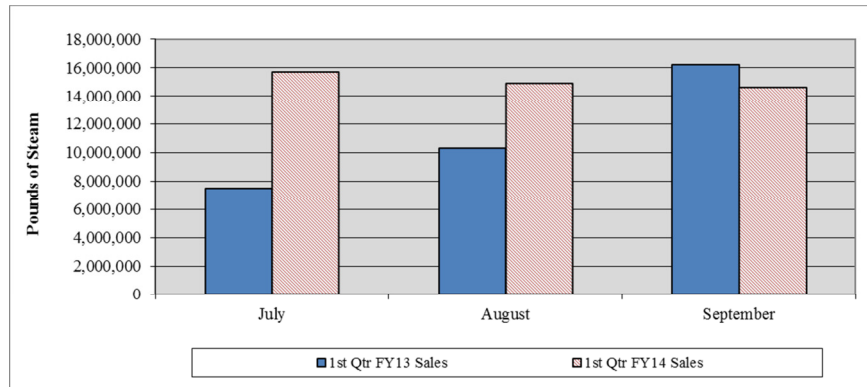
**Figure 7. Steam Sales Comparison for the First Quarter FY14**

The steam sendout increased by approximately 17.2% over the previous First Quarter (FY13), and the sales increased by approximately 33% due largely to the Music City Center. The steam system losses decreased approximately 23.5% relative to sendout. The number of heating degree days decreased by approximately 91% over the previous First Quarter. A comparison for the First Quarter steam sales is shown in Figure 7.

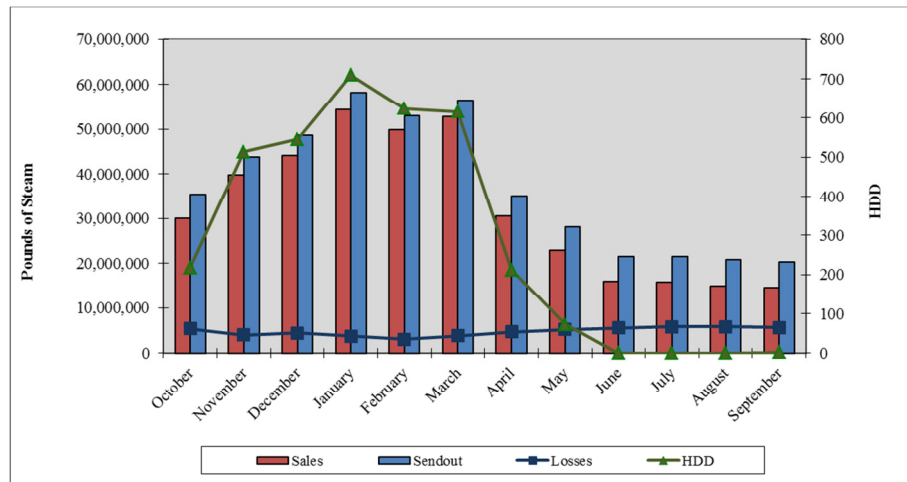
**Figure 8. Steam Sales, Sendout, Losses and HDD for the Previous Twelve Months**

Figure 8 shows the steam sales, sendout and losses for the previous twelve months. The losses on this figure are defined as the difference in pounds per month between the recorded sendout and sales values and represent the total mass loss in the EDS between the EGF and the customer meters.

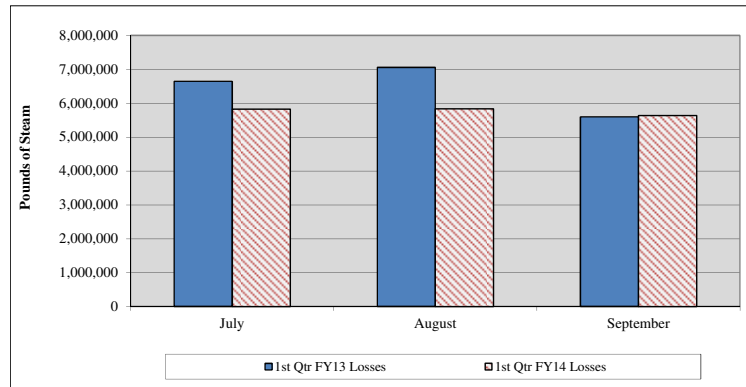
**Figure 9. First Quarter FY14 Steam System Losses**

A comparison of the total steam mass losses in the EDS for the First Quarter is shown in Figure 9. The mass loss is caused by the heat loss in the EDS between the EGF and the customer meters, resulting in a mass loss at steam traps. Faulty traps, steam leaks or meter error could also be a contributing cause of these losses.

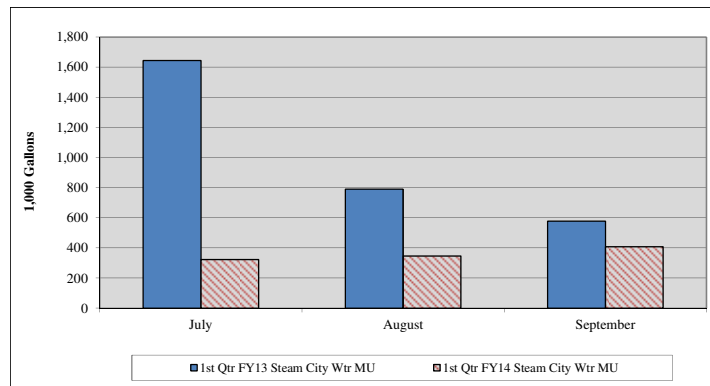
**Figure 10. First Quarter FY14 Steam System City Water Make-up Comparison**

The amount of city water make-up (MU) to the steam system consists of the loss in mass between the EGF and the customers, in the condensate return from the customers to the EGF and losses at the EGF. This data is shown in the comparison of First Quarter data in Figure 10.

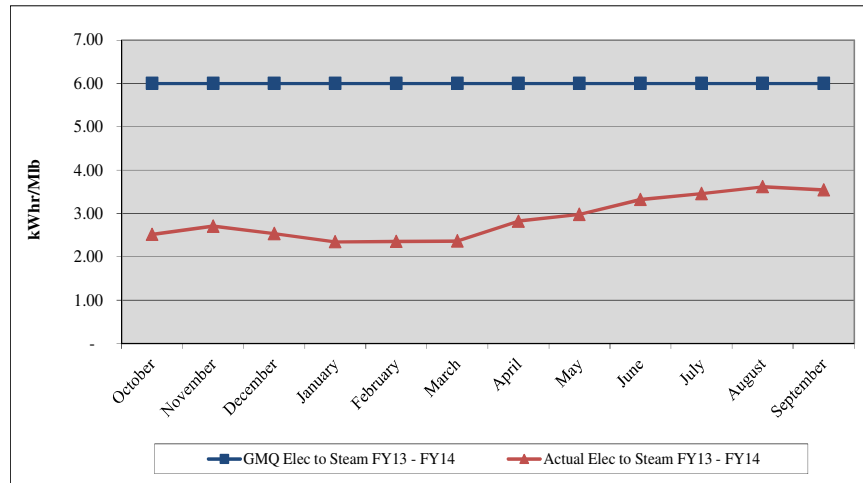
**Figure 11. Steam Plant Electric Performance Guarantee for the Previous Twelve Months**

The performance of the steam system aspect of the EGF is presented by the following three charts, Figures 11, 12 and 13. Under the management of CNE, the System Performance Guarantee levels as described in the ARMA are being achieved satisfactorily.

The current quarter experienced a 6.2% increase in the steam plant electric consumption while experiencing a 20% decrease in the electric conversion factor (due to an increase in steam sales). The water consumption for the steam plant decreased 64% this quarter as compared to the previous First Quarter. The fuel consumption per unit of steam sales is relatively constant throughout the year and when compared to the historic data. The boiler plant fuel efficiency increased 3.8% for the current quarter due to an increase in the amount and temperature of the condensate return.
