Operations Monitoring Report

First Quarter FY16

**Thermal Engineering Group, Inc.
105 Hazel Path Court, Ste 2
Hendersonville, TN 37075**

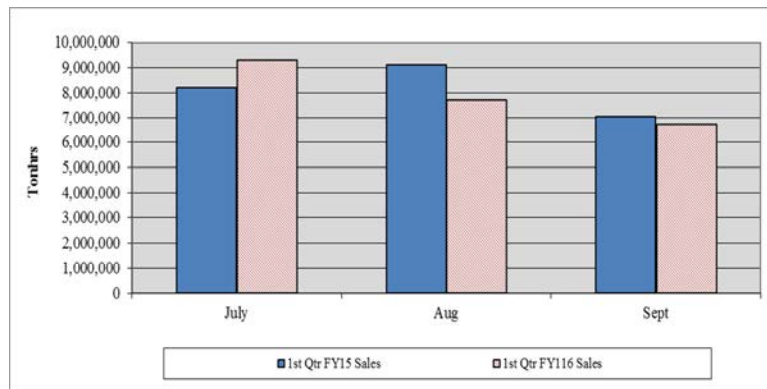
Figure 1. Chilled Water Sales Comparison

A comparison for the First Quarter chilled water sales is shown in Figure 1. This data reflects a 2.86% decrease in sales for the current quarter over the same quarter of the previous fiscal year.

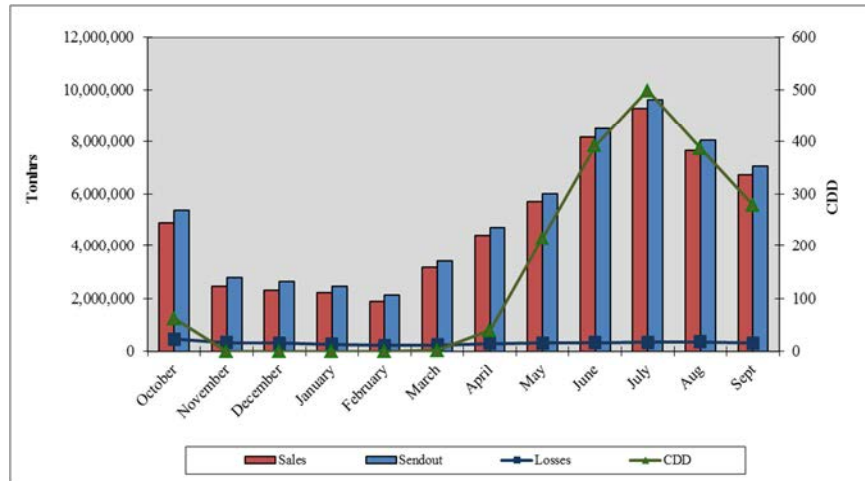
Figure 2. Chilled Water Sales, Sendout, Losses and CDD for the Previous Twelve Months

Figure 2 shows the chilled water sales, sendout and losses for the previous twelve months. The losses on this figure are defined as the difference in tonhrs per month between the recorded sendout and sales values and represent the total energy loss for chilled water in the EDS. The number of cooling degree days per month are also tracked for comparison.

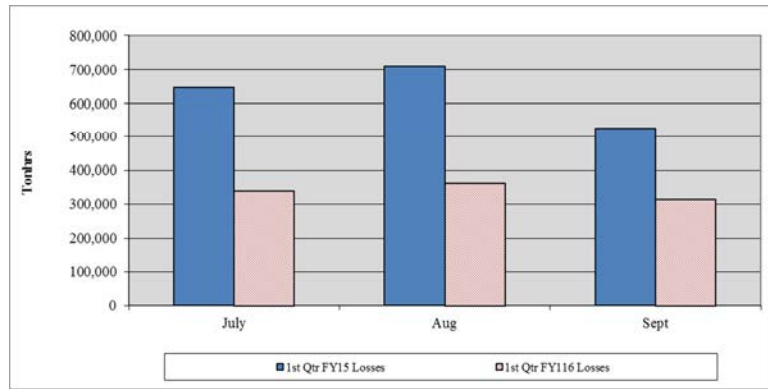
Figure 3. Chilled Water System Loss Comparison

A comparison of the total, chilled water energy losses in the EDS for the First Quarter is shown in Figure 3. These losses are the difference in chilled water sendout and sales.

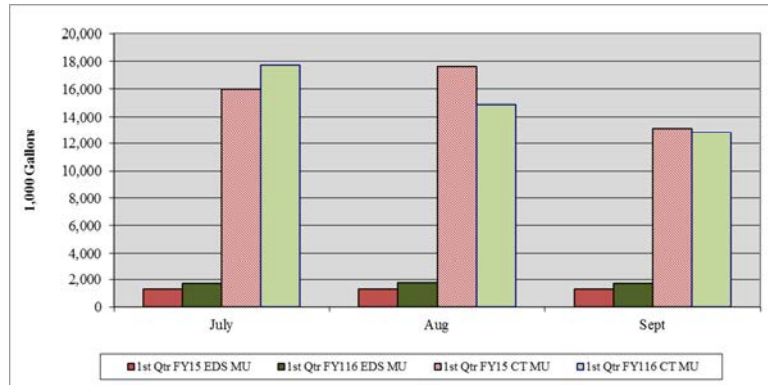
Figure 4. Chilled Water System City Water Usage Comparison

The total energy losses have decreased by approximately 45.7% over the previous First Quarter. The make-up to the cooling towers decreased 2.9% during the quarter. The number of cycles of concentration in the condensing water circuit experienced a marginal increase during the current. The overall city water make-up comparison for the chilled water system is shown in Figure 4.

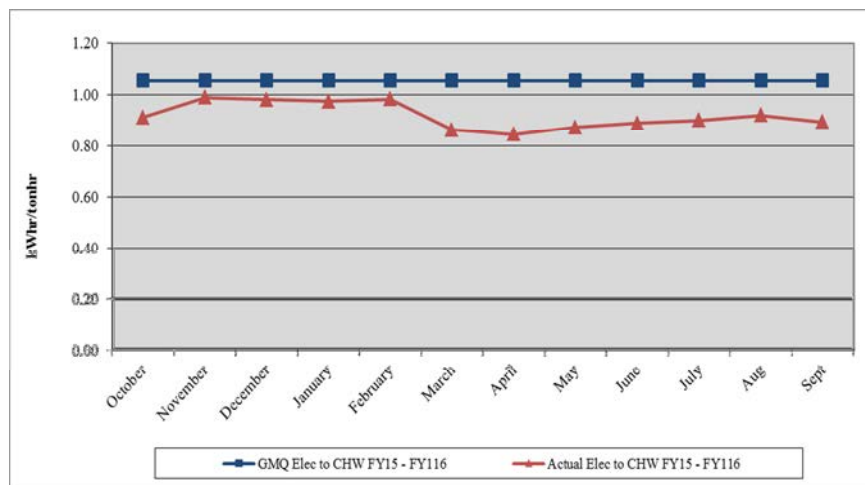
Figure 5. Chiller Plant Electric Performance Guarantee Comparison for the Previous Twelve Months

The performance of the chilled water aspect of the EGF is presented by the following two charts, Figures 5 and 6, for the previous twelve months. Under the management of CNE, the System Performance Guarantee levels as described in the ARMA are being achieved quite satisfactorily.

The chilled water allocation of the electric consumption falls under the GMQ limit of 1.055 kWhr per tonhr for the current quarter, and no excursion is reported for the current fiscal year. However, the chiller plant electric usage continued to show a steady increase over previous years until March 2015. CNE made some operational changes in the First Quarter FY15 that led to an increase in electric use during the Second and Third Quarters. Additional changes were made in March that appears to have led to a subsequent reduction in electric use. The electric usage per unit of sales decreased approximately 0.6% over the First Quarter for FY15 (Figure 5). TEG and CNE continue to work together to improve the efficiency of the chiller plant.

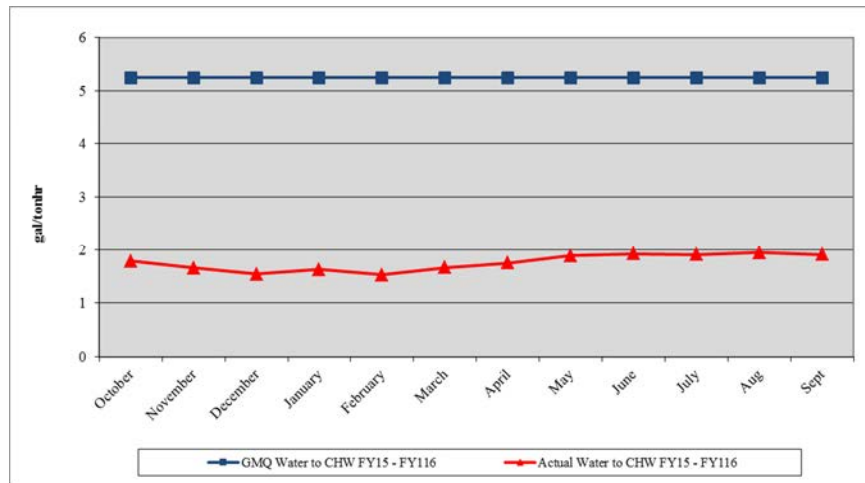
Figure 6. Chiller Plant Water Consumption Performance Guarantee Comparison for the Previous Twelve Months

The actual chilled water plant water conversion factor increased approximately 2.9% over the previous First Quarter. However, the total consumption of city water for the chiller plant for the current quarter increased marginally.

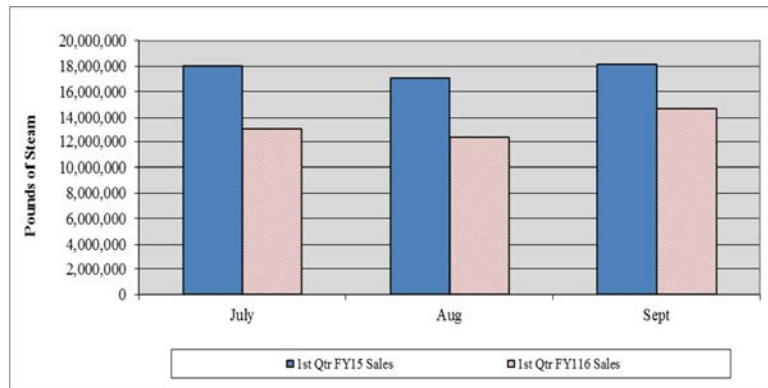
Figure 7. Steam Sales Comparison

The steam sendout decreased by approximately 15.5% over the previous First Quarter (FY15), and the sales also decreased by approximately 24.4%. The First Quarter FY15 and FY16 did not have any heating degree days. The steam system losses increased 33.3% over the previous First Quarter. Whenever steam sales decrease from the previous quarter, the percent of system losses can be expected to increase since the majority of these losses are based on a near constant heat loss of the system. A comparison for the First Quarter steam sales is shown in Figure 7.

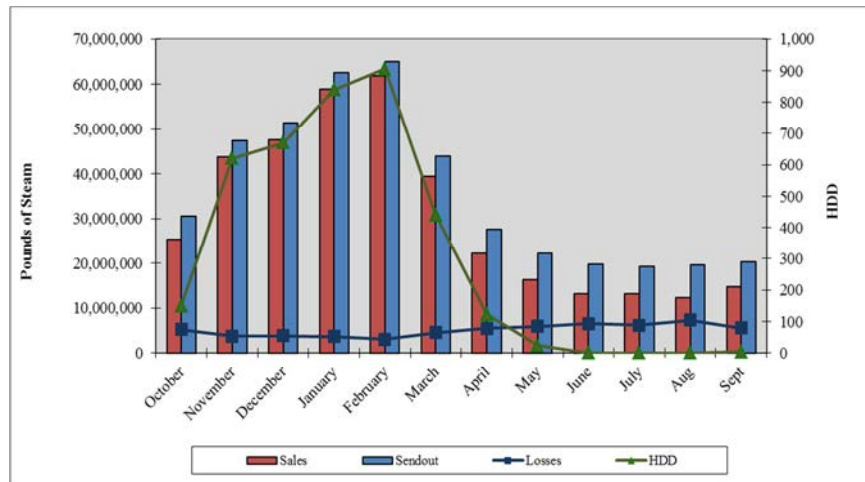
Figure 8. Steam Sales, Sendout, Losses and HDD for the Previous Twelve Months

Figure 8 shows the steam sales, sendout and losses for the previous twelve months. The losses on this figure are defined as the difference in pounds per month between the recorded sendout and sales values and represent the total mass loss in the EDS between the EGF and the customer meters.

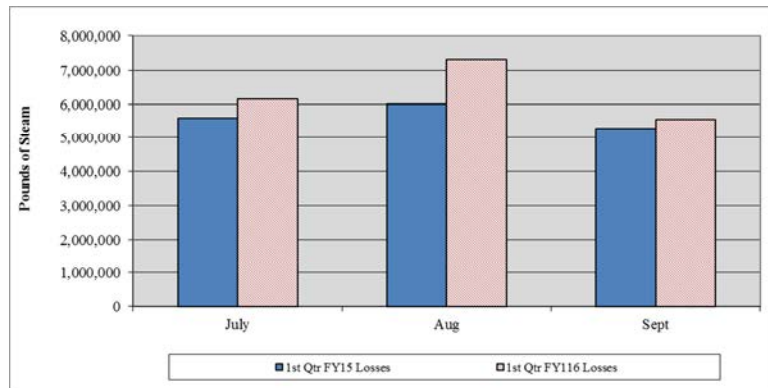
Figure 9. Steam System Losses

A comparison of the total steam mass losses in the EDS for the First Quarter is shown in Figure 9. The mass loss is caused by the heat loss in the EDS between the EGF and the customer meters, resulting in a mass loss at steam traps. Faulty traps, steam leaks or meter error could also be a contributing cause of these losses.

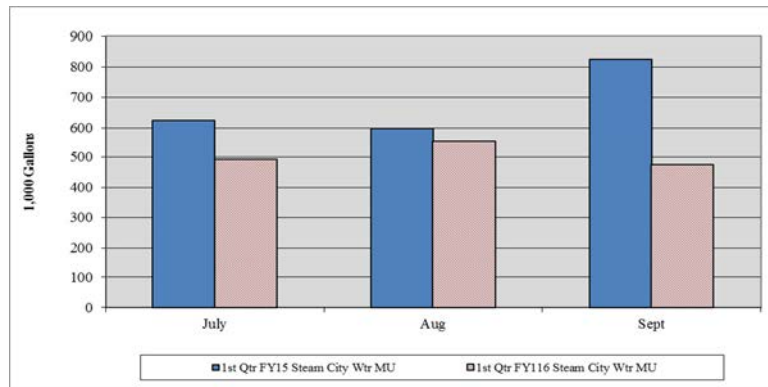
Figure 10. Steam System City Water Make-up Comparison

The amount of city water make-up (MU) to the steam system consists of the loss in mass between the EGF and the customers, in the condensate return from the customers to the EGF and losses at the EGF. This data is shown in the comparison of First Quarter data in Figure 10.

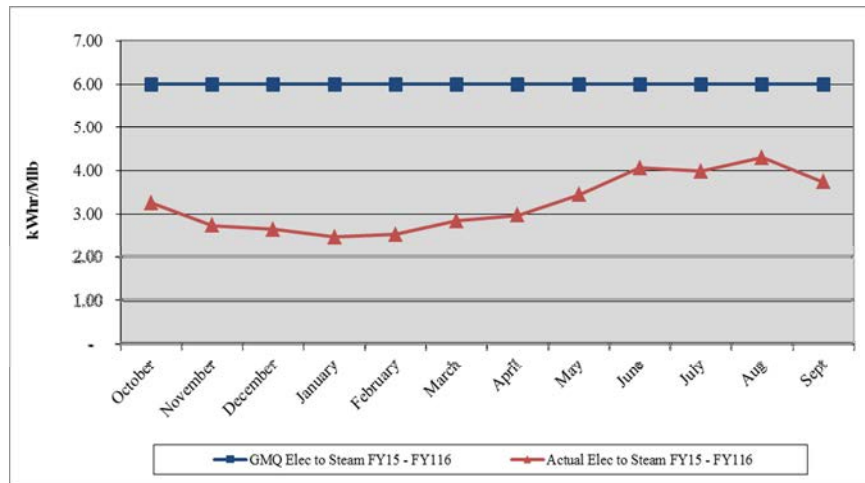
Figure 11. Steam Plant Electric Performance Guarantee for the Previous Twelve Months

The performance of the steam system aspect of the EGF is presented by the following three charts, Figures 11, 12 and 13. Under the management of CNE, the System Performance Guarantee levels as described in the ARMA are being achieved satisfactorily.

The current quarter experienced a 0.5% decrease in the steam plant electric consumption while experiencing a 31.7% increase in the electric conversion factor due to a decrease in sales. The water consumption for the steam plant decreased 26% this quarter as compared to the previous First Quarter. The fuel consumption per unit of steam sales has been relatively constant throughout the the historic data. However, the boiler plant fuel efficiency decreased 3.64% for the current quarter.
