## **Operations Monitoring Report**

**Third Quarter FY16**

**Thermal Engineering Group, Inc.  
105 Hazel Path Court, Ste 2  
Hendersonville, TN 37075**

**April 27, 2016**

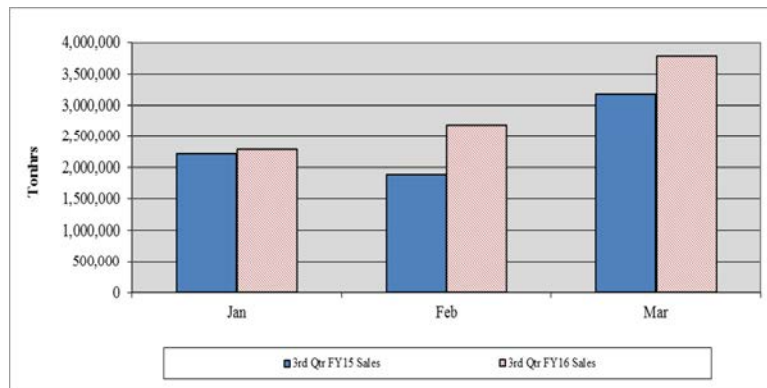
**Figure 1. Chilled Water Sales Comparison**

A comparison for the Third Quarter chilled water sales is shown in Figure 1. This data reflects a 20.2% increase in sales for the current quarter over the same quarter of the previous fiscal year. The increase in chilled water sales is largely due to a warmer than normal January and February.

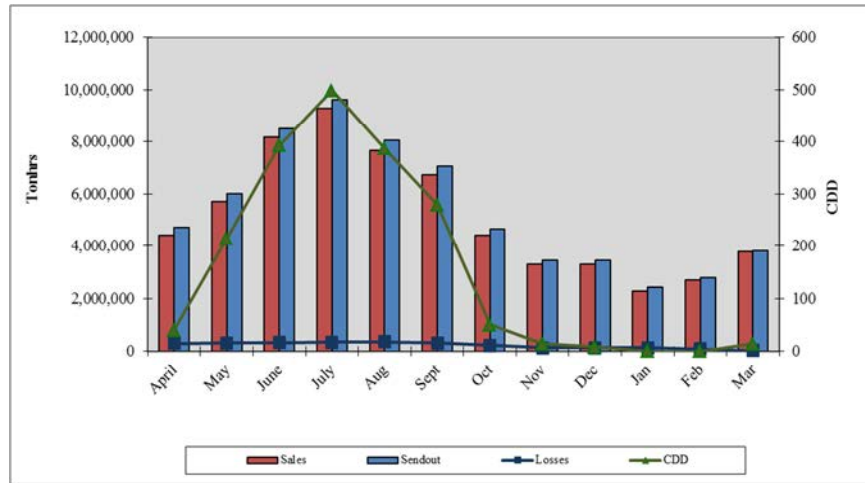
**Figure 2. Chilled Water Sales, Sendout, Losses and CDD for the Previous Twelve Months**

Figure 2 shows the chilled water sales, sendout and losses for the previous twelve months. The losses on this figure are defined as the difference in tonhrs per month between the recorded sendout and sales values and represent the total energy loss for chilled water in the EDS. The number of cooling degree days per month are also tracked for comparison.

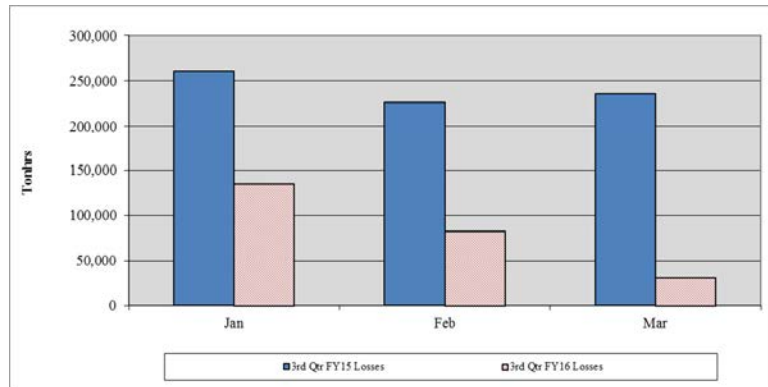
**Figure 3. Chilled Water System Loss Comparison**

A comparison of the total, chilled water energy losses in the EDS for the Third Quarter is shown in Figure 3. These losses are the difference in chilled water sendout and sales.

The EDS make-up increased by approximately 21.8% over the previous Third Quarter. CNE is continuing to investigate the sources of the chilled water leaks that cause the increase in EDS make-up. A new project (DES-125) has been implemented and has included several excavations in suspected areas to find the sources of the leaks. The total EDS water usage represents only a small part of the total EGF water usage for the quarter, but the percentage is increasing.

The total energy losses have decreased by approximately 65.2% over the previous Third Quarter. The make-up to the cooling towers increased 15.4% during the quarter due largely to an increase in chilled water sales. The number of cycles of

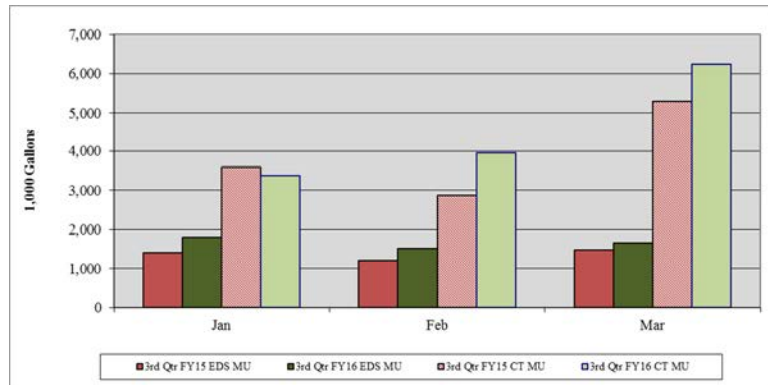
**Figure 4. Chilled Water System City Water Usage Comparison**

concentration in the condensing water circuit experienced a 1.9% increase during the current quarter. The overall city water make-up comparison for the chilled water system is shown in Figure 4.

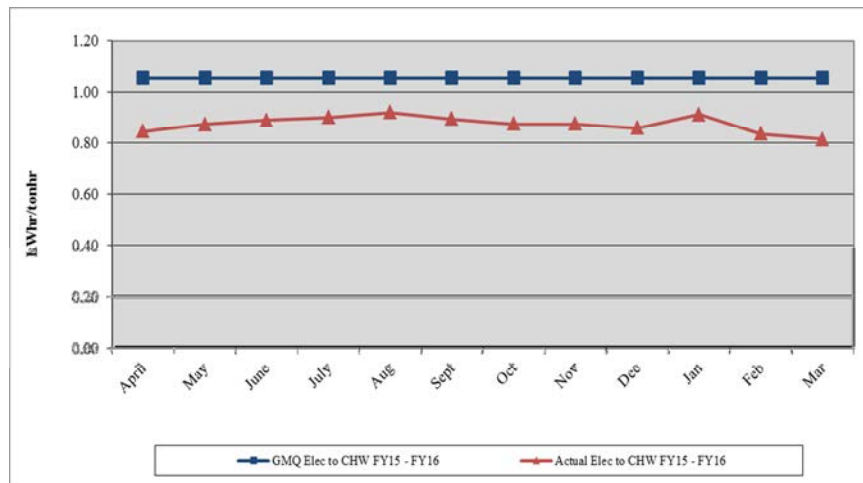
**Figure 5. Chiller Plant Electric Performance Guarantee Comparison for the Previous Twelve Months**

The performance of the chilled water aspect of the EGF is presented by the following two charts, Figures 5 and 6, for the previous twelve months. Under the management of CNE, the System Performance Guarantee levels as described in the ARMA are being achieved quite satisfactorily.

The chilled water allocation of the electric consumption falls under the GMQ limit of 1.055 kWhr per tonhr for the current quarter, and no excursion is reported for the current fiscal year. The steady increase in electric consumption previously reported has been remedied through operational changes made by CNE. The electric usage per unit of sales decreased approximately 8.8% over the Third Quarter for FY15 (Figure 5). TEG will continue to monitor CNE’s performance in operating the chiller plant to ensure continued efficient operation.

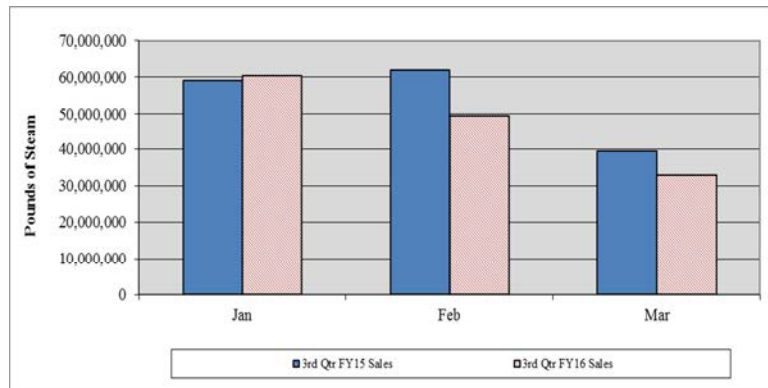
**Figure 7. Steam Sales Comparison**

The steam sendout decreased by approximately 10.1% over the previous Third Quarter (FY15), and the sales also decreased by approximately 10.7%. The Quarter experienced a 20.4% decrease in the number of heating degree days. The steam system losses increased 2.1% over the previous Third Quarter. A comparison for the Third Quarter steam sales is shown in Figure 7.

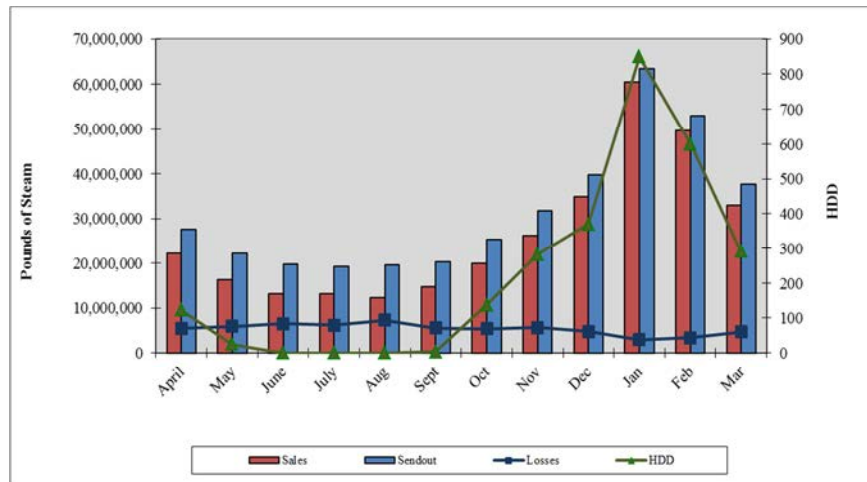
**Figure 8. Steam Sales, Sendout, Losses and HDD for the Previous Twelve Months**

Figure 8 shows the steam sales, sendout and losses for the previous twelve months. The losses on this figure are defined as the difference in pounds per month between the recorded sendout and sales values and represent the total mass loss in the EDS between the EGF and the customer meters.

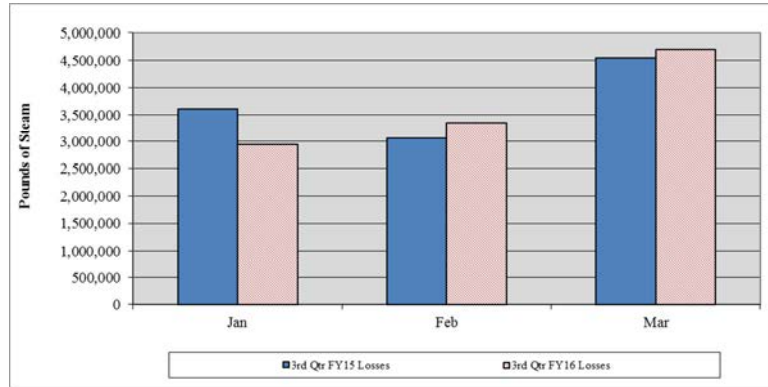
**Figure 9. Steam System Losses**

A comparison of the total steam mass losses in the EDS for the Third Quarter is shown in Figure 9. The mass loss is caused by the heat loss in the EDS between the EGF and the customer meters, resulting in a mass loss at steam traps. Faulty traps, steam leaks or meter error could also be a contributing cause of these losses. Whenever steam sales decrease from the previous quarter, the percent of system

losses can be expected to increase since the majority of these losses are based on a near constant heat loss of the system.

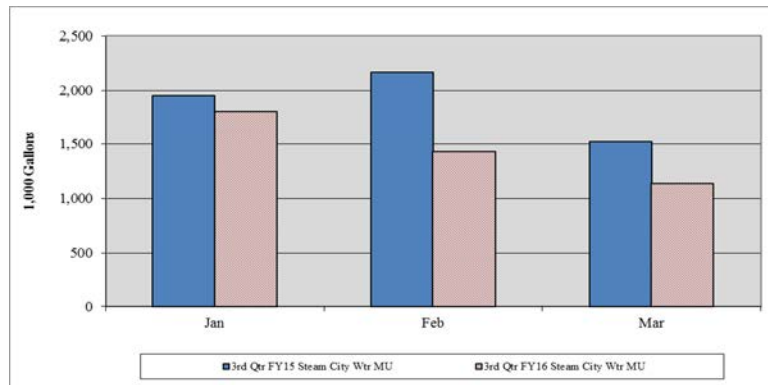
**Figure 10. Steam System City Water Make-up Comparison**

The amount of city water make-up (MU) to the steam system consists of the loss in mass between the EGF and the customers, in the condensate return from the customers to the EGF and losses at the EGF. This data is shown in the comparison of Second Quarter data in Figure 10.

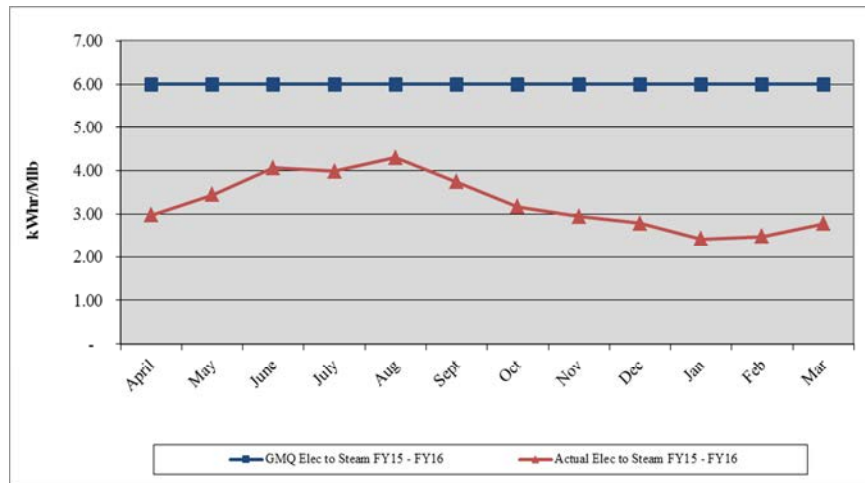
**Figure 11. Steam Plant Electric Performance Guarantee for the Previous Twelve Months**

The performance of the steam system aspect of the EGF is presented by the following three charts, Figures 11, 12 and 13. Under the management of CNE, the System Performance Guarantee levels as described in the ARMA are being achieved satisfactorily.

The current quarter experienced a 12.8% decrease in the steam plant electric consumption while experiencing a 2.4% decrease in the electric conversion factor. The water consumption for the steam plant decreased 22.3% this quarter as compared to the previous Third Quarter. The fuel consumption per unit of steam sales recovered to similar historic values during the quarter. However, the average efficiency for the quarter remains 2.2% lower than the previous Third Quarter due to the January performance. The February and March values are more consistent and represent much improved performance.
