Operations Monitoring Report

First Quarter FY17

**Thermal Engineering Group, Inc.
105 Hazel Path Court, Ste 2
Hendersonville, TN 37075**

October 31, 2016

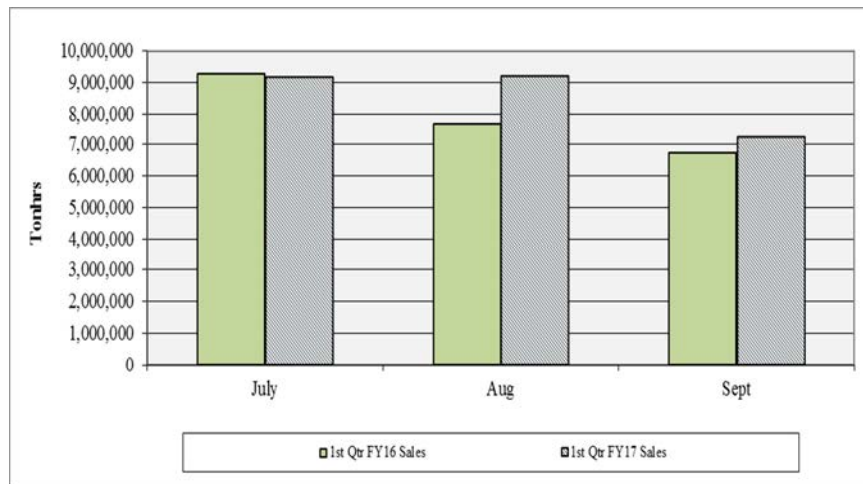
Figure 1. Chilled Water Sales Comparison

A comparison for the First Quarter chilled water sales is shown in Figure 1. This data reflects a 7.9% increase in sales for the current quarter over the same quarter of the previous fiscal year.

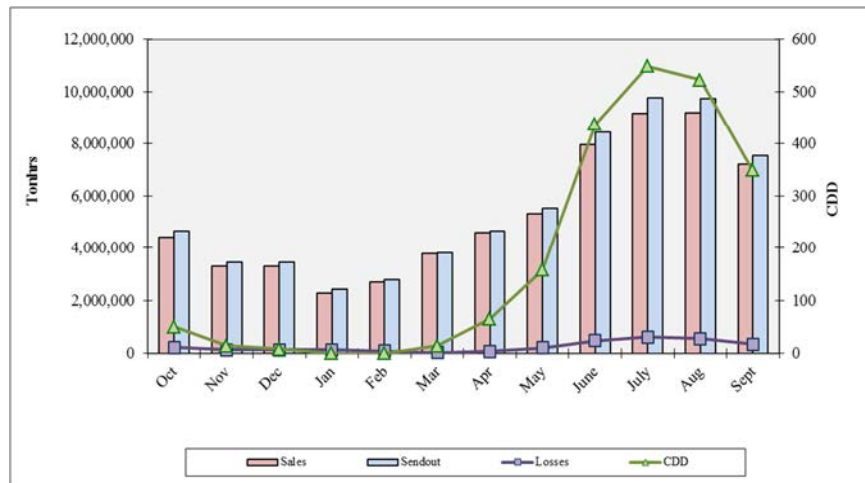
Figure 2. Chilled Water Sales, Sendout, Losses and CDD for the Previous Twelve Months

Figure 2 shows the chilled water sales, sendout and losses for the previous twelve months. The losses on this figure are defined as the difference in tonhrs per month between the recorded sendout and sales values and represent the total energy loss for chilled water in the EDS. The number of cooling degree days per month are also tracked for comparison.

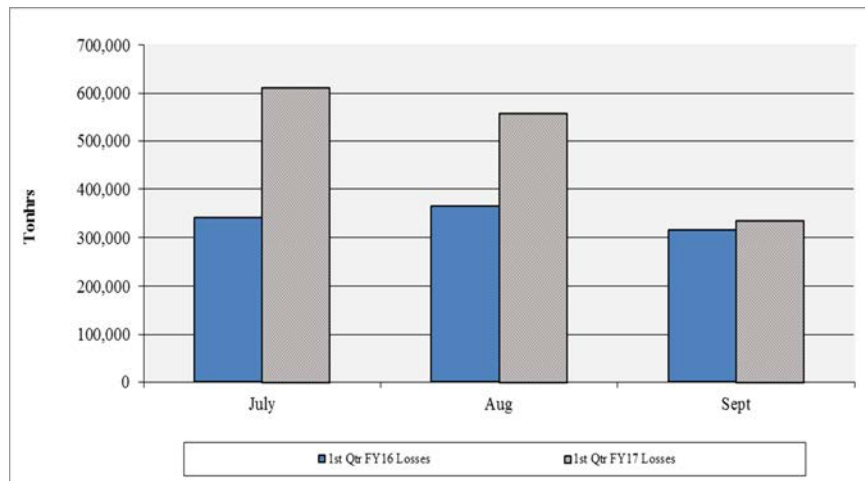
Figure 3. Chilled Water System Loss Comparison

A comparison of the total, chilled water energy losses in the EDS for the First Quarter is shown in Figure 3. These losses are the difference in chilled water sendout and sales.

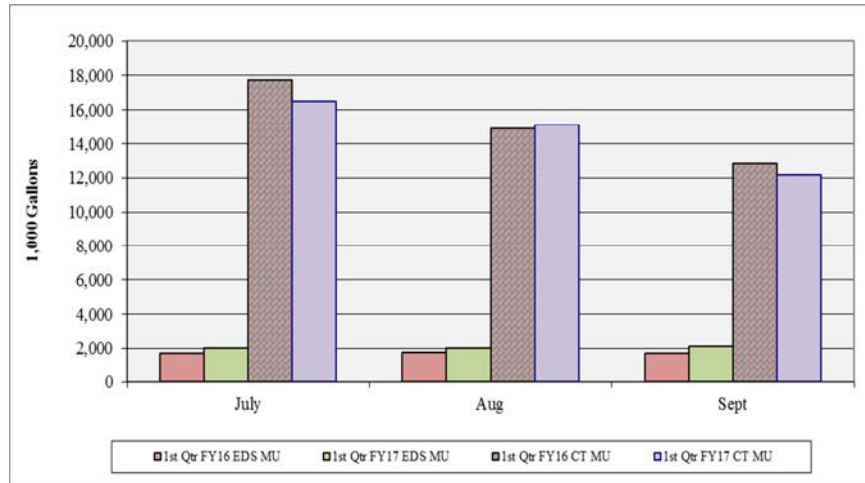
Figure 4. Chilled Water System City Water Usage Comparison

The total energy losses have increased by approximately 47.7% over the previous First Quarter. The make-up to the cooling towers decreased marginally during the quarter. The number of cycles of concentration in the condensing water circuit experienced a 24.7% decrease during the current quarter. The overall city water make-up comparison for the chilled water system is shown in Figure 4.

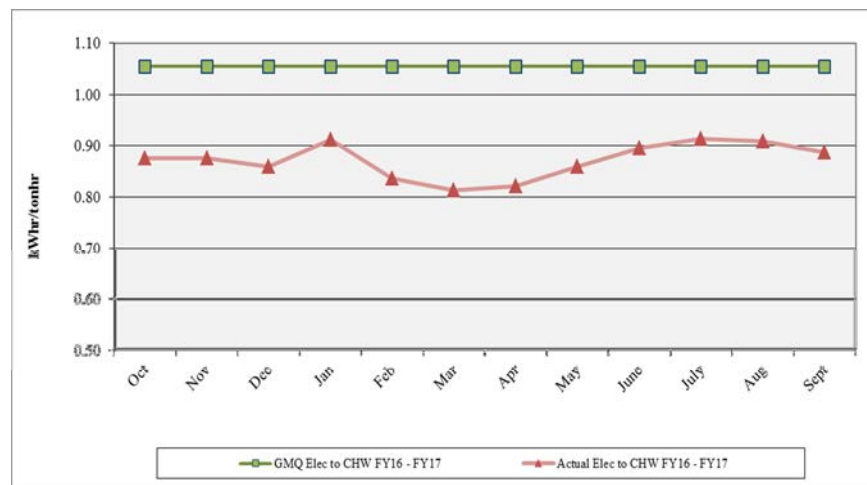
Figure 5. Chiller Plant Electric Performance Guarantee Comparison for the Previous Twelve Months

The performance of the chilled water aspect of the EGF is presented by the following two charts, Figures 5 and 6, for the previous twelve months. Under the management of CNE, the System Performance Guarantee levels as described in the ARMA are being achieved quite satisfactorily.

The chilled water allocation of the electric consumption falls under the GMQ limit of 1.055 kWhr per tonhr for the current quarter, and no excursion is reported for the current fiscal year. The electric usage per unit of sales decreased approximately 0.23% over the First Quarter for FY16 (Figure 5), resulting in a slightly improved performance.

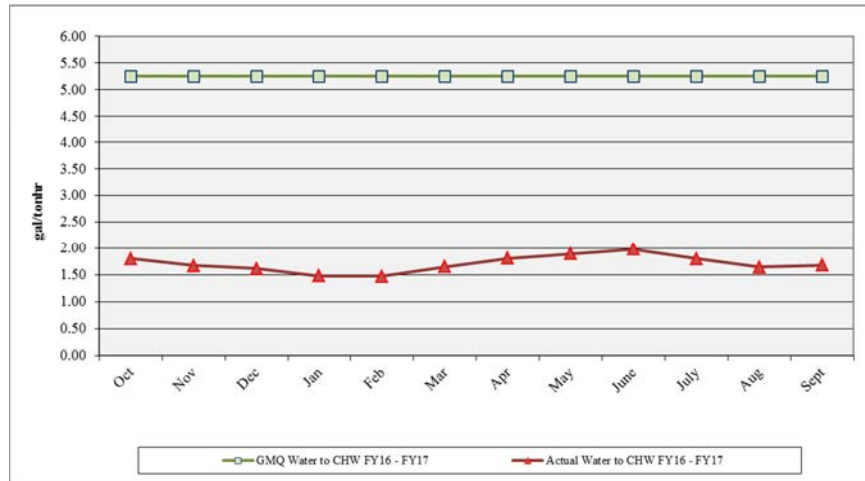
Figure 6. Chiller Plant Water Consumption Performance Guarantee Comparison for the Previous Twelve Months

The actual chiller plant water conversion factor decreased approximately 8.6% over the previous First Quarter. The total consumption of city water for the chiller plant for the current quarter decreased 1.4%.

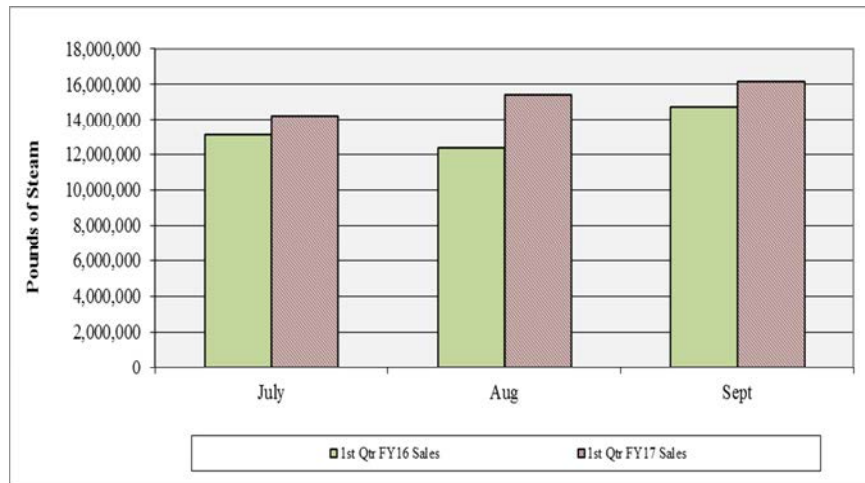
Figure 7. Steam Sales Comparison

The steam sendout increased by approximately 5.4% over the previous First Quarter (FY16), and the sales also increased by approximately 7.9%. The Quarter experienced a significant increase in the number of heating degree days due to cooler than normal weather in late September. The steam system losses decreased 12.6% over the previous First Quarter. A comparison for the First Quarter steam sales is shown in Figure 7.

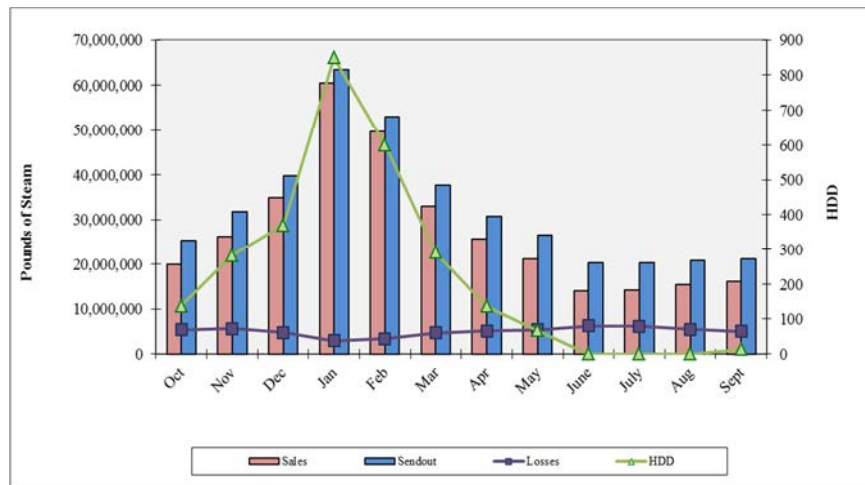
Figure 8. Steam Sales, Sendout, Losses and HDD for the Previous Twelve Months

Figure 8 shows the steam sales, sendout and losses for the previous twelve months. The losses on this figure are defined as the difference in pounds per month between the recorded sendout and sales values and represent the total mass loss in the EDS between the EGF and the customer meters.

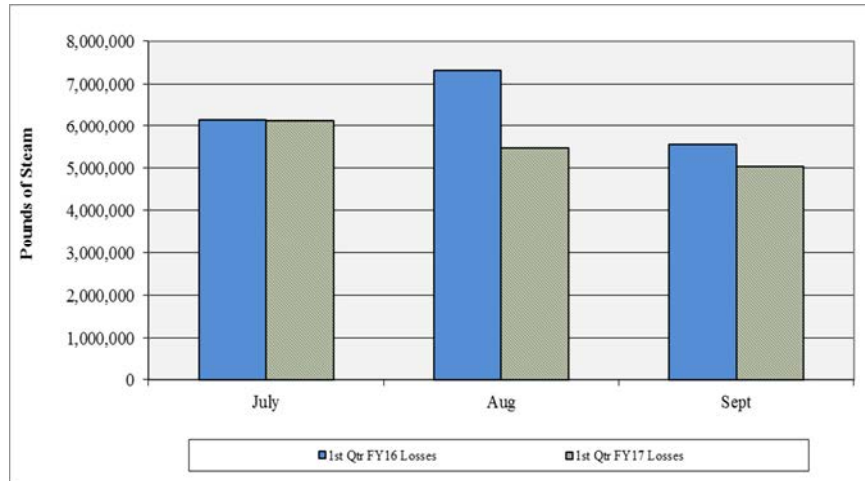
Figure 9. Steam System Losses

A comparison of the total steam mass losses in the EDS for the First Quarter is shown in Figure 9. The mass loss is caused by the heat loss in the EDS between the EGF and the customer meters, resulting in a mass loss at steam traps. Faulty

traps, steam leaks or meter error could also be a contributing cause of these losses. Whenever steam sales decrease from the previous quarter, the percent of system losses can be expected to increase since the majority of these losses are based on a near constant heat loss of the system.

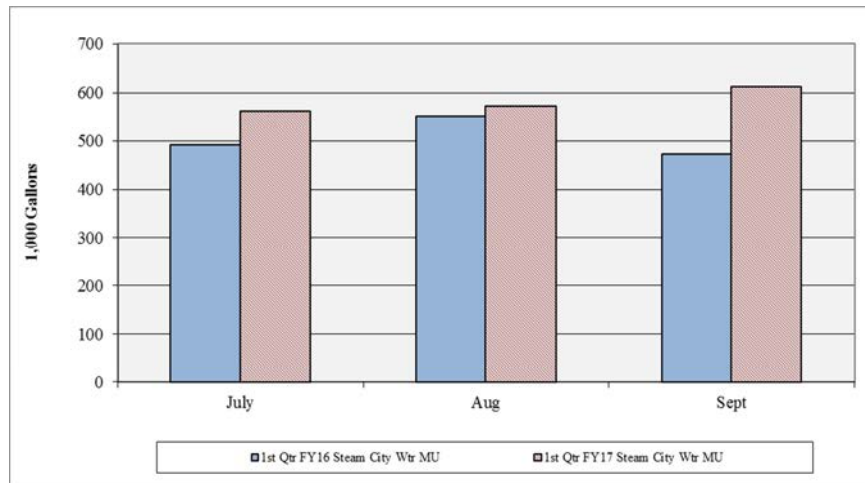
Figure 10. Steam System City Water Make-up Comparison

The amount of city water make-up (MU) to the steam system consists of the loss in mass between the EGF and the customers, in the condensate return from the customers to the EGF and losses at the EGF. This data is shown in the comparison of First Quarter data in Figure 10.

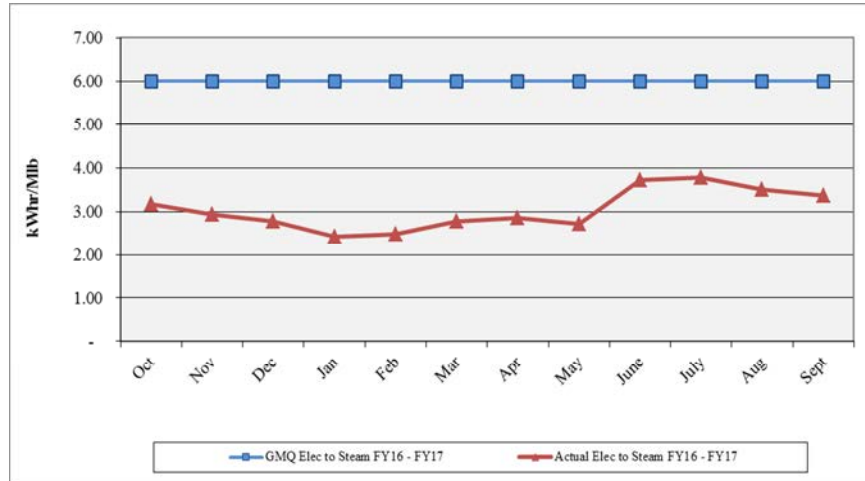
Figure 11. Steam Plant Electric Performance Guarantee for the Previous Twelve Months

The performance of the steam system aspect of the EGF is presented by the following three charts, Figures 11, 12 and 13. Under the management of CNE,

The current quarter experienced a 1.2% increase in the steam plant electric consumption while experiencing an 11.2% decrease in the electric conversion factor. The water consumption for the steam plant increased 15.2% this quarter as compared to the previous First Quarter. The fuel consumption per unit of steam sales was 3.4% lower than in the previous First Quarter.
