Operations Monitoring Report

Fourth Quarter FY17

**Thermal Engineering Group, Inc.
105 Hazel Path Court, Ste 2
Hendersonville, TN 37075**

July 31, 2017

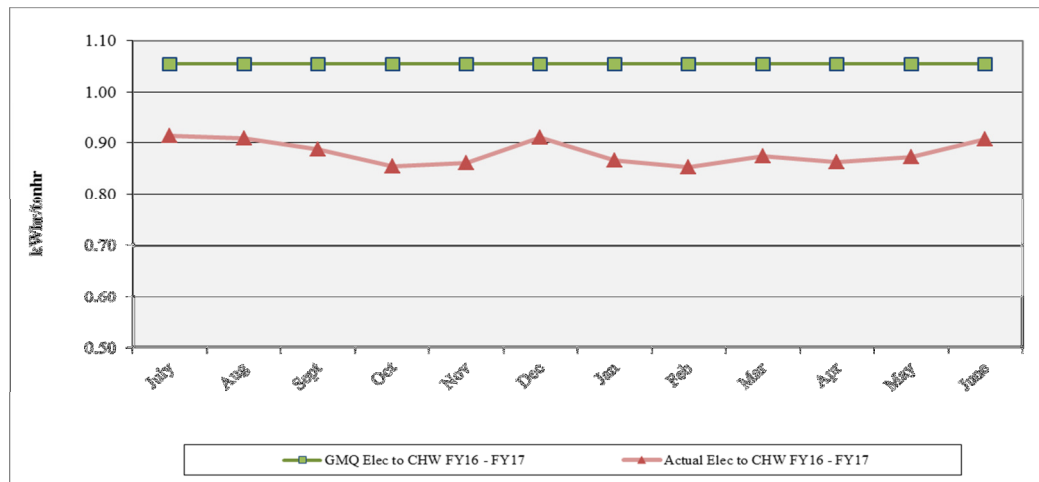
Figure 5. Chiller Plant Electric Performance Guarantee Comparison for the Previous Twelve Months

The performance of the chilled water aspect of the EGF is presented by the following two charts, Figures 5 and 6, for the previous twelve months. Under the management of CNE, the System Performance Guarantee levels as described in the ARMA are being achieved satisfactorily.

The chilled water allocation of the electric consumption falls under the GMQ limit of 1.055 kWhr per tonhr for the current quarter, and no excursion is reported for the current fiscal year. The electric usage per unit of sales increased approximately 2.1% over the Fourth Quarter for FY16, resulting in a slightly poorer performance.
