Operations Monitoring Report

Second Quarter FY18

**Thermal Engineering Group, Inc.
105 Hazel Path Court, Ste 2
Hendersonville, TN 37075**

January 31, 2018

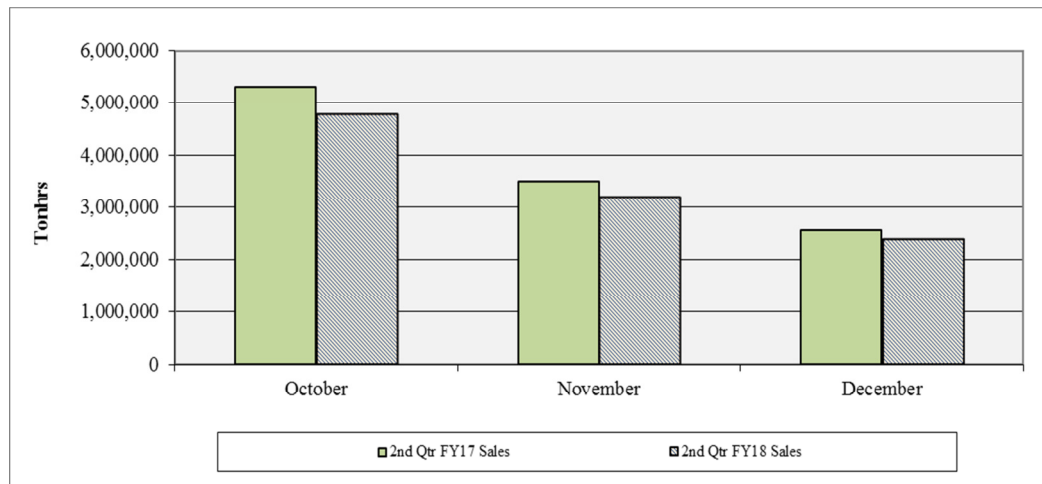
Figure 1. Chilled Water Sales Comparison

A comparison for the Second Quarter chilled water sales is shown in Figure 1. This data reflects an 8.8% decrease in sales for the current quarter over the same quarter of the previous fiscal year.

The peak chilled water demand for the current quarter was 14,926 tons, which represents a 5.3% increase over the previous Second Quarter.

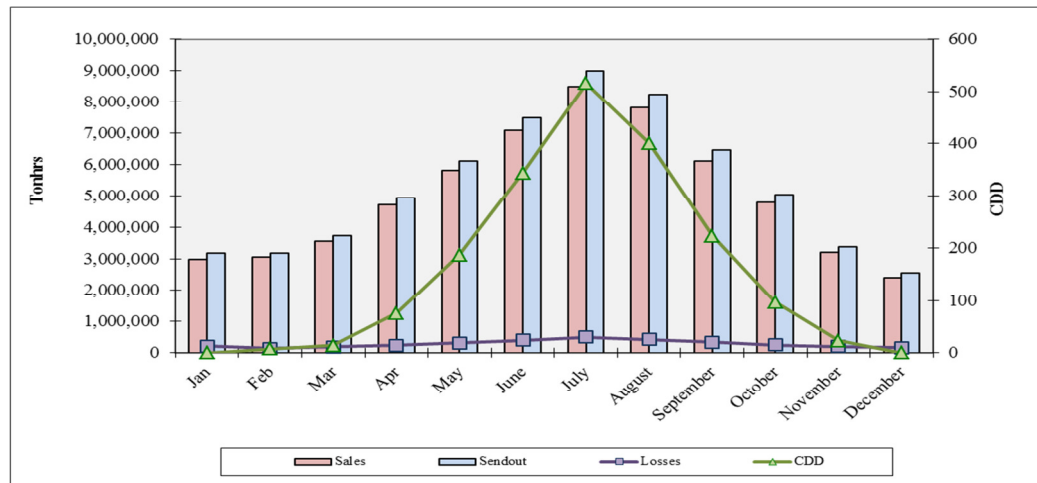
Figure 2. Chilled Water Sales, Sendout, Losses and CDD for the Previous Twelve Months

Figure 2 shows the chilled water sales, sendout and losses for the previous twelve months. The losses on this figure are defined as the difference in tonhrs per month between the recorded sendout and sales values and represent the total energy loss for chilled water in the EDS. The number of cooling degree days per month are also tracked for comparison.

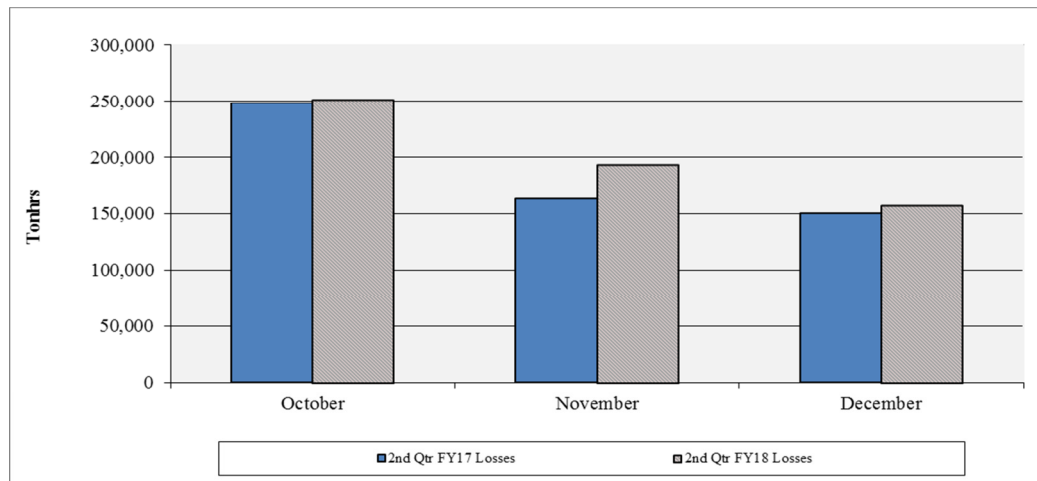
Figure 3. Chilled Water System Loss Comparison

A comparison of the total, chilled water energy losses in the EDS for the Second Quarter is shown in Figure 3. These losses are the difference in chilled water sendout and sales.

The EDS make-up increased by approximately 37.0% over the previous Second Quarter. CNE and TEG are continuing to investigate the sources of the chilled water leaks that cause the increase in EDS make-up. Potential locations for the leak are suspected, and additional excavations began during the quarter. Any repairs to the chilled water piping will have to be made immediately and most likely require the shutdown of customer buildings.

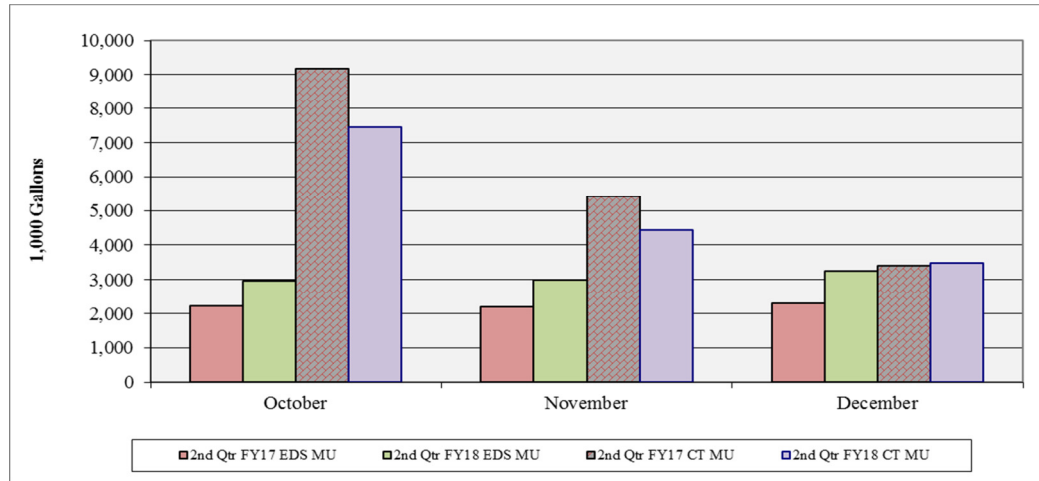
Figure 4. Chilled Water System City Water Usage Comparison

The make-up to the cooling towers decreased approximately 14.5% during the quarter. The number of cycles of concentration in the condensing water circuit experienced a 51.2% increase during the current quarter. The overall city water make-up comparison for the chilled water system is shown in Figure 4.

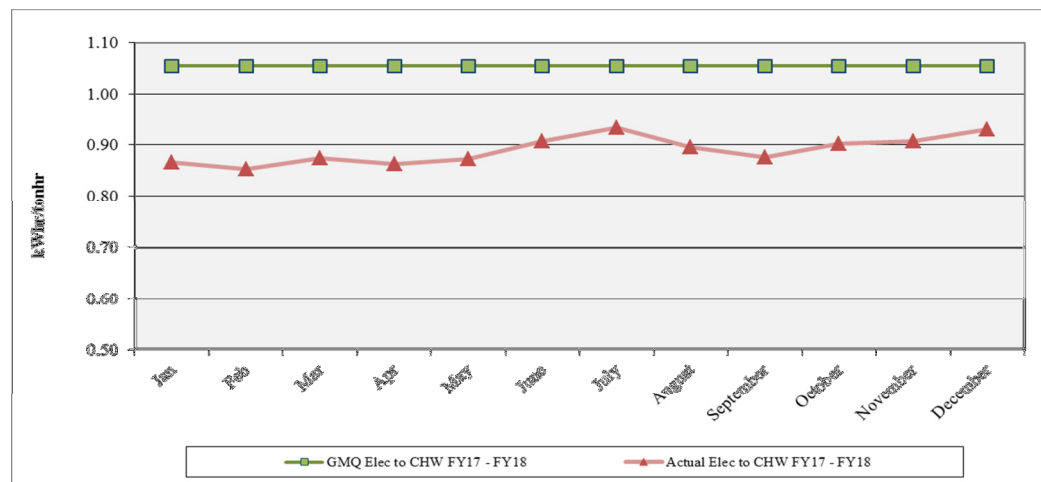
Figure 5. Chiller Plant Electric Performance Guarantee Comparison for the Previous Twelve Months

The performance of the chilled water aspect of the EGF is presented by the following two charts, Figures 5 and 6, for the previous twelve months. Under the management of CNE, the System Performance Guarantee levels as described in the ARMA are being achieved satisfactorily.

The chilled water allocation of the electric consumption falls under the GMQ limit of 1.055 kWhr per tonhr for the current quarter, and no excursion is reported for the current fiscal year. The electric usage per unit of sales increased 4.7% over the previous Second Quarter.

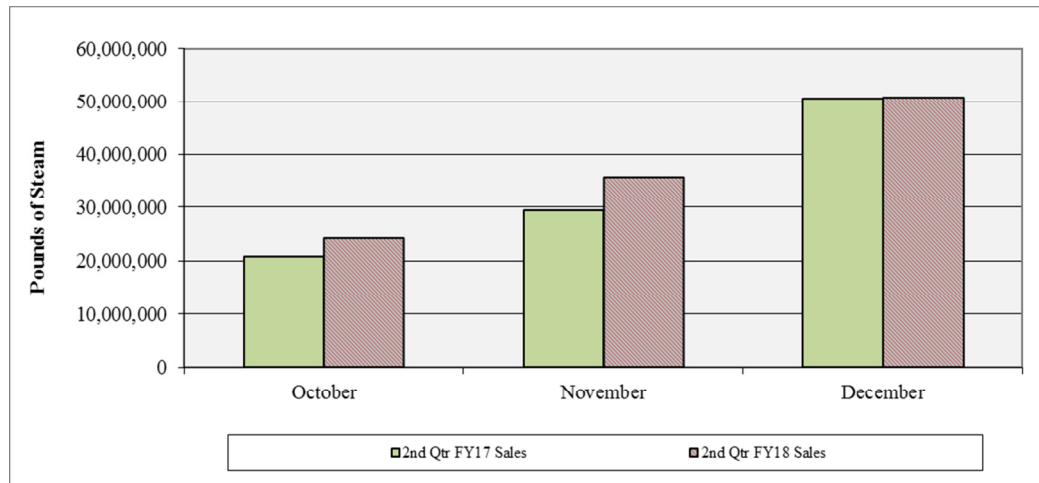
Figure 7. Steam Sales Comparison

The steam sendout increased by approximately 10.0% over the previous Second Quarter (FY17), and the sales also increased by approximately 10.0%. The Quarter experienced an approximate 28.9% increase in the number of heating degree days. The steam system losses increased 10.7% over the previous Second Quarter. A comparison for the Second Quarter steam sales is shown in Figure 7.

The peak steam demand for the current quarter was 138,438 pph, which reflects an approximate 9.7% increase in the peak steam production over the previous Second Quarter.

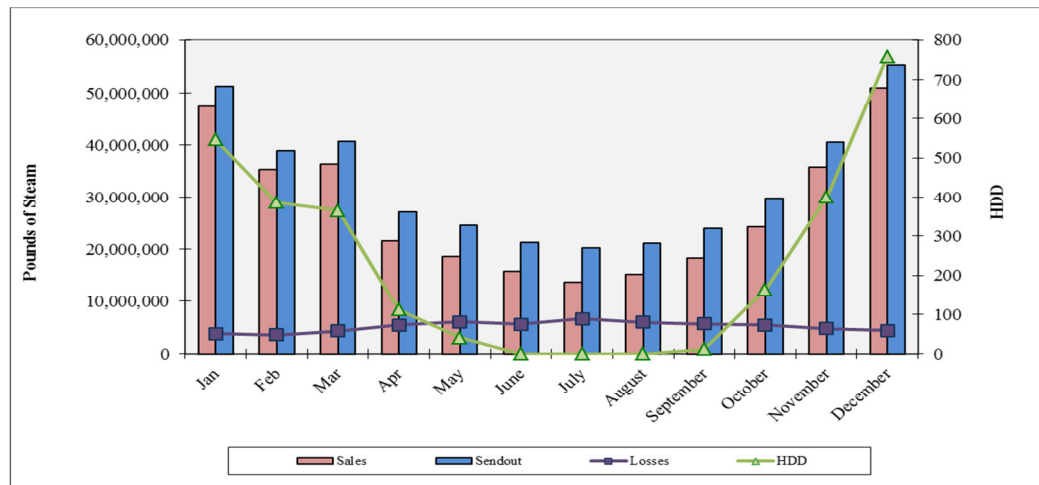
Figure 8. Steam Sales, Sendout, Losses and HDD for the Previous Twelve Months

Figure 8 shows the steam sales, sendout and losses for the previous twelve months. The losses on this figure are defined as the difference in pounds per month between the recorded sendout and sales values and represent the total mass loss in the EDS between the EGF and the customer meters.

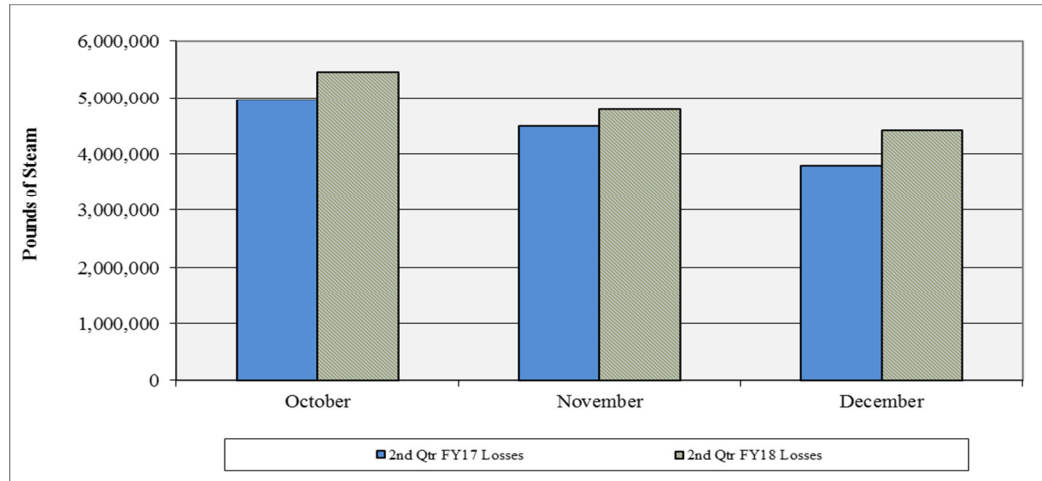
Figure 9. Steam System Losses

A comparison of the total steam mass losses in the EDS for the Second Quarter is shown in Figure 9. The mass loss is caused by the heat loss in the EDS between the EGF and the customer meters, resulting in a mass loss at steam traps. Faulty

traps, steam leaks or meter error could also be a contributing cause of these losses. Whenever steam sales decrease from the previous quarter, the percent of system losses can be expected to increase since the majority of these losses are based on a near constant heat loss of the system.

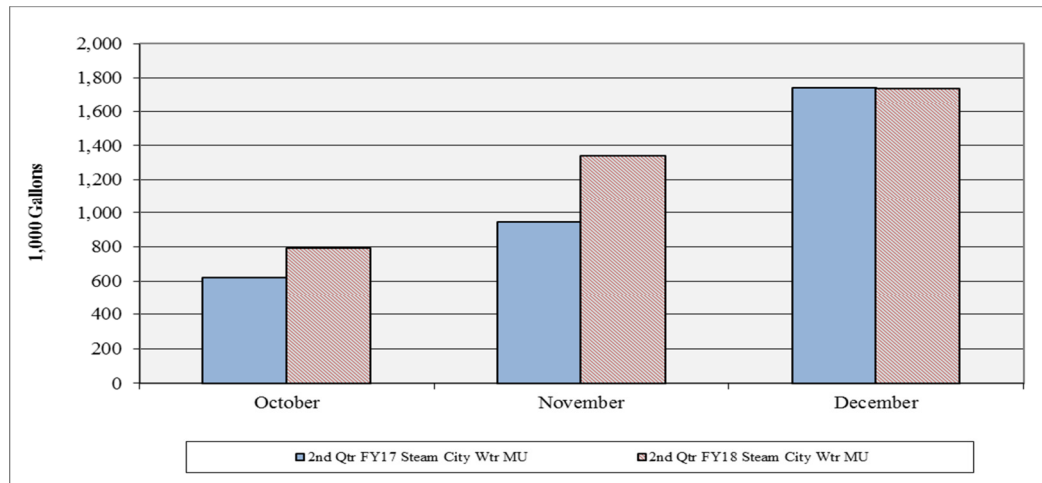
Figure 10. Steam System City Water Make-up Comparison

The amount of city water make-up (MU) to the steam system consists of the loss in mass between the EGF and the customers, in the condensate return from the customers to the EGF and losses at the EGF. This data is shown in the comparison of Second Quarter data in Figure 10.

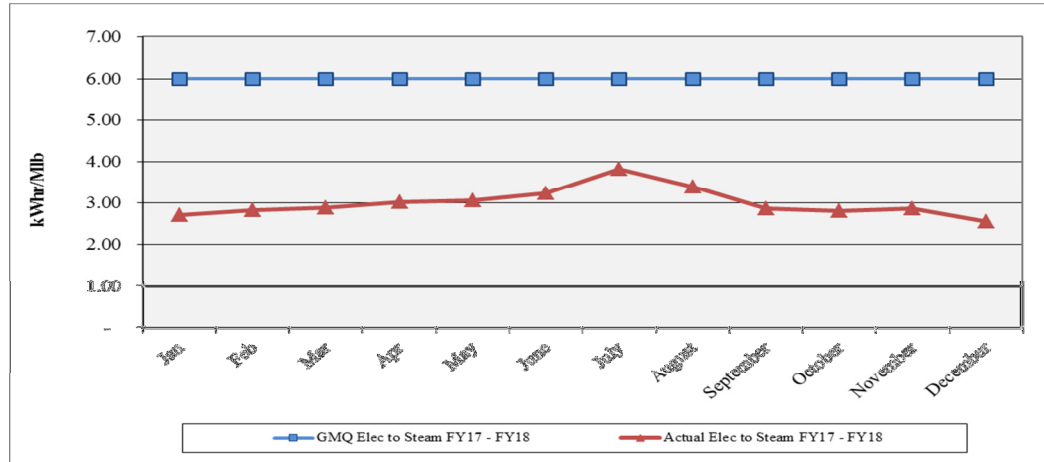
Figure 11. Steam Plant Electric Performance Guarantee for the Previous Twelve Months

The performance of the steam system of the EGF is presented by the following three charts, Figures 11, 12 and 13. Under the management of CNE, the System

Performance Guarantee levels as described in the ARMA are being achieved satisfactorily.

The current quarter experienced a 1.0% decrease in the steam plant electric consumption while experiencing an approximate 8.1% decrease in the electric conversion factor. The water consumption for the steam plant increased 17.0% this quarter as compared to the previous Second Quarter. The fuel consumption per unit of steam sales was marginally lower than in the previous Second Quarter.
