Operations Monitoring Report

First Quarter FY19

**Thermal Engineering Group, Inc.
105 Hazel Path Court, Ste 2
Hendersonville, TN 37075**

October 26, 2018

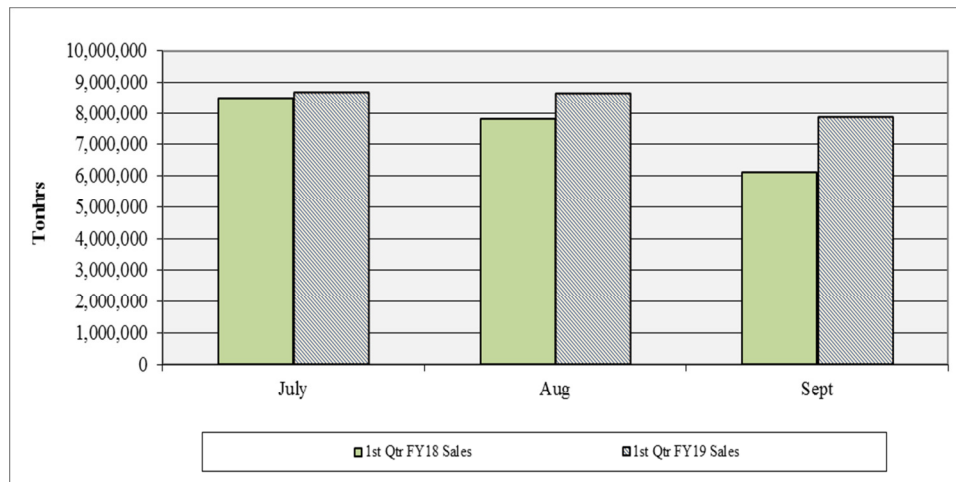
Figure 1. Chilled Water Sales Comparison

A comparison for the First Quarter chilled water sales is shown in Figure 1. This data reflects a 12.1% increase in sales for the current quarter over the same quarter of the previous fiscal year.

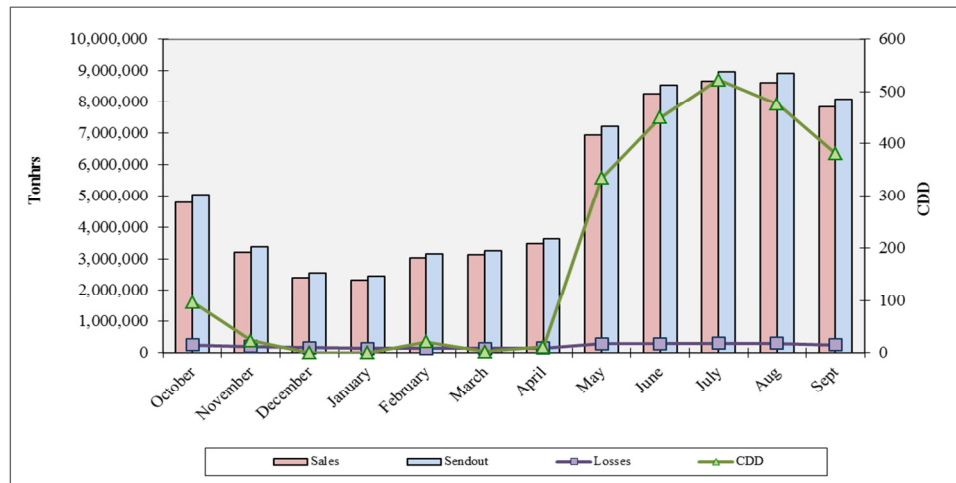
Figure 2. Chilled Water Sales, Sendout, Losses and CDD for the Previous Twelve Months

Figure 2 shows the chilled water sales, sendout and losses for the previous twelve months. The losses on this figure are defined as the difference in tonhrs per month between the recorded sendout and sales values and represent the total energy loss for chilled water in the EDS. The number of cooling degree days per month are also tracked for comparison.

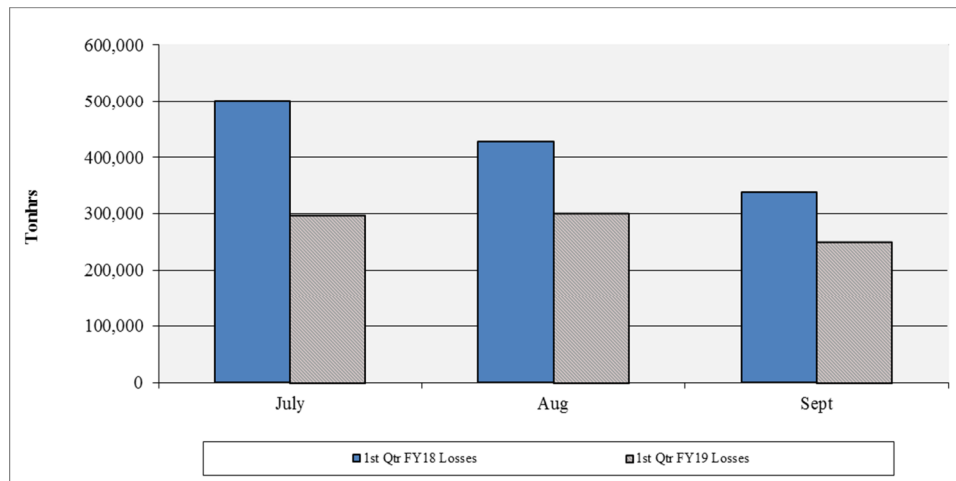
Figure 3. Chilled Water System Loss Comparison

A comparison of the total, chilled water energy losses in the EDS for the First Quarter is shown in Figure 3. These losses are the difference in chilled water sendout and sales.

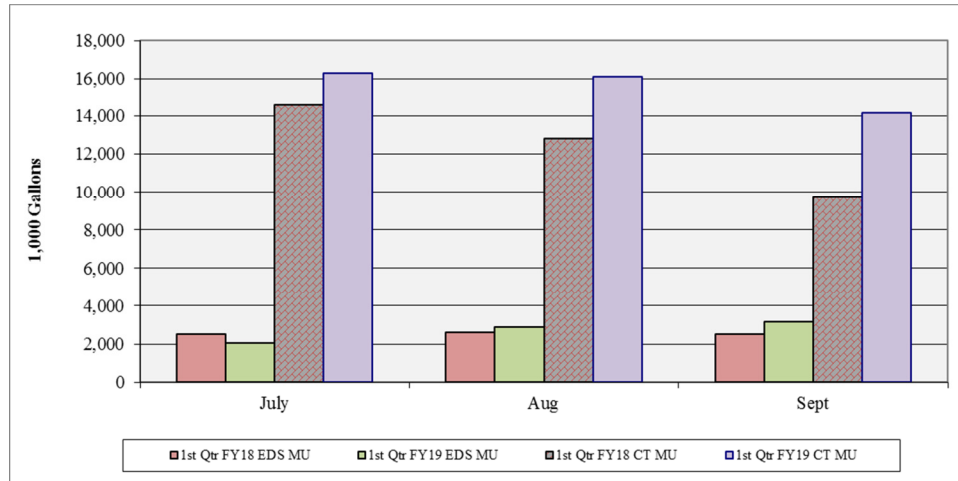
Figure 4. Chilled Water System City Water Usage Comparison

The make-up to the cooling towers increased approximately 25.2% during the quarter. The number of cycles of concentration in the condensing water circuit experienced a 5.5% increase during the current quarter. The overall city water make-up comparison for the chilled water system is shown in Figure 4.

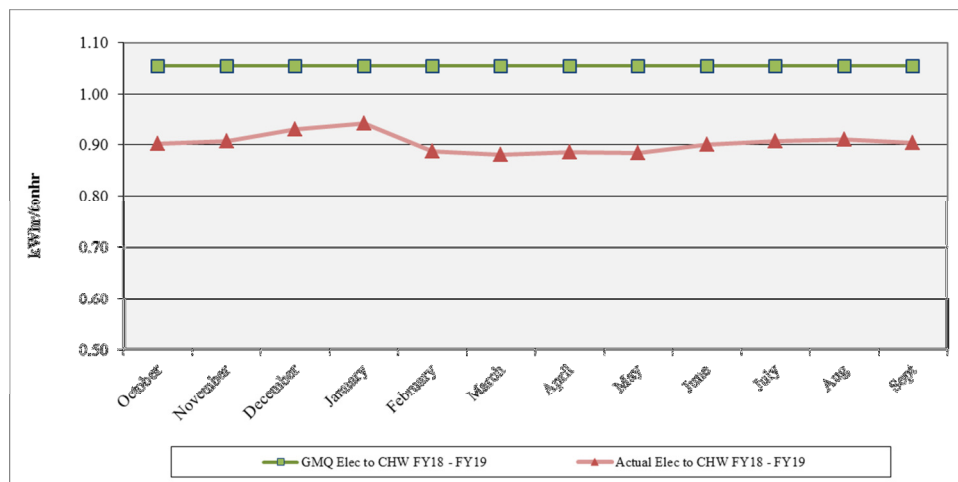
Figure 5. Chiller Plant Electric Performance Guarantee Comparison for the Previous Twelve Months

The performance of the chilled water aspect of the EGF is presented by the following two charts, Figures 5 and 6, for the previous twelve months. Under the management of CNE, the System Performance Guarantee levels as described in the ARMA are being achieved satisfactorily.

The chilled water allocation of the electric consumption falls under the GMQ limit of 1.055 kWhr per tonhr for the current quarter, and no excursion is reported for the current fiscal year. The electric usage per unit of sales increased 0.3% over the previous First Quarter.

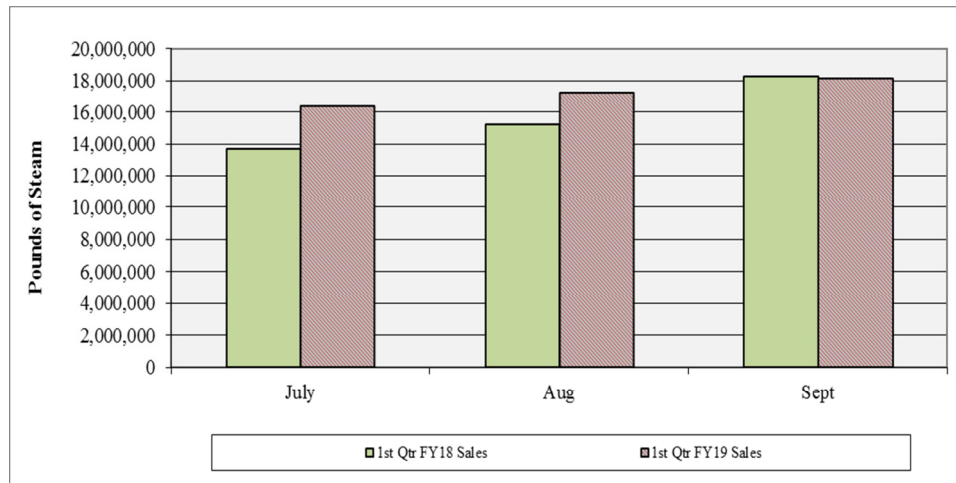
Figure 7. Steam Sales Comparison

The steam sendout increased by approximately 5.4% over the previous First Quarter (FY18), and the sales also increased by approximately 10.0%. The Quarter experienced an approximate 83.3% decrease in the number of heating degree days. The steam system losses decreased 6.5% over the previous First Quarter. A comparison for the First Quarter steam sales is shown in Figure 7.

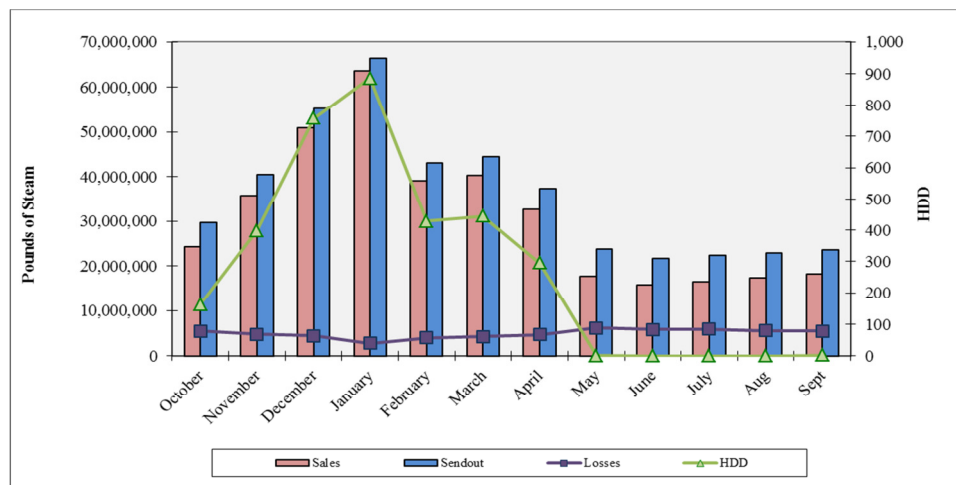
Figure 8. Steam Sales, Sendout, Losses and HDD for the Previous Twelve Months

Figure 8 shows the steam sales, sendout and losses for the previous twelve months. The losses on this figure are defined as the difference in pounds per month between the recorded sendout and sales values and represent the total mass loss in the EDS between the EGF and the customer meters.

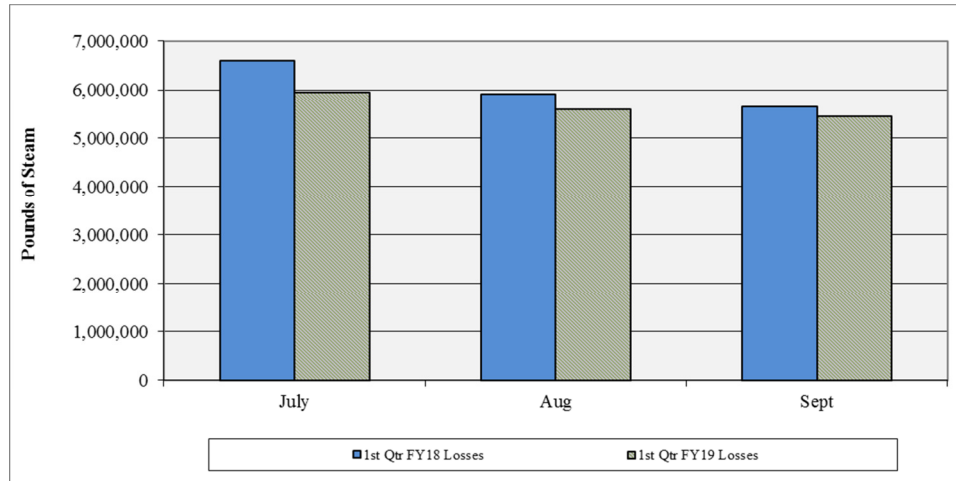
Figure 9. Steam System Losses

A comparison of the total steam mass losses in the EDS for the First Quarter is shown in Figure 9. The mass loss is caused by the heat loss in the EDS between the EGF and the customer meters, resulting in a mass loss at steam traps. Faulty

traps, steam leaks or meter error could also be a contributing cause of these losses. Whenever steam sales decrease from the previous quarter, the percent of system losses can be expected to increase since the majority of these losses are based on a near constant heat loss of the system.

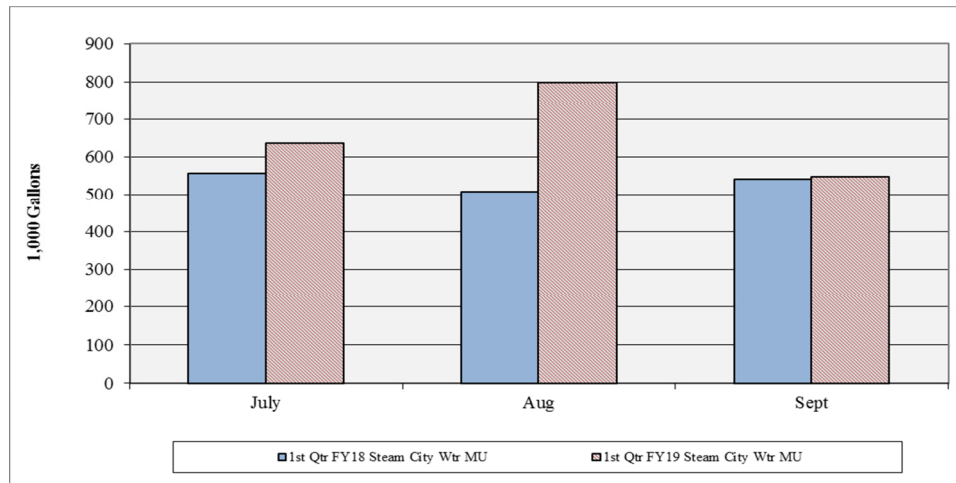
Figure 10. Steam System City Water Make-up Comparison

The amount of city water make-up (MU) to the steam system consists of the loss in mass between the EGF and the customers, in the condensate return from the customers to the EGF and losses at the EGF. This data is shown in the comparison of First Quarter data in Figure 10.

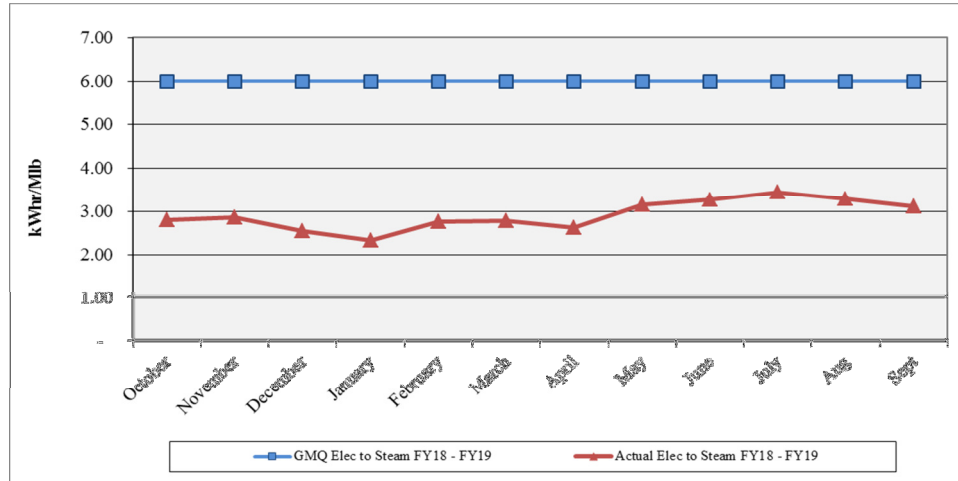
Figure 11. Steam Plant Electric Performance Guarantee for the Previous Twelve Months

The performance of the steam system of the EGF is presented by the following three charts, Figures 11, 12 and 13. Under the management of CNE, the System

The current quarter experienced a 9.0% increase in the steam plant electric consumption while experiencing a 0.9% decrease in the electric conversion factor. The water consumption for the steam plant decreased 23.4% this quarter as compared to the previous First Quarter. The fuel consumption per unit of steam sales was 1.1% higher than in the previous First Quarter.
