Operations Monitoring Report

Second Quarter FY20

**Thermal Engineering Group, Inc.
105 Hazel Path Court, Ste 2
Hendersonville, TN 37075**

January 31, 2020

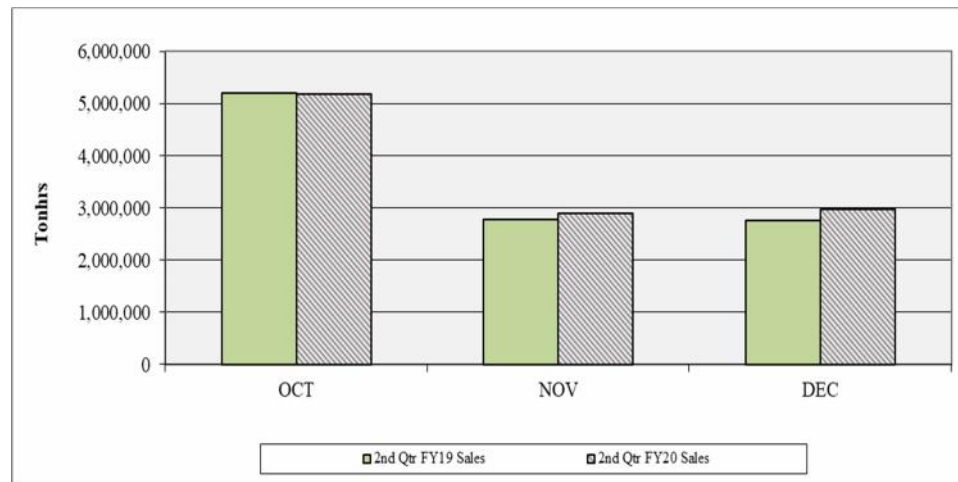
Figure 1. Chilled Water Sales Comparison

A comparison for the Second Quarter chilled water sales is shown in Figure 1. This data reflects a 2.9% increase in sales for the current quarter over the same quarter of the previous fiscal year.

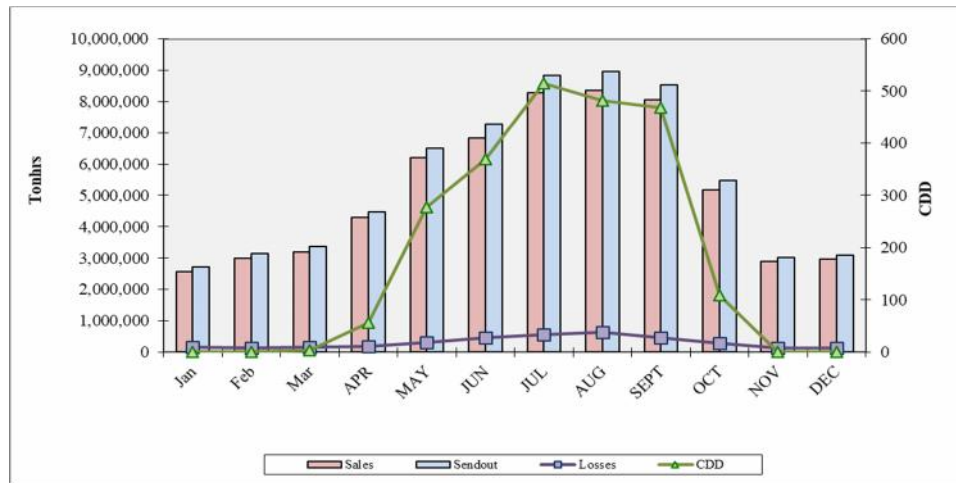
Figure 2. Chilled Water Sales, Sendout, Losses and CDD for the Previous Twelve Months

Figure 2 shows the chilled water sales, sendout and losses for the previous twelve months. The losses on this figure are defined as the difference in tonhrs per month between the recorded sendout and sales values and represent the total energy loss for chilled water in the EDS. The number of cooling degree days per month are also tracked for comparison.

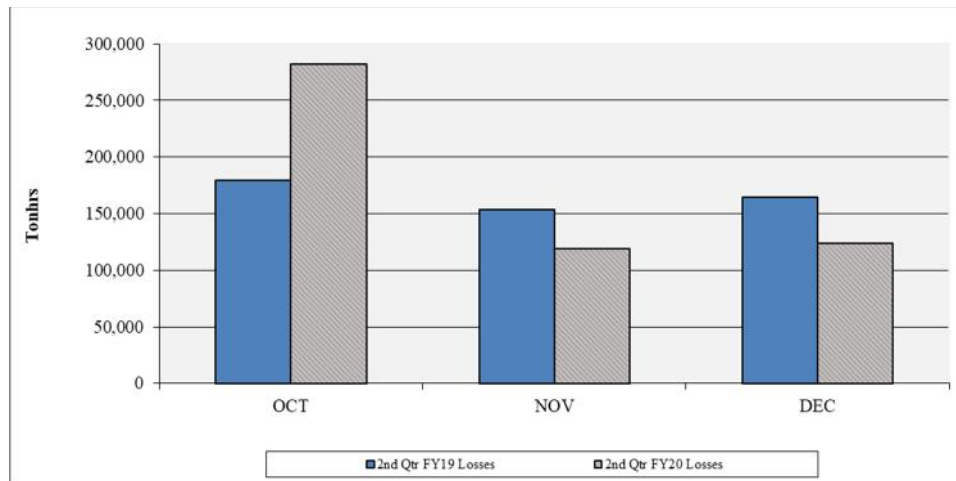
Figure 3. Chilled Water System Loss Comparison

A comparison of the total, chilled water energy losses in the EDS for the Second Quarter is shown in Figure 3. These losses are the difference in chilled water sendout and sales.

The EDS make-up decreased by 23.2% over the previous Second Quarter. All but one of the known distribution leaks have been found and repaired. The remaining leak location is on 3rd Ave N but previous efforts to locate this leak have been unsuccessful. TEG and CNE continue to investigate areas of suspected leaks and will continue to monitor the system losses to determine the cause.

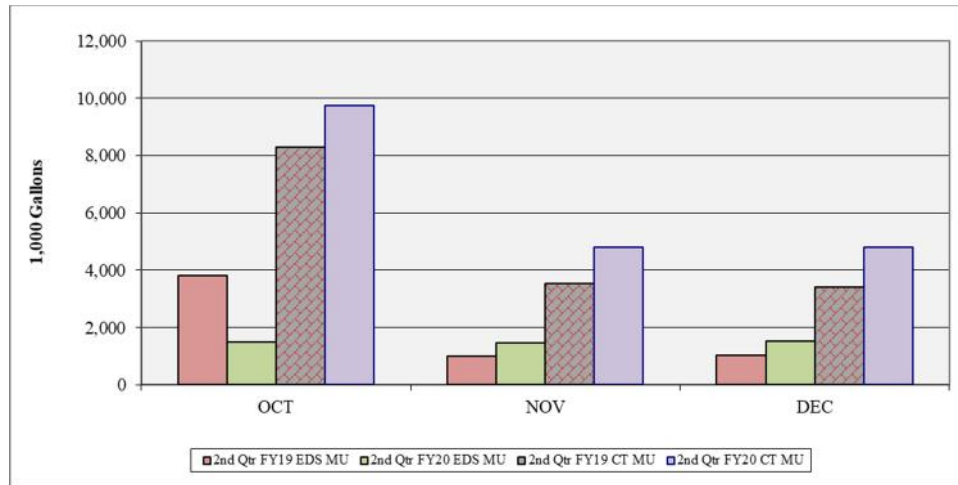
Figure 4. Chilled Water System City Water Usage Comparison

The make-up to the cooling towers increased 27.0% over the previous Second Quarter. The number of cycles of concentration in the condensing water circuit

increased 97.1%; however, CNE had to replace the faulty blowdown meter in September 2019, thus the number of cycles presented could include some erroneous meter readings. The overall city water make-up comparison for the chilled water system is shown in Figure 4.

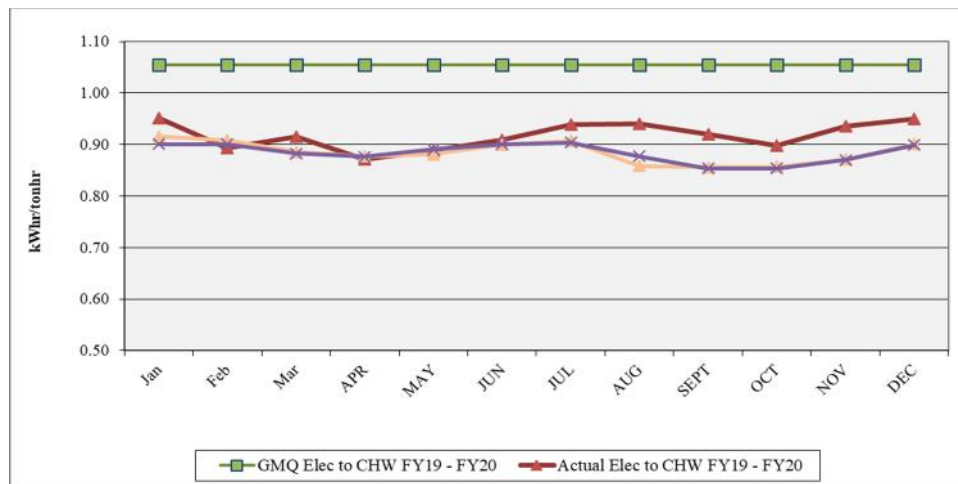
Figure 5. Chiller Plant Electric Performance Guarantee Comparison for the Previous Twelve Months

The performance of the chilled water aspect of the EGF is presented by the following two charts, Figures 5 and 6, for the previous twelve months. Under the management of CNE, the System Performance Guarantee levels as described in the ARMA are being achieved.

The chilled water allocation of the electric consumption falls under the GMQ limit of 1.055 kWhr per tonhr for the current quarter, and no excursion is reported for the current fiscal year. The electric usage per unit of sales decreased 1.2% over the previous Second Quarter. Although the performance for the current quarter is similar to the previous Second Quarter’s performance, the general trend of the chiller plant performance shows a decrease in efficiency over historic values (see Figure 5). TEG believes this decrease in performance is related to a decrease in the condition, maintenance and operation of the cooling towers and chillers. CNE and TEG have had several conversations regarding this issue within the past year and TEG does not believe that CNE has adequately addressed this issue. However, CNE has performed some maintenance on the cooling towers during the quarter which may have helped improve this quarter’s performance.

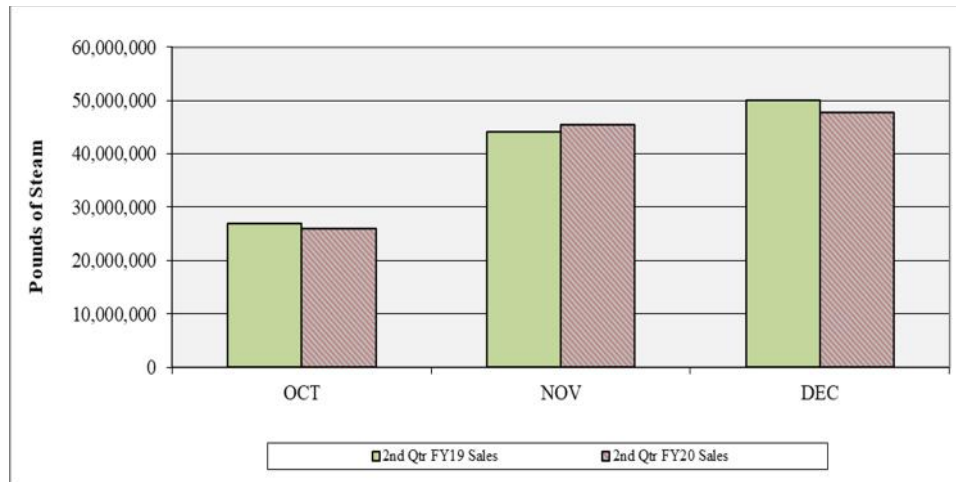
Figure 7. Steam Sales Comparison

The steam system losses increased 19.2% over the previous Second Quarter. A comparison for the Second Quarter steam sales is shown in Figure 7.

The peak steam demand for the current quarter was 135,438 pph, which reflects an approximate 10.5% increase in the peak steam production over the previous Second Quarter.

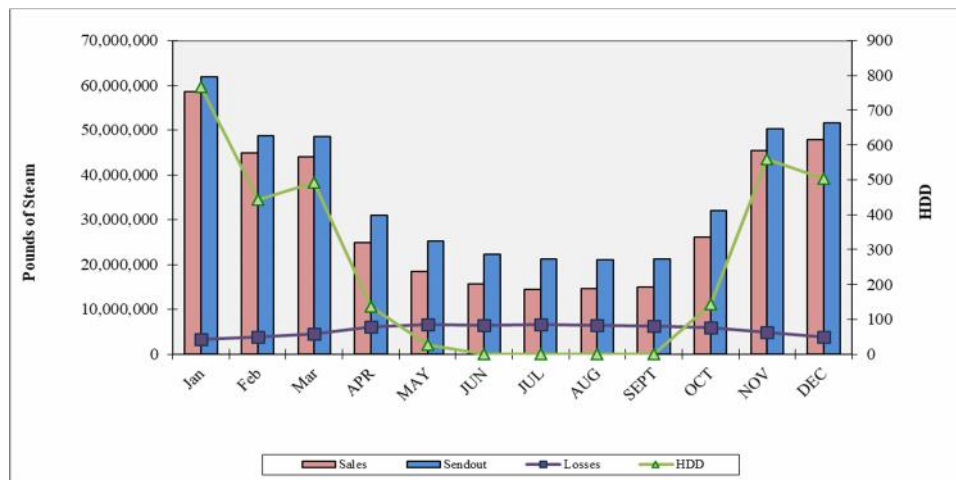
Figure 8. Steam Sales, Sendout, Losses and HDD for the Previous Twelve Months

Figure 8 shows the steam sales, sendout and losses for the previous twelve months. The losses on this figure are defined as the difference in pounds per month between the recorded sendout and sales values and represent the total mass loss in the EDS between the EGF and the customer meters.

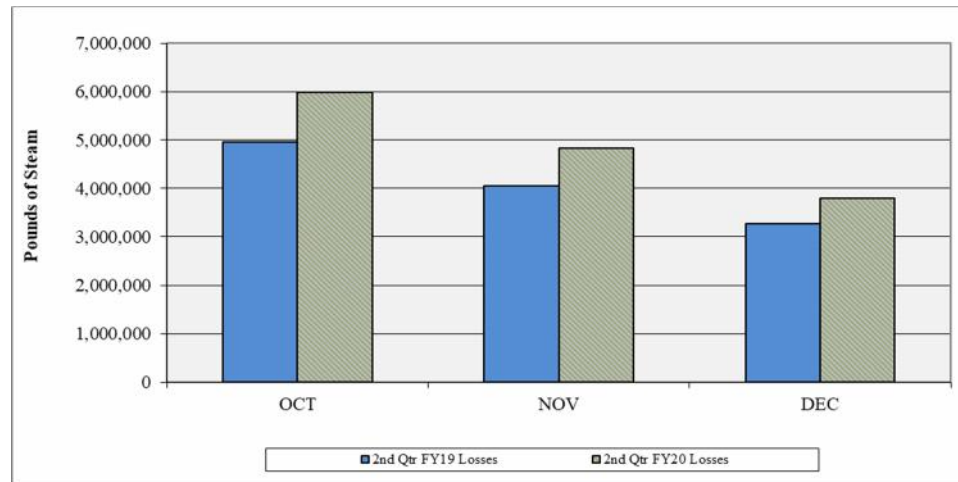
Figure 9. Steam System Losses

A comparison of the total steam mass losses in the EDS for the Second Quarter is shown in Figure 9. The mass loss is caused by the heat loss in the EDS between the EGF and the customer meters, resulting in a mass loss at steam traps. Faulty traps, steam leaks or meter error could also be a contributing cause of these losses. Whenever steam sales decrease from the previous quarter, the percent of system losses can be expected to increase since most of these losses are based on a near constant heat loss of the system.

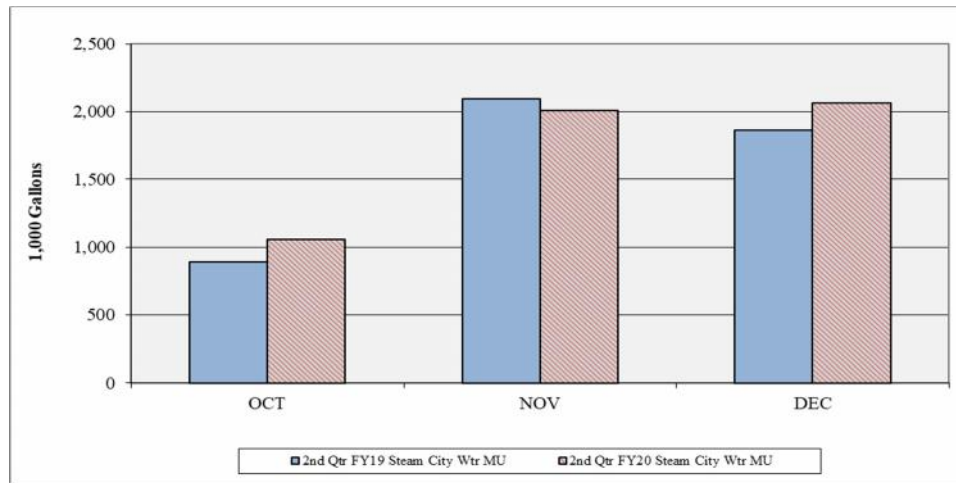
Figure 10. Steam System City Water Make-up Comparison

The amount of city water make-up (MU) to the steam system consists of the loss in mass between the EGF and the customers, in the condensate return from the customers to the EGF and losses at the EGF. The amount of condensate return decreased by approximately 5.9% during the Second Quarter. This data is shown in the comparison of Second Quarter data in Figure 10.

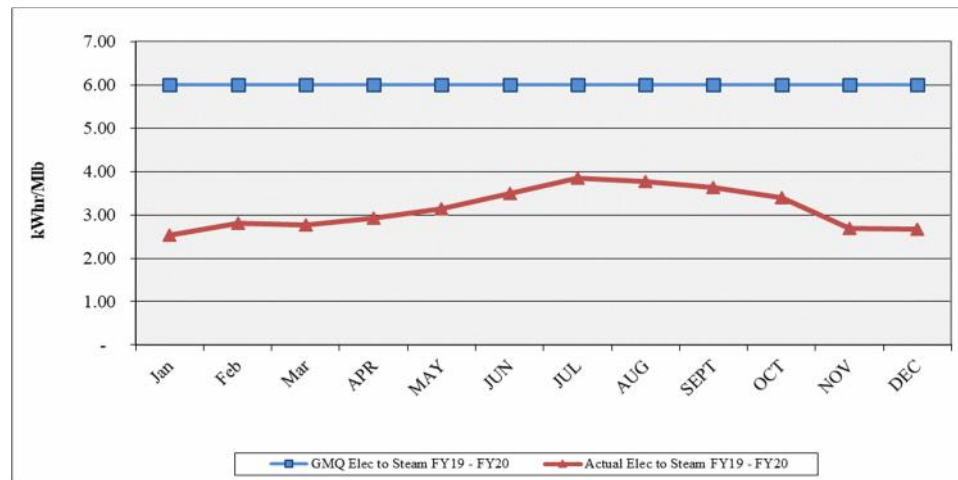
Figure 11. Steam Plant Electric Performance Guarantee for the Previous Twelve Months

The performance of the steam system of the EGF is presented by the following three charts, Figures 11, 12 and 13. Under the management of CNE, the System Performance Guarantee levels as described in the ARMA are being achieved satisfactorily.

The current quarter experienced a 1.6% decrease in the steam plant electric consumption while experiencing a marginal decrease in the electric conversion factor. The water consumption for the steam plant increased 5.9% this quarter as compared to the previous Second Quarter. The fuel consumption per unit of steam sales was 0.6% lower than in the previous Second Quarter.
