Operations Monitoring Report

First Quarter FY21

**Thermal Engineering Group, Inc.
105 Hazel Path Court, Ste 2
Hendersonville, TN 37075**

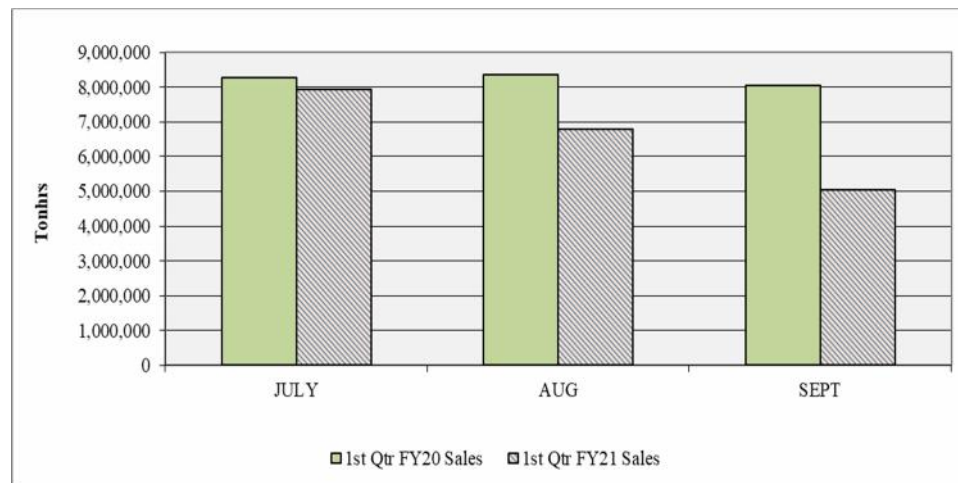
Figure 1. Chilled Water Sales Comparison

A comparison for the First Quarter chilled water sales is shown in Figure 1. This data reflects a 19.9% decrease in sales for the current quarter over the same quarter of the previous fiscal year.

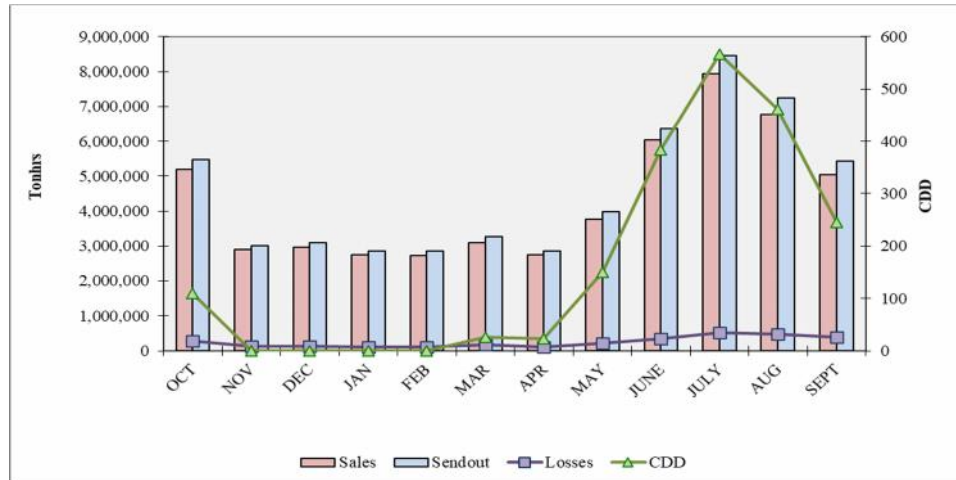
Figure 2. Chilled Water Sales, Sendout, Losses and CDD for the Previous Twelve Months

Figure 2 shows the chilled water sales, sendout and losses for the previous twelve months. The losses on this figure are defined as the difference in tonhrs per month between the recorded sendout and sales values and represent the total energy loss for chilled water in the EDS. The number of cooling degree days per month are also tracked for comparison.

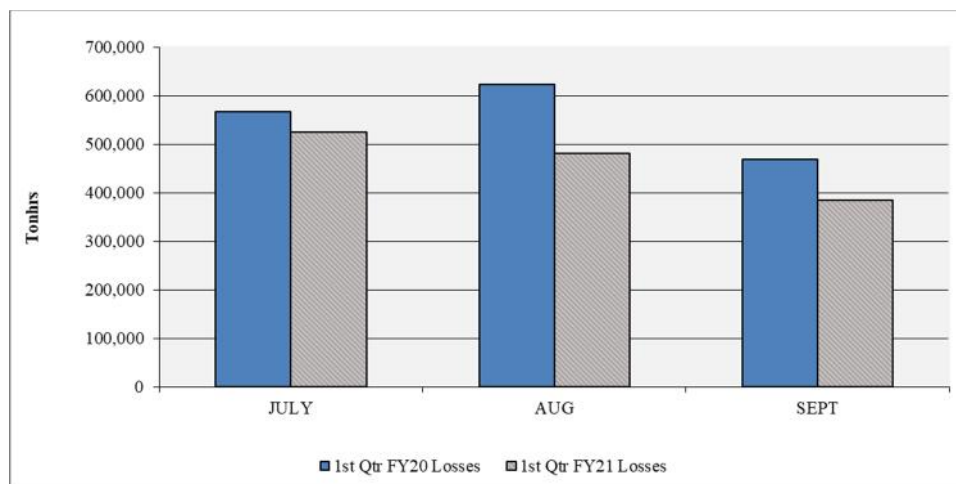
Figure 3. Chilled Water System Loss Comparison

A comparison of the total, chilled water energy losses in the EDS for the First Quarter is shown in Figure 3. These losses are the difference in chilled water sendout and sales.

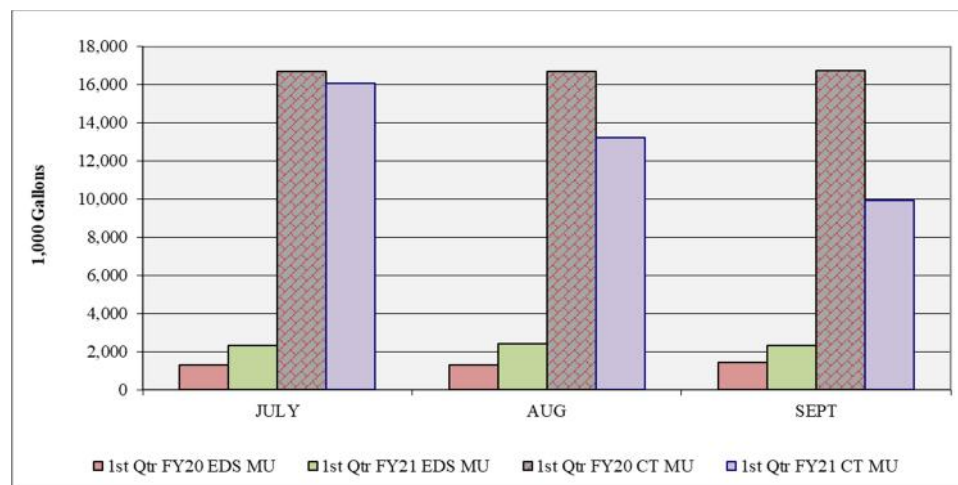
Figure 4. Chilled Water System City Water Usage Comparison

The make-up to the cooling towers decreased 11.5% over the previous First Quarter. The water usage in the cooling towers is largely due to the consumption of chilled water and should vary with chilled water sales. The number of cycles of concentration in the condensing water circuit decreased 44.6%. The total chiller plant water use decreased 14.5% over the First Quarter FY20. The overall city water make-up comparison for the chilled water system First Quarter is shown in Figure 4.

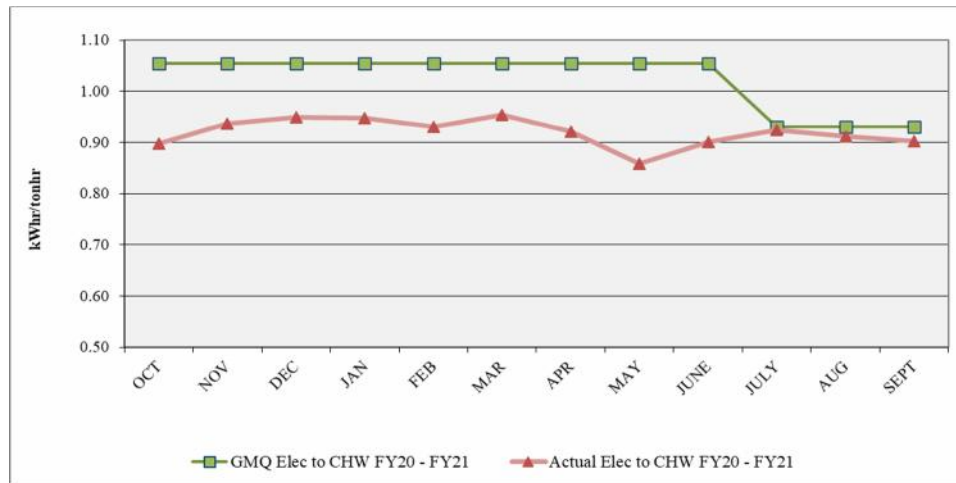
Figure 5. Chiller Plant Electric Performance Guarantee Comparison for the Previous Twelve Months

The performance of the chilled water aspect of the EGF is presented by the following two charts, Figures 5 and 6, for the previous twelve months. The System Performance Guarantee levels as described in Amendment 2 of the ARMA are not being achieved for the chilled water-water conversion for the quarter.

The chilled water allocation of the electric consumption falls under the GMQ limit of 0.93 kWhr per tonhr for the current quarter, and no excursion is reported for the current fiscal year. The electric usage per unit of sales decreased 2.2% over the previous First Quarter.

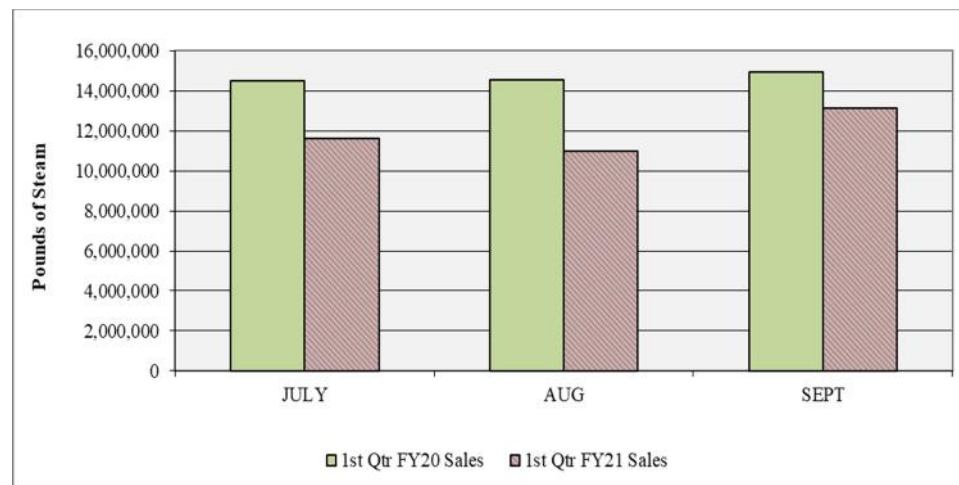
Figure 7. Steam Sales Comparison

The steam sendout decreased by approximately 13.0% over the previous First Quarter (FY20), and the sales also decreased by approximately 18.8%. The Quarter experienced an increase in the number of heating degree days. The steam system losses remained approximately the same as in the previous First Quarter and experienced a decrease in the relative amount of condensate return of 32.8%. A comparison for the First Quarter steam sales is shown in Figure 7.

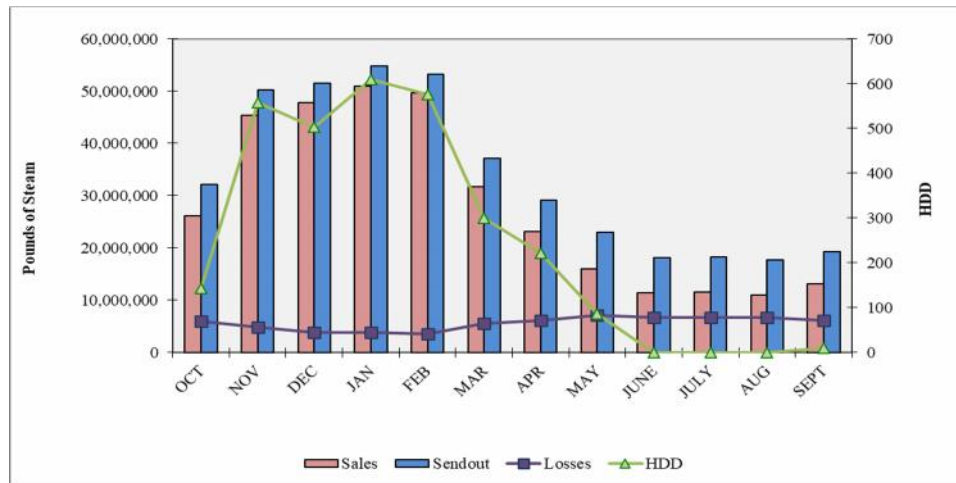
Figure 8. Steam Sales, Sendout, Losses and HDD for the Previous Twelve Months

Figure 8 shows the steam sales, sendout and losses for the previous twelve months. The losses on this figure are defined as the difference in pounds per month between the recorded sendout and sales values and represent the total mass loss in the EDS between the EGF and the customer meters.

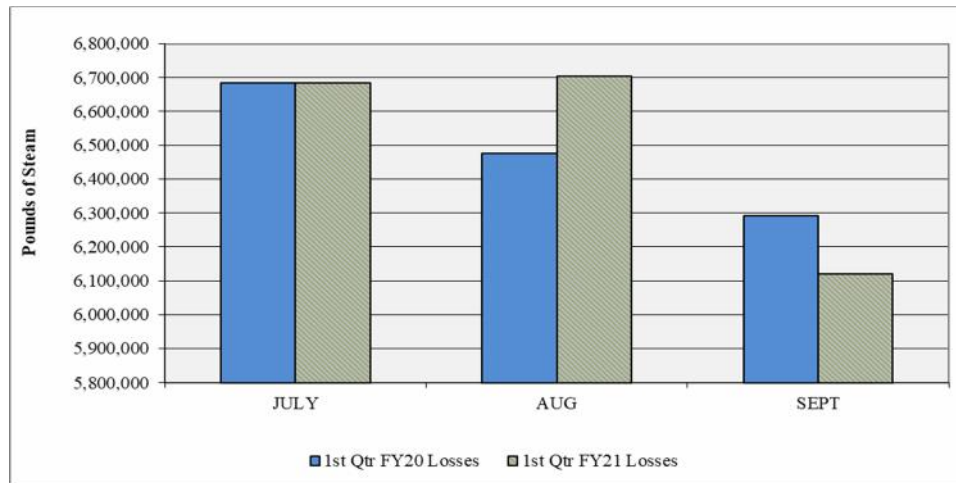
Figure 9. Steam System Losses

A comparison of the total steam mass losses in the EDS for the First Quarter is shown in Figure 9. The mass loss is caused by the heat loss in the EDS between the EGF and the customer meters, resulting in a mass loss at steam traps. Faulty traps, steam leaks or meter error could also be a contributing cause of these losses. Whenever steam sales decrease from the previous quarter, the percent of system losses can be expected to increase since most of these losses are based on a near constant heat loss of the system.

The increase in the losses and make-up shown in Figures 9 and 10 was largely due to a leak in the condensate system near MH-9. This leak was discovered in late FY20 and repaired in July 2020. As a result of the leak, it is believed that gravel may have entered the condensate pipe that remained and caused the condensate return hardness level to be higher than tolerable for the system. Therefore, CNE placed the condensate to drain in the 4th Ave tunnel and continued to monitor the hardness levels daily. The hardness continued to decline during the quarter, and condensate return from this area of the system is expected to be re-established in the Second Quarter. The cost for the repairs to this leak are being tracked as DES176.

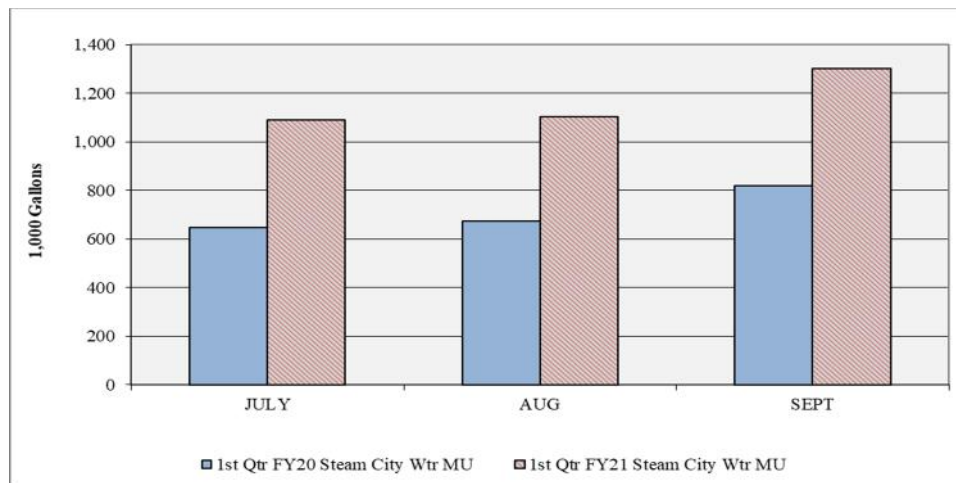
Figure 10. Steam System City Water Make-up Comparison

The amount of city water make-up (MU) to the steam system consists of the loss in mass between the EGF and the customers, in the condensate return from the customers to the EGF and losses at the EGF. The corresponding data for steam system make-up is shown in the comparison of First Quarter data in Figure 10.

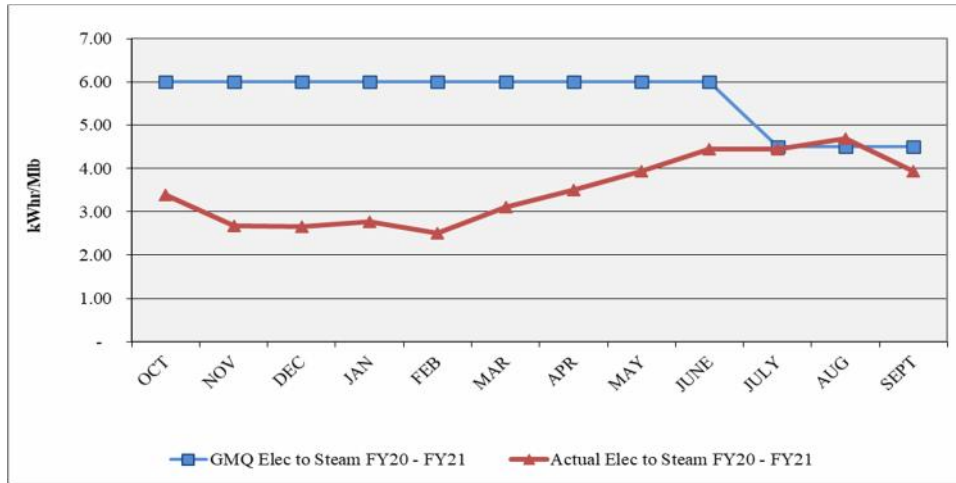
Figure 11. Steam Plant Electric Performance Guarantee for the Previous Twelve Months

The performance of the steam system of the EGF is presented by the following three charts, Figures 11, 12 and 13. The System Performance Guarantee levels as described in Amendment 2 of the ARMA are not consistently being achieved for the steam fuel and steam electric conversions for the quarter.

The current quarter experienced a 6.0% increase in the steam plant electric consumption while experiencing a 16.5% increase in the electric conversion factor. The water consumption for the steam plant increased 63.2% this quarter as compared to the previous First Quarter due largely to the condensate leak and the dumping of condensate due to hardness levels. The fuel consumption per unit of steam sales was 3.1% higher than in the previous First Quarter. The increase in the fuel consumption per unit of sales represents a decrease in boiler plant efficiency. This change may be due to the significantly lower steam sales and sendout. TEG will continue to monitor this issue.
