APPENDIX B

**STRUCTURAL SKETCHES**

Project Title:  
**FORT NEGLEY  
1100 FORT NEGLEY BLVD.  
NASHVILLE, TN 37203**

# FORT NEGLEY (NASHVILLE, TN) FORTIFICATION WALL PROFILE SURVEY

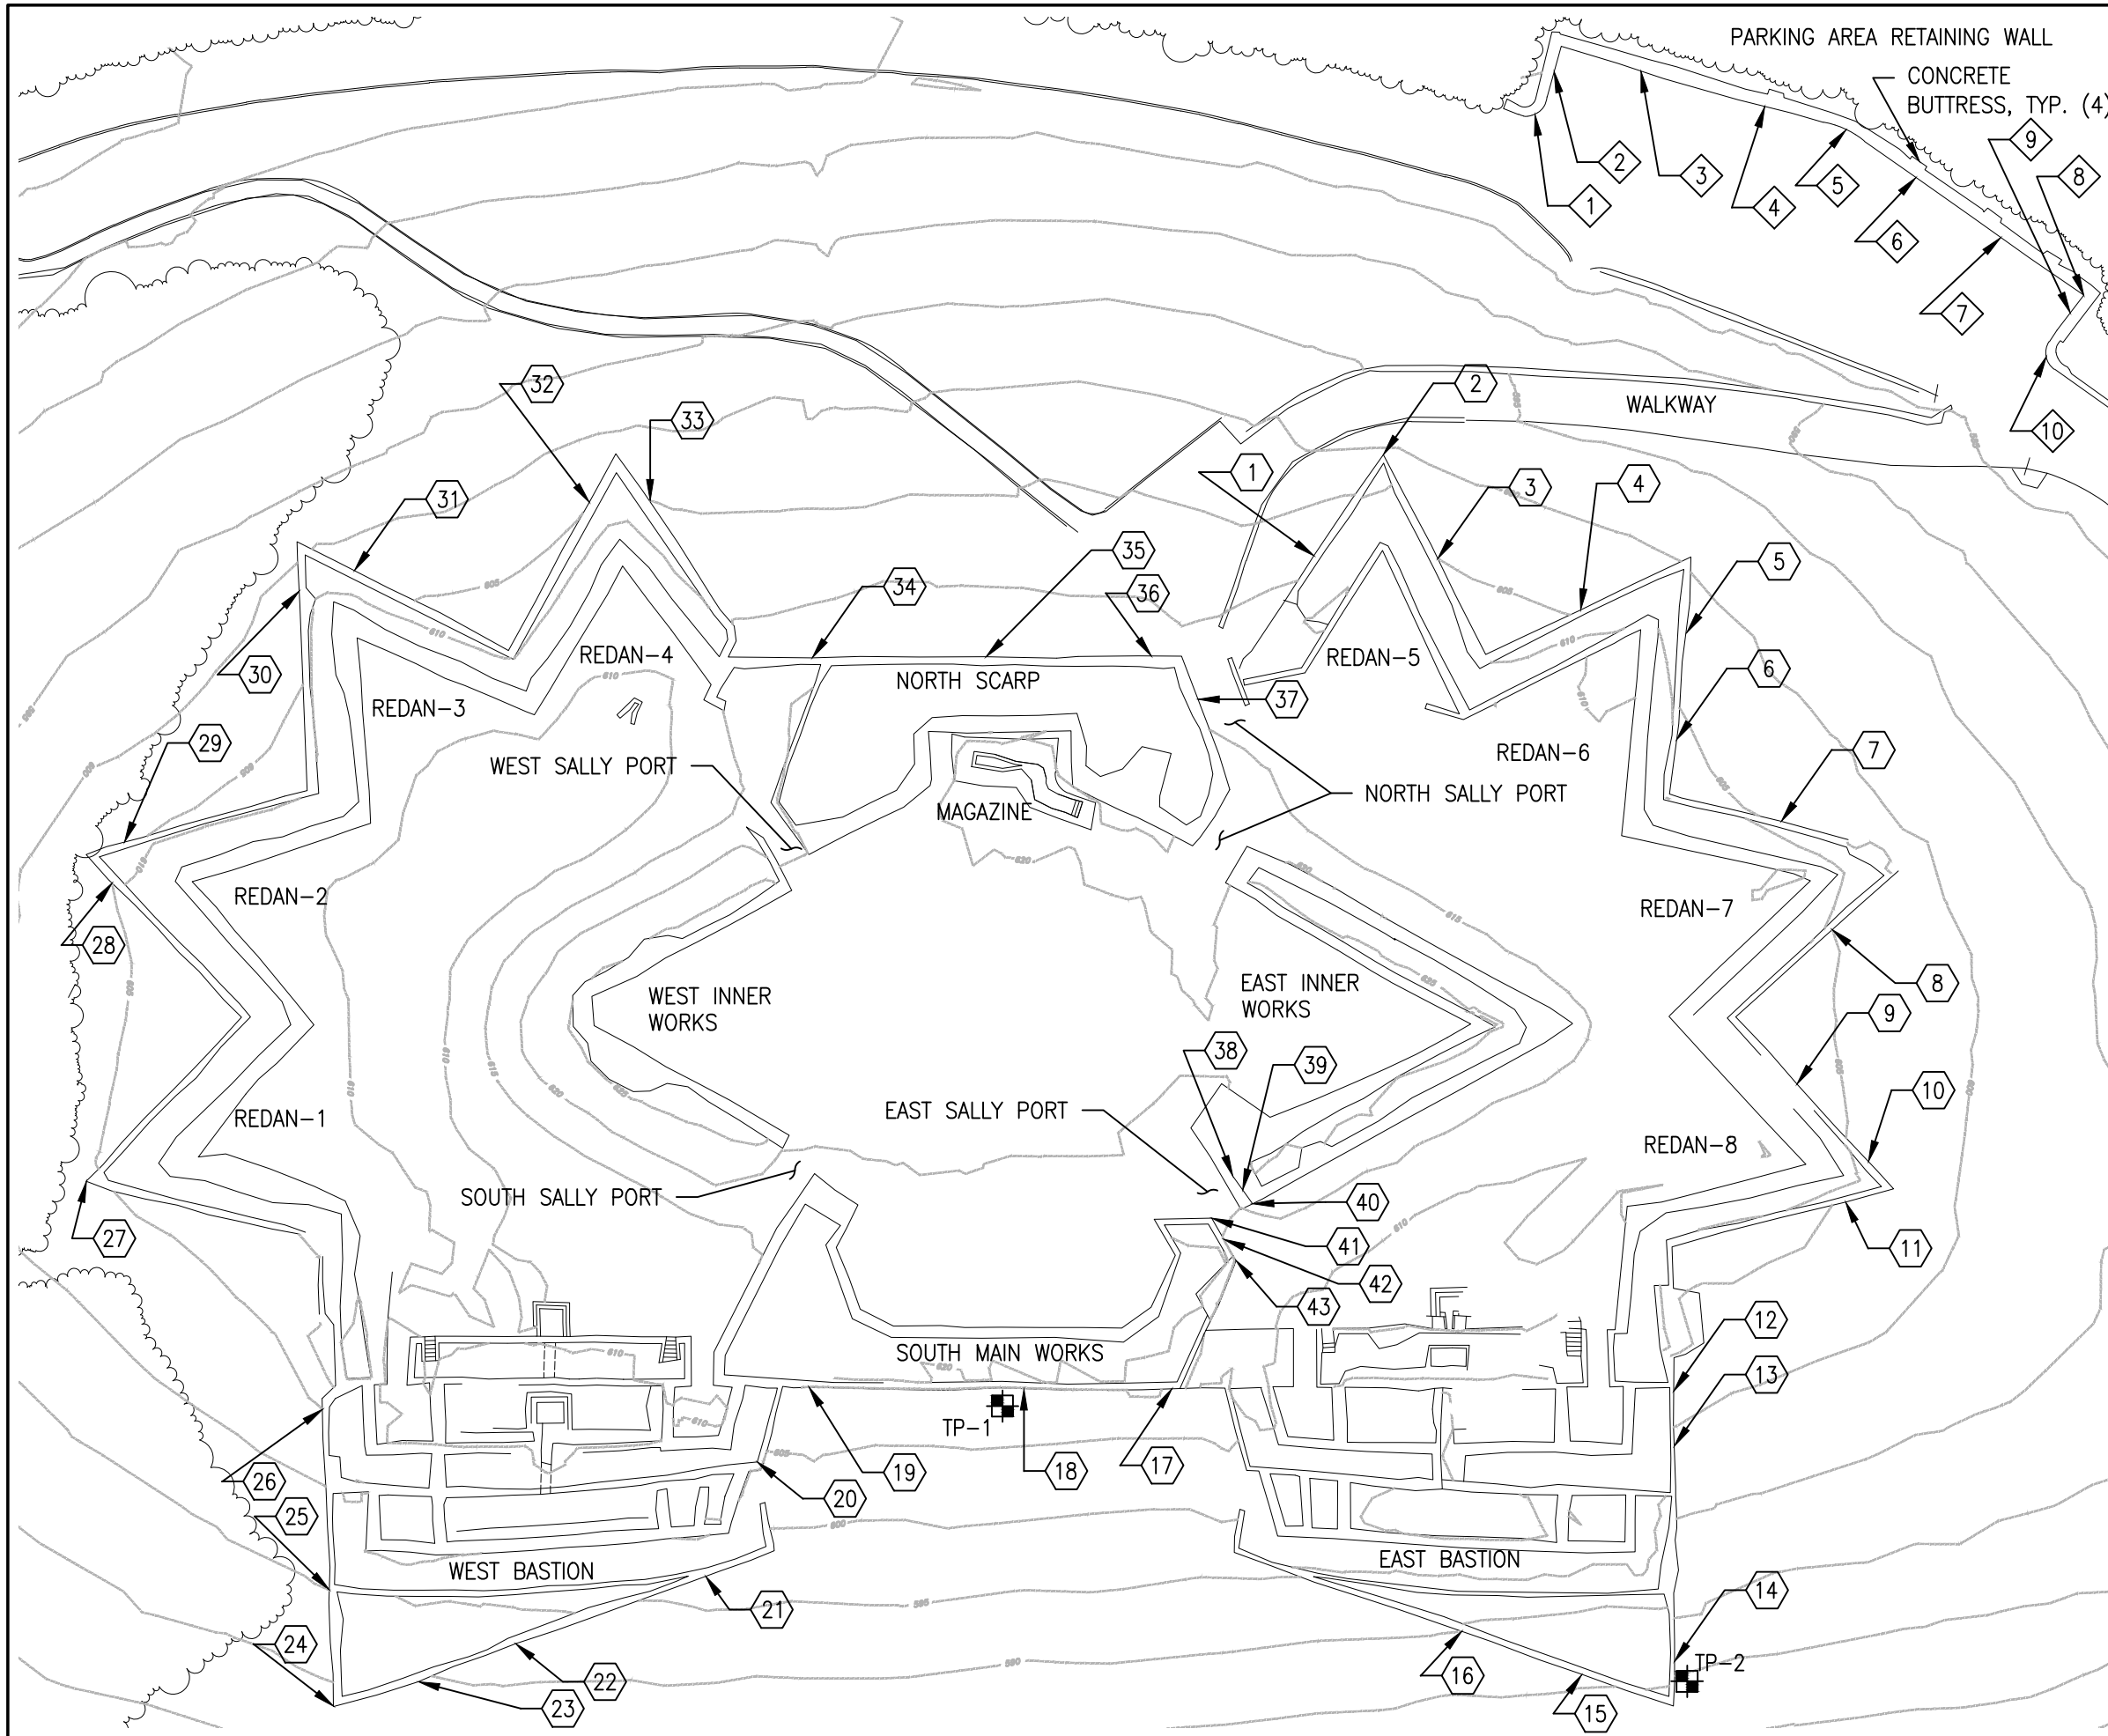
**SSK-0**

**SITE PLAN: WALL PROFILE SURVEY LOCATIONS**

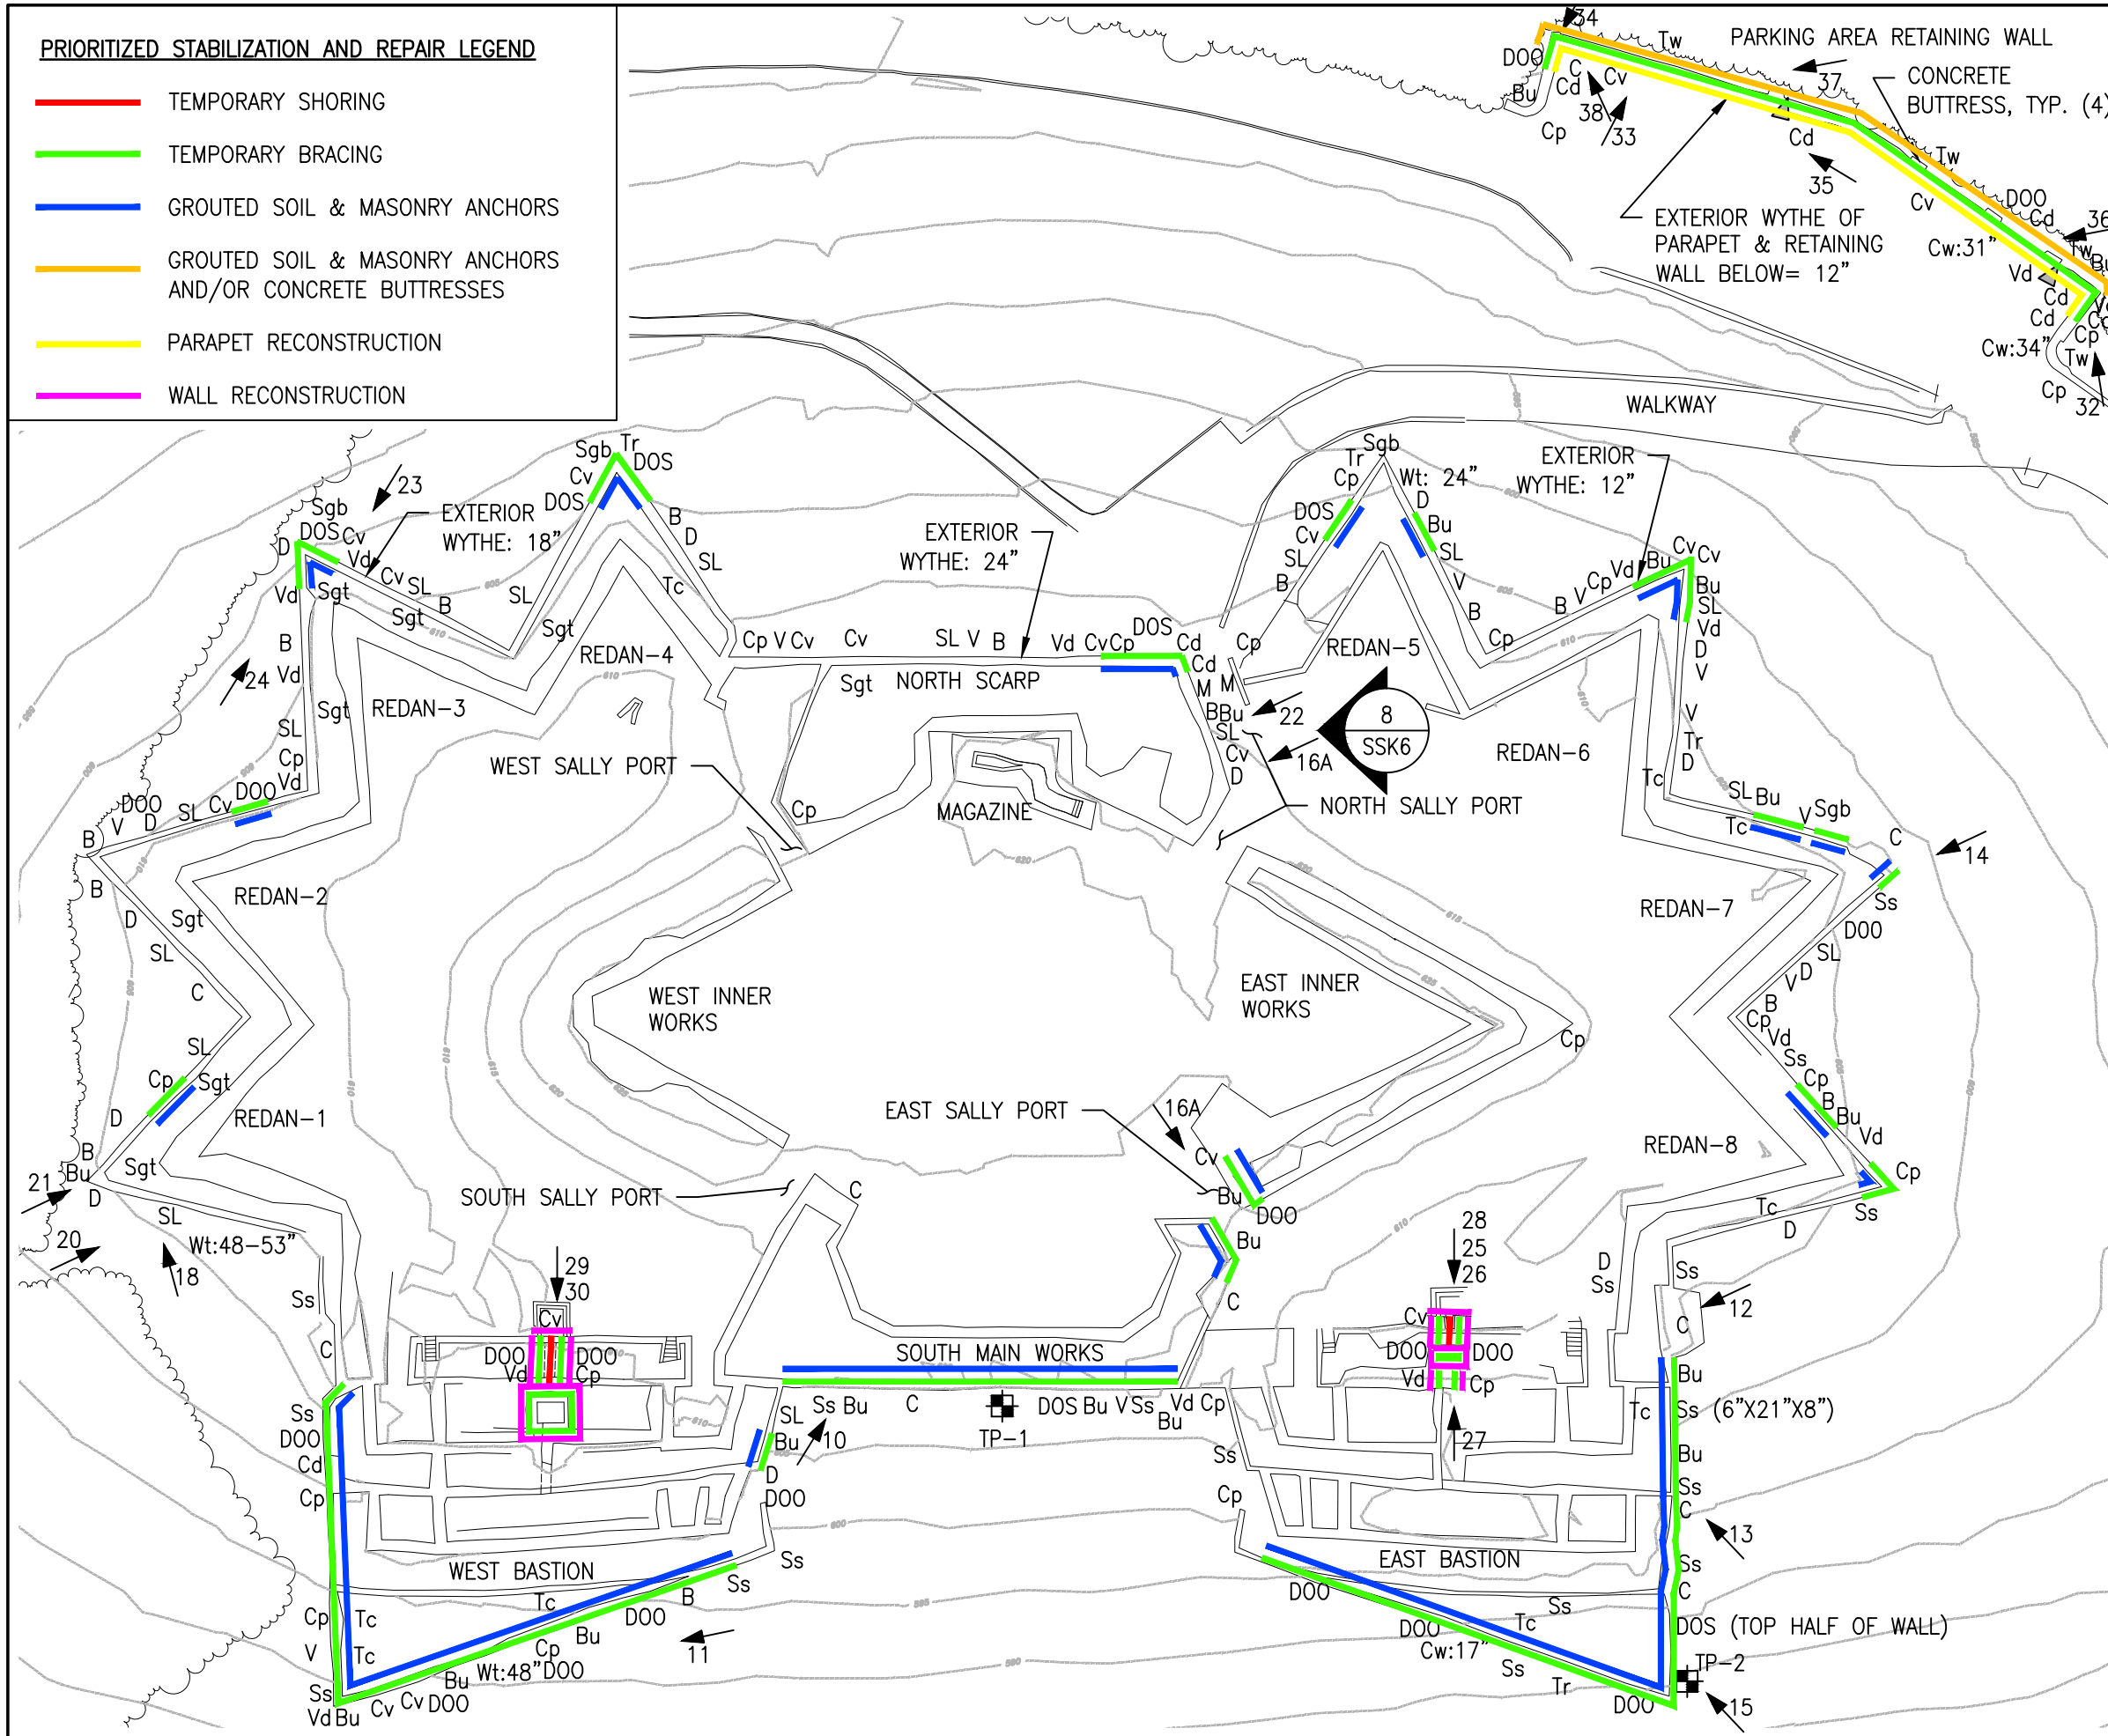
**SSK-1**

**SITE PLAN: EXISTING CONDITIONS & PRIORITIZED REPAIRS**

- TEMPORARY SHORING
- TEMPORARY BRACING
- GROUTED SOIL & MASONRY ANCHORS
- GROUTED SOIL & MASONRY ANCHORS AND/OR CONCRETE BUTTRESSES
- PARAPET RECONSTRUCTION
- WALL RECONSTRUCTION

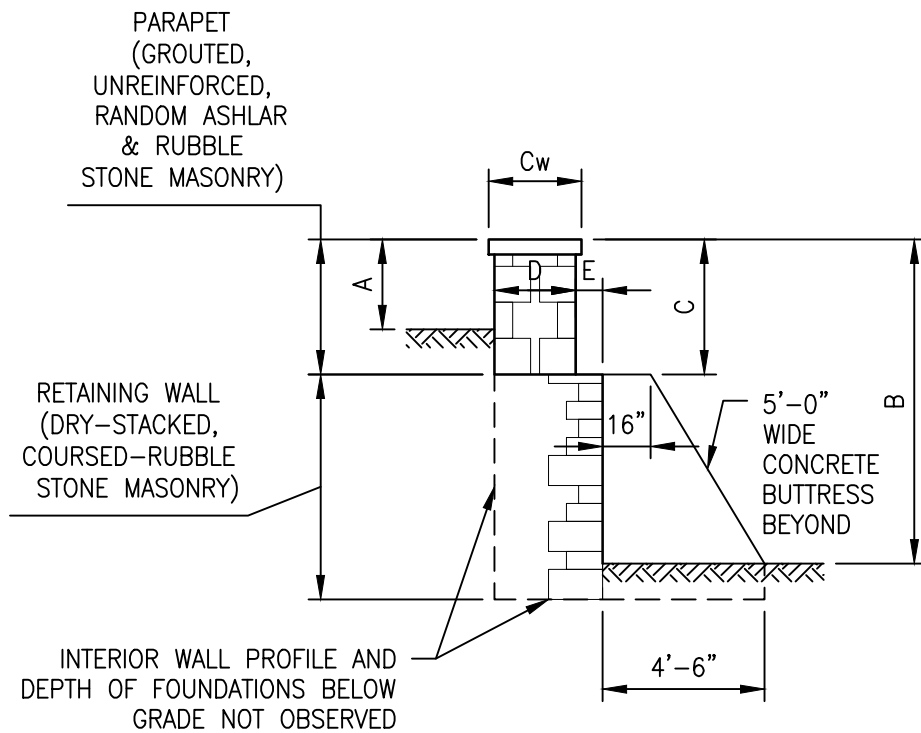
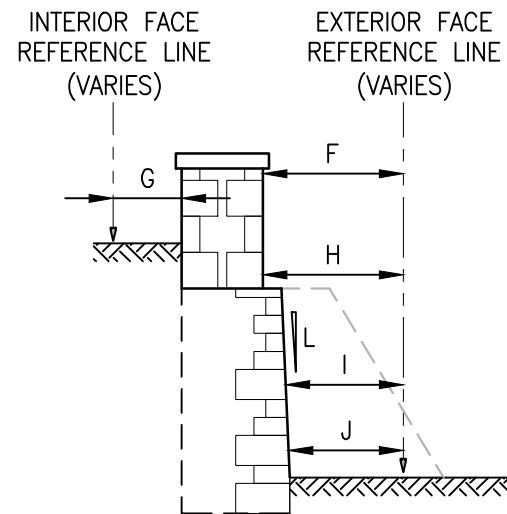
1 WALL SECTIONS W/ MEASUREMENT NOMENCLATURE  
 SSK-5 SCALE: 3/16" = 1'-0"

DETAIL A: GEOMETRY

BATTER PROFILE (L) NOTES:  
 +(H:V)= SLOPE TOWARDS CENTERLINE OF WALL  
 (AS SHOWN IN DIAGRAM)  
 -(H:V) = SLOPE AWAY FROM WALL CENTERLINE

DETAIL B: PLUMBNESS & PROFILE

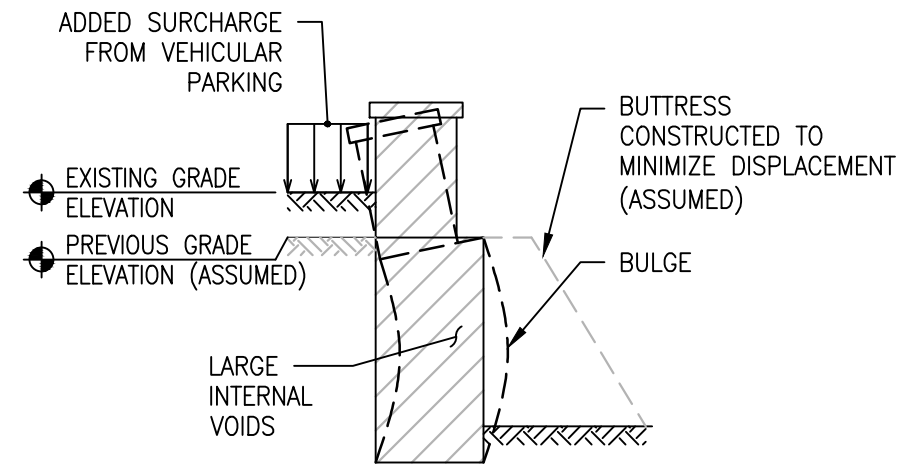
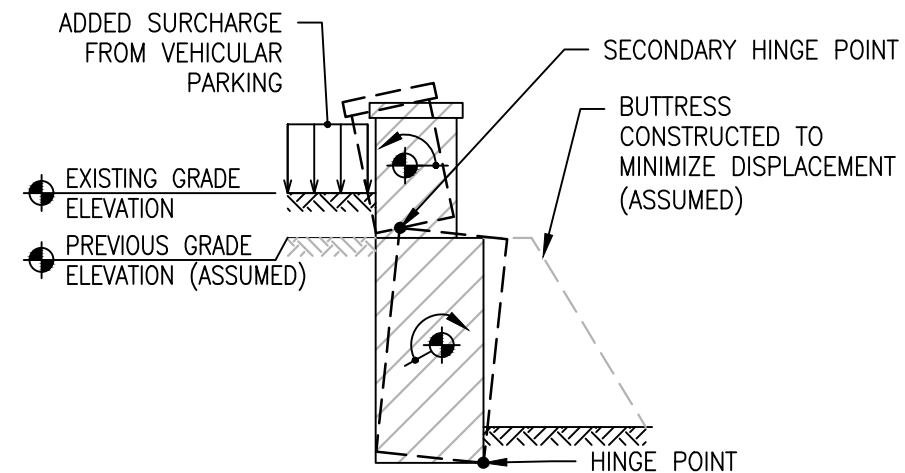
2 WALL BEHAVIOR & OBSERVED DISPLACEMENT  
 SSK-5 SCALE: 3/16" = 1'-0"

DETAIL A: OUT-OF-PLANE DISPLACEMENT  
(WALL BULGE WITH INTERNAL VOIDS)

DETAIL B: OUT-OF-PLANE ROTATION (OVERTURNING)

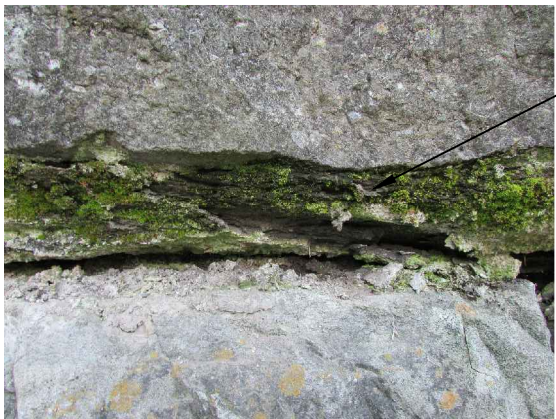
4 HEAVY DELAMINATION  
SSK-6 SCALE: N.T.S.

DELAMINATION OF SEDIMENTARY STONES WITH CLAY-RICH LAYERS DUE TO WEATHERING. EXFOLIATION OCCURS DUE TO EXPANSION AND CONTRACTION OF TRAPPED MOISTURE.

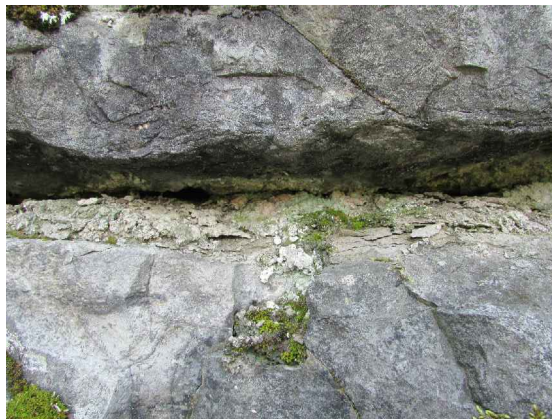
5 STONE LOSS/DELAMINATION  
SSK-6 SCALE: N.T.S.

STONE W/ VERTICAL CRACK DUE TO SHEAR FAILURE. STONE FORCED TO SPAN W/ LOSS OF SUPPORT BELOW

STONE DELAMINATION & LOSS, SEE 5/SSK-6.

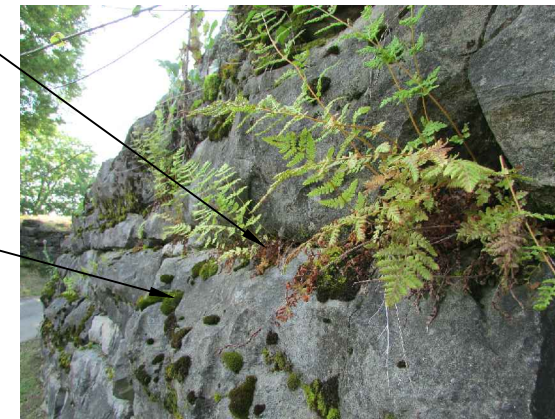
6 VEGETATIVE & BIO GROWTH  
SSK-6 SCALE: N.T.S.

VEGETATION GROWTH WITHIN STONE JOINTS AND CRACKS DUE TO LIMITED MAINTENANCE.

BIOLOGICAL GROWTH FORMS ON SURFACE, AT AREAS OF DELAMINATION, AND WITHIN HAIRLINE FISSURES

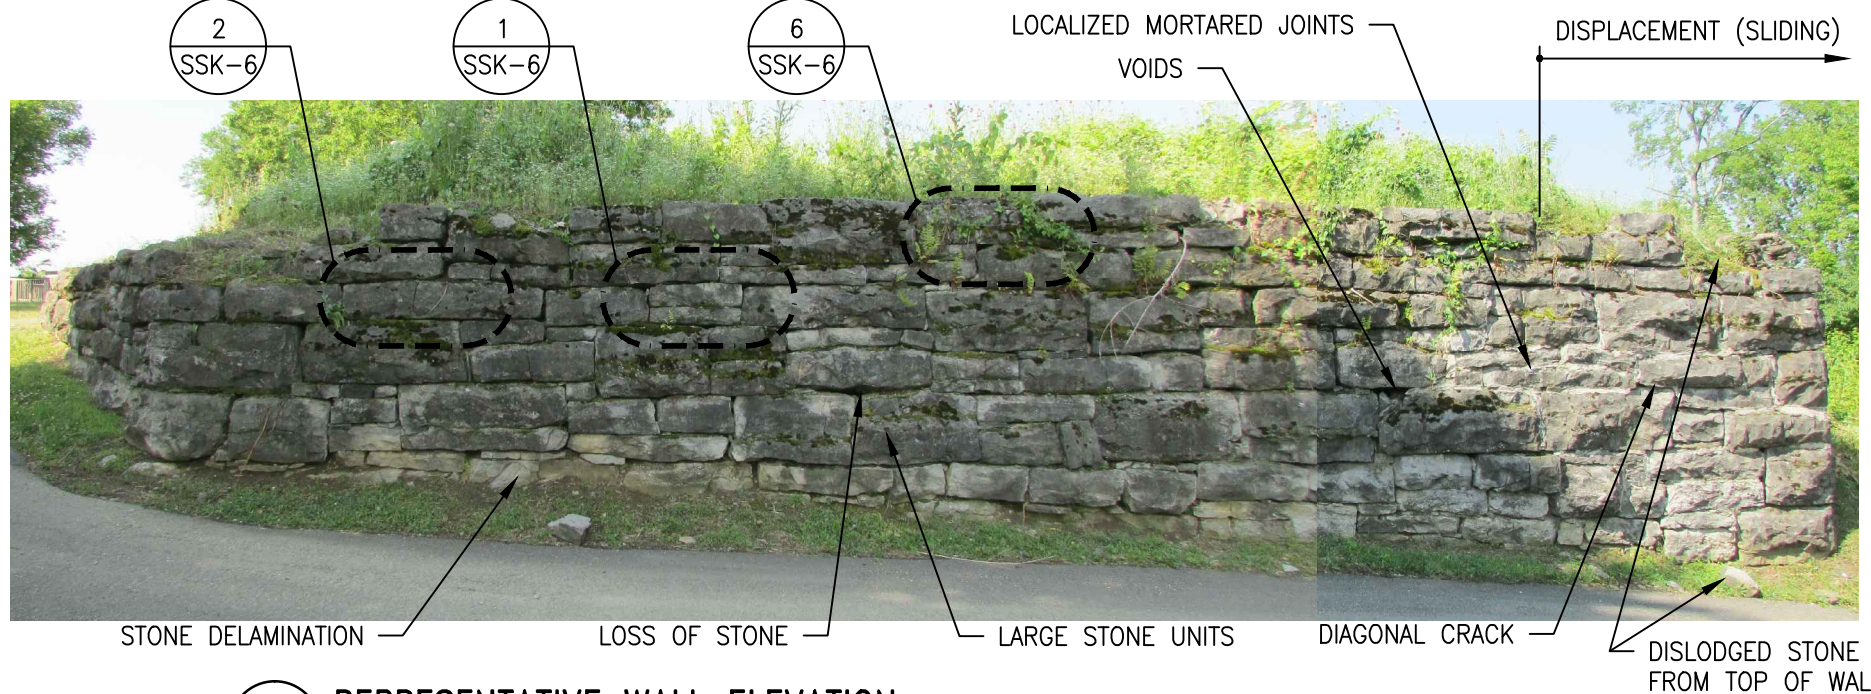
8 REPRESENTATIVE WALL ELEVATION  
SSK-6 SCALE: N.T.S.

STONE DELAMINATION

LOSS OF STONE

LARGE STONE UNITS

DIAGONAL CRACK

DISLODGED STONE FROM TOP OF WALL

LOCALIZED MORTARED JOINTS

VOIDS

DISPLACEMENT (SLIDING)
