APPENDIX C

STRUCTURAL CALCULATIONS

DRY-STACKED STONE GRAVITY RETAINING WALL

Fort Negley (40DV189) Historic Structures Report: Archaeological Investigations

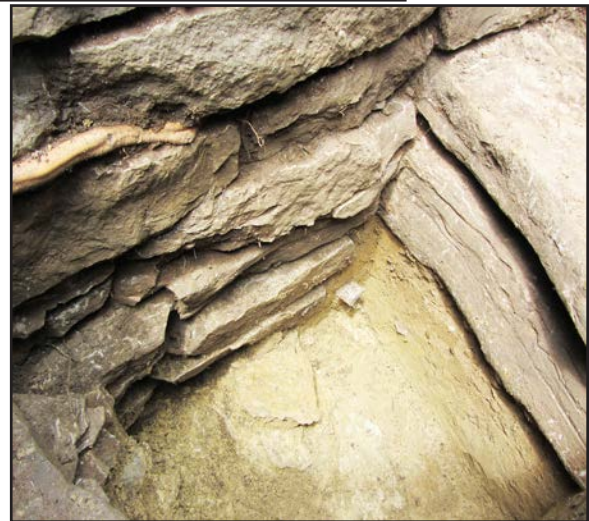
B. West Wall Oblique View of Trench 2 Showing the Basal Course of Cut Stones on a Limestone Slab (Left of Photograph) and Residuum.

The foundation of the east bastion wall was exposed in Trench 2 and the basal courses of limestone blocks were positioned atop limestone slabs (Stratum III) and residuum (Stratum IVD). In addition, the foundation of the east bastion wall was stepped to accommodate the southward slope of the hillside on which it was constructed. Despite exposing the east bastion wall foundation, the temporal affiliation of the stone wall could not be determined. Stratum II in this trench consisted of fill material used to build a berm along the east bastion wall. Stratum I was the A horizon and filled the ditch or depression at the east bastion wall. The artifacts from Strata I and II do not clearly indicate if the fill layers in Trench 2 reflect Civil War era building events or WPA reconstruction. Temporally diagnostic artifacts from both strata have lengthy manufacturing date ranges and do not provide precise dates.
