Historic Structure Report  
**Fort Negley**

1100 Fort Negley Blvd.  
 Nashville, TN

West Bastion  
 West Exterior Wall  
 Photo Elevations

Redans 2 & 3  
Interior  
Photo Elevations

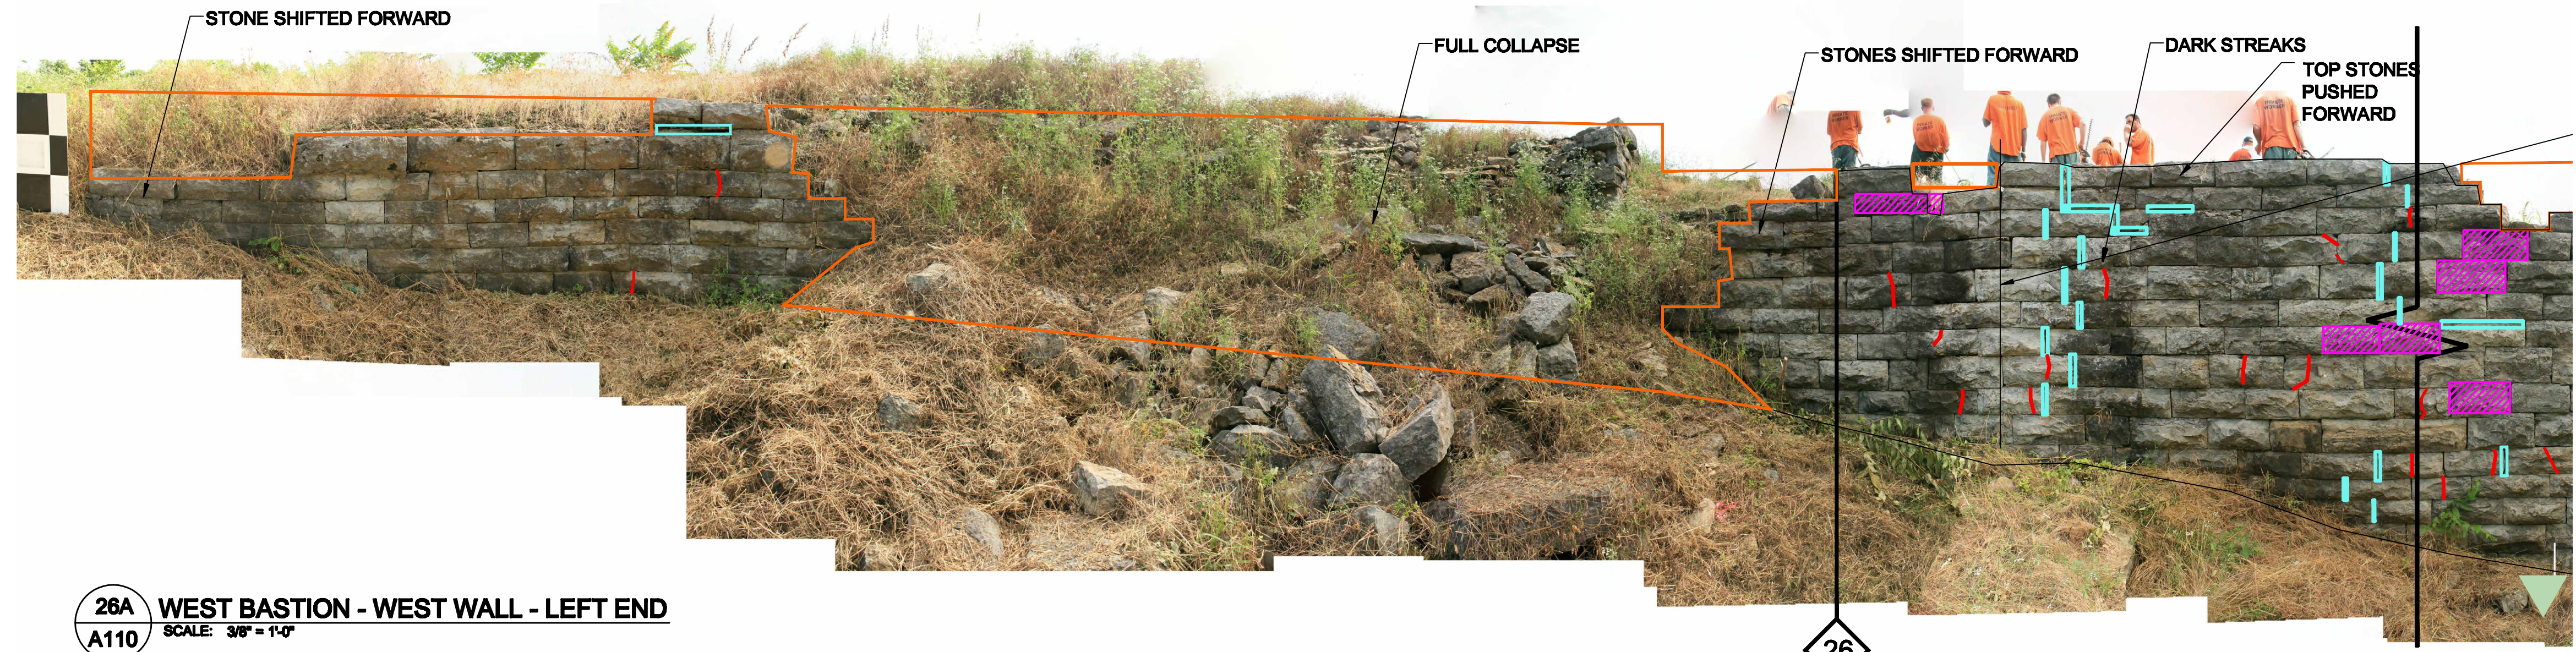
26A WEST BASTION - WEST WALL - LEFT END  
 A110 SCALE: 3/8" = 1'-0"

CAMBER: WALL IS MOSTLY BATTERED  
 STONE SIZE: STONES ARE VERY UNIFORM IN HEIGHT AND LONGER THAN IN OTHER WALLS. TOP STONES ARE CUT AT AN ANGLE  
 COURSING: COURSED  
 CHINKING: NONE  
 VEGETATION: SMALL WEEDS IN FACE  
 SLOPE: GROUND SLOPES AWAY FROM AND PARALLEL TO WALL

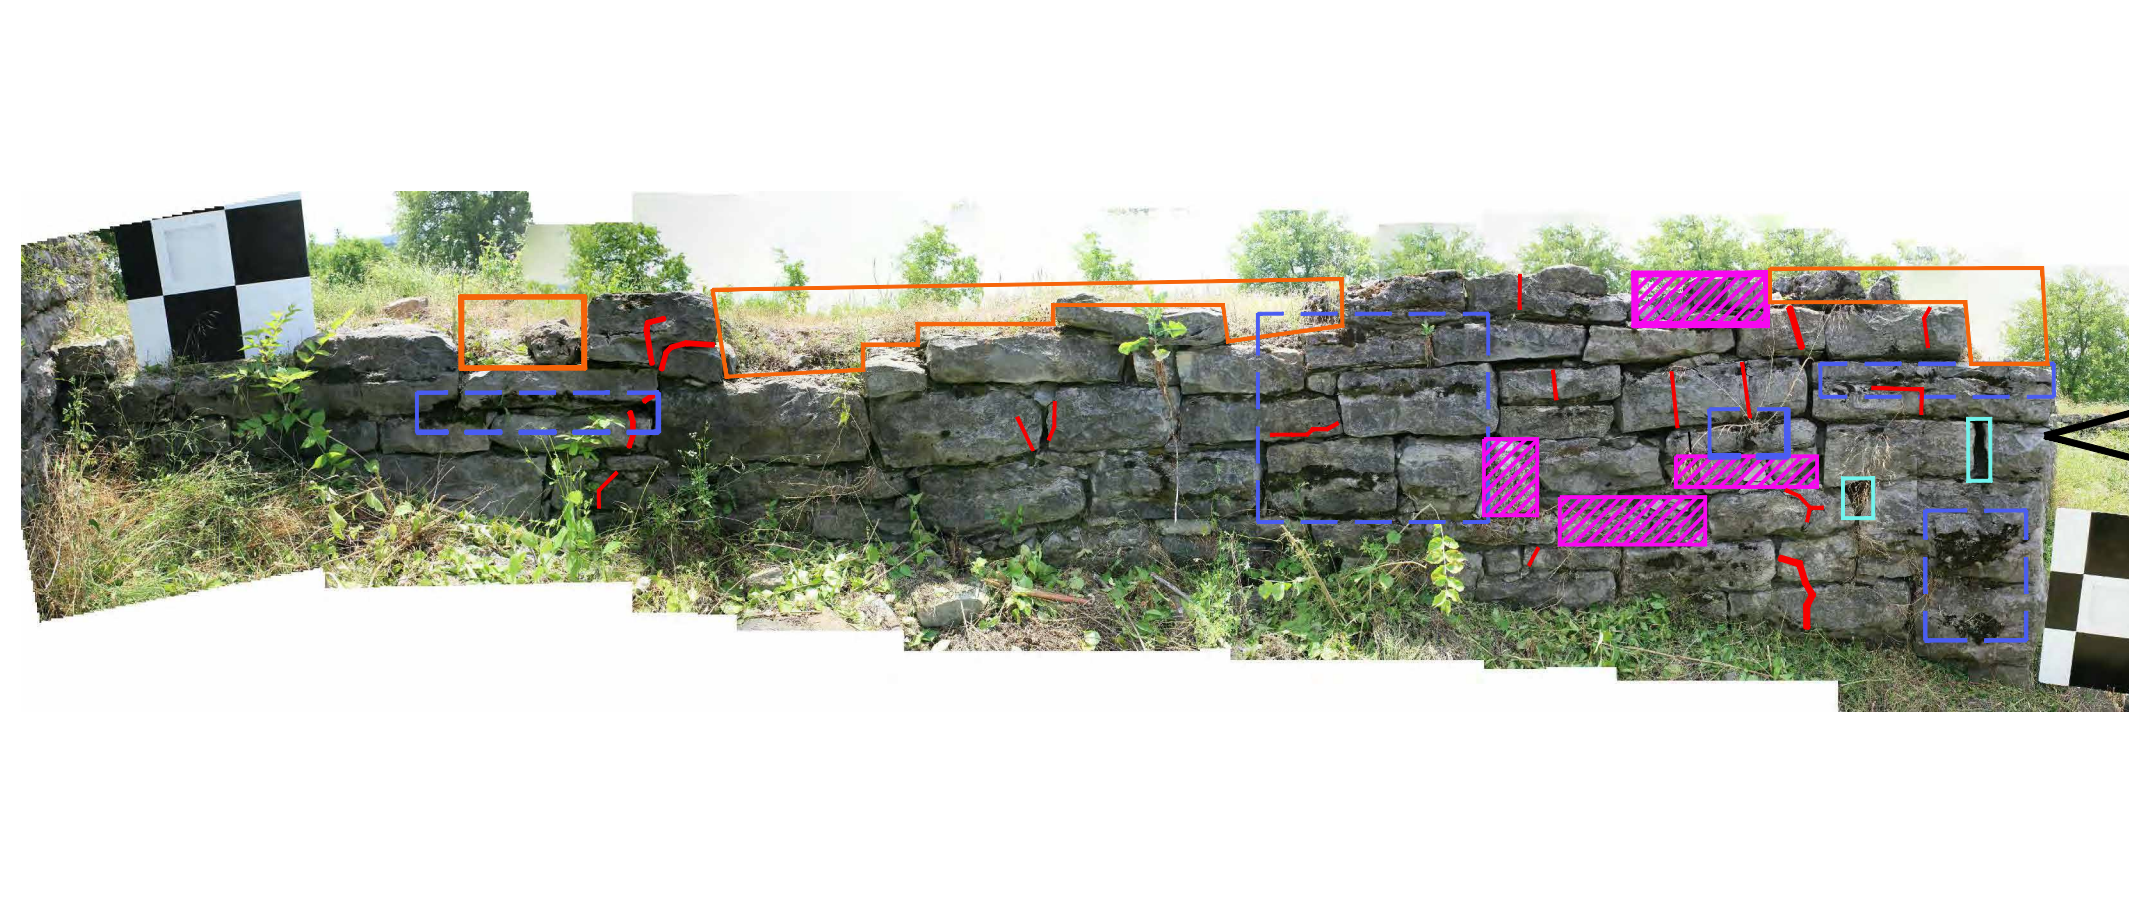
28A WEST BASTION - NORTH INTERIOR WALL - EAST END  
A111 SCALE: 3/8" = 1'-0"

CAMBER: WALLS ARE MOSTLY PERPENDICULAR WITH ONLY BATTERING AT STAIR WALLS  
STONE SIZE: RANDOM, MEDIUM TO LARGE  
COURSING: IRREGULARLY COURSED  
CHINKING: SOME USE OF SMALL AND MEDIUM SIZED STONES FOR CHINKING  
VEGETATION: SMALL WEEDS IN FACE. NO TREES  
SLOPE: MOSTLY LEVEL

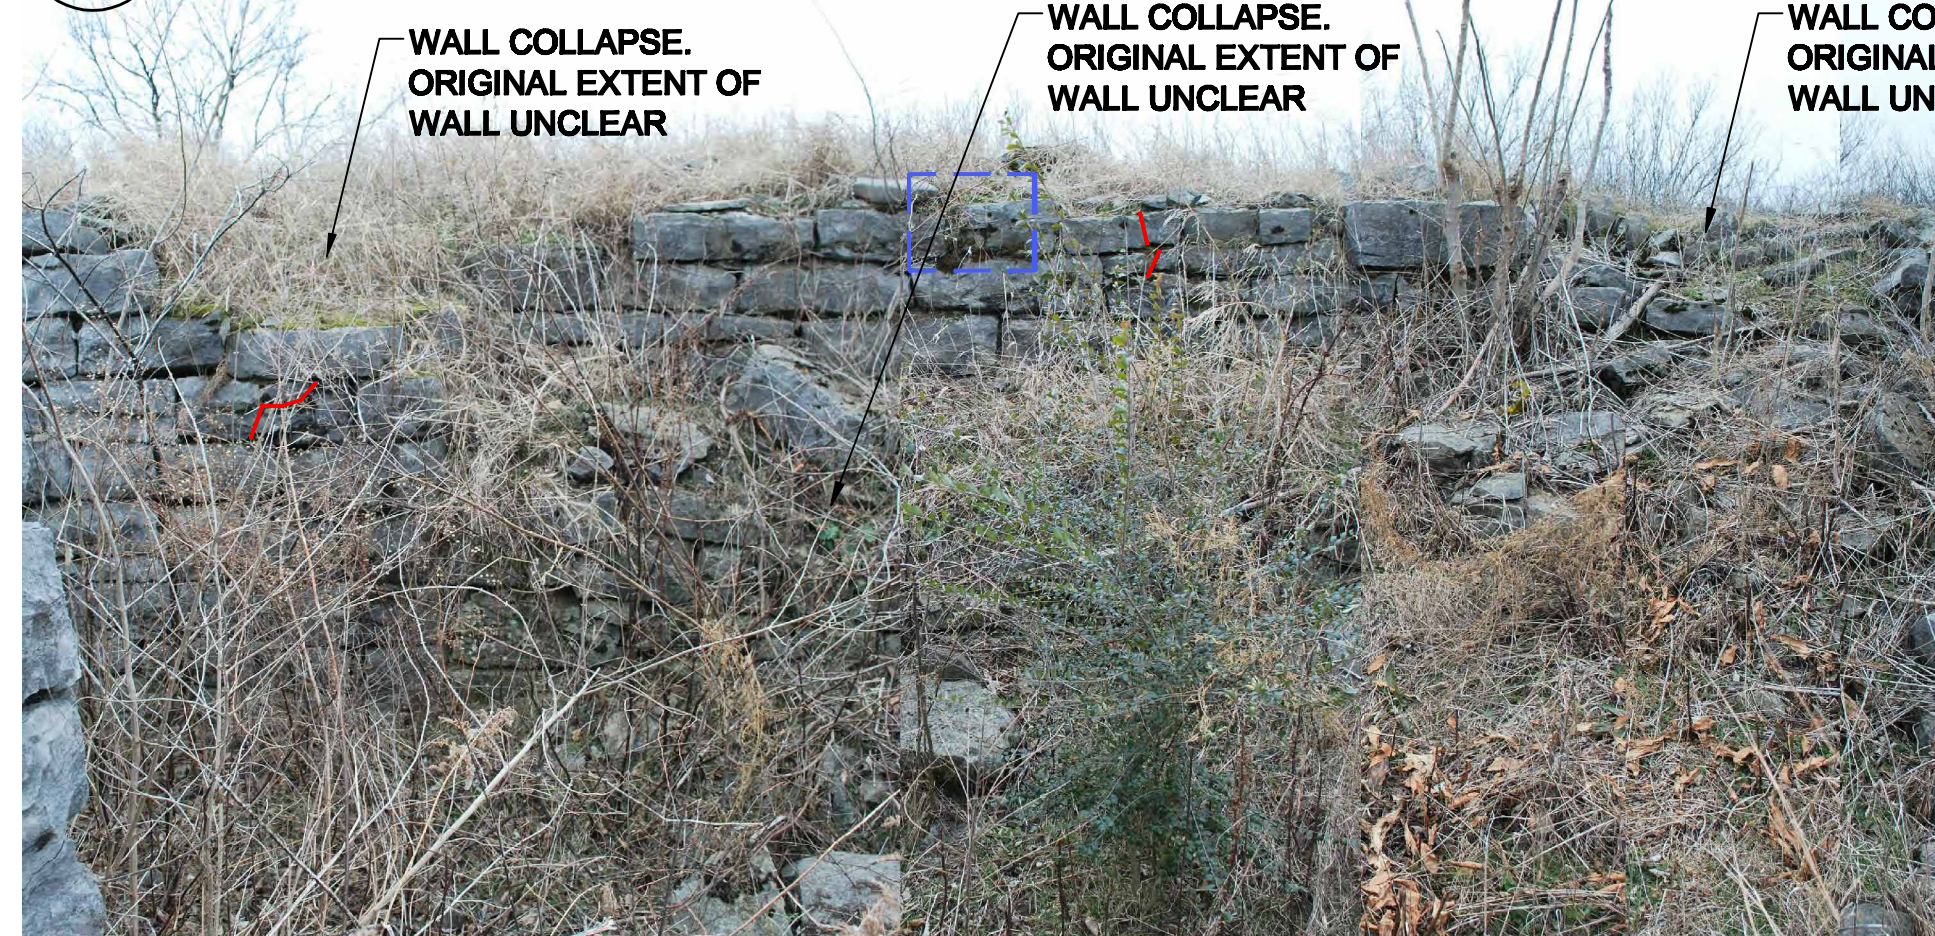
29 WEST BASTION - INTERIOR WALL BETWEEN WEST BASTION AND REDAN #1  
A111 SCALE: 3/8" = 1'-0" (APPROXIMATE)

CAMBER: COLLAPSED WALLS, CAMBER NOT APPARENT  
STONE SIZE: RANDOM, MEDIUM TO LARGE  
COURSING: SOMEWHAT COURSED  
CHINKING: SOME USE OF SMALL AND MEDIUM SIZED STONES FOR CHINKING  
VEGETATION: WEEDS AND SMALL TREES IN FACE.  
SLOPE: VERY STEEP PARALLEL, SLIGHT SLOPE PERPENDICULAR

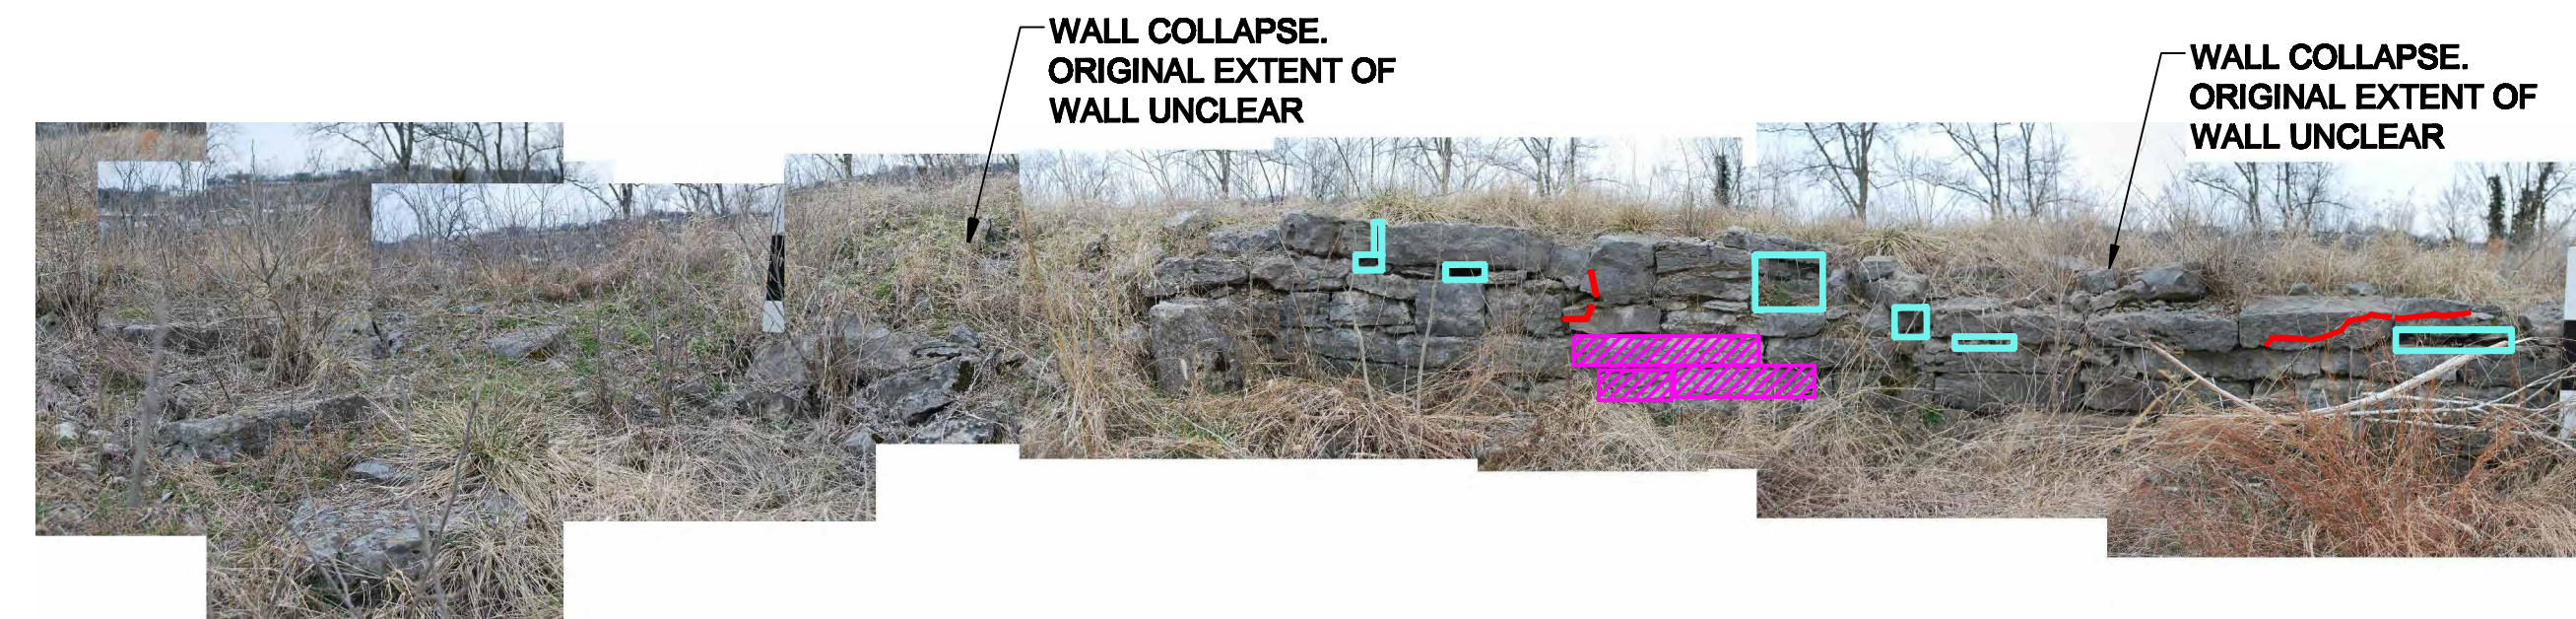
30 REDAN #1 - NORTH INTERIOR WALL  
A111 SCALE: 3/8" = 1'-0"

CAMBER: COLLAPSED WALLS, LEANS FORWARD  
STONE SIZE: RANDOM, MEDIUM TO LARGE  
COURSING: SOMEWHAT COURSED  
CHINKING: SOME USE OF SMALL AND MEDIUM SIZED STONES FOR CHINKING  
VEGETATION: WEEDS IN FACE.  
SLOPE: SLIGHT SLOPE PERPENDICULAR

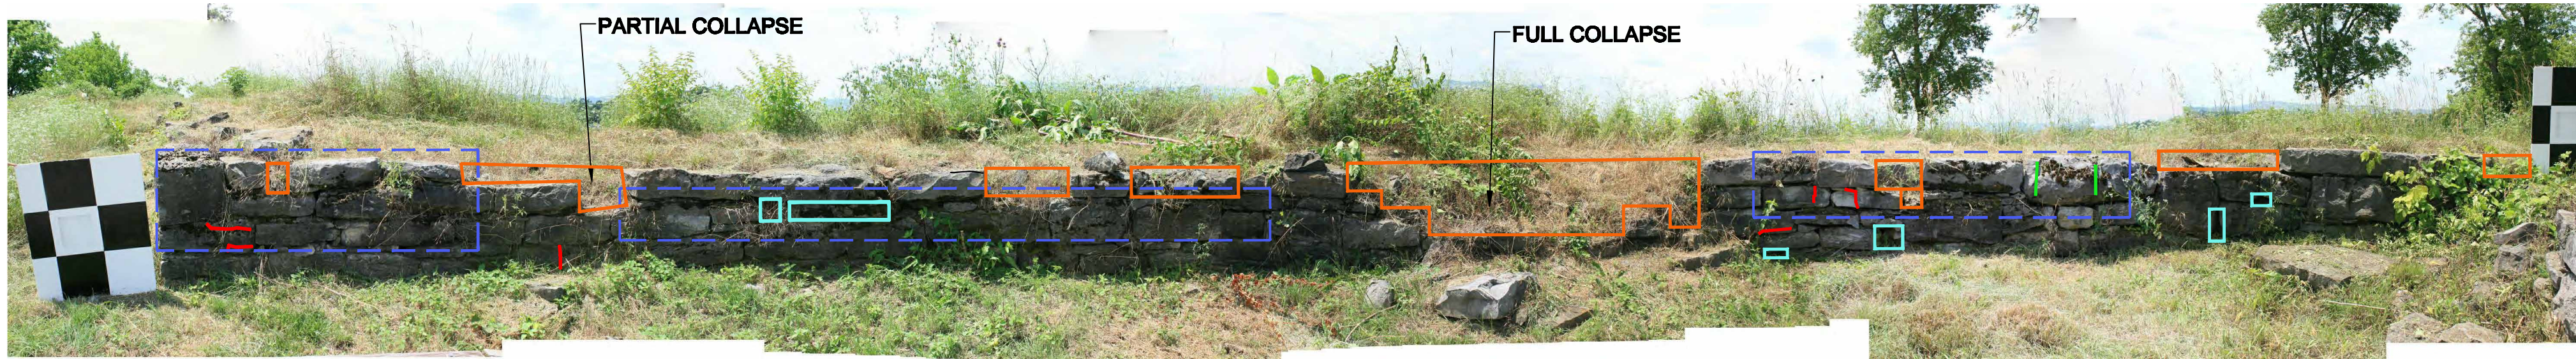
31 REDAN #2 - INTERIOR - SOUTH SIDE  
A112 SCALE: 3/8" = 1'-0"

CAMBER: RANDOM, SOME VERY LARGE STONES  
STONE SIZE: UN-COURSED  
COURSING: MAY HAVE BEEN A LOT, OPEN JOINTS MAY HAVE HAD CHINKING  
CHINKING: SMALL WEEDS IN FACE, NO TREES  
VEGETATION: GROUND IS MOSTLY FLAT IN FRONT OF WALL, LOW AREA AT BLOWOUT  
SLOPE:

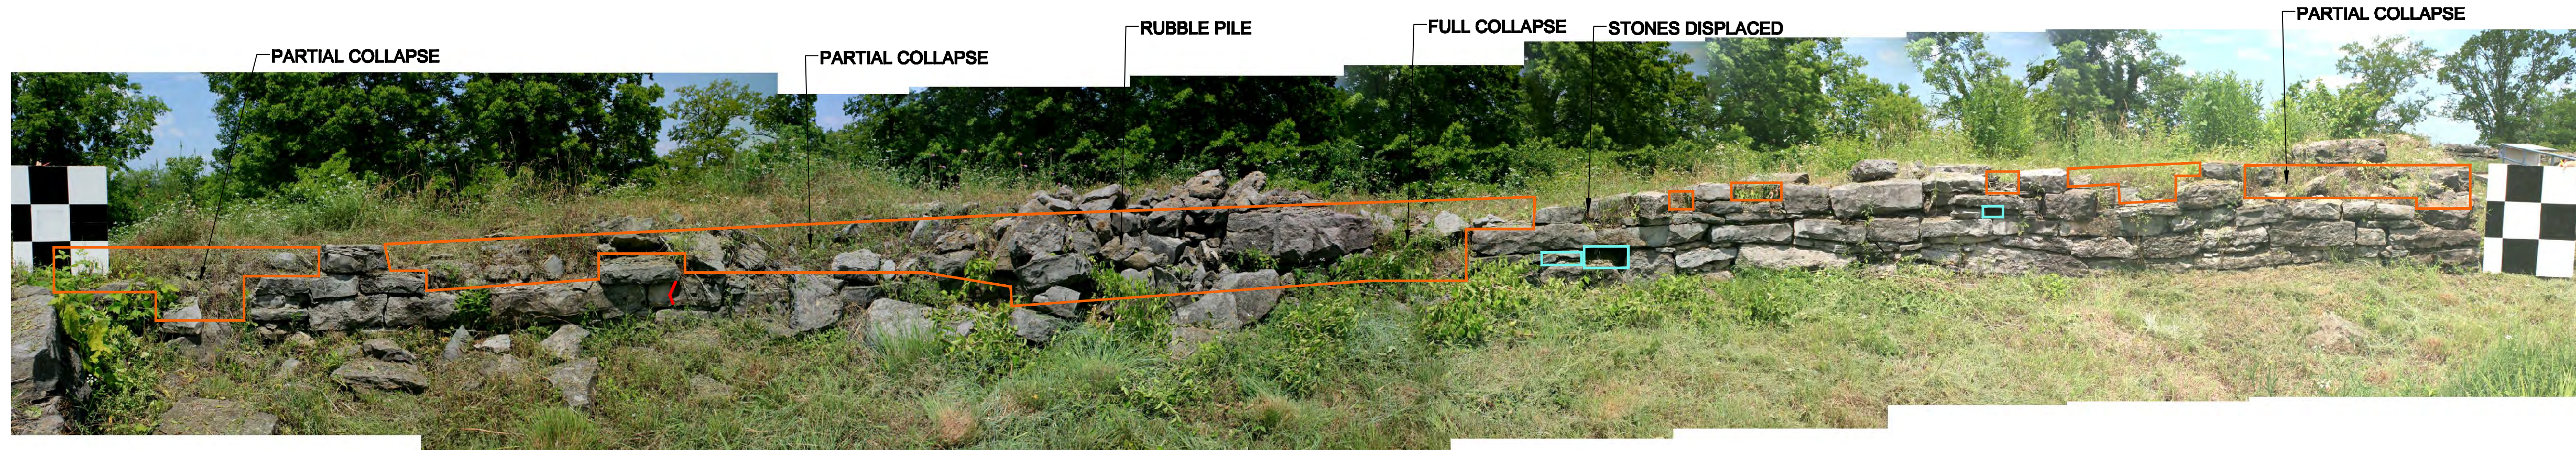
32 REDAN #2 - INTERIOR - NORTH SIDE  
A112 SCALE: 3/8" = 1'-0"

CAMBER: WALL FALLING FORWARD AND COLLAPSED  
STONE SIZE: RANDOM, SOME LARGE STONES  
COURSING: NOT WELL DEFINED, IRREGULAR  
CHINKING: NOT MUCH  
VEGETATION: MOSTLY VINES AND WEEDS IN WALL, NO TREES  
SLOPE: MOSTLY LEVEL IN FRONT.

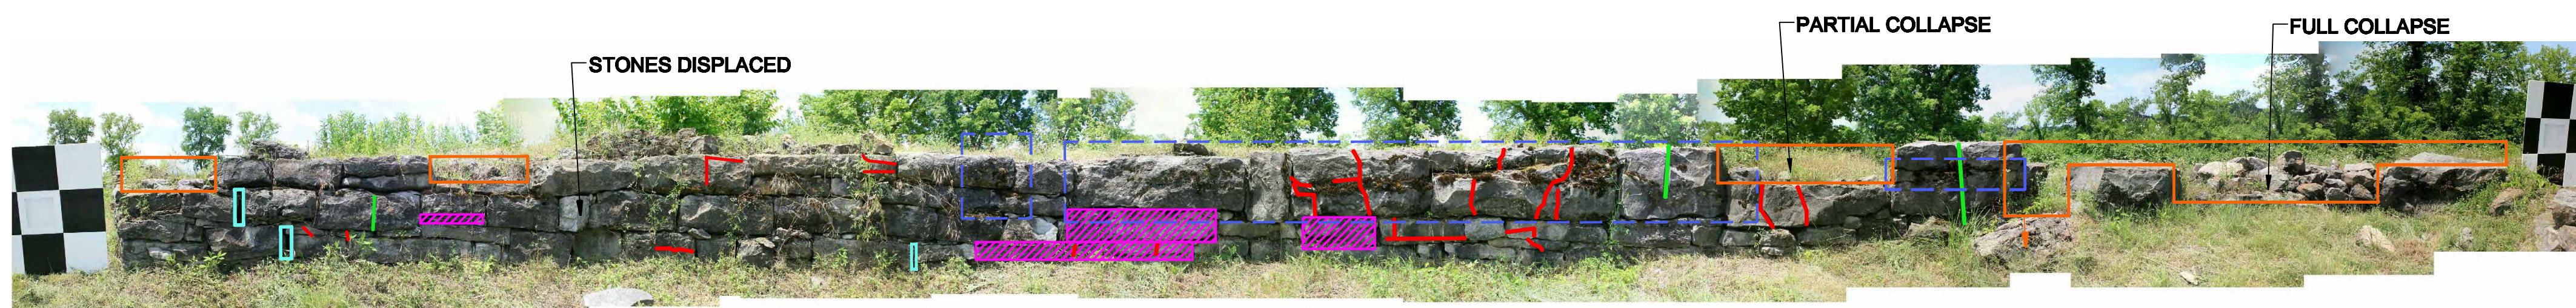
33 REDAN #3 - INTERIOR - WEST SIDE  
A112 SCALE: 3/8" = 1'-0"

CAMBER: MOSTLY VERTICAL, SOME COLLAPSE AND ROLLING OFF OF CAP  
STONE SIZE: RANDOM, MANY LARGE STONES  
COURSING: SOMEWHAT COURSED, BUT NOT WELL DEFINED, IRREGULAR  
CHINKING: MANY SMALL STONES, ALSO LONG THIN STONES  
VEGETATION: VINES AND WEEDS IN WALL, NO TREES  
SLOPE: MOSTLY LEVEL IN FRONT

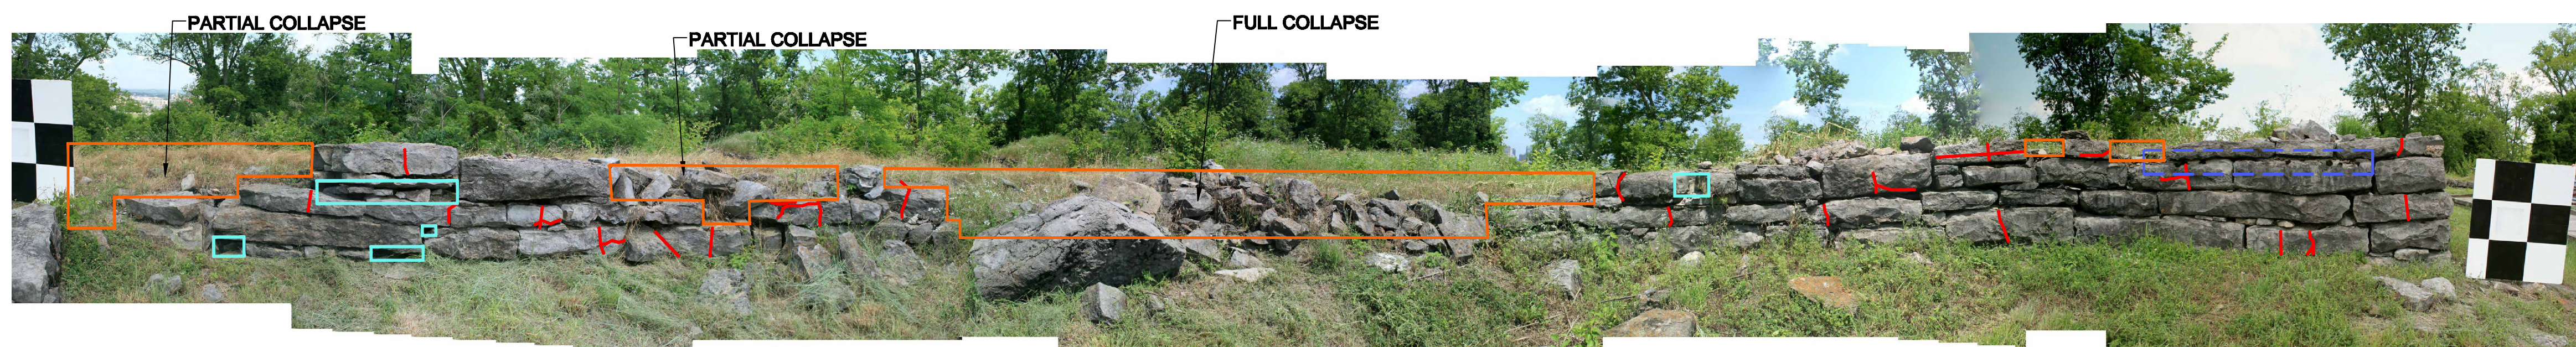
34 REDAN #3 - INTERIOR - SOUTH SIDE  
A112 SCALE: 3/8" = 1'-0"

CAMBER: HEAVILY COLLAPSED  
STONE SIZE: VARIES ALONG WALL, REGULAR AT RIGHT END, BUT RANDOM AND ROUNDED IN MIDDLE AT BLOWOUT  
COURSING: MOSTLY IRREGULAR, BUT SOME AREAS ARE MORE COURSED  
CHINKING: SOME EVIDENCE OF MEDIUM TO SMALL CHINKING REMAINS  
VEGETATION: VINES AND WEEDS IN WALL, NO TREES  
SLOPE: AWAY FROM WALL

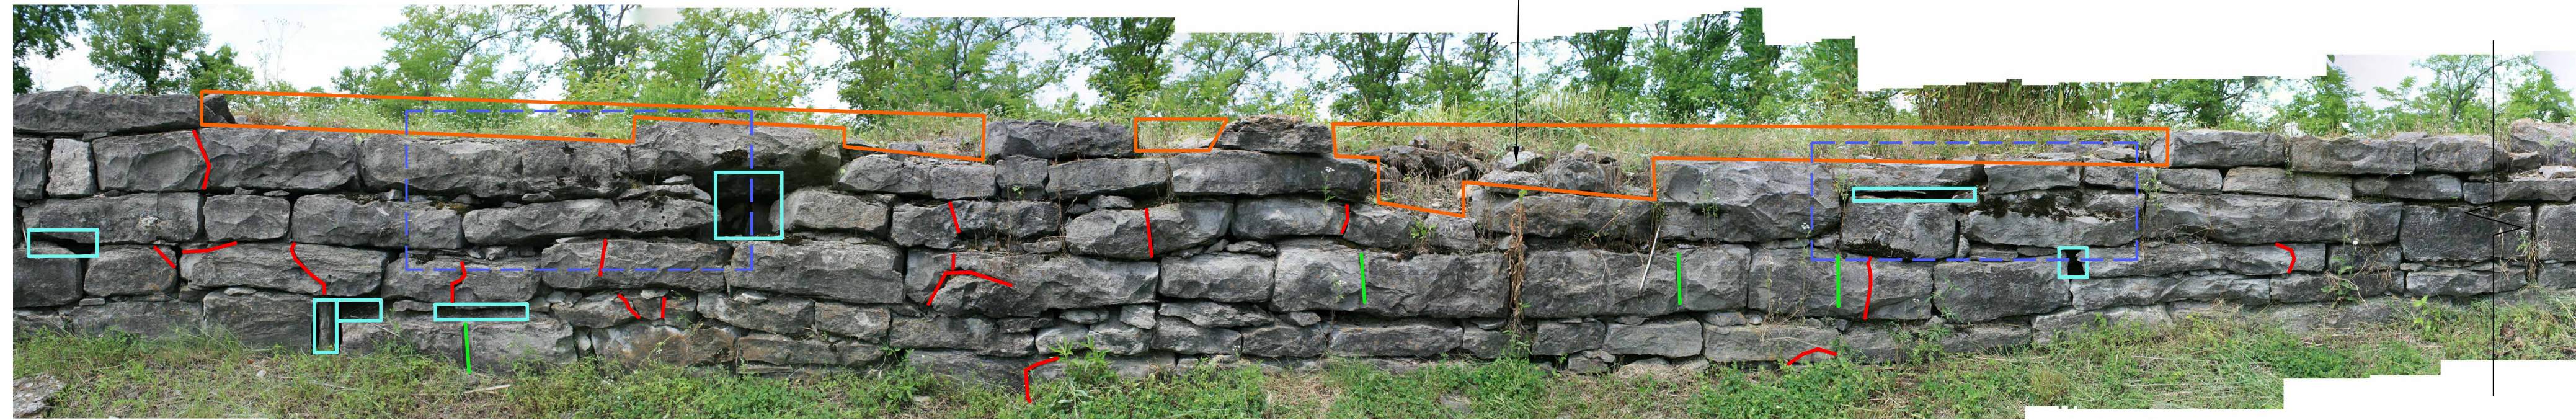
35A REDAN #4 - INTERIOR - WEST SIDE PARTIAL  
A113 SCALE: 3/8" = 1'-0"

CAMBER: MOSTLY VERTICAL  
STONE SIZE: MEDIUM, MOSTLY UNIFORM  
COURSING: UNCOURSED  
CHINKING: STILL A GOOD AMOUNT VISIBLE  
VEGETATION: SMALL WEEDS IN FACE, NO TREES  
SLOPE: GROUND IS MOSTLY FLAT IN FRONT OF WALL

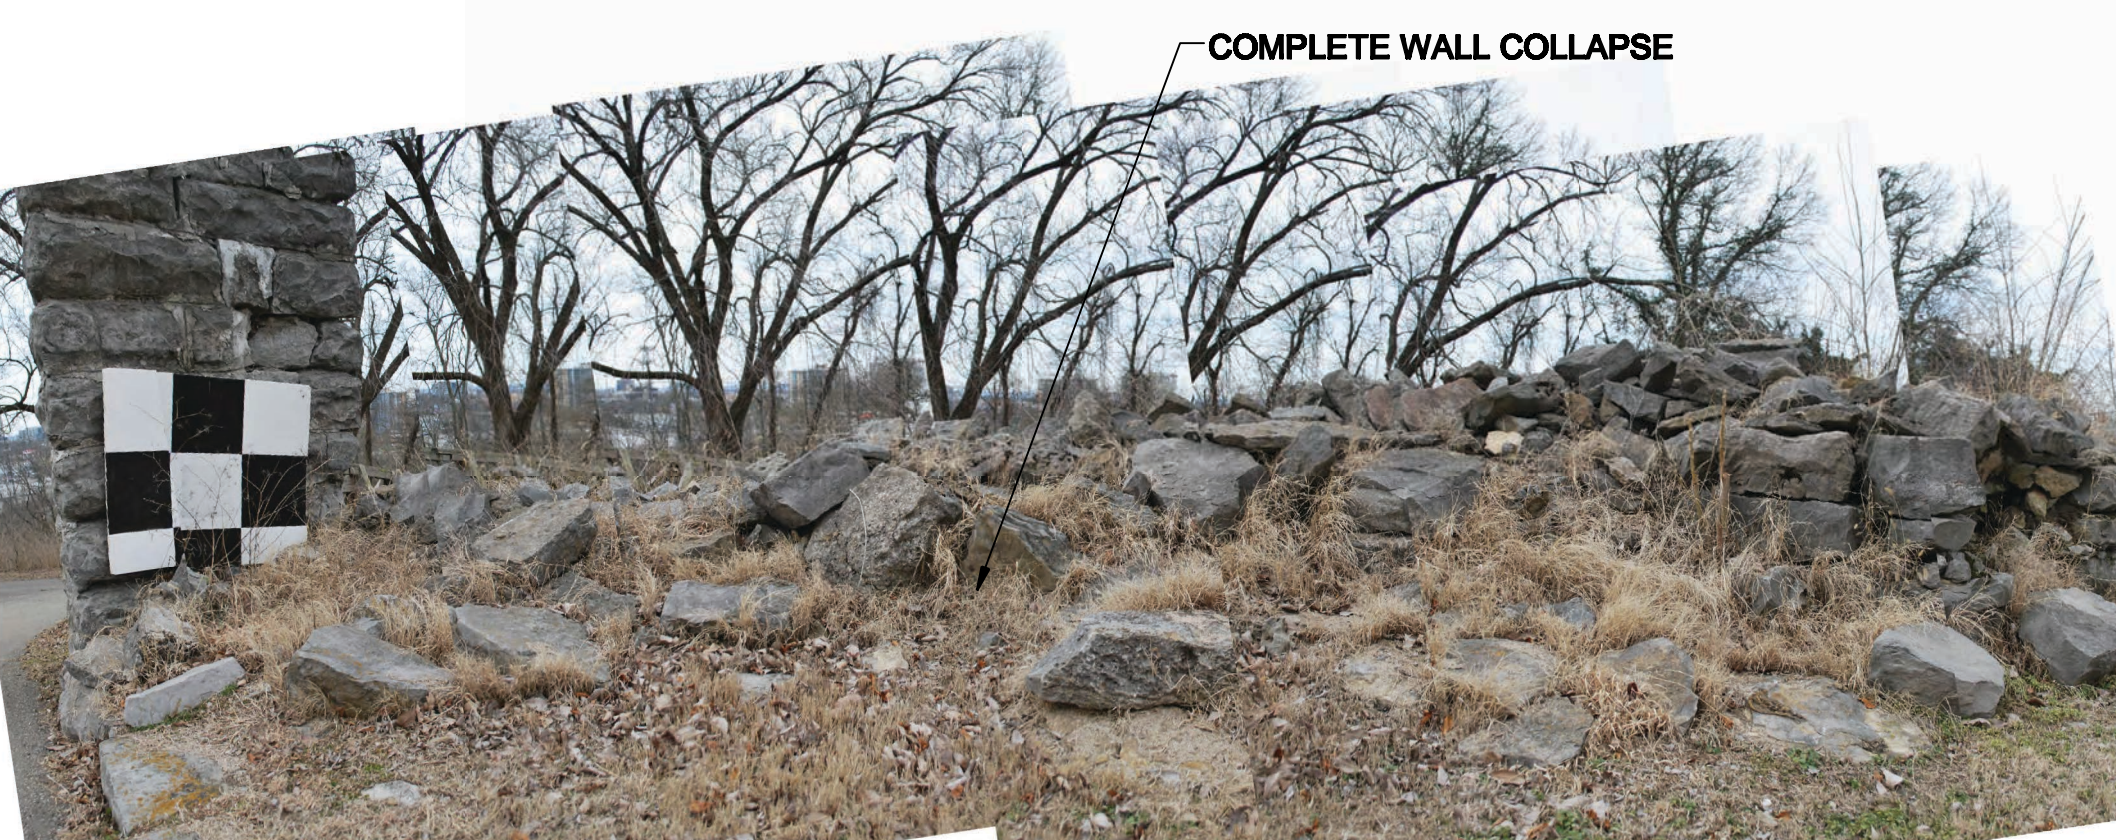
39 NORTH MAIN WORKS, WEST SIDE FACING REDAN #4  
A113 SCALE: 3/8" = 1'-0"

CAMBER: WALLS ARE SLIGHTLY BATTERED  
STONE SIZE: IRREGULAR, MANY VERY LARGE STONES  
COURSING: IRREGULAR COURSING  
CHINKING: MINIMAL, NOTE USE OF MORTAR IN SOME AREAS  
VEGETATION: SMALL WEEDS IN FACE, SOME TREES  
SLOPE: AWAY FROM WALL AND ALSO PARALLEL

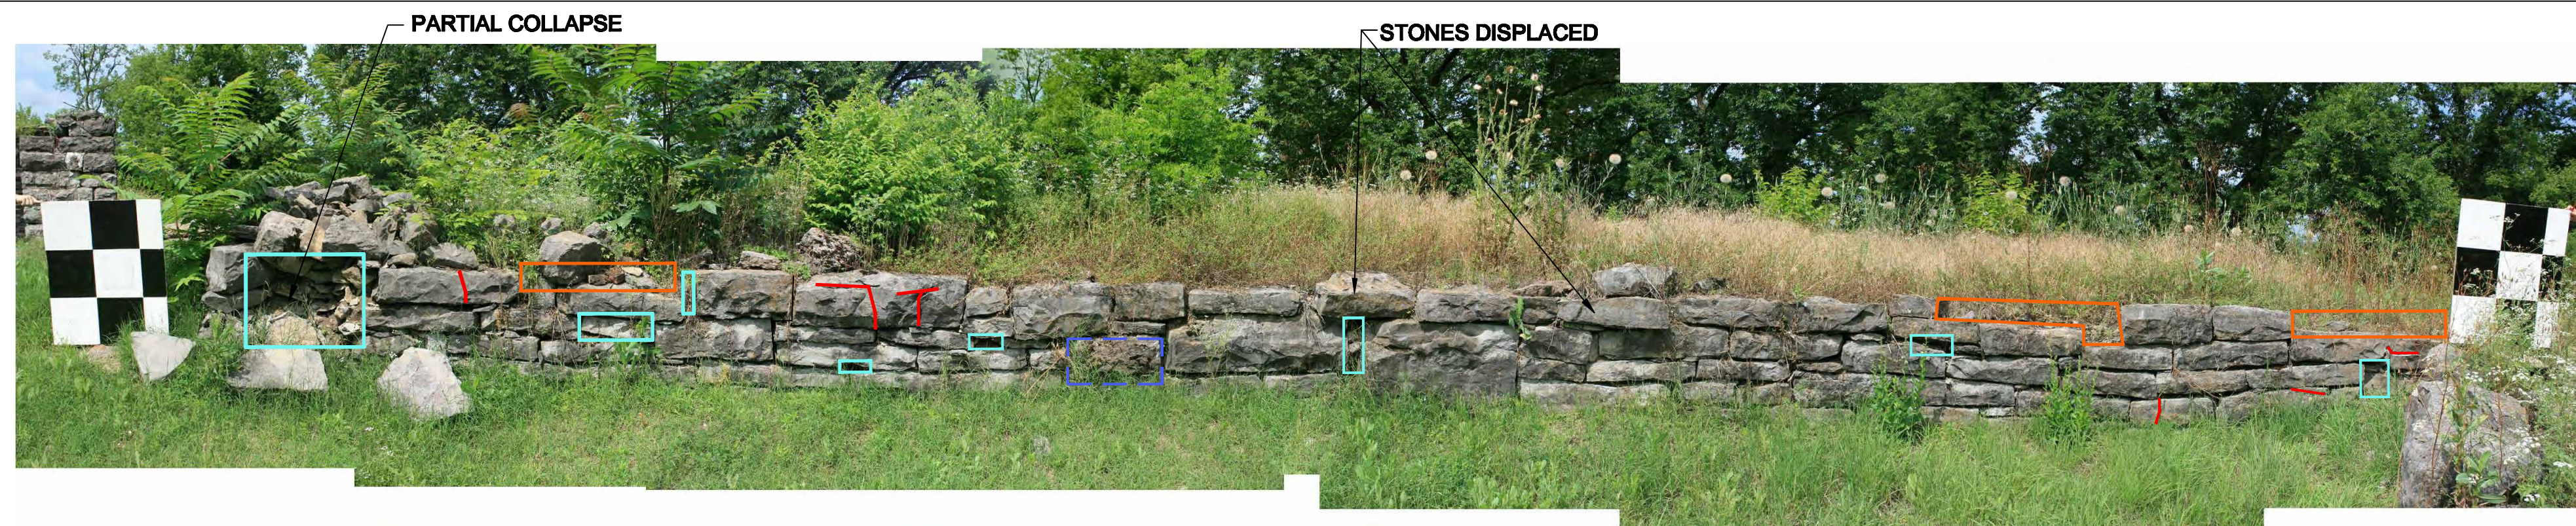
40 REDAN #5 INTERIOR - WEST SIDE  
 A114 SCALE: 3/8" = 1'-0"

CAMBER: MOSTLY VERTICAL. BLOWOUT AT ONE END AND TOP COURSE IS MOVING FORWARD AND FALLING  
 STONE SIZE: MEDIUM, FAIRLY REGULAR  
 COURSING: IRREGULAR  
 CHINKING: SOME SMALL STONES, AND GAPS LIKELY FROM PREVIOUS FACE CHINKING  
 VEGETATION: SOME SMALL WEEDS AND VINES  
 SLOPE: MOSTLY LEVEL IN FRONT.

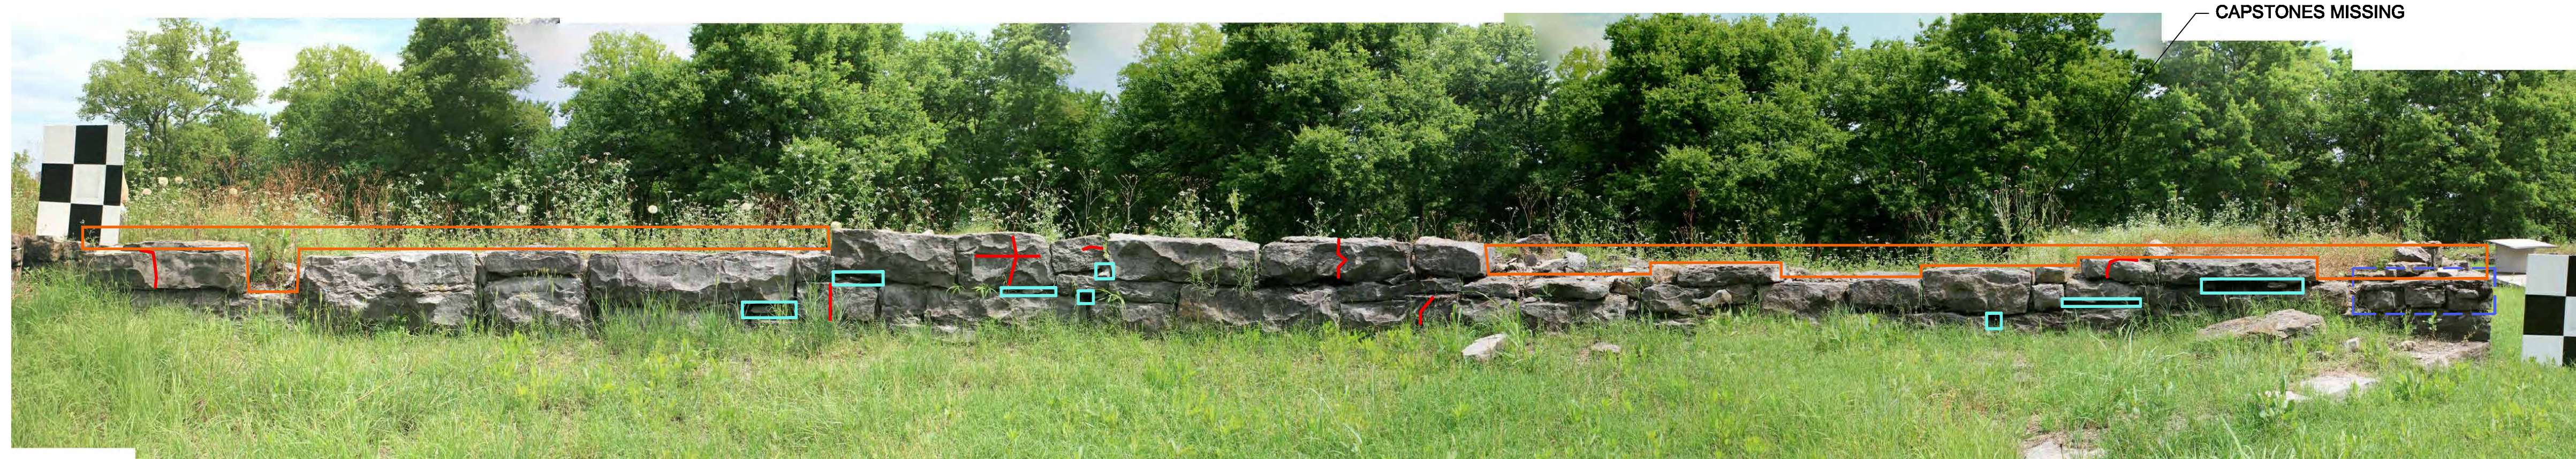
41 REDAN #5 INTERIOR - EAST SIDE  
 A114 SCALE: 3/8" = 1'-0"

CAMBER: ONLY ONE COURSE REMAINS  
 STONE SIZE: LARGE STONES  
 COURSING: NOT DISCERNABLE  
 CHINKING: NOT DISCERNABLE  
 VEGETATION: MINIMAL  
 SLOPE: MOSTLY LEVEL IN FRONT.

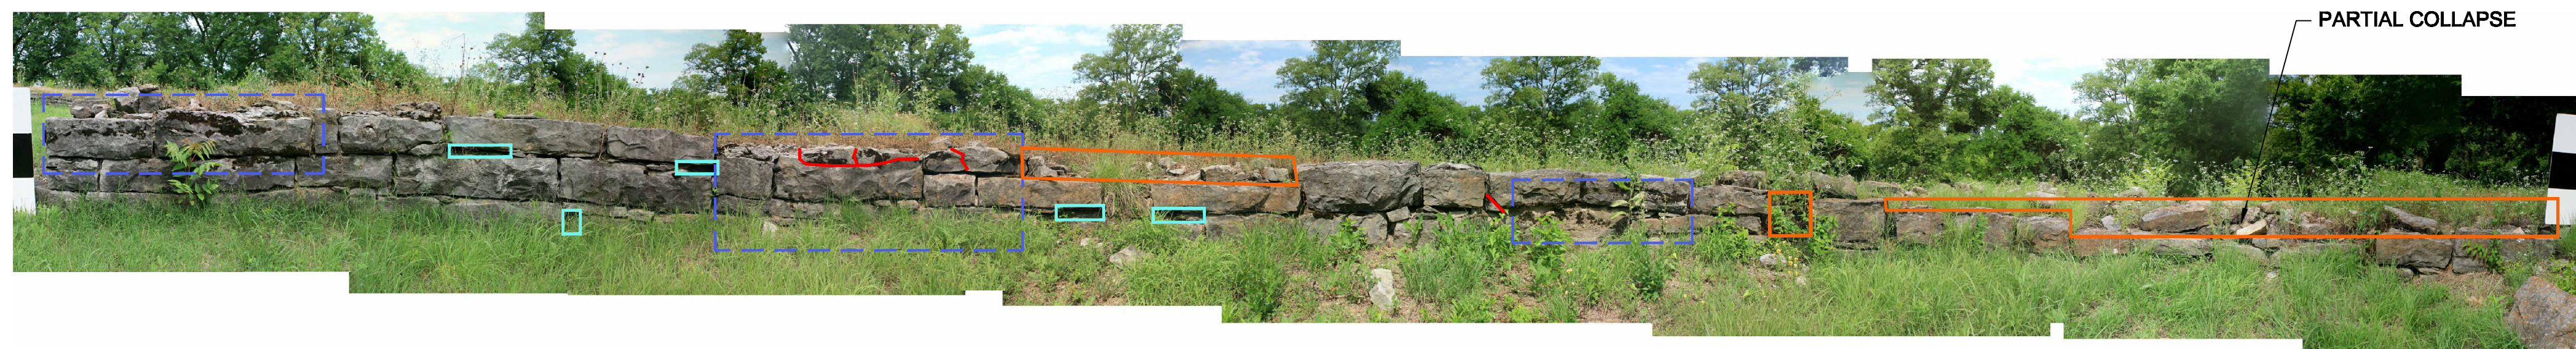
42 REDAN #6 INTERIOR - WEST SIDE  
 A114 SCALE: 3/8" = 1'-0"

CAMBER: NOT DISCERNABLE. STONES FALLING FORWARD AND BACKWARD FROM TOP  
 STONE SIZE: LARGE STONES, VERY SQUARED.  
 COURSING: SOMEWHAT COURSED  
 CHINKING: SOME STILL VISIBLE, BUT LOOKS LIKE A LOT HAVE FALLEN OUT  
 VEGETATION: MINIMAL  
 SLOPE: MOSTLY LEVEL IN FRONT.

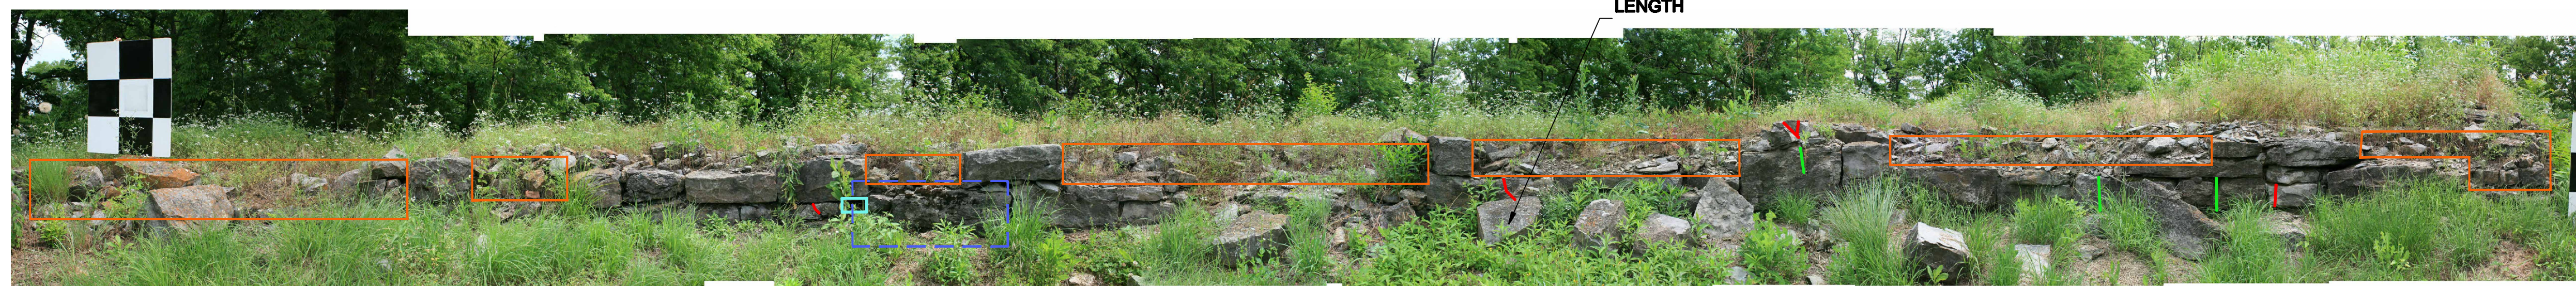
43 REDAN #6 INTERIOR - EAST SIDE  
 A114 SCALE: 3/8" = 1'-0"

CAMBER: ONLY ONE COURSE REMAINS  
 STONE SIZE: LARGE STONES.  
 COURSING: NOT DISCERNABLE  
 CHINKING: NOT DISCERNABLE  
 VEGETATION: MINIMAL  
 SLOPE: MOSTLY LEVEL IN FRONT.

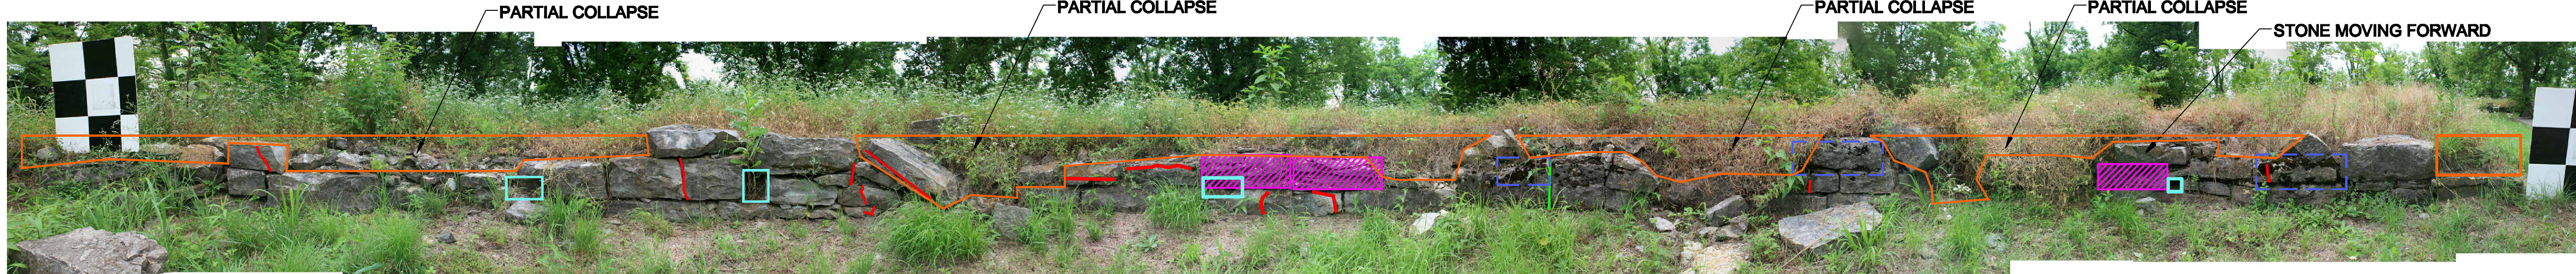
45 REDAN #7 INTERIOR - EAST SIDE  
A115 SCALE: 3/8" = 1'-0"

CAMBER: VERTICAL, OR STONES FALLING FORWARD AND PARTIAL COLLAPSE  
STONE SIZE: MIXED, SOME LARGE STONES  
COURSING: IRREGULAR  
CHINKING: FACE CHINKING IS FALLING OUT  
VEGETATION: VINES AND WEEDS  
SLOPE: MOSTLY LEVEL IN FRONT.

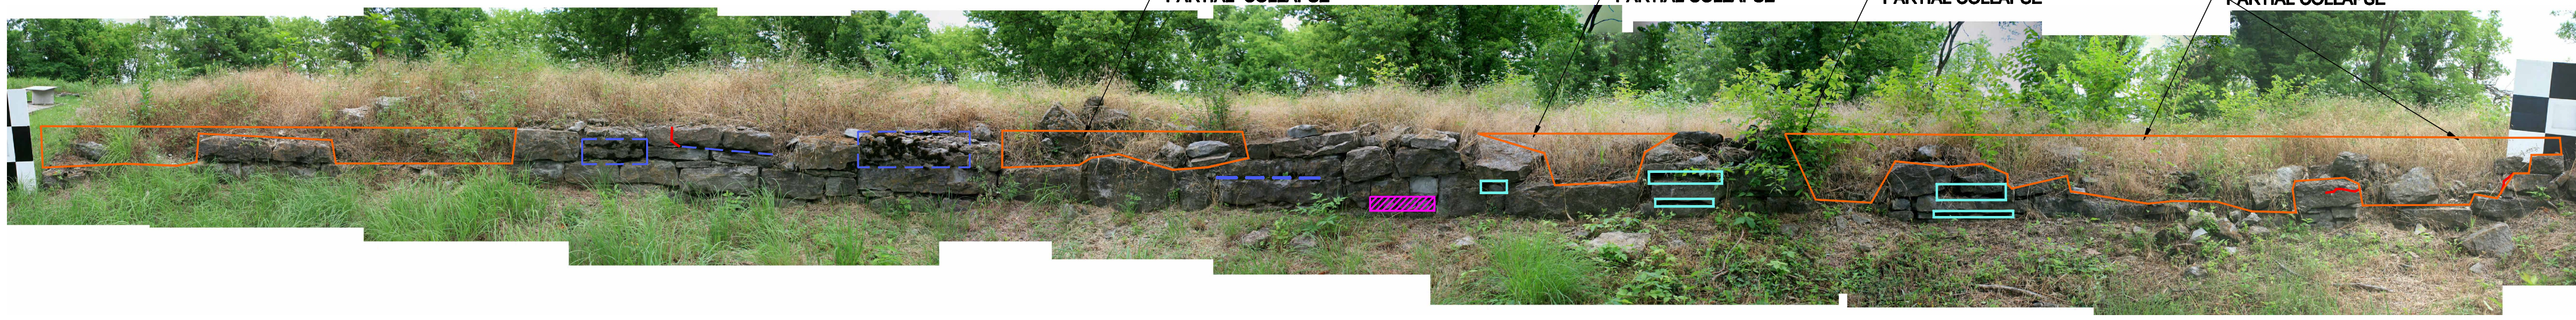
46 REDAN #8 INTERIOR - NORTH SIDE  
A115 SCALE: 3/8" = 1'-0"

CAMBER: VERTICAL. STONES FALLING FORWARD OR BLOWOUTS  
STONE SIZE: MIXED  
COURSING: SOMEWHAT COURSED  
CHINKING: SOME LARGER STONES USED FOR CHINKING. MANY HAVE FALLEN OUT.  
VEGETATION: GRASS, VINES, AND SOME SMALL SUMAC TREES.  
SLOPE: MOSTLY LEVEL IN FRONT.

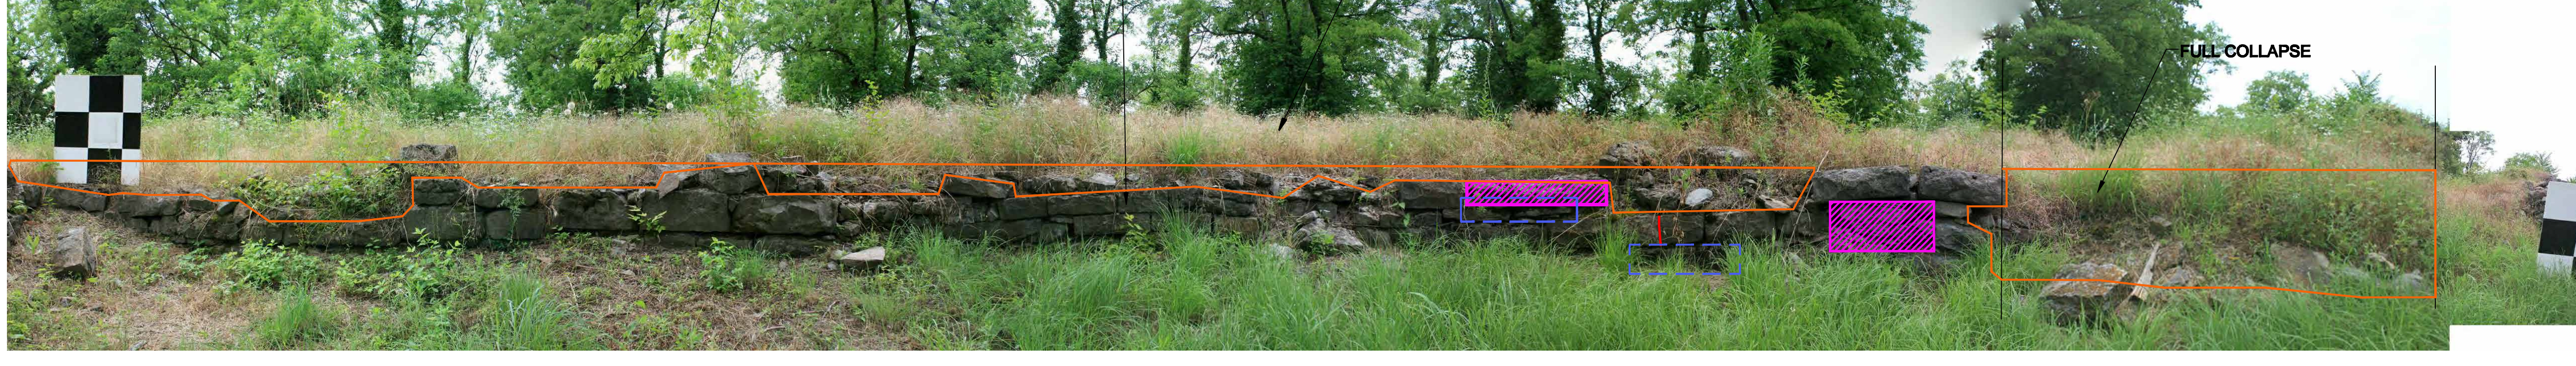
47 REDAN #8 INTERIOR - EAST SIDE  
A115 SCALE: 3/8" = 1'-0"

CAMBER: MOSTLY VERTICAL. SEVERAL BLOWOUTS, TOP COURSE MISSING  
STONE SIZE: MIXED  
COURSING: IRREGULAR  
CHINKING: NOT DISCERNABLE  
VEGETATION: GRASSES AND VINES  
SLOPE: MOSTLY LEVEL IN FRONT.
