East Bastion  
South & West Walls  
Photo Elevations

South Main Works  
Exterior  
Photo Elevations

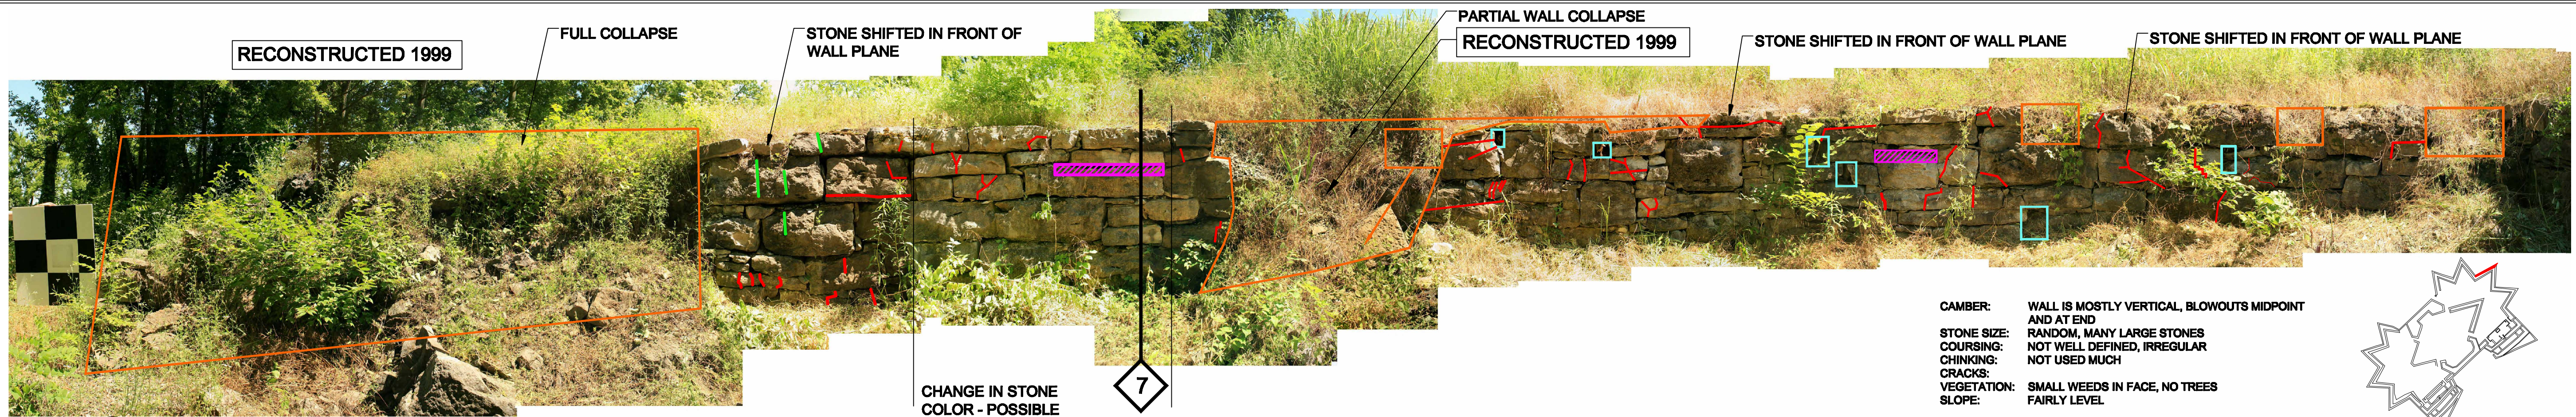
15 REDAN #7 - EXTERIOR - NORTH SIDE  
A105 SCALE: 3/8" = 1'-0"

CAMBER: WALL IS MOSTLY VERTICAL, BLOWOUTS MIDPOINT AND AT END  
STONE SIZE: RANDOM, MANY LARGE STONES  
COURSING: NOT WELL DEFINED, IRREGULAR  
CHINKING: NOT USED MUCH  
CRACKS: NOT USED MUCH  
VEGETATION: SMALL WEEDS IN FACE, NO TREES  
SLOPE: FAIRLY LEVEL

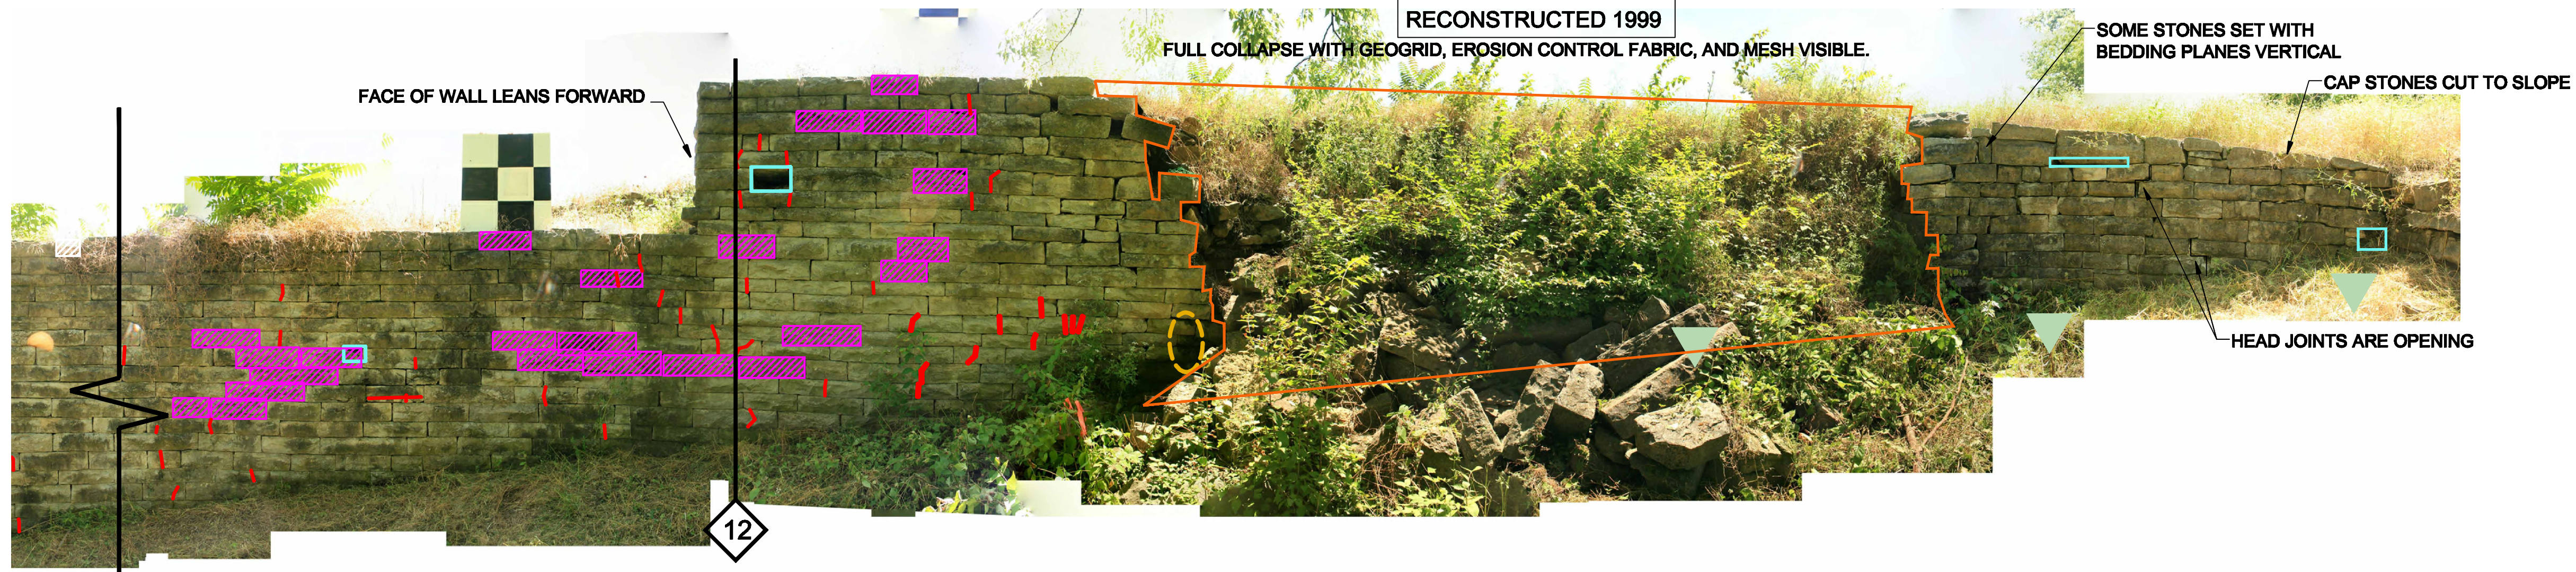
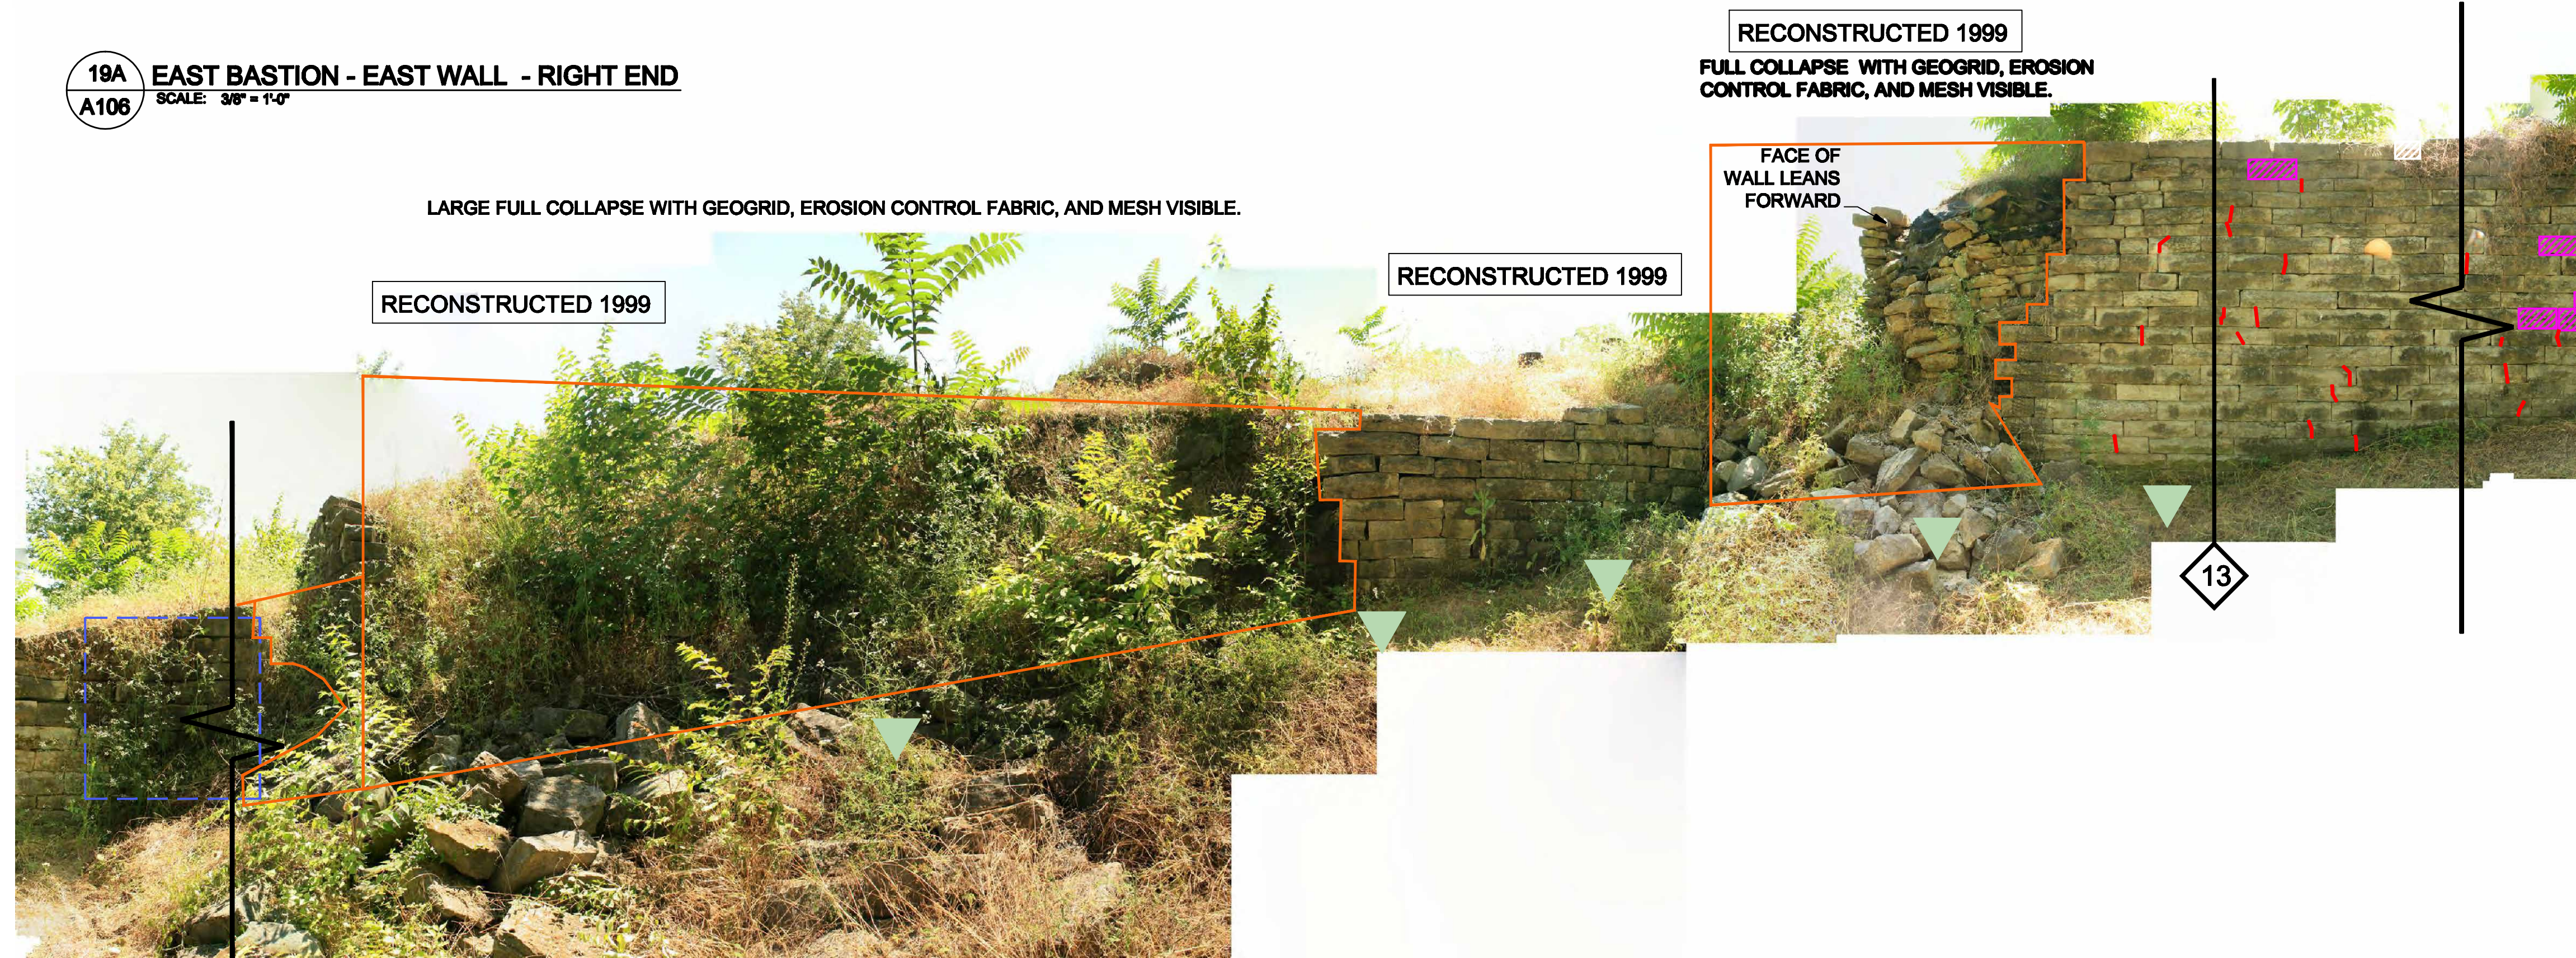
19A EAST BASTION - EAST WALL - RIGHT END  
A106 SCALE: 3/8" = 1'-0"

CAMBER: SLIGHTLY BATTERED, MORE VERTICAL AT LEFT SIDE  
STONE SIZE: COMPLETELY DIFFERENT FROM STONE AT REDANS.  
ASHLAR IS VERY REGULAR IN SIZE.  
COURSING: DEFINED COURSING  
CHINKING: NONE  
VEGETATION: VERY FEW SMALL WEEDS IN FACE, NO TREES  
SLOPE: PARALLEL TO WALL

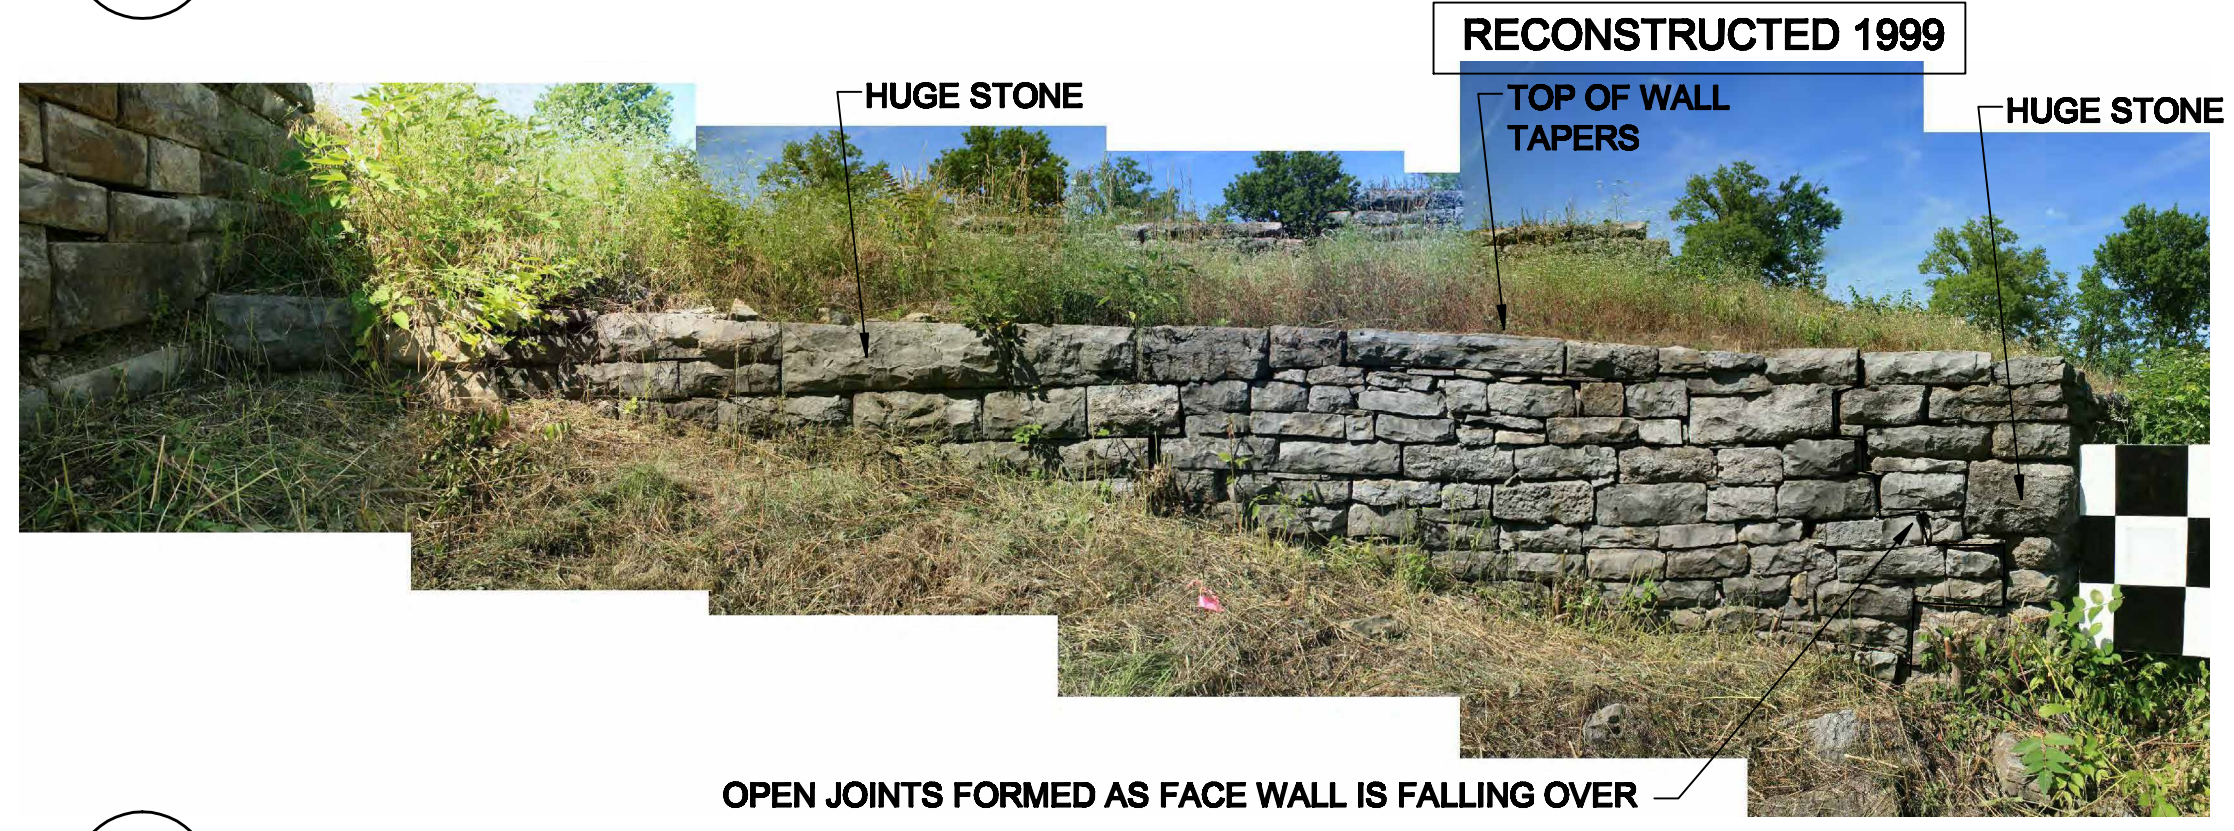
**21A EAST BASTION - WEST WALL - LEFT**  
A107 SCALE: 3/8" = 1'-0"

CAMBER: WALL IS PERPENDICULAR WITH NO BATTER  
STONE SIZE: RANDOM SIZES WITH A FEW VERY LARGE STONES  
COURSING: SOMEWHAT COURSED  
CHINKING: VERY VISIBLE, UNLIKE OTHER BASTION WALLS  
VEGETATION: SMALL WEEDS IN FACE, NO TREES  
SLOPE: GROUND ADJACENT TO WALL SLOPES TOWARD WALL
