APPENDIX A2

**ANNOTATED
OUTLINE
ELEVATIONS -
EXISTING CONDITIONS (2013)**

Redans 1 & 2
Exterior
Line Elevations

Historic Structure Report
Fort Negley

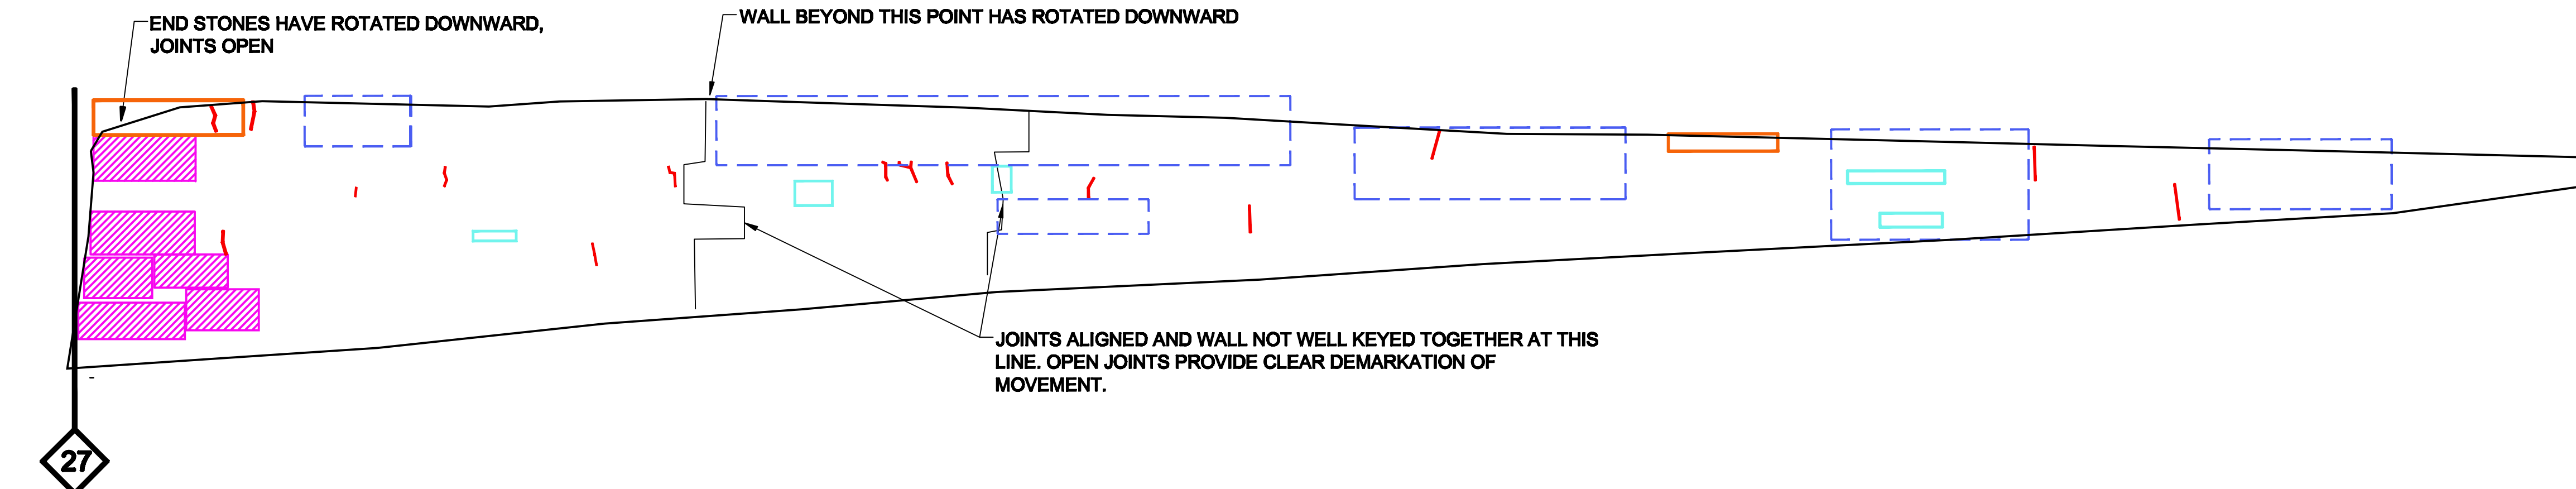
1 REDAN #1 - EXTERIOR - SOUTH SIDE
SCALE: 3/8" = 1'-0"

CAMBER: SLIGHTLY BATTERED
STONE SIZE: RANDOM, BUT NOT A HUGE VARIATION IN OVERALL SIZES
COURSING: FAIRLY WELL COURSED
CHINKING: NOT MUCH, A LITTLE AT RIGHT SIDE
VEGETATION: SMALL WEEDS IN FACE, NO TREES
CRACKS: FALLS AWAY ROUGHLY PERPENDICULAR TO WALL

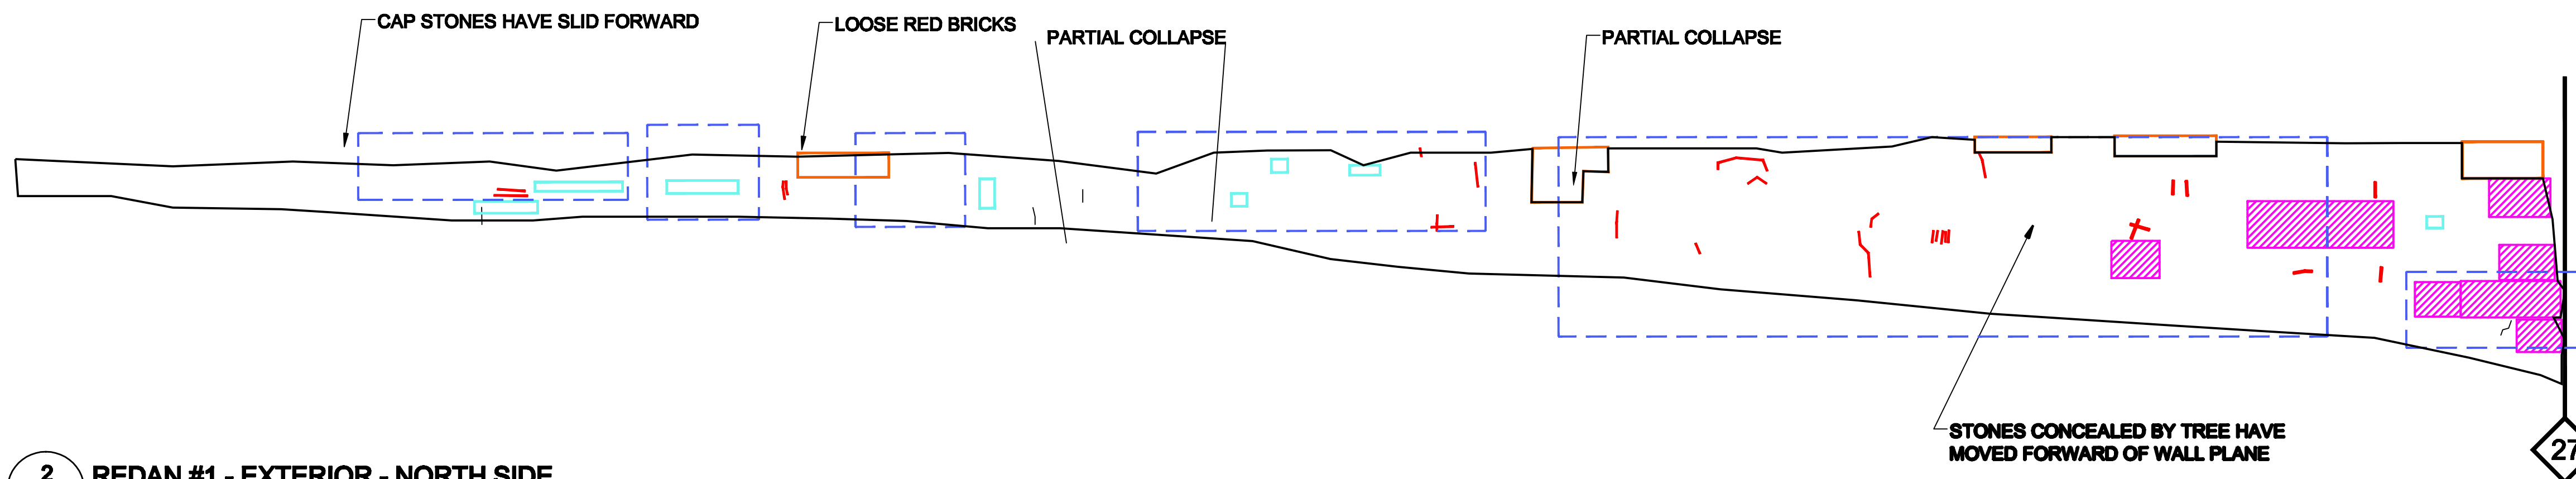
2 REDAN #1 - EXTERIOR - NORTH SIDE
SCALE: 3/8" = 1'-0"

CAMBER: BATTERED AT RIGHT, LEANING OUT AT LEFT SIDE
STONE SIZE: RANDOM, SOME LARGE STONES. STONE AT RIGHT SIDE IS OF LESSER QUALITY
COURSING: NOT WELL DEFINED, IRREGULAR
CHINKING: NOT MUCH
VEGETATION: MOSTLY VINES AND WEEDS IN WALL, NO TREES
SLOPE: FALLS AWAY ROUGHLY PERPENDICULAR TO WALL

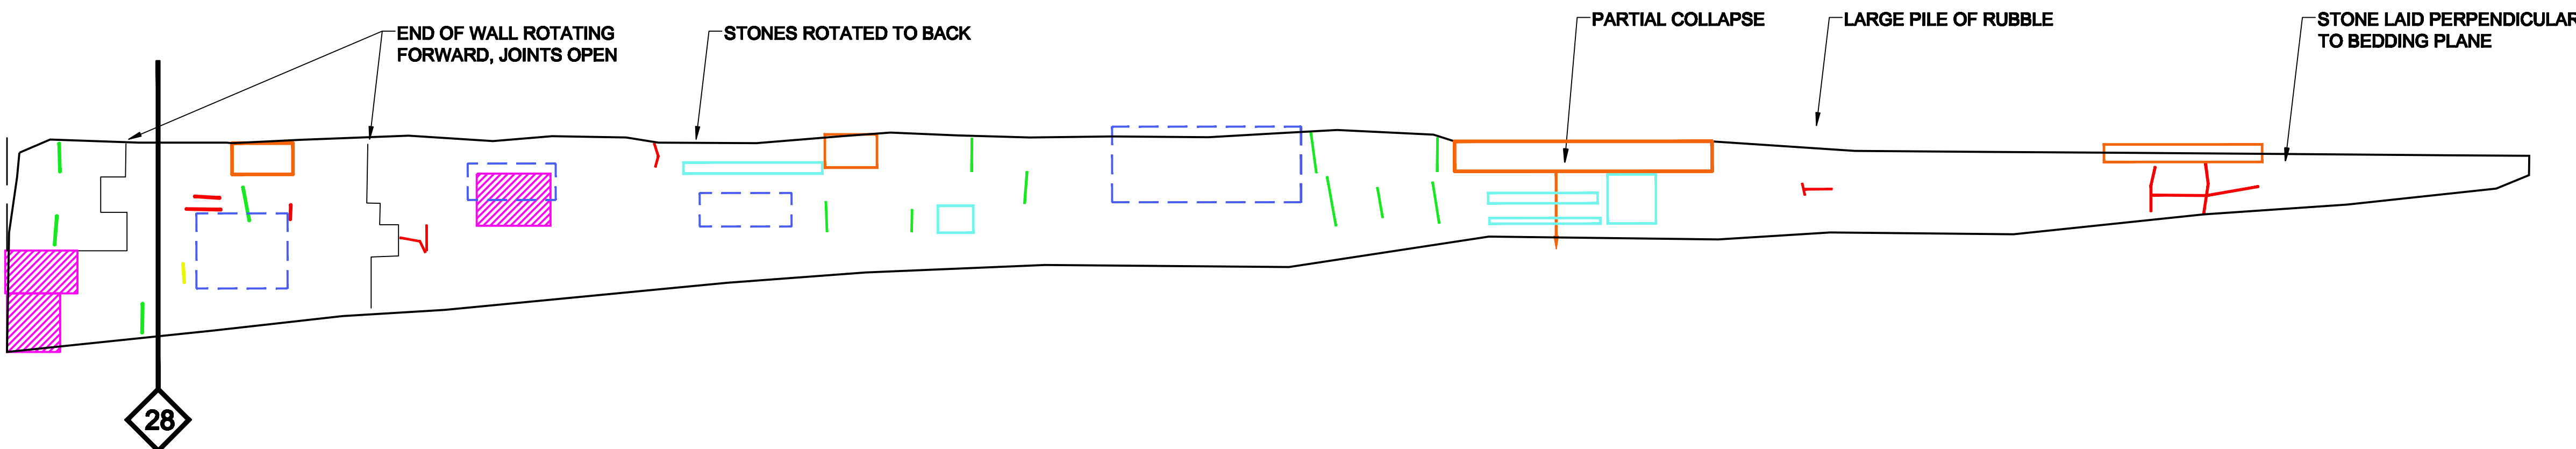
3 REDAN #2 - EXTERIOR - SOUTH SIDE
SCALE: 3/8" = 1'-0"

CAMBER: SLIGHTLY BATTERED, MORE VERTICAL AT RIGHT
STONE SIZE: RANDOM, NOT MANY LARGE STONES
COURSING: SOMEWHAT COURSED, BUT NOT WELL DEFINED, IRREGULAR
CHINKING: NONE
VEGETATION: VINES AND WEEDS IN WALL, NO TREES
SLOPE: FALLS AWAY ROUGHLY PERPENDICULAR TO WALL, FAIRLY LEVEL

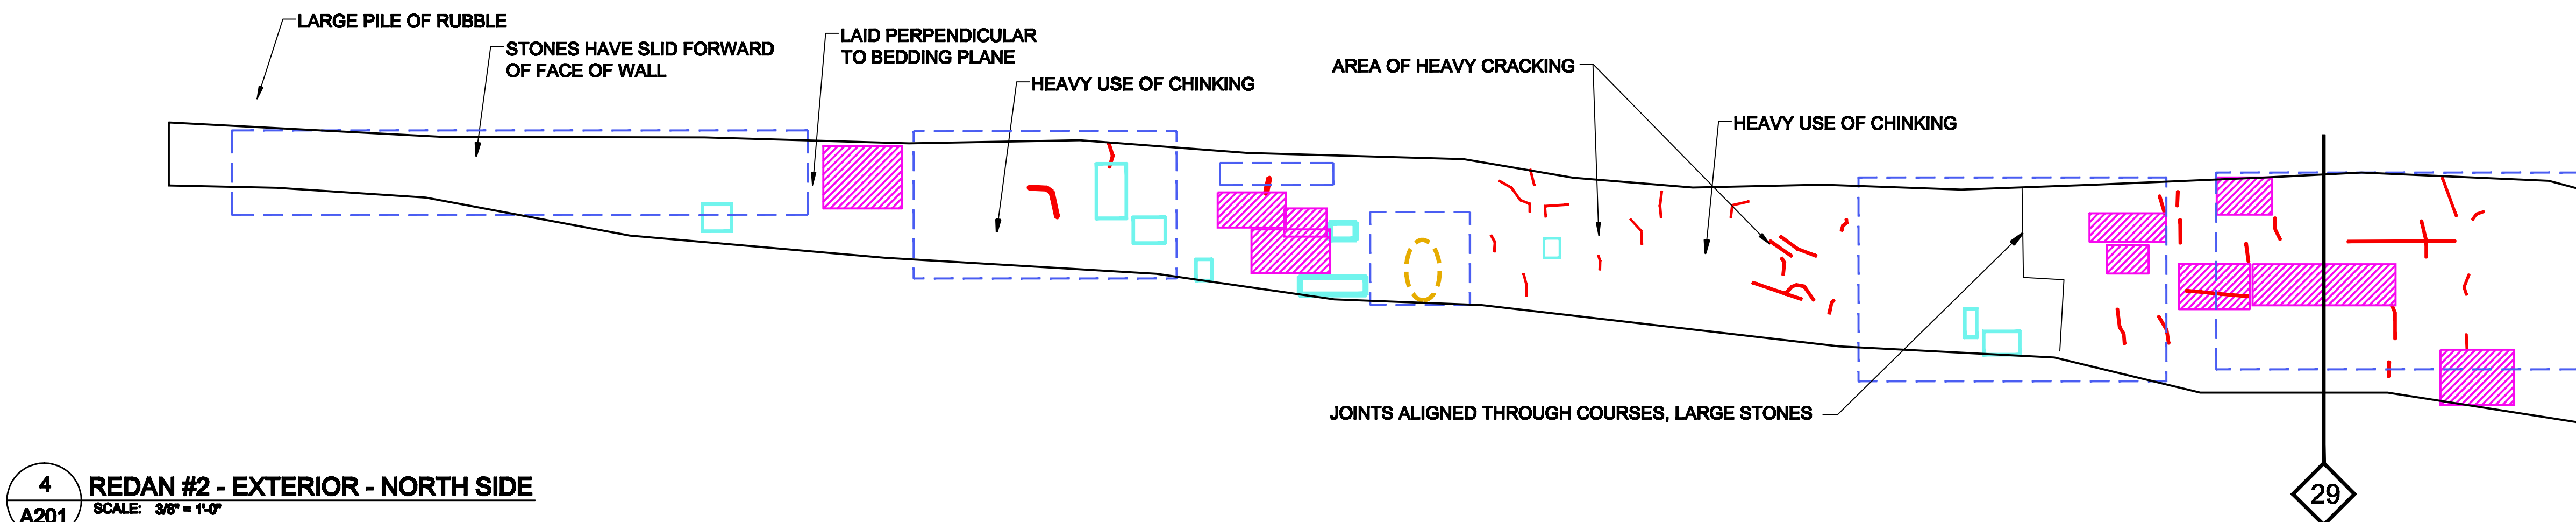
4 REDAN #2 - EXTERIOR - NORTH SIDE
SCALE: 3/8" = 1'-0"

CAMBER: MOSTLY BATTERED,
STONE SIZE: RANDOM. MANY STONES ARE FRACTURED AND CRUMBLING
COURSING: MOSTLY IRREGULAR, BUT SOME AREAS ARE MORE COURSED
CHINKING: FALLING OUT
VEGETATION: VINES AND WEEDS IN WALL, NO TREES
SLOPE:

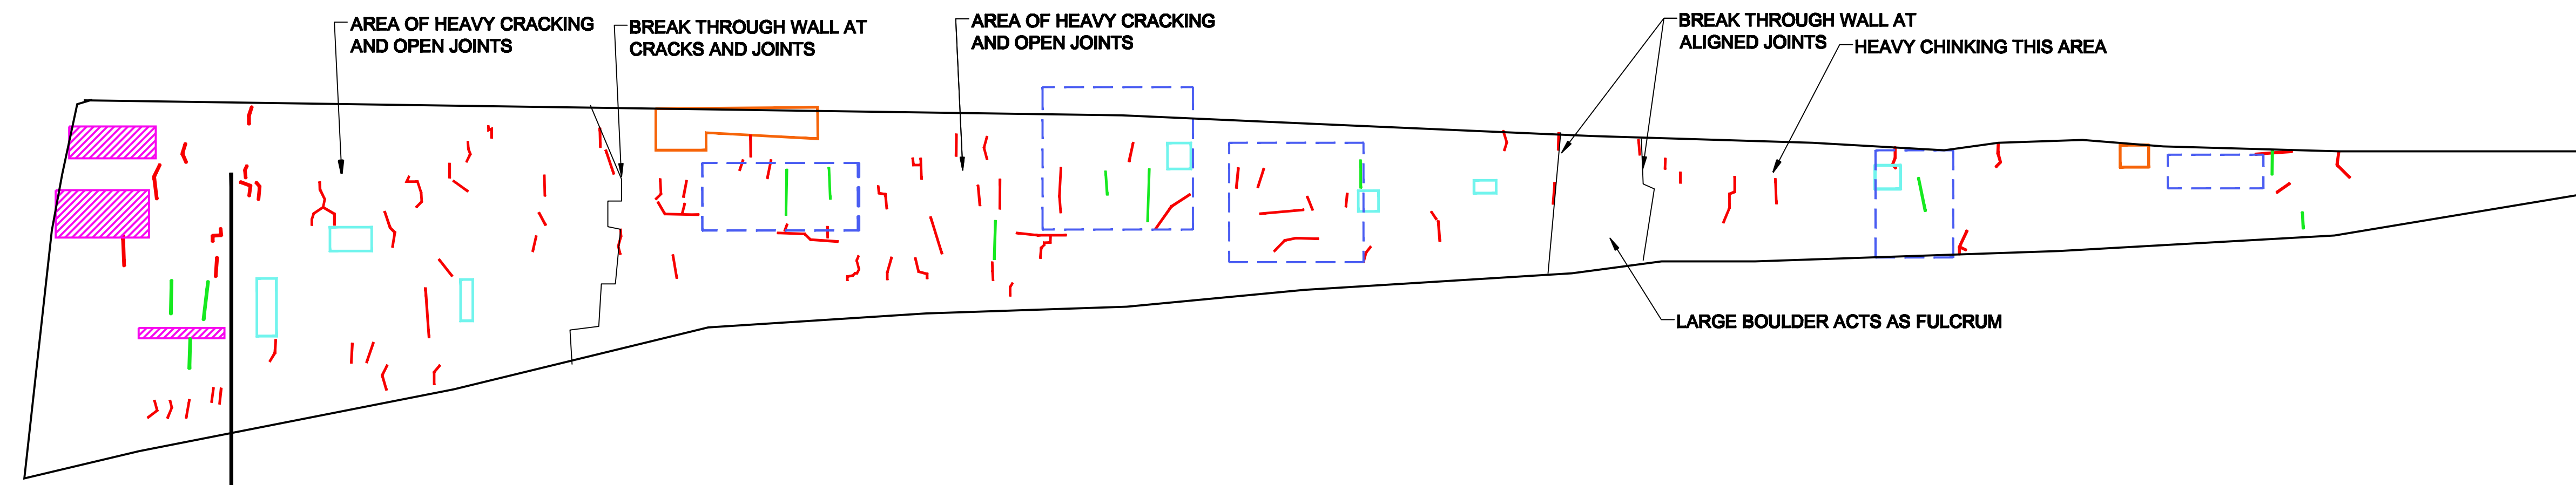
5 REDAN #3 - EXTERIOR - WEST SIDE
SCALE: 3/8" = 1'-0"

CAMBER: OVERALL, BATTERED, BUT IRREGULAR
STONE SIZE: RANDOM, SOME VERY LARGE STONES
COURSING: MOSTLY NOT COURSED, MORE COURSED AT
LEFT END
CHINKING: AREAS OF HEAVY CHINKING
CRACKS: AT THREE POINTS, CRACKS ALIGN WITH JOINTS
FOR CLEAR BREAK THROUGH WALL HEIGHT
VEGETATION: SMALL WEEDS IN FACE, NO TREES
SLOPE: FALLS AWAY ROUGHLY PERPENDICULAR TO
WALL, SLOPE PARALLEL TO WALL AT LEFT END

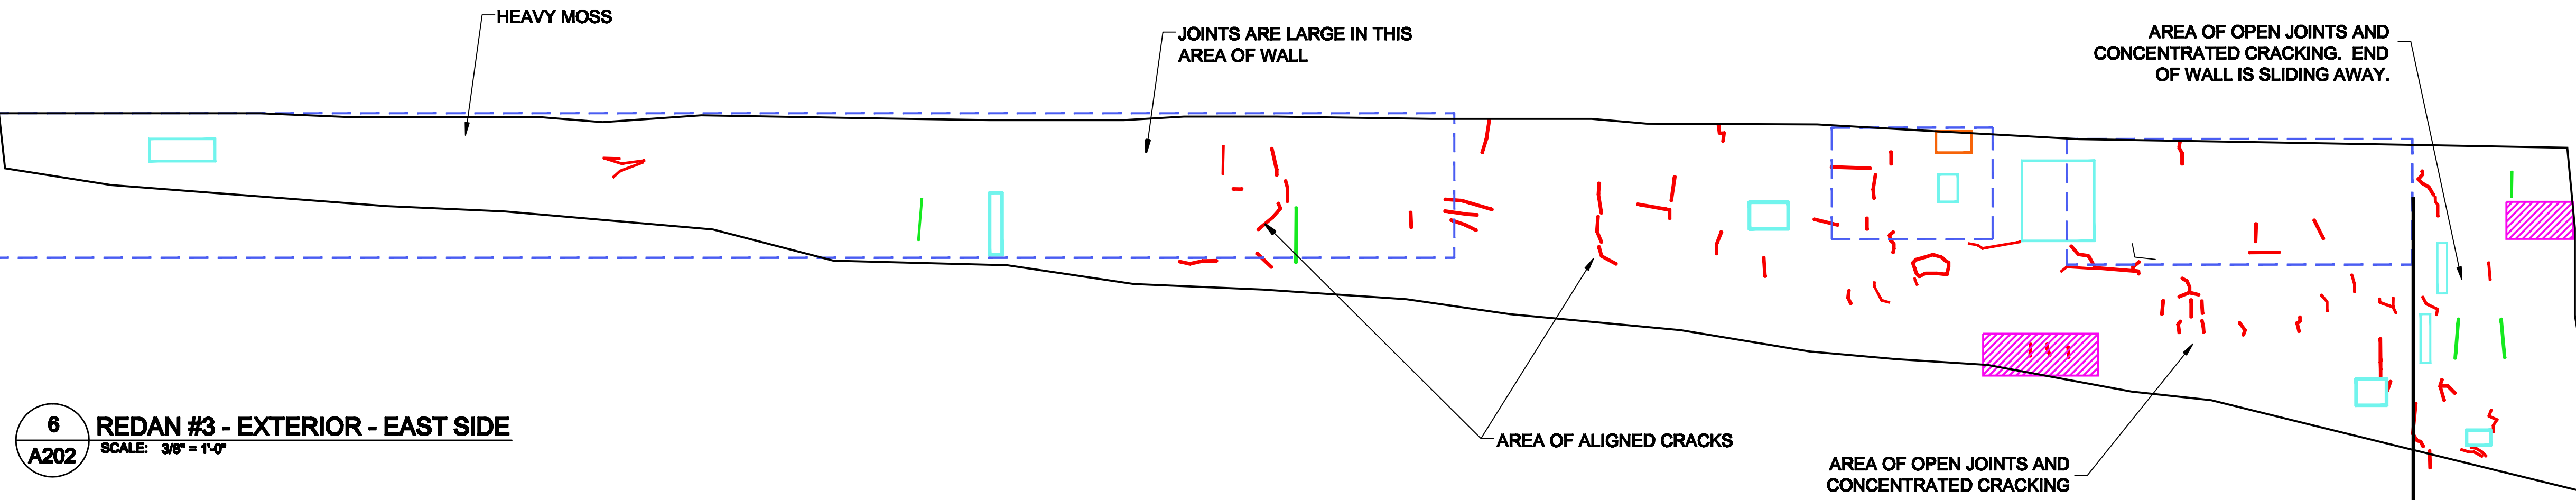
6 REDAN #3 - EXTERIOR - EAST SIDE
SCALE: 3/8" = 1'-0"

CAMBER: BATTERED, BUT BULGING IN AREAS
STONE SIZE: RANDOM, THERE ARE SOME LARGE STONES.
COURSING: MIXED, SOME AREAS CLEARLY COURSED,
OTHERS MORE RANDOM. MAY INDICATE
REPAIR CAMPAIGNS
CHINKING: NOT MUCH
VEGETATION: VINES AND WEEDS IN WALL, NO TREES
SLOPE: FALLS AWAY ROUGHLY PERPENDICULAR TO
WALL. AT RIGHT END, GROUND SLOPES
ALONG WALL AT A STEEP GRADE.

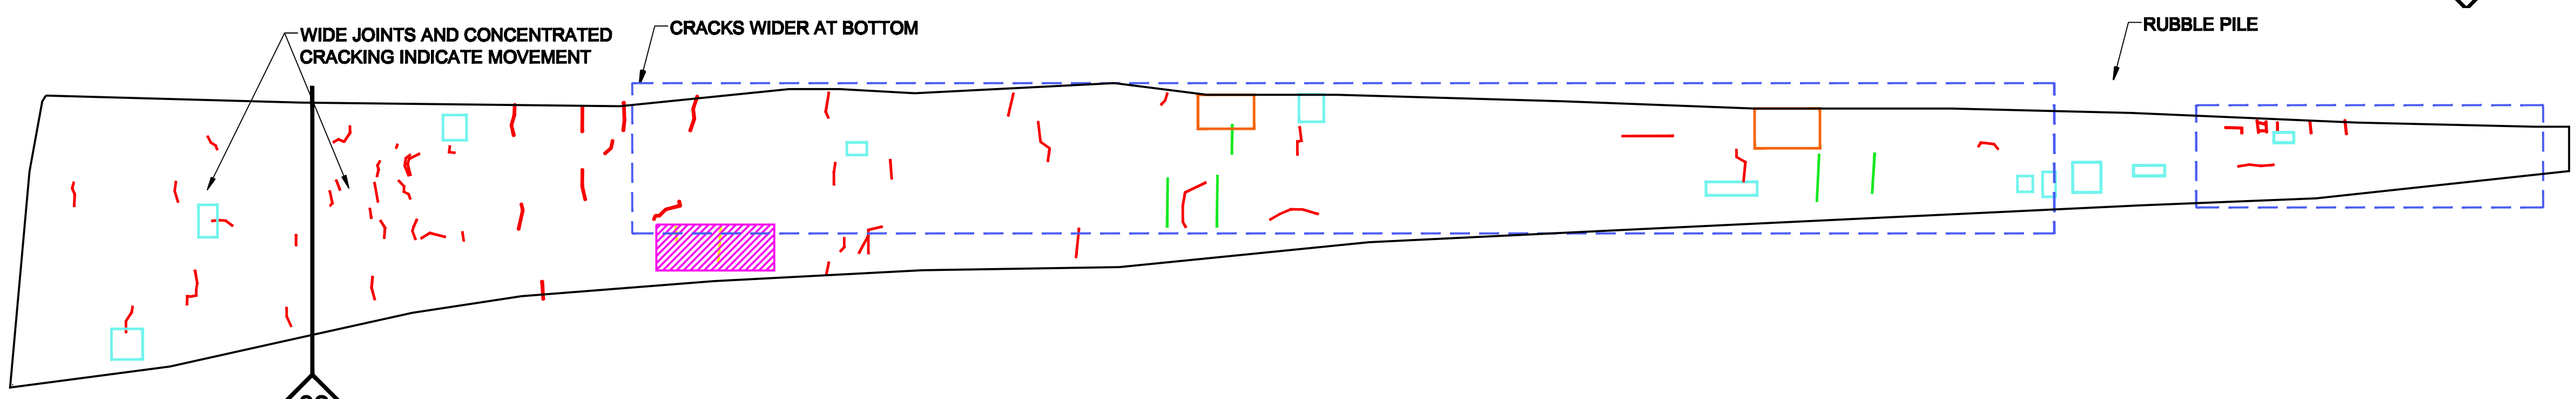
7 REDAN #4 - EXTERIOR - WEST SIDE
SCALE: 3/8" = 1'-0"

CAMBER: SLIGHTLY BATTERED, BUT IRREGULAR
STONE SIZE: RANDOM, SOME LARGE STONES AT RIGHT END
COURSING: SOMEWHAT COURSED
CHINKING: NONE
VEGETATION: VINES AND WEEDS IN WALL, NO TREES
SLOPE: FALLS AWAY ROUGHLY PERPENDICULAR TO WALL
BUT MORE PARALLEL TO WALL AT LEFT END

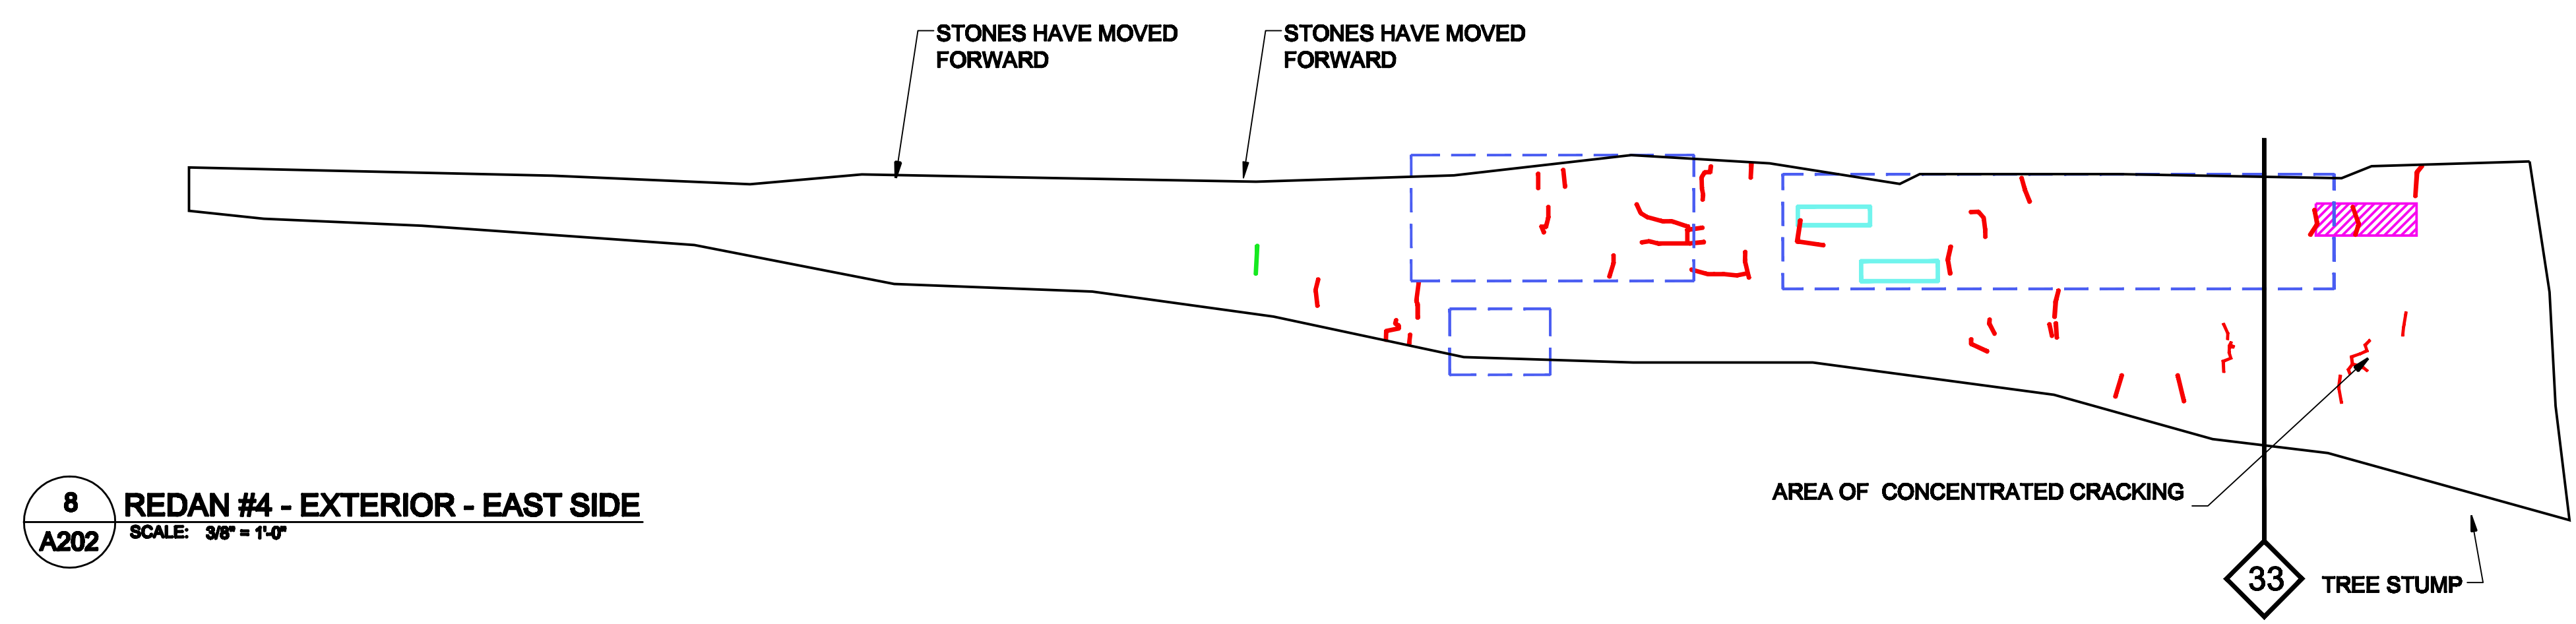
8 REDAN #4 - EXTERIOR - EAST SIDE
SCALE: 3/8" = 1'-0"

CAMBER: BATTERED AT RIGHT, LEANING
FORWARD AT LEFT
STONE SIZE: FAIRLY UNIFORM, MEDIUM TO
LARGE
COURSING: MOSTLY IRREGULAR
CHINKING: SOME AT RIGHT SIDE
VEGETATION: VINES AND WEEDS IN WALL, NO
TREES, BUT ONE STUMP
SLOPE: PERPENDICULAR TO WALL, BUT
SLOPES MORE PARALLEL AT
RIGHT END

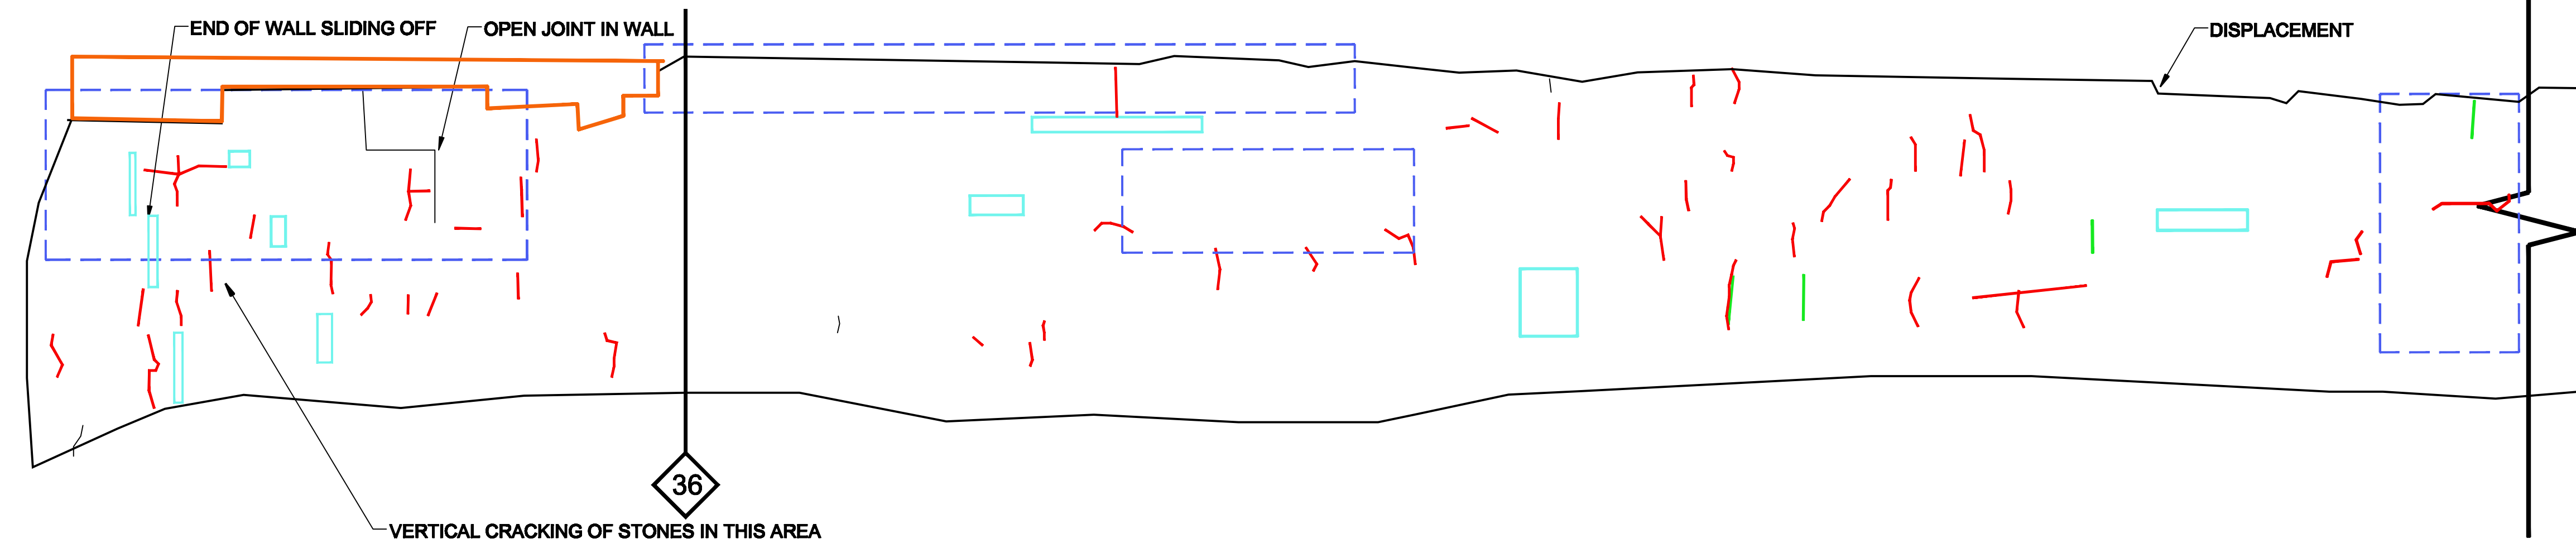
9A NORTH MAIN WORKS - EXTERIOR - LEFT END
A202 SCALE: 3/8" = 1'-0"

CAMBER: IRREGULAR, SOME VERY LARGE STONES
STONE SIZE: IRREGULAR COURSING
COURSING: HEAVILY CHINKED IN SOME AREAS
CHINKING: SMALL WEEDS IN FACE, SOME TREES
VEGETATION: AWAY FROM WALL SLIGHTLY SLOPED
SLOPE:

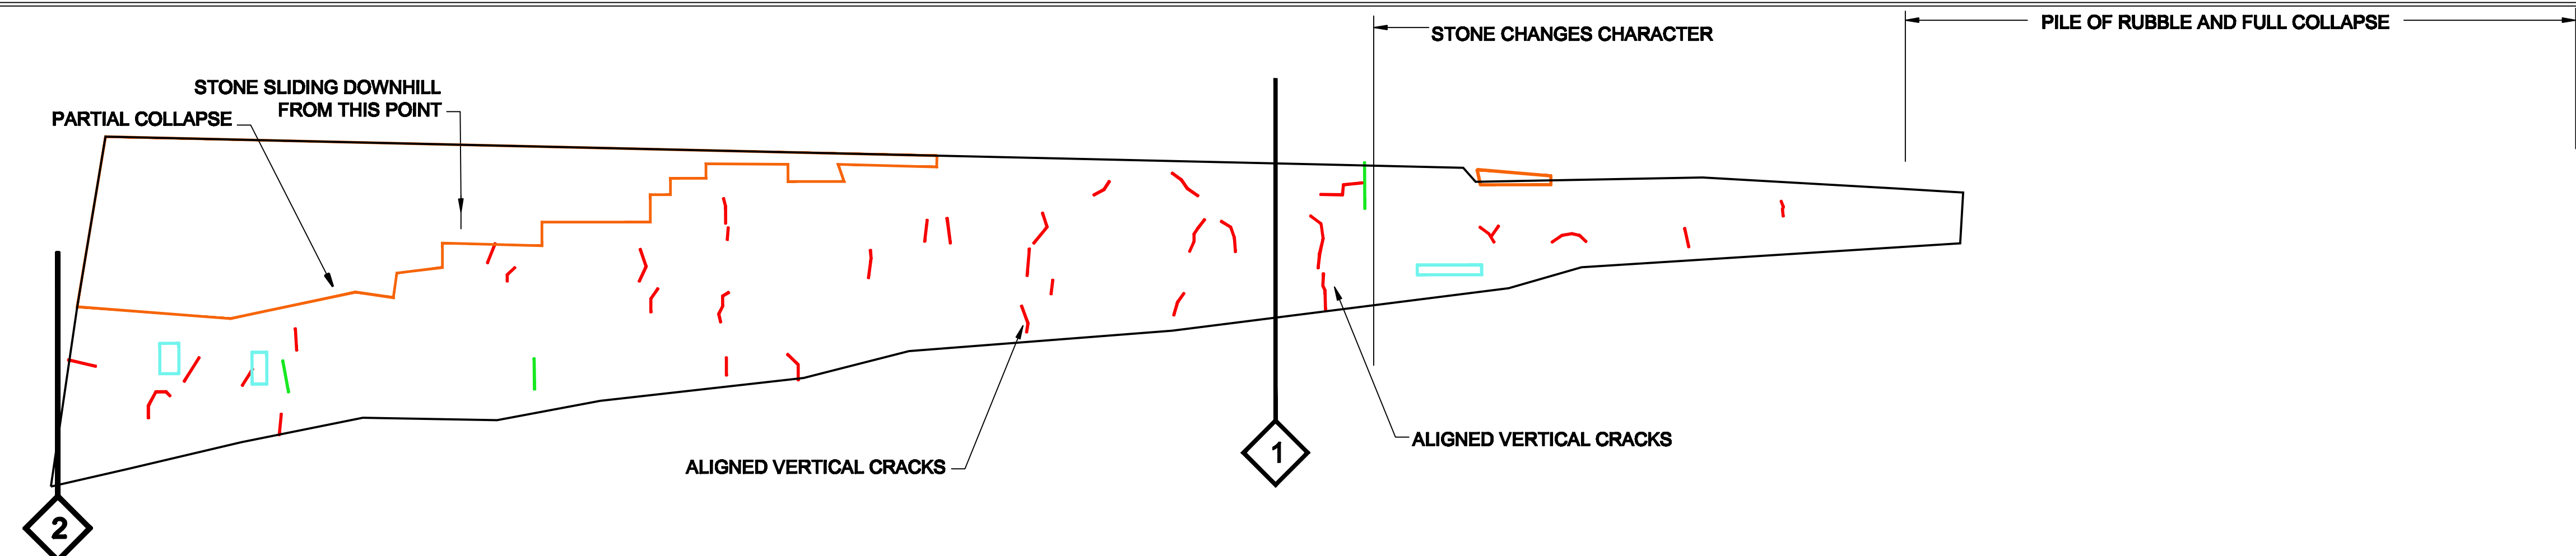
11 REDAN #5 - EXTERIOR - WEST SIDE
A204 SCALE: 3/8" = 1'-0"

CAMBER: SLIGHTLY BATTERED, MORE VERTICAL AT LEFT SIDE
STONE SIZE: RANDOM, MANY LARGE STONES
COURSING: NOT WELL DEFINED, IRREGULAR
CHINKING: NOT MUCH AT RIGHT, BUT MORE PREVALENT MOVING TO LEFT
CRACKS: EXTEND THROUGH WALL VERTICALLY
VEGETATION: SMALL WEEDS IN FACE, NO TREES
SLOPE: FALLS AWAY ROUGHLY PERPENDICULAR TO WALL

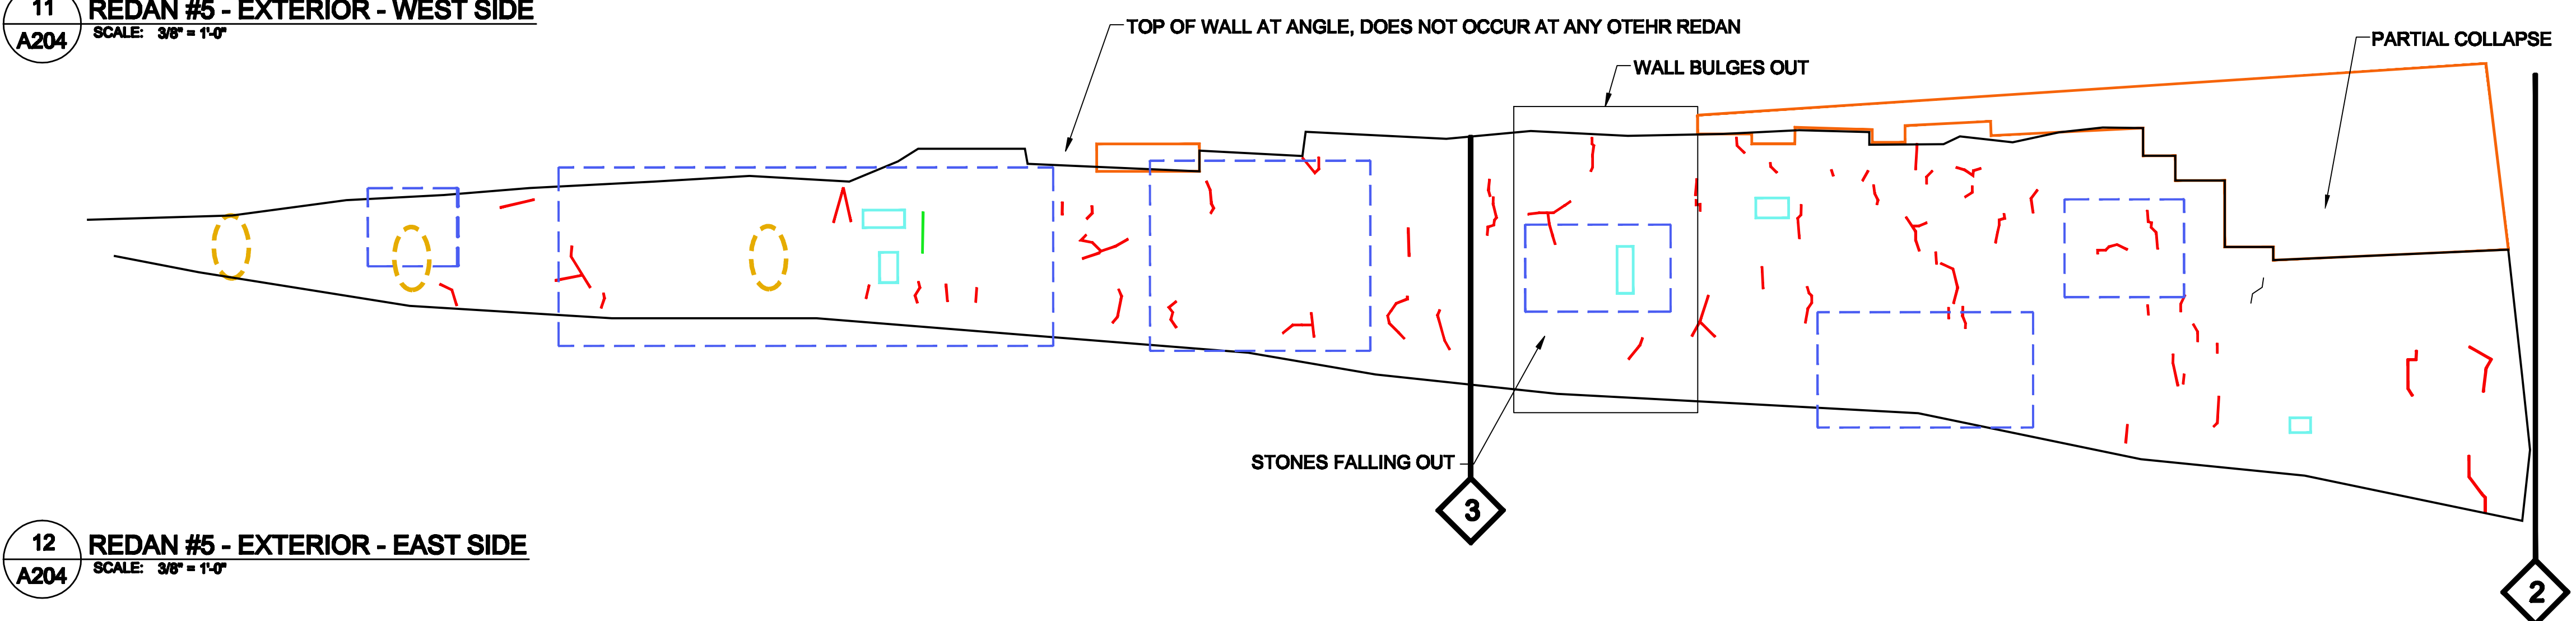
12 REDAN #5 - EXTERIOR - EAST SIDE
A204 SCALE: 3/8" = 1'-0"

CAMBER: SLIGHTLY BATTERED, MORE VERTICAL AT RIGHT SIDE
STONE SIZE: RANDOM, MANY LARGE STONES
COURSING: NOT WELL DEFINED, IRREGULAR
CHINKING: LARGE AND FLAT CHINKING STONES
VEGETATION: MOSTLY VINES AND WEEDS IN WALL, NO TREES
SLOPE: FALLS AWAY ROUGHLY PERPENDICULAR TO WALL BUT BECOMES PARALLEL AT RIGHT END

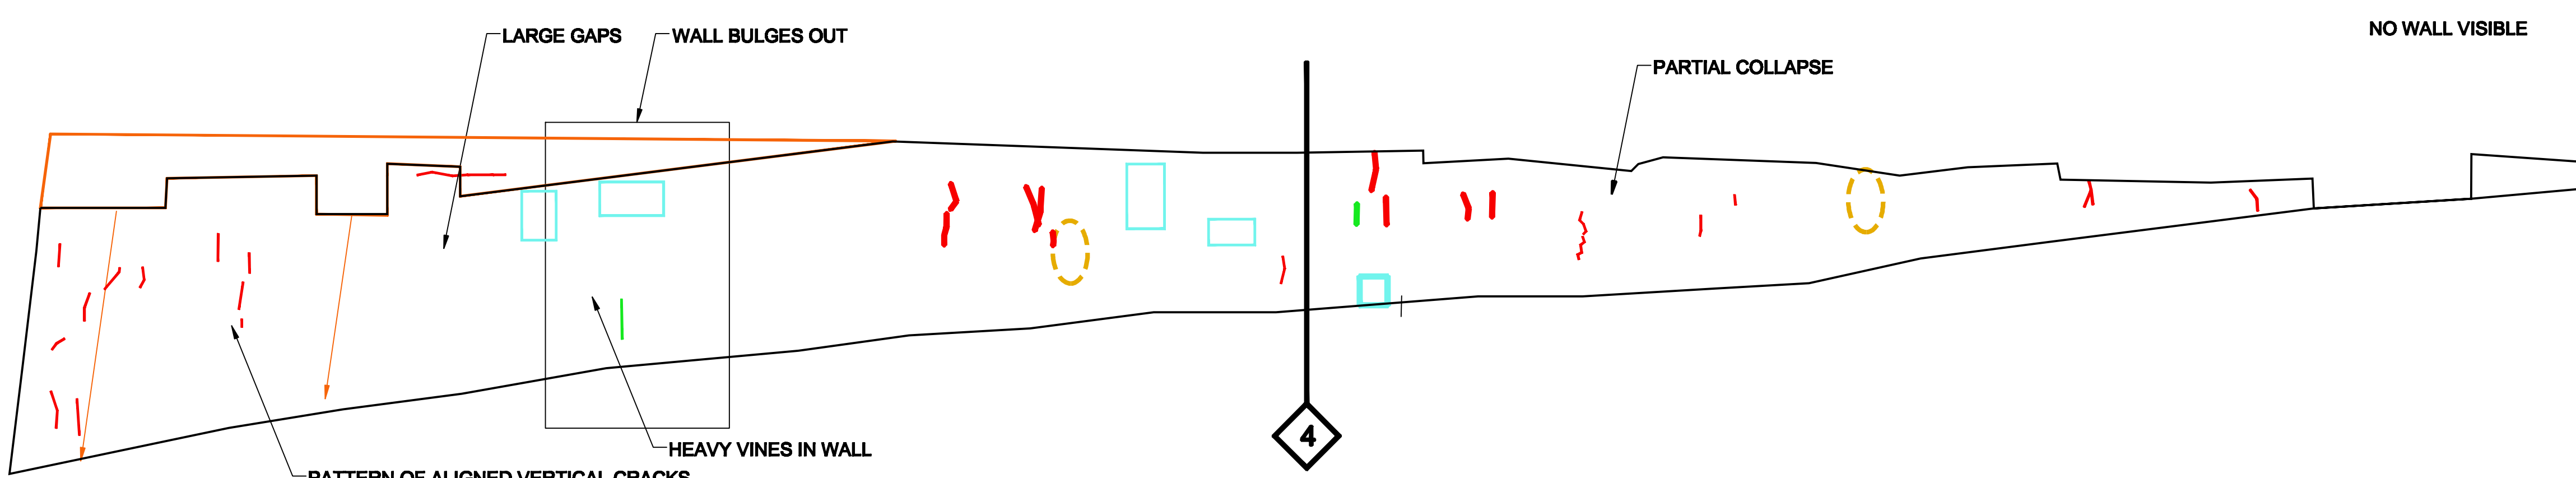
13 REDAN #6 - EXTERIOR - WEST SIDE
A204 SCALE: 3/8" = 1'-0"

CAMBER: SLIGHTLY BATTERED, MORE VERTICAL AT RIGHT, BULGE MID-WAY TOWARD LEFT
STONE SIZE: RANDOM, NOT MANY LARGE STONES
COURSING: NOT WELL DEFINED, IRREGULAR
CHINKING: VERY FEW CHINKING STONES
VEGETATION: VINES AND WEEDS IN WALL, NO TREES
SLOPE: FALLS AWAY ROUGHLY PERPENDICULAR TO WALL, FAIRLY LEVEL

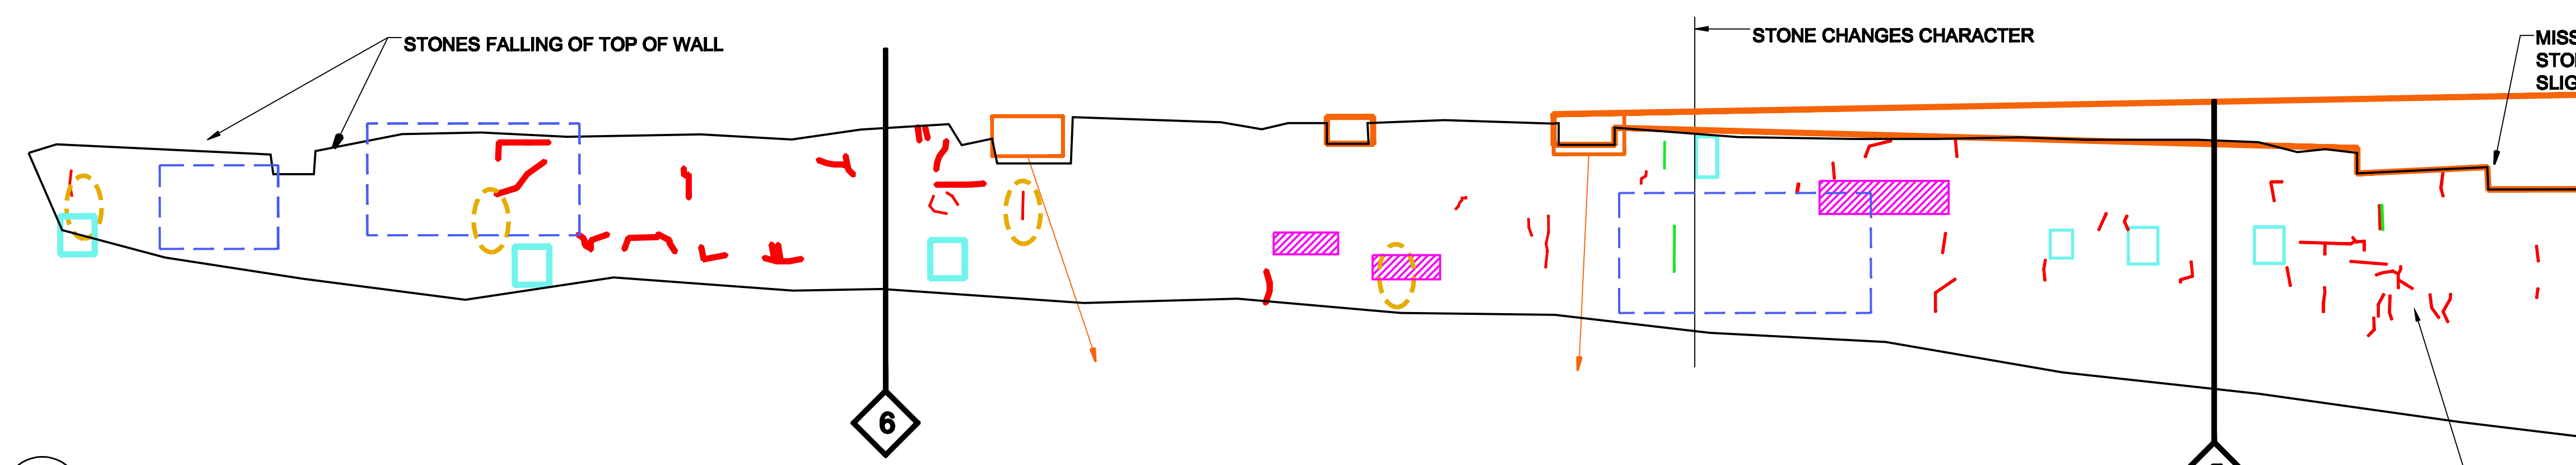
14 REDAN #6 - EXTERIOR - EAST SIDE
A204 SCALE: 3/8" = 1'-0"

CAMBER: SLIGHTLY BATTERED,
STONE SIZE: RANDOM, NOT MANY LARGE STONES AT RIGHT, CHANGES WITH LARGER STONES TO LEFT END
COURSING: MOSTLY IRREGULAR, CHANGES MIDWAY
CHINKING: FALLING OUT
VEGETATION: VINES AND WEEDS IN WALL, NO TREES
SLOPE: SLOPE RUNS PARALLEL TO WALL

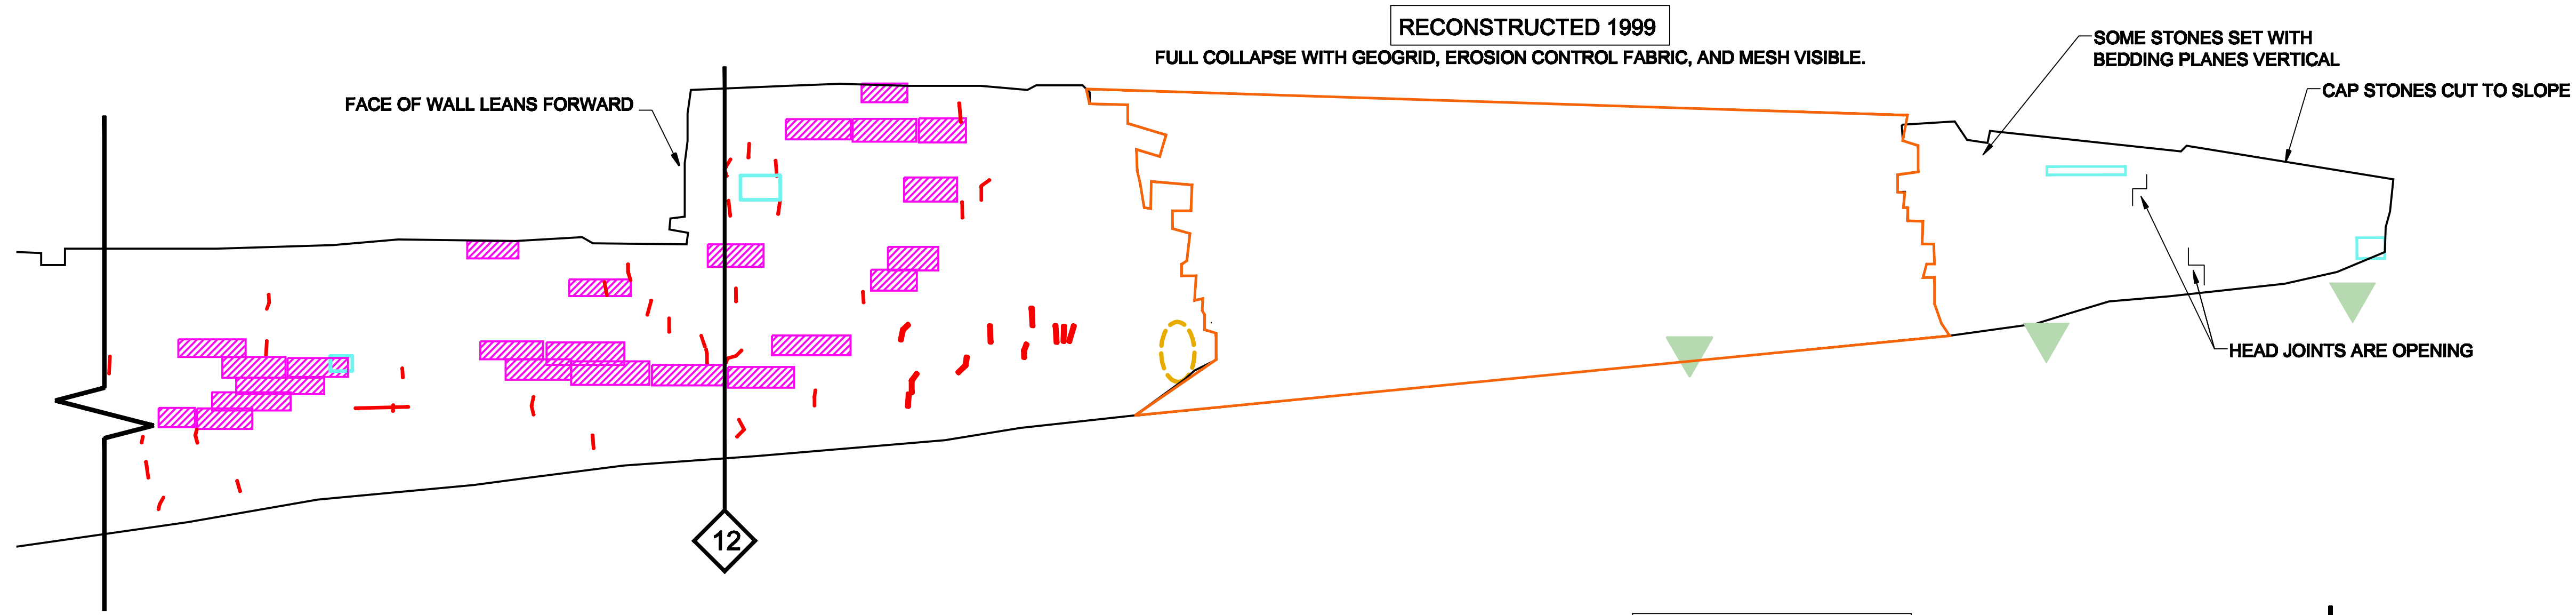
19A EAST BASTION - EAST WALL - RIGHT END
A206 SCALE: 3/8" = 1'-0"

CAMBER: SLIGHTLY BATTERED, MORE VERTICAL AT LEFT SIDE
STONE SIZE: COMPLETELY DIFFERENT FROM STONE AT REDANS.
ASHLAR IS VERY REGULAR IN SIZE.
COURSING: DEFINED COURSING
CHINKING: NONE
VEGETATION: VERY FEW SMALL WEEDS IN FACE, NO TREES
SLOPE: PARALLEL TO WALL

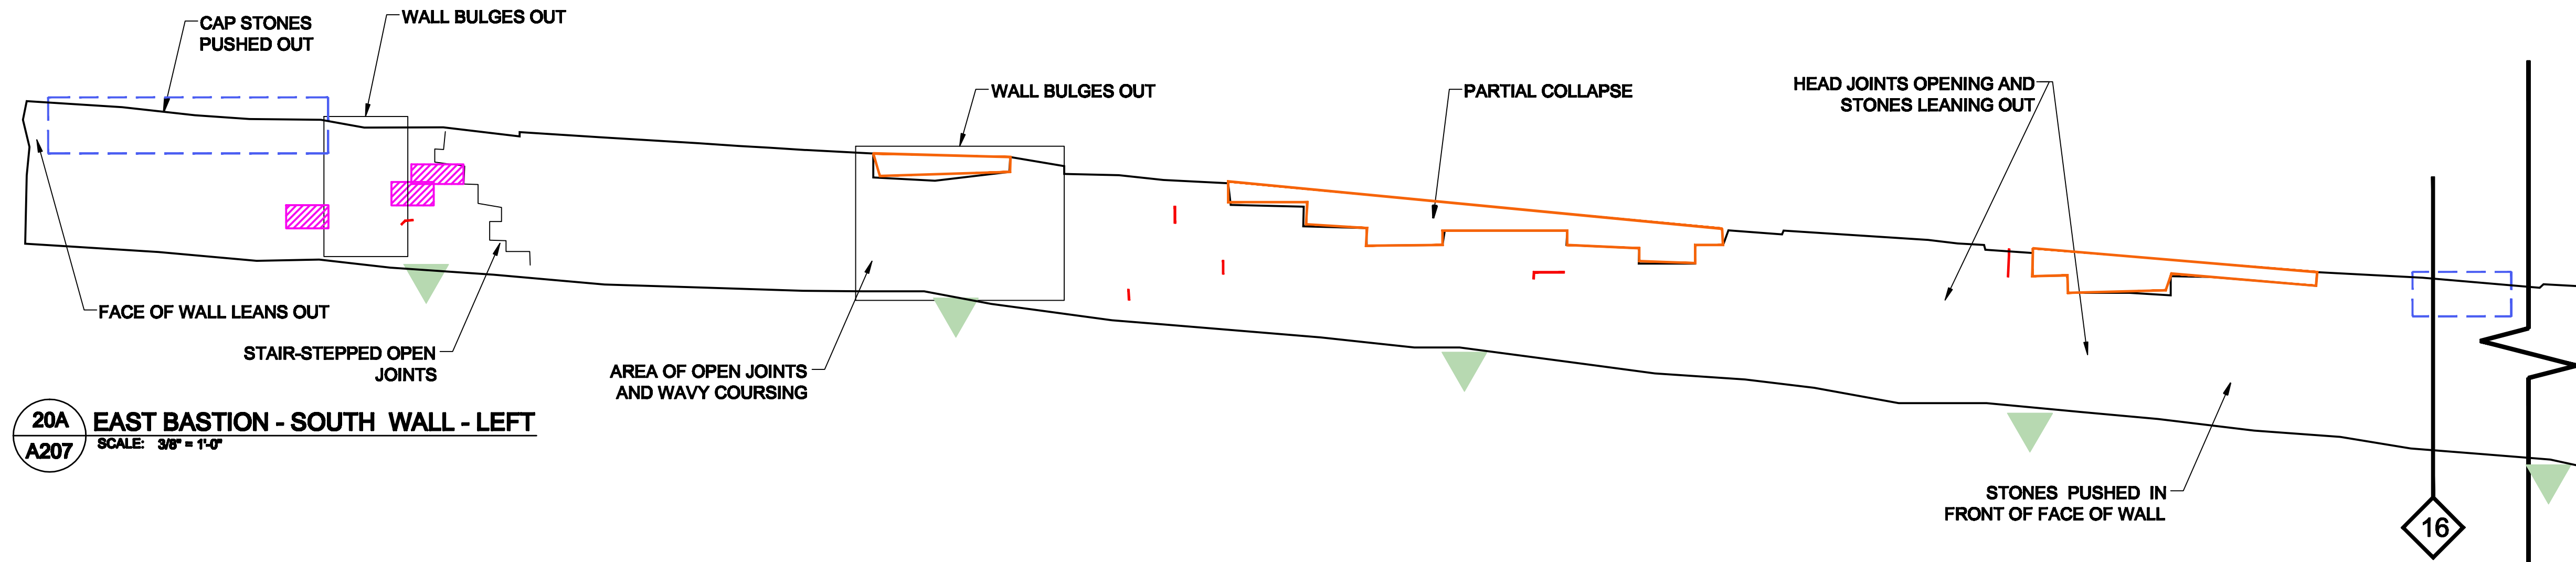
20A EAST BASTION - SOUTH WALL - LEFT
A207 SCALE: 3/8" = 1'-0"

CAMBER: WALLS ARE PERPENDICULAR WITH NO BATTER
STONE SIZE: VERY REGULAR LENGTH AND HEIGHT
COURSING: STRONG COURSING, BUT COURSING IS NOT PARALLEL, RUNS DOWNHILL
CHINKING: MINIMAL, MANY HORIZONTAL GAPS MAY BE FORMER CHINKING LOCATIONS
VEGETATION: SMALL WEEDS IN FACE, NO TREES
SLOPE: PERPENDICULAR TO WALL, BUT SLIGHT

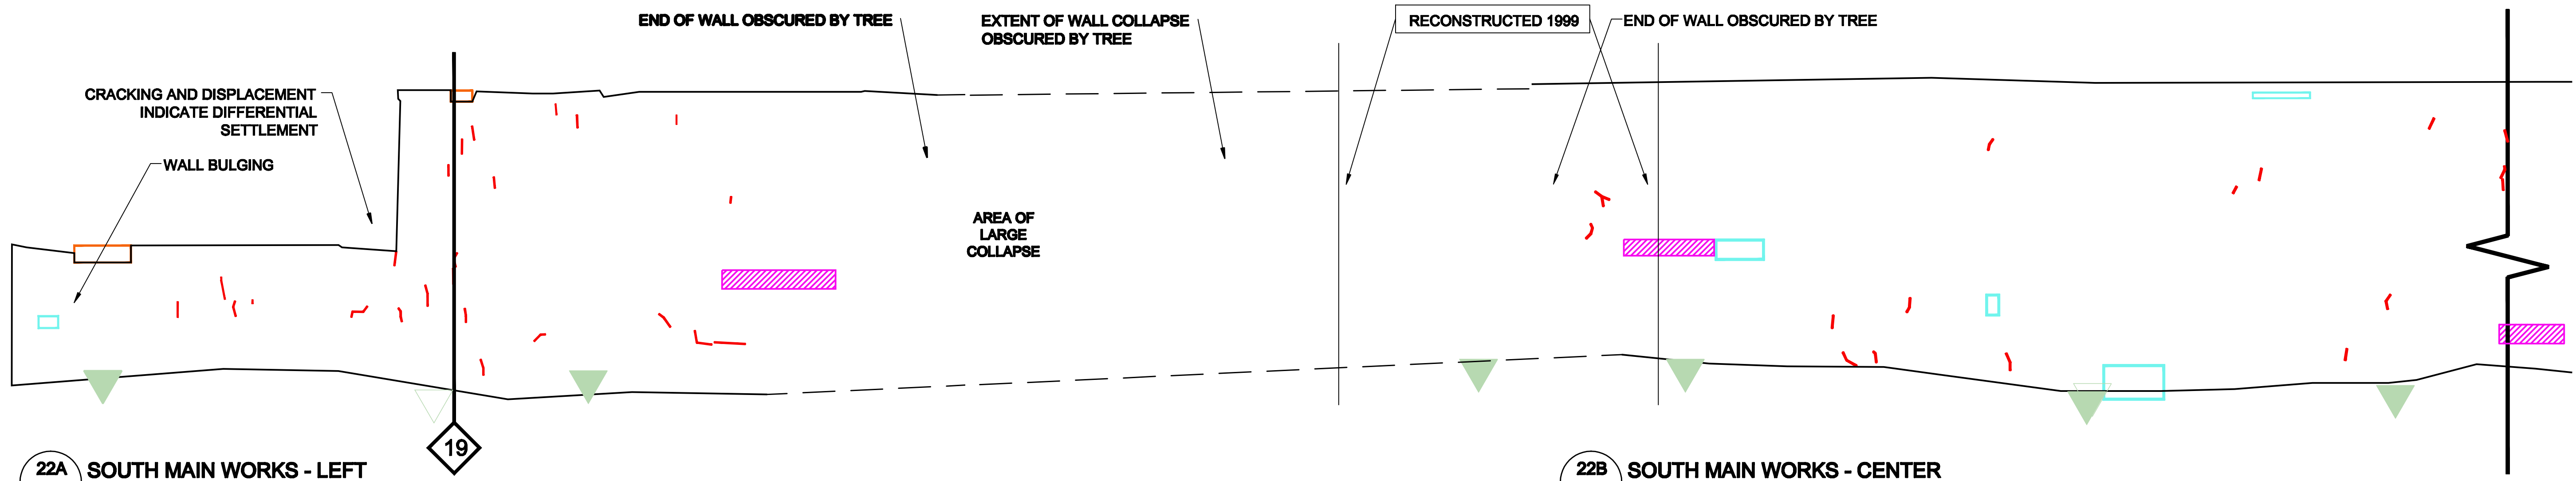
22A SOUTH MAIN WORKS - LEFT
A208 SCALE: 3/8" = 1'-0"

CAMBER: WALLS ARE PERPENDICULAR WITH NO BATTER
STONE SIZE: VERY REGULAR LENGTH AND HEIGHT
COURSING: STRONG COURSING
CHINKING: NONE
VEGETATION: SMALL WEEDS IN FACE, SOME TREES
SLOPE: AWAY FROM WALL SLIGHTLY SLOPED
