APPENDIX A2

**ANNOTATED
OUTLINE
ELEVATIONS -
EXISTING CONDITIONS (2013)**

Redans 1 & 2
Exterior
Line Elevations

Historic Structure Report
Fort Negley

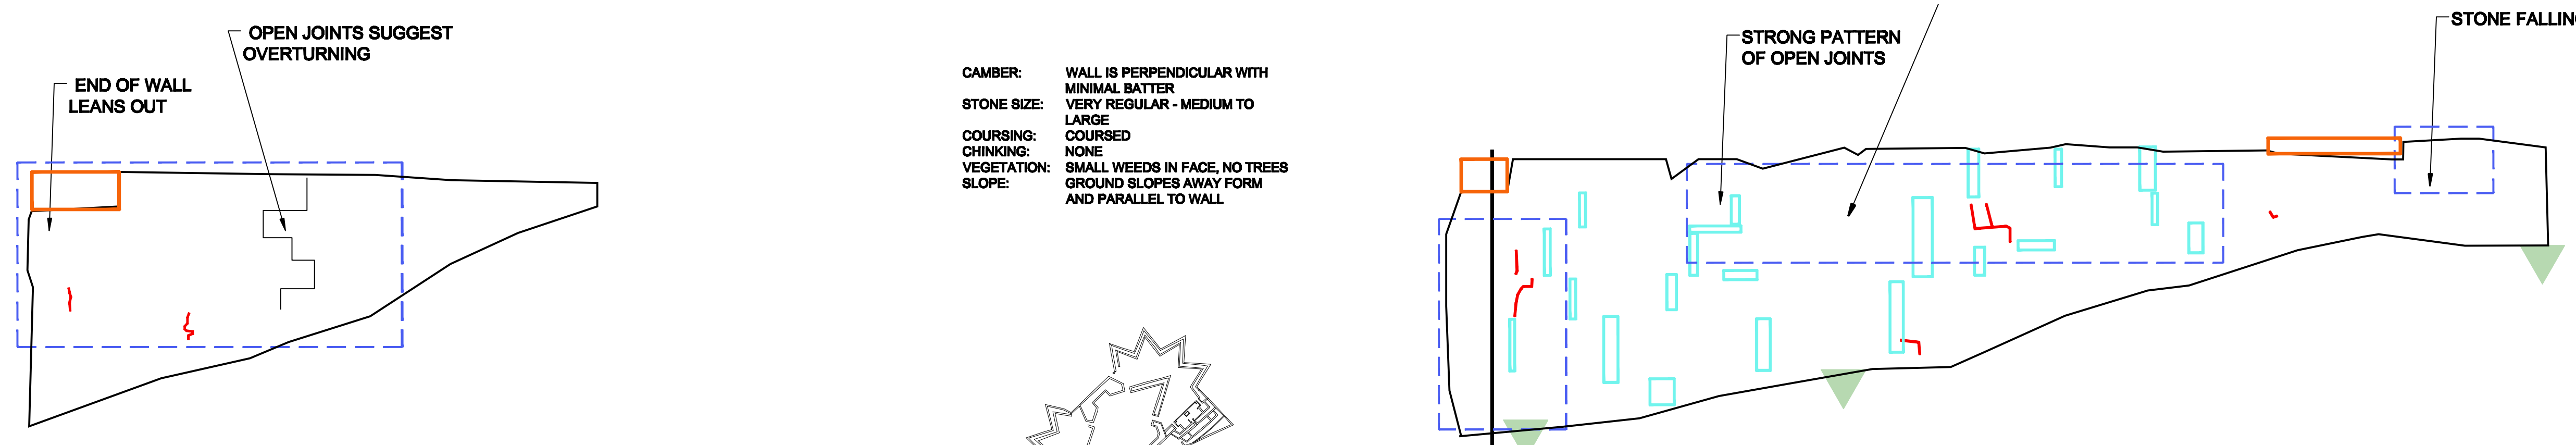
23 WEST BASTION - EAST WALL - LEFT END
 A209 SCALE: 3/8" = 1'-0"

CAMBER: WALLS ARE PERPENDICULAR WITH ONLY MINIMAL BATTER
 STONE SIZE: VERY REGULAR LENGTH AND HEIGHT
 COURSING: STRONG COURSING, BUT COURSING IS NOT PARALLEL, RUNS DOWNHILL
 CHINKING: MINIMAL, MANY HORIZONTAL GAPS MAY BE FORMER CHINKING LOCATIONS
 VEGETATION: SMALL WEEDS IN FACE, NO TREES
 SLOPE: PERPENDICULAR TO WALL, BUT SLIGHT

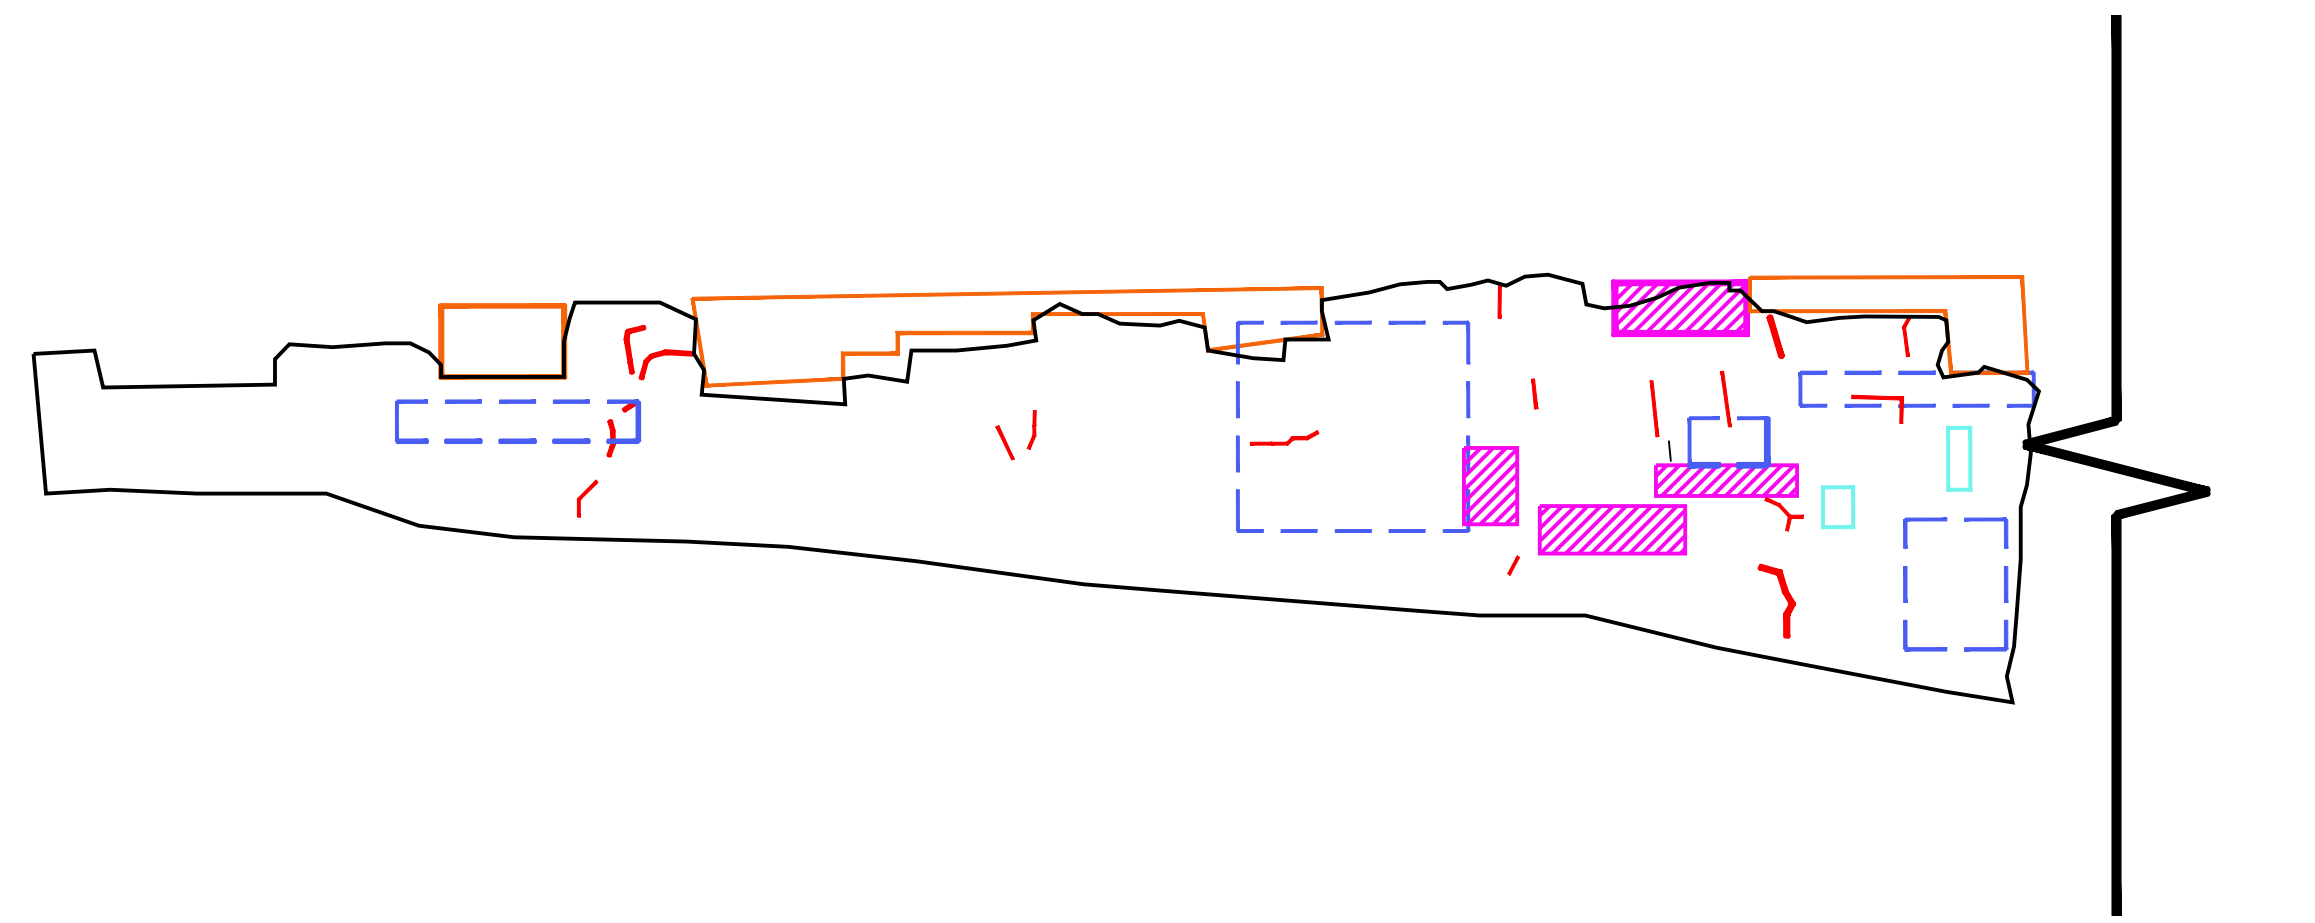
CAMBER: WALLS ARE MOSTLY PERPENDICULAR WITH ONLY BATTERING AT STAR WALLS
STONE SIZE: RANDOM, MEDIUM TO LARGE
COURSING: IRREGULARLY COURSED
CHINKING: SOME USE OF SMALL AND MEDIUM SIZED STONES FOR CHINKING
VEGETATION: SMALL WEEDS IN FACE, NO TREES
SLOPE: MOSTLY LEVEL

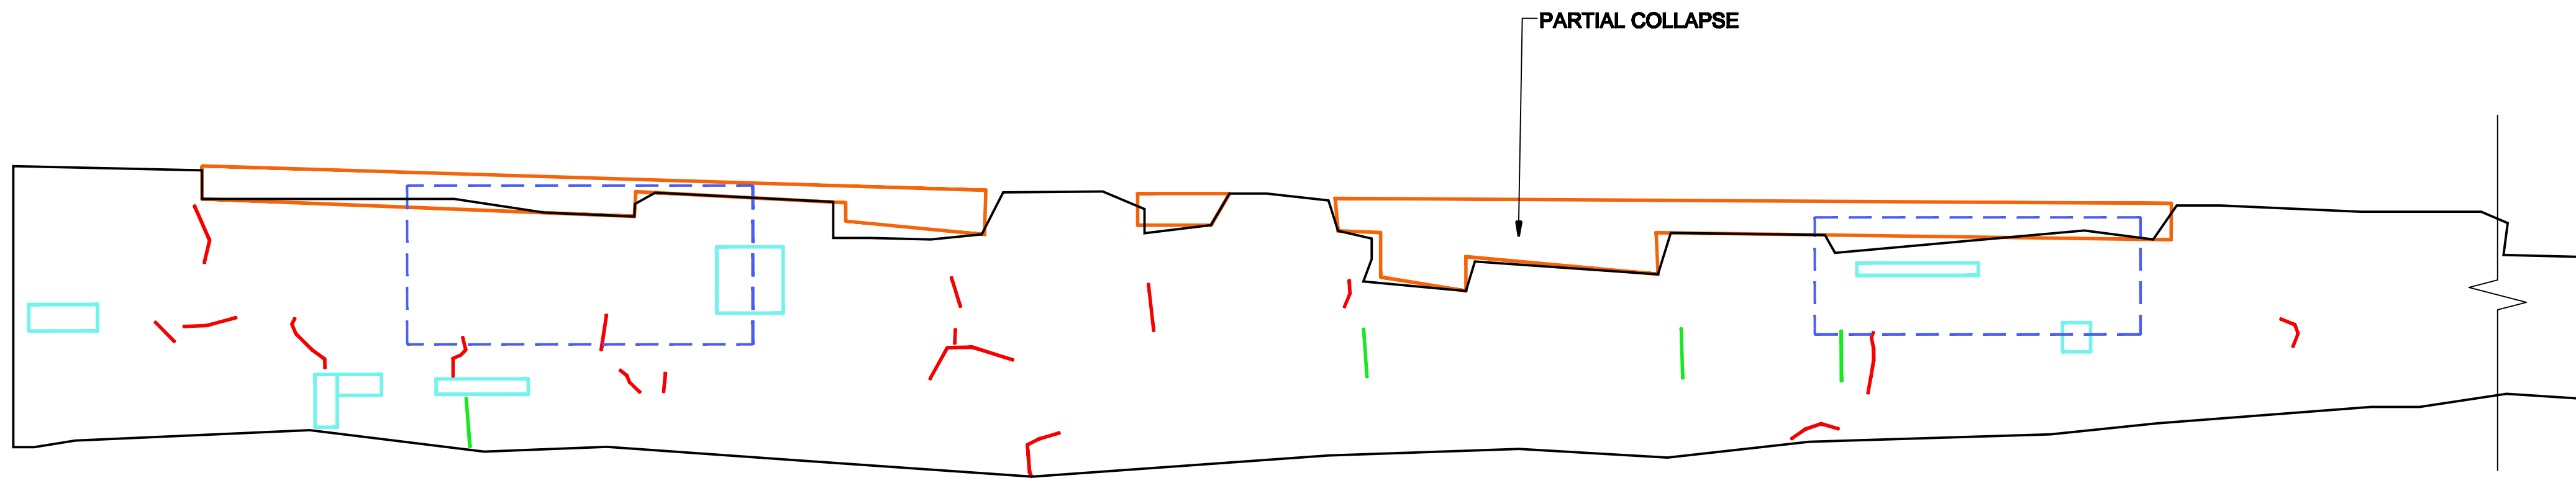
35A REDAN #4 - INTERIOR - WEST SIDE PARTIAL
A213 SCALE: 3/8" = 1'-0"

CAMBER: MOSTLY VERTICAL
STONE SIZE: MEDIUM, MOSTLY UNIFORM
COURSING: UNCOURSED
CHINKING: STILL A GOOD AMOUNT VISIBLE
VEGETATION: SMALL WEEDS IN FACE, NO TREES
SLOPE: GROUND IS MOSTLY FLAT IN FRONT OF WALL

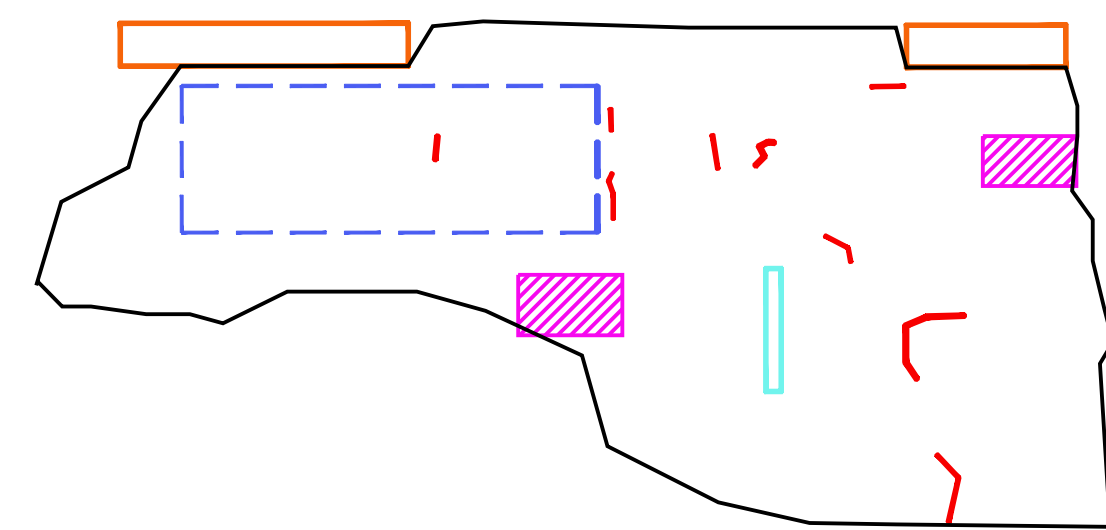
37 NORTH MAIN WORKS, WEST SIDE FACING REDAN #4
A213 SCALE: 3/8" = 1'-0"

CAMBER: SLIGHTLY BATTERED, BIG RUBBLE PILES
STONE SIZE: ADJACENT RANDOM, SOME LARGE STONES, SOME VERY HORIZONTAL
COURSING: SOMEWHAT COURSED, BUT NOT WELL DEFINED, IRREGULAR
CHINKING: MANY SMALL STONES, LOOKS LIKE MANY HAVE FALLEN OUT
VEGETATION: VINES AND WEEDS IN WALL, NO TREES
SLOPE: MOSTLY LEVEL IN FRONT

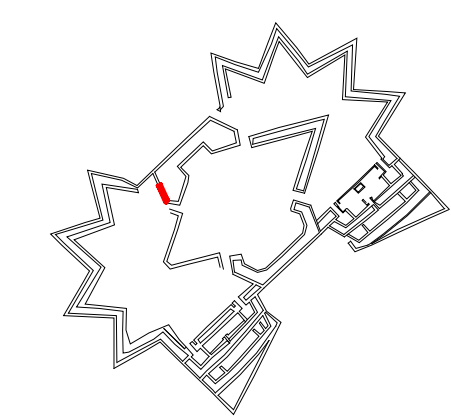
39 NORTH MAIN WORKS, WEST SIDE FACING REDAN #4
A213 SCALE: 3/8" = 1'-0"

CAMBER: NOT DISCERNABLE
STONE SIZE: RANDOM
COURSING: NOT DISCERNABLE
CHINKING: NOT DISCERNABLE
VEGETATION: WEEDS AND SMALL TREES IN WALL
SLOPE: MOSTLY LEVEL IN FRONT

COMPLETE WALL COLLAPSE

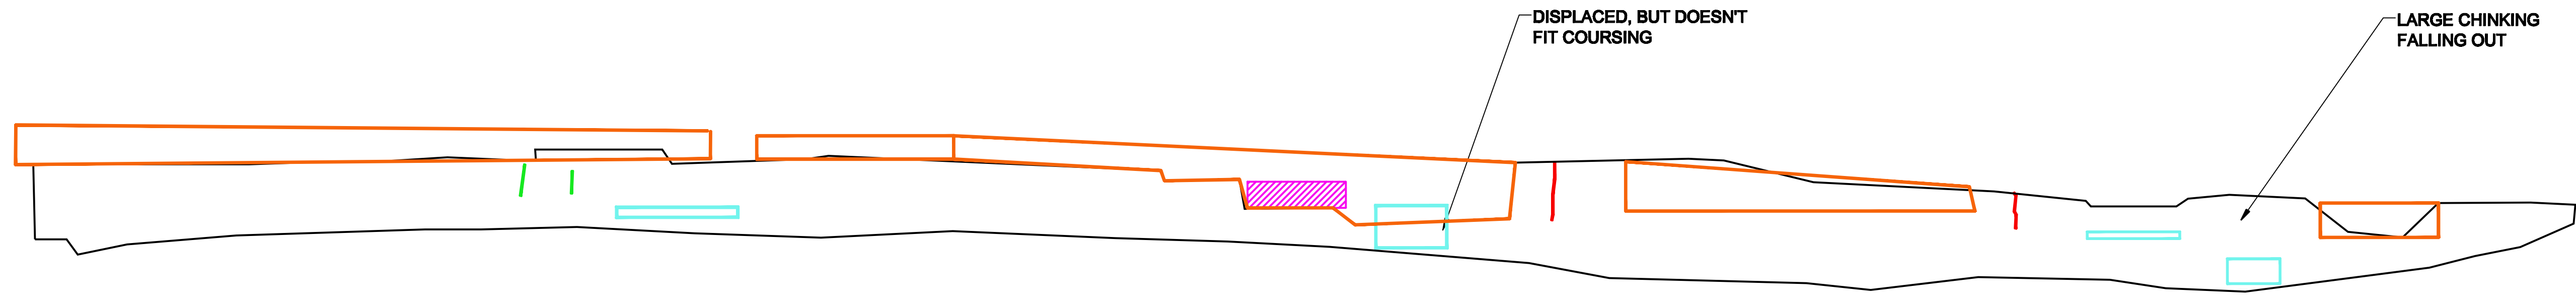
44 REDAN #7 INTERIOR - NORTH SIDE
A215 SCALE: 3/8" = 1'-0"

CAMBER: MOSTLY VERTICAL. SEVERAL BLOWOUTS, TOP COURSE MISSING
STONE SIZE: MIXED
COURSING: IRREGULAR
CHINKING: NOT DISCERNABLE
VEGETATION: GRASSES AND VINES
SLOPE: MOSTLY LEVEL IN FRONT.

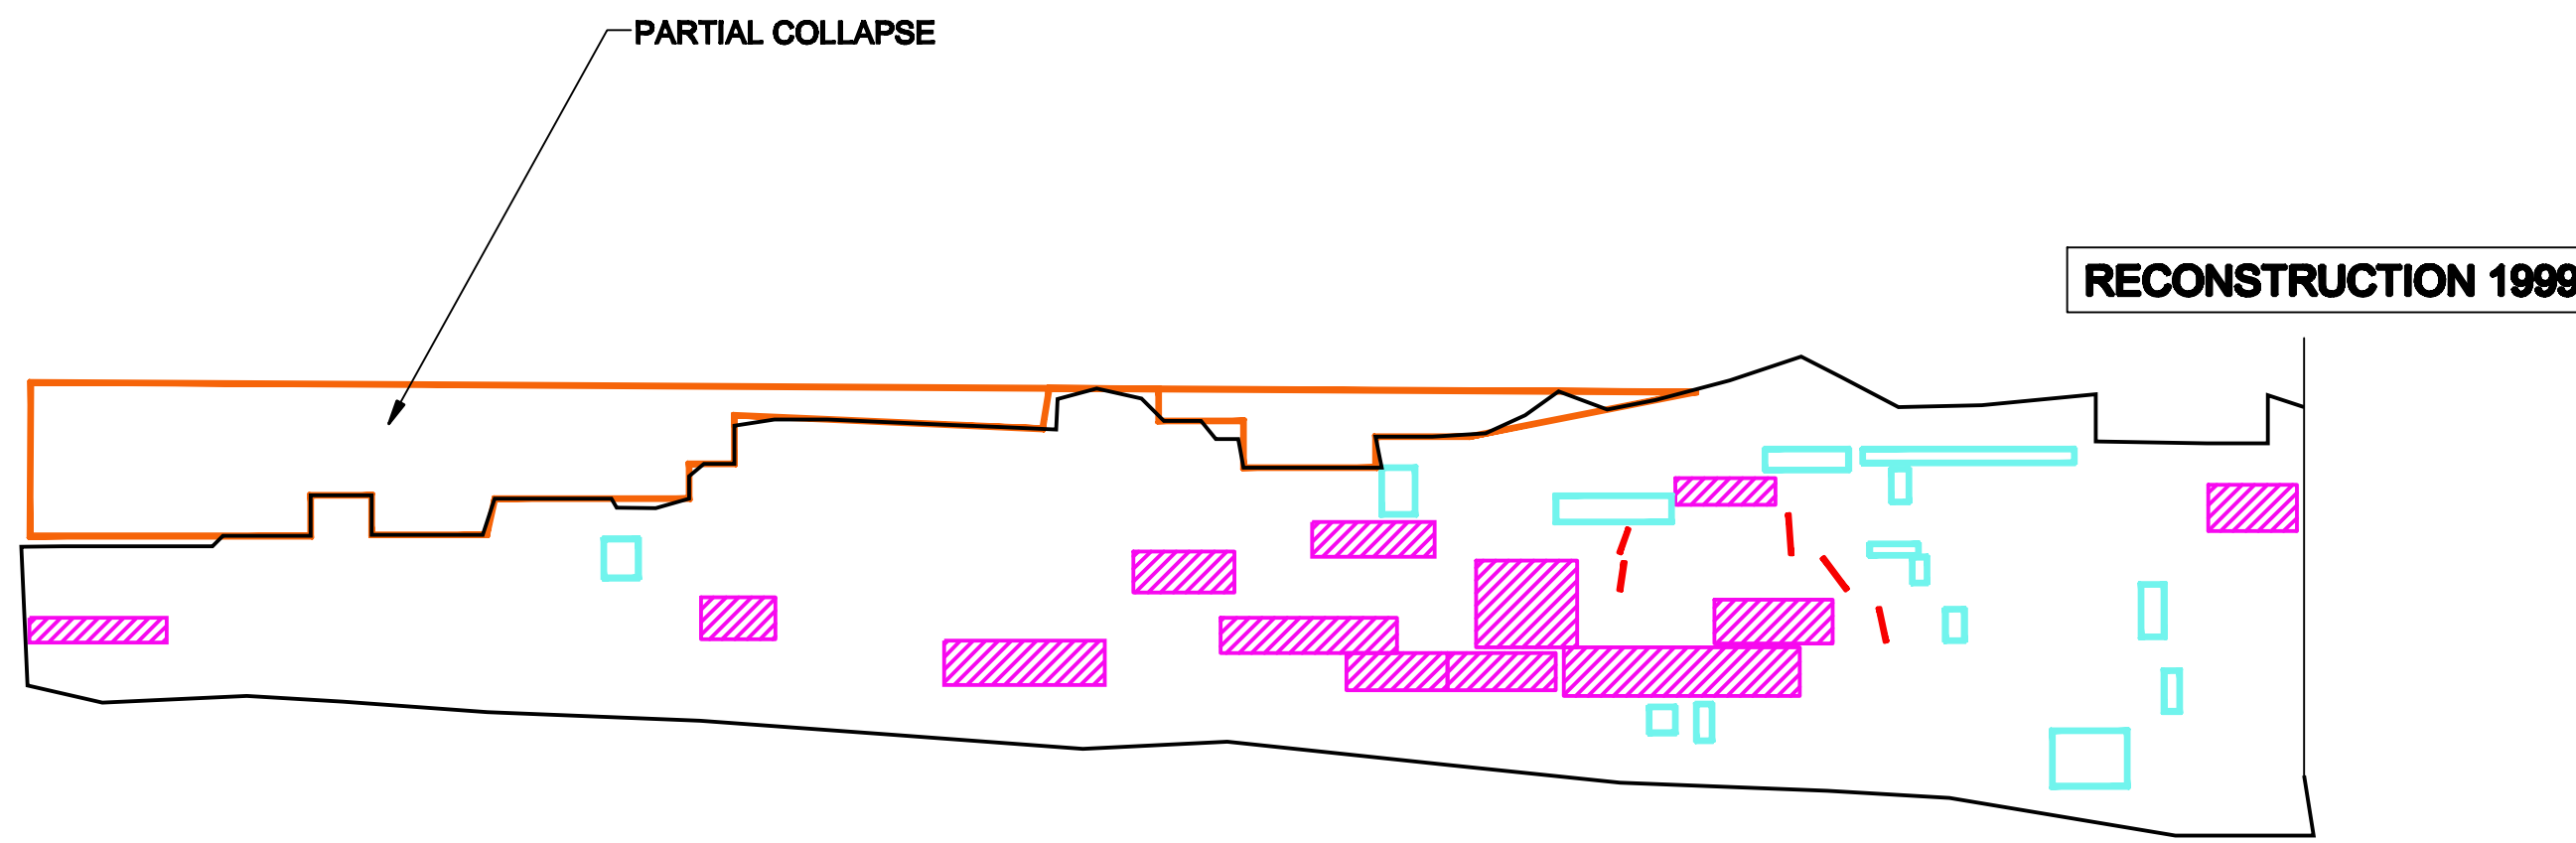
48 EAST BASTION - REDAN #8 CONNECTION WALL
A216 SCALE: 3/8" = 1'-0"

CAMBER: WALLS HAS COLLAPSED.
STONE SIZE: NONE REMAINING
COURSING: NONE REMAINING
CHINKING: NONE REMAINING
VEGETATION: VEGETATION COMPLETELY COVERS THE
FORMER WALL AREA.
SLOPE: MOSTLY LEVEL IN FRONT OF WALL

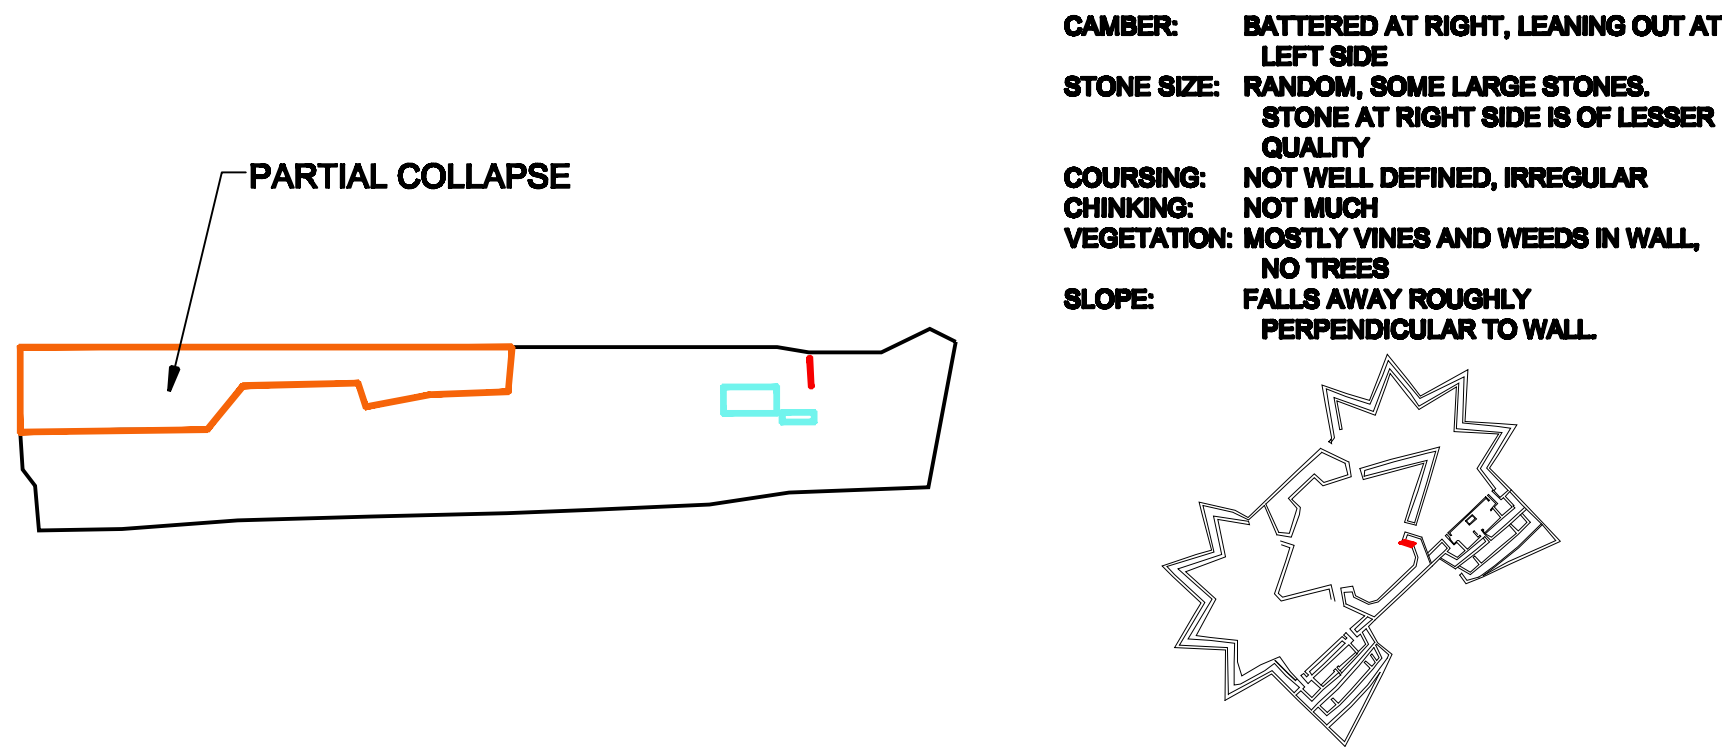
51 SOUTH MAIN WORKS - EAST - FACING EAST INNER WORKS
A217 SCALE: 3/8" = 1'-0"

CAMBER: BATTERED AT RIGHT, LEANING OUT AT LEFT SIDE
STONE SIZE: RANDOM, SOME LARGE STONES. STONE AT RIGHT SIDE IS OF LESSER QUALITY
COURSING: NOT WELL DEFINED, IRREGULAR
CHINKING: NOT MUCH
VEGETATION: MOSTLY VINES AND WEEDS IN WALL, NO TREES
SLOPE: FALLS AWAY ROUGHLY PERPENDICULAR TO WALL

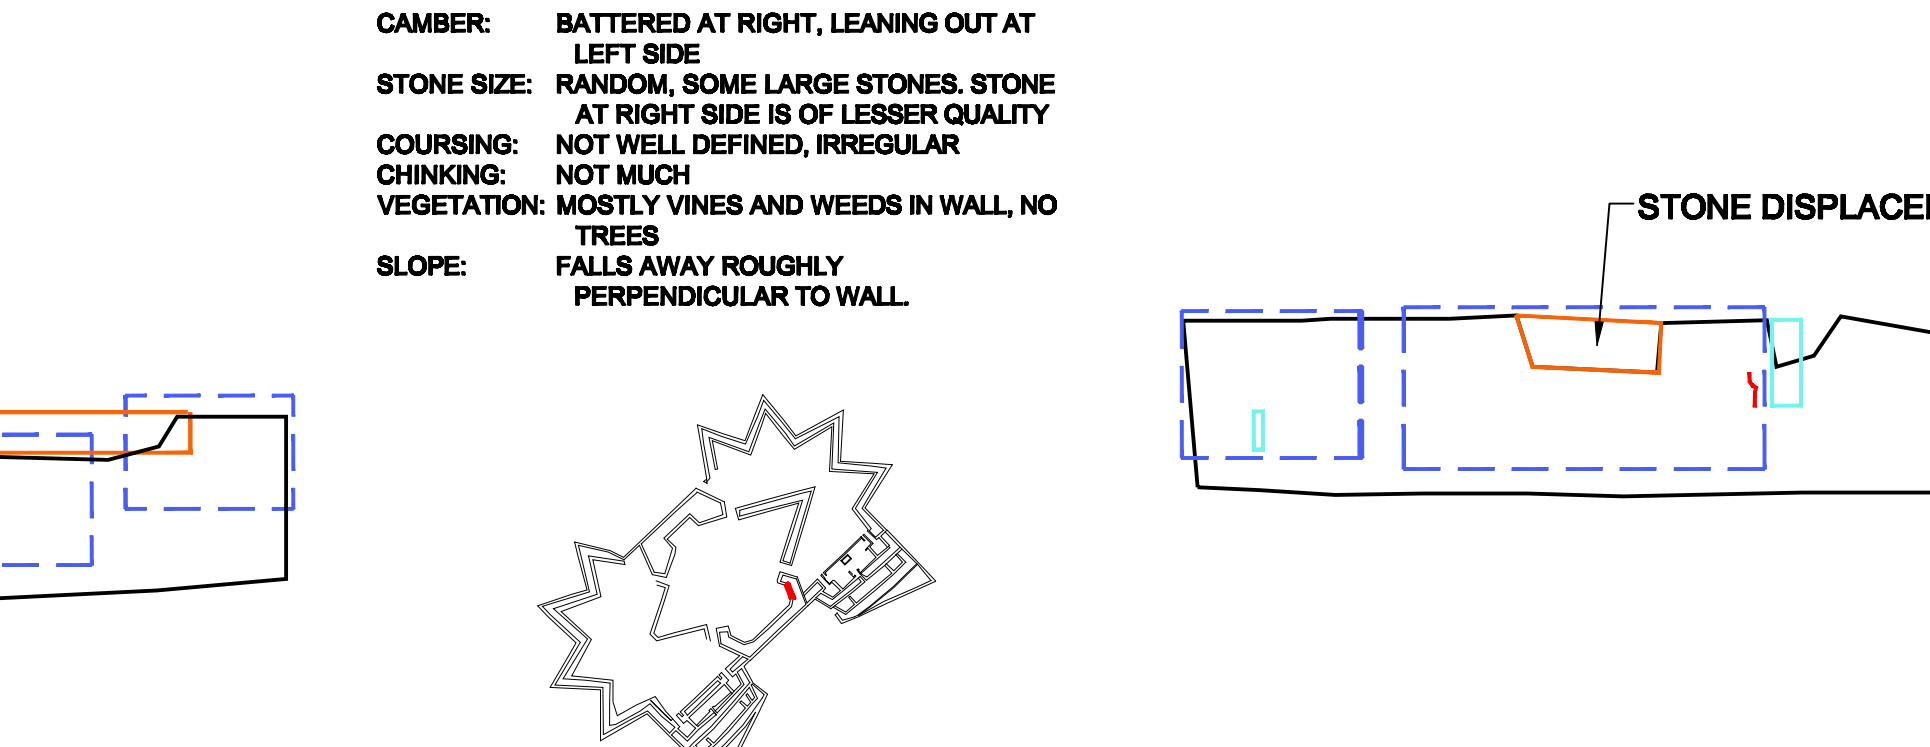
52 SOUTH MAIN WORKS - EAST - END FACING STOCKADE AREA
A217 SCALE: 3/8" = 1'-0" NOTE: PHOTO TAKEN FROM ABOVE BARRICADES, VERTICAL SCALE NOT ACCURATE

CAMBER: BATTERED AT RIGHT, LEANING OUT AT LEFT SIDE
STONE SIZE: RANDOM, SOME LARGE STONES. STONE AT RIGHT SIDE IS OF LESSER QUALITY
COURSING: NOT WELL DEFINED, IRREGULAR
CHINKING: NOT MUCH
VEGETATION: MOSTLY VINES AND WEEDS IN WALL, NO TREES
SLOPE: FALLS AWAY ROUGHLY PERPENDICULAR TO WALL

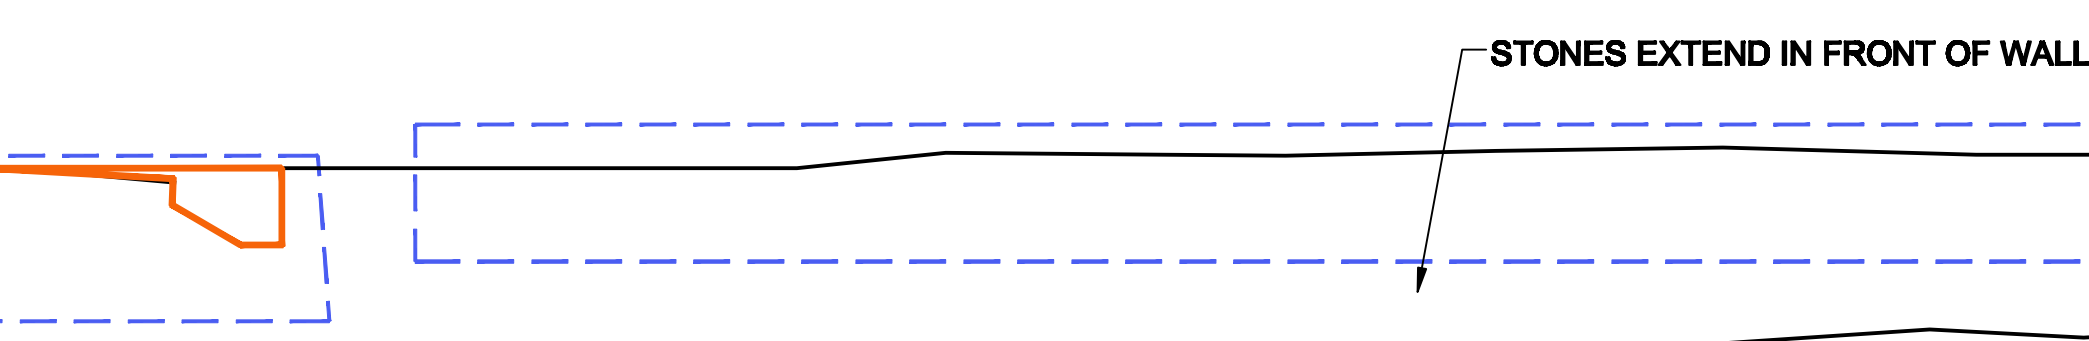
55 SOUTH MAIN WORKS - INTERIOR - EAST - SOUTH SECTION
A217 SCALE: 3/8" = 1'-0"

CAMBER: SLIGHTLY BATTERED, MORE VERTICAL AT RIGHT
STONE SIZE: RANDOM, NOT MANY LARGE STONES
COURSING: SOMEWHAT COURSED, BUT NOT WELL DEFINED, IRREGULAR
CHINKING: NONE
VEGETATION: VINES AND WEEDS IN WALL, NO TREES
SLOPE: FALLS AWAY ROUGHLY PERPENDICULAR TO WALL, FAIRLY LEVEL

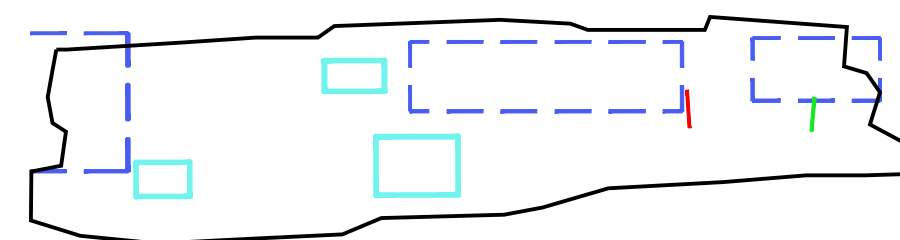
FULL COLLAPSE, APPEARS TO BE STONE STOCKPILE

CAMBER: NOT DISCERNABLE
STONE SIZE: NOT DISCERNABLE
COURSING: NOT DISCERNABLE
CHINKING: NOT DISCERNABLE
VEGETATION: VINES AND WEEDS IN WALL, NO TREES
SLOPE: FALLS AWAY SLIGHTLY ROUGHLY PERPENDICULAR TO WALL, FAIRLY LEVEL

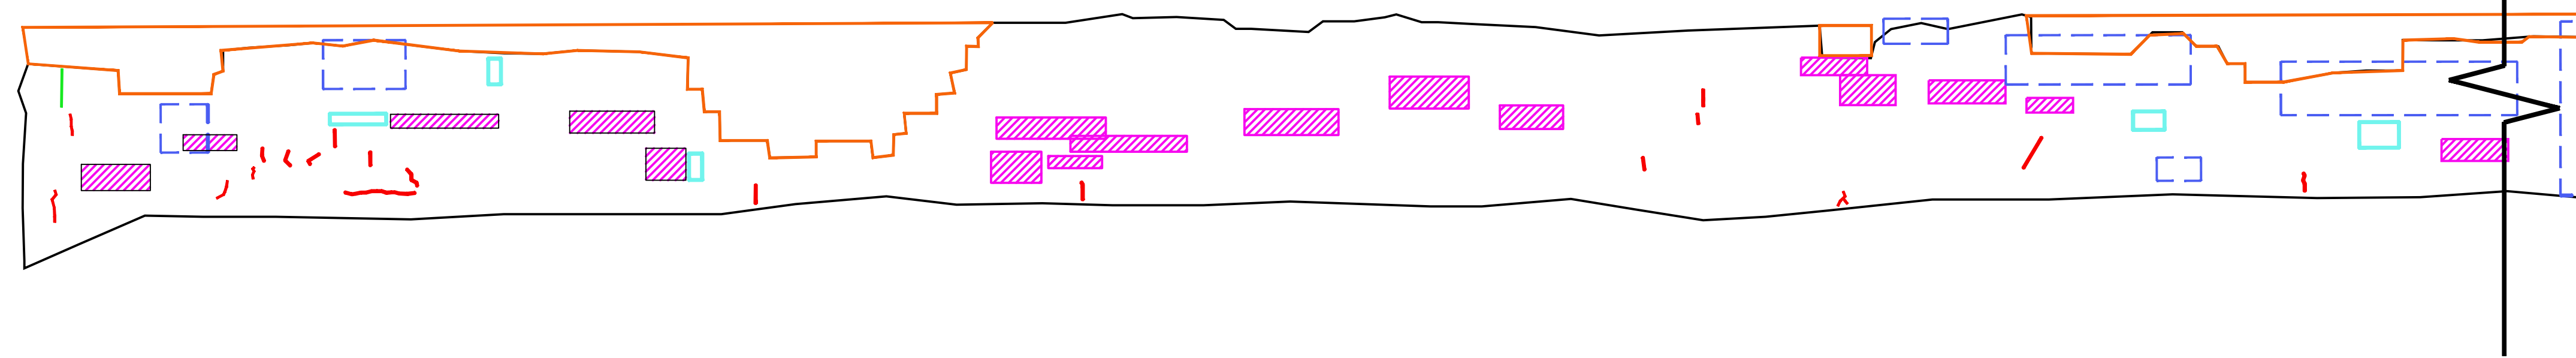
60A EAST INNER WORKS - EXTERIOR - SOUTH - LEFT END
A218 SCALE: 3/8" = 1'-0"

CAMBER: MOSTLY VERTICAL
STONE SIZE: MEDIUM, HORIZONTAL, FAIRLY HOMOGENOUS
COURSING: FAIRLY WELL COURSED
CHINKING: NOT MUCH, BUT SOIL FILLS JOINTS
VEGETATION: SMALL WEEDS IN FACE, NO TREES
CRACKS: FALLS AWAY SLIGHTLY, ROUGHLY PERPENDICULAR TO WALL

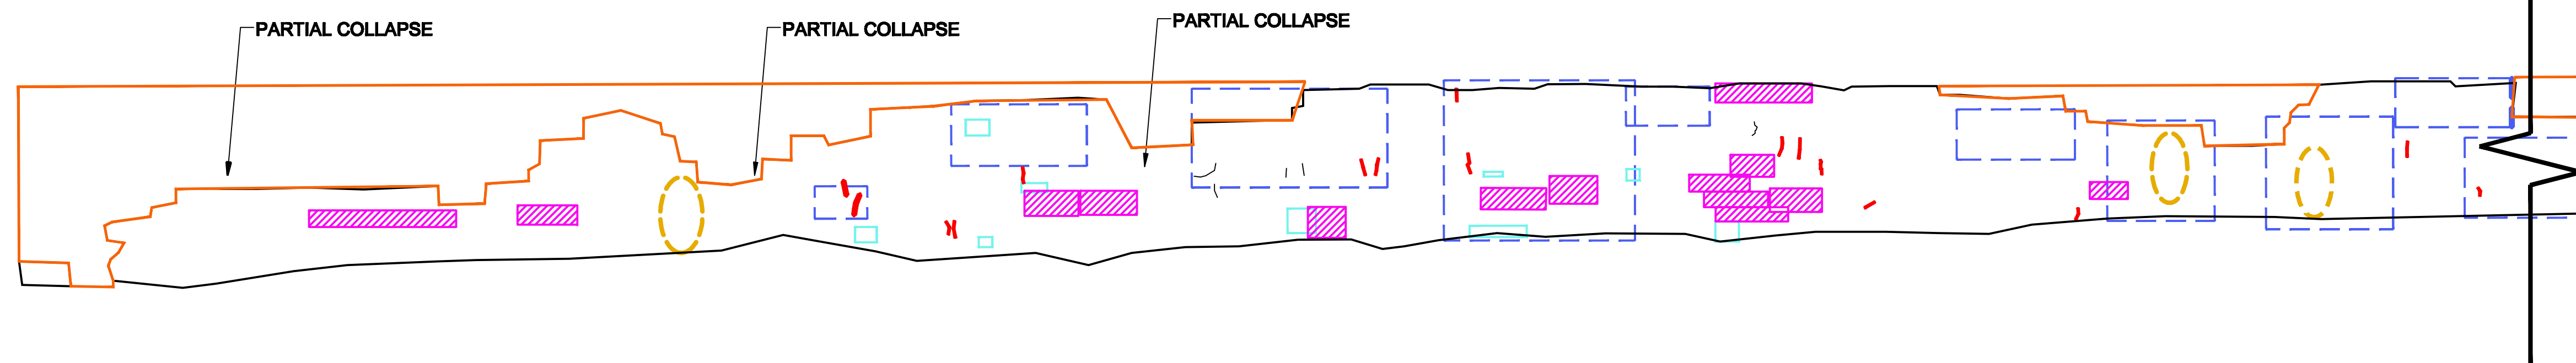
61A EAST INNER WORKS - EXTERIOR - NORTH - LEFT END
A218 SCALE: 3/8" = 1'-0"

CAMBER: MOSTLY VERTICAL
STONE SIZE: MEDIUM, HORIZONTAL, FAIRLY HOMOGENOUS
COURSING: FAIRLY WELL COURSED
CHINKING: NOT MUCH, BUT SOIL FILLS JOINTS
VEGETATION: SMALL WEEDS IN FACE, NO TREES
CRACKS: FALLS AWAY SLIGHTLY, ROUGHLY PERPENDICULAR TO WALL

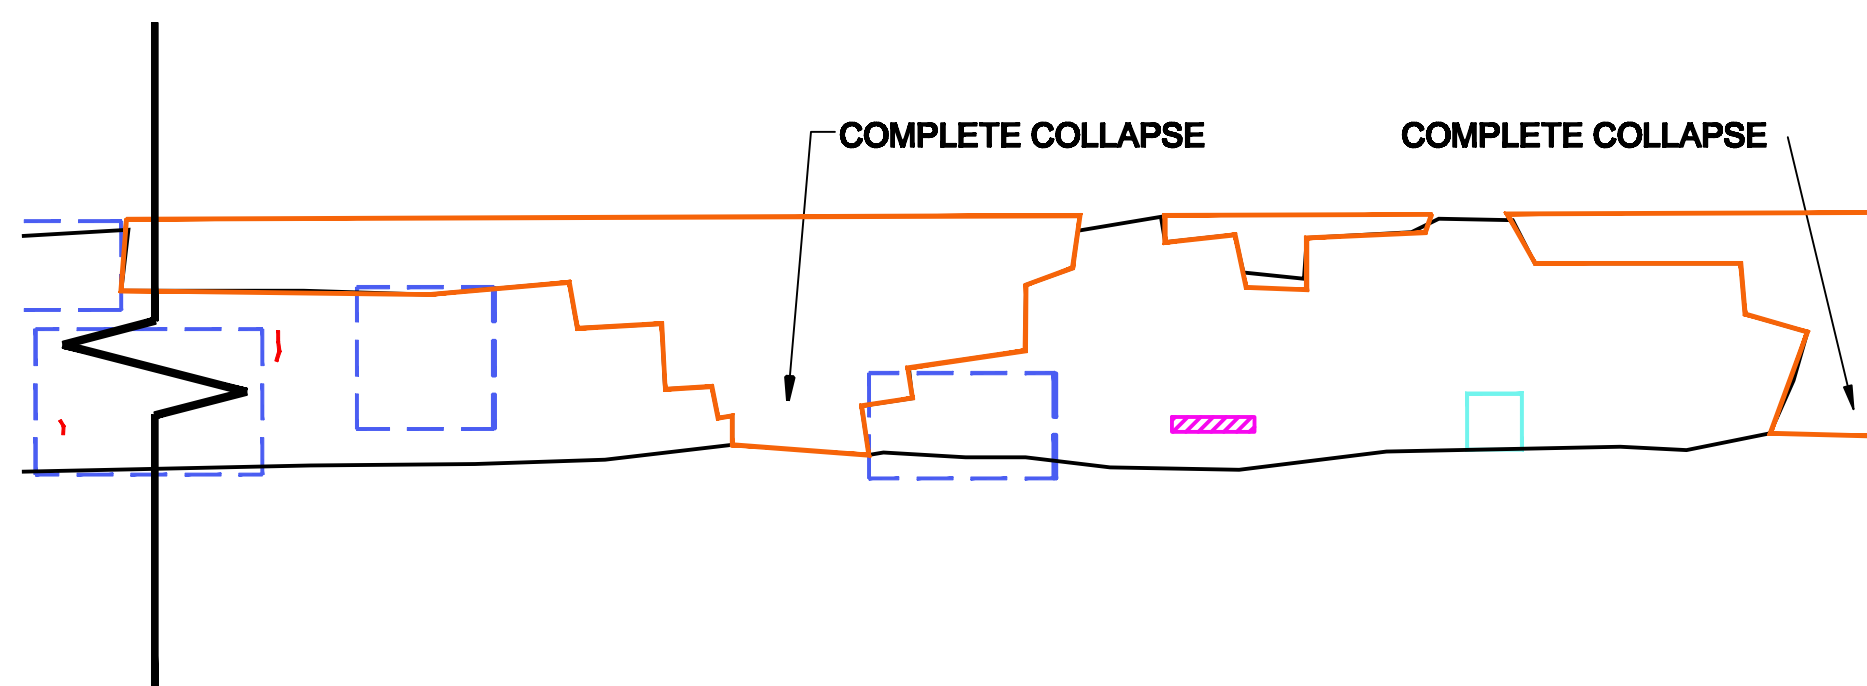
61B EAST INNER WORKS - EXTERIOR - NORTH - RIGHT END
A218 SCALE: 3/8" = 1'-0"

CAMBER: VERTICAL OR LEANING OUT
STONE SIZE: MEDIUM AND LARGE, BY COURSE
COURSING: COURSED
CHINKING: NONE
VEGETATION: VINES AND WEEDS IN WALL, NO TREES
SLOPE: FALLS AWAY ROUGHLY PARALLEL TO WALL

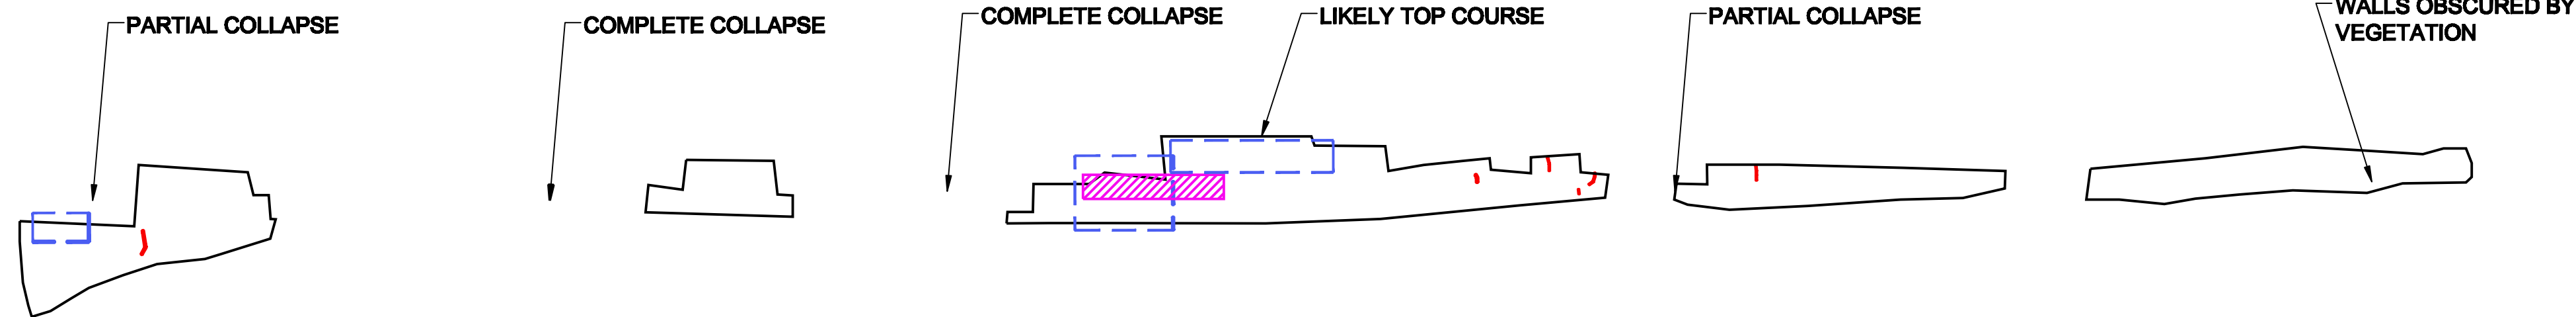
CAMBER: VERTICAL OR LEANING OUT
STONE SIZE: MEDIUM AND FAIRLY REGULAR
COURSING: NOT WELL DEFINED, IRREGULAR
CHINKING: NOT MUCH
VEGETATION: VINES AND WEEDS IN WALL, NO TREES
SLOPE: MOSTLY LEVEL

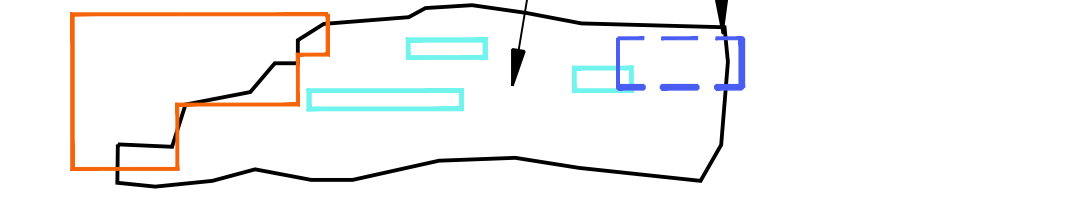
69 WEST INNER WORKS - INTERIOR - INSIDE CENTER FACING WEST
A220 SCALE: 3/8" = 1'-0"

CAMBER: WALLS ARE VERTICAL
STONE SIZE: IRREGULAR, MANY VERY LARGE STONES
COURSING: IRREGULAR COURSING
CHINKING: LARGE CHINKING STONES HAVE FALLEN OUT
VEGETATION: SMALL WEEDS IN FACE
SLOPE: AWAY FROM WALL SLIGHTLY

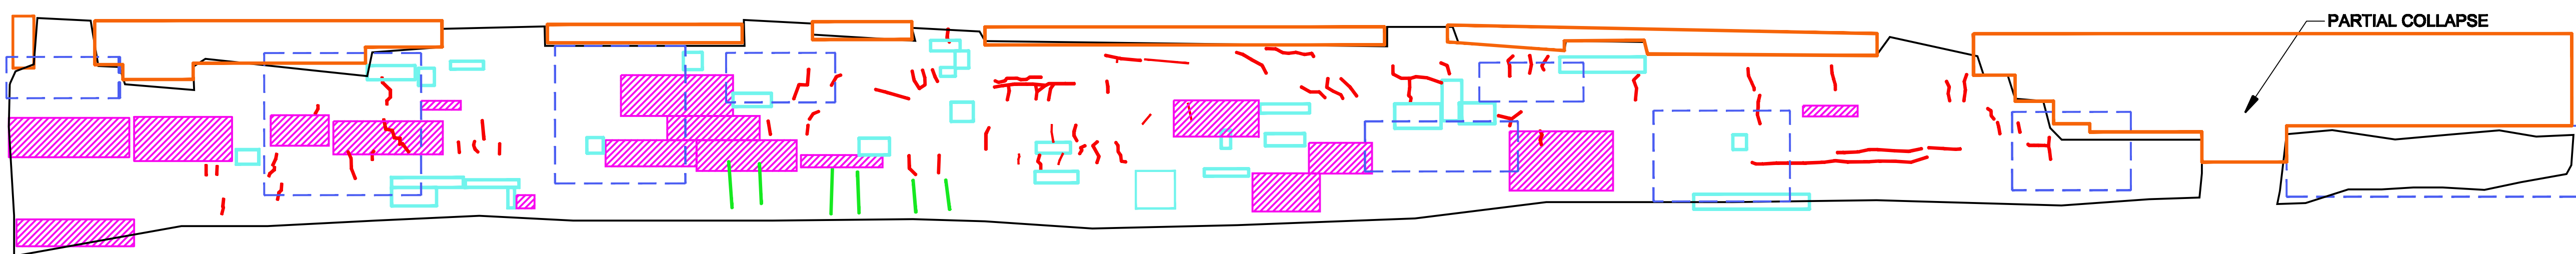
68 WEST INNER WORKS - INTERIOR - INSIDE FACING SOUTH
A220 SCALE: 3/8" = 1'-0"

CAMBER:
STONE SIZE: MIXED, BUT SOME VERY LARGE STONES. MANY OF BAD QUALITY
COURSING: IRREGULAR COURSING
CHINKING: HEAVY, FALLING OUT OR MISSING IN AREAS
VEGETATION: SMALL WEEDS IN FACE
SLOPE: MOSTLY LEVEL.

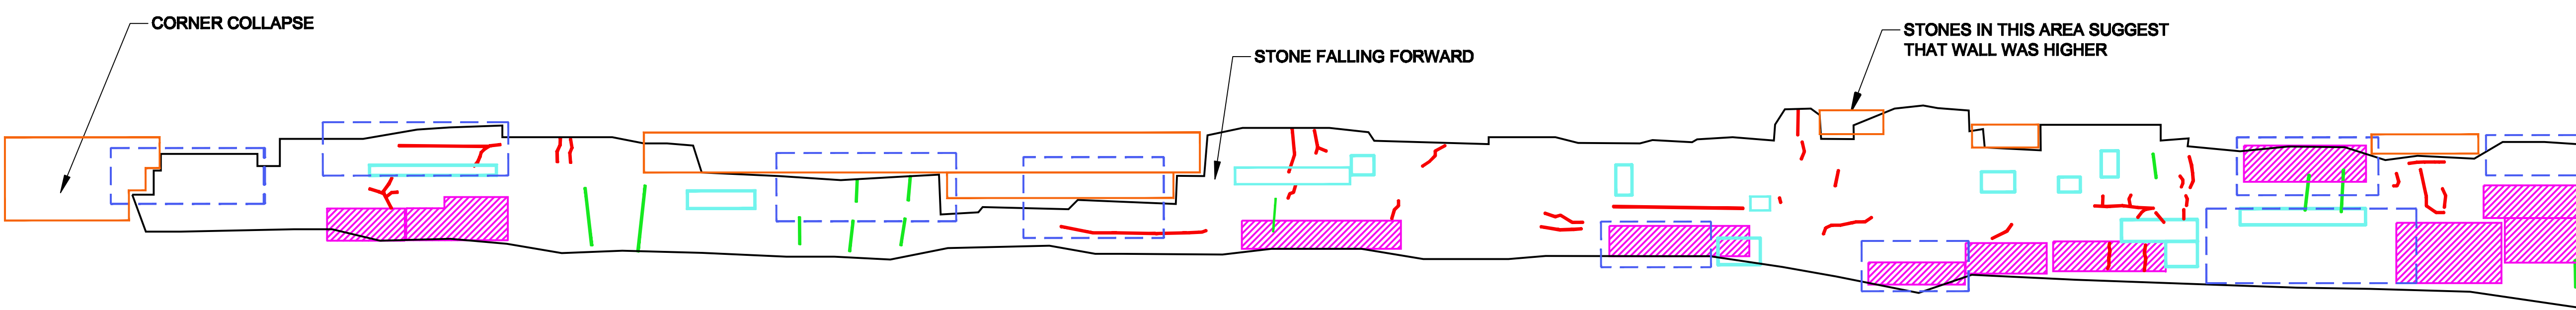
70 WEST INNER WORKS - INTERIOR - INSIDE FACING NORTH
A220 SCALE: 3/8" = 1'-0"

CAMBER: WALL HAS FALLEN FORWARD
STONE SIZE: MEDIUM TO SMALL STONES
COURSING: IRREGULAR COURSING
CHINKING: HEAVILY CHINKED AT LEFT END
VEGETATION: SMALL WEEDS IN FACE, GRASS HAS GROWN OVER AND THROUGH
SLOPE: GROUND SLOPES AWAY FROM WALL BOTH PERPENDICULAR AND PARALLEL

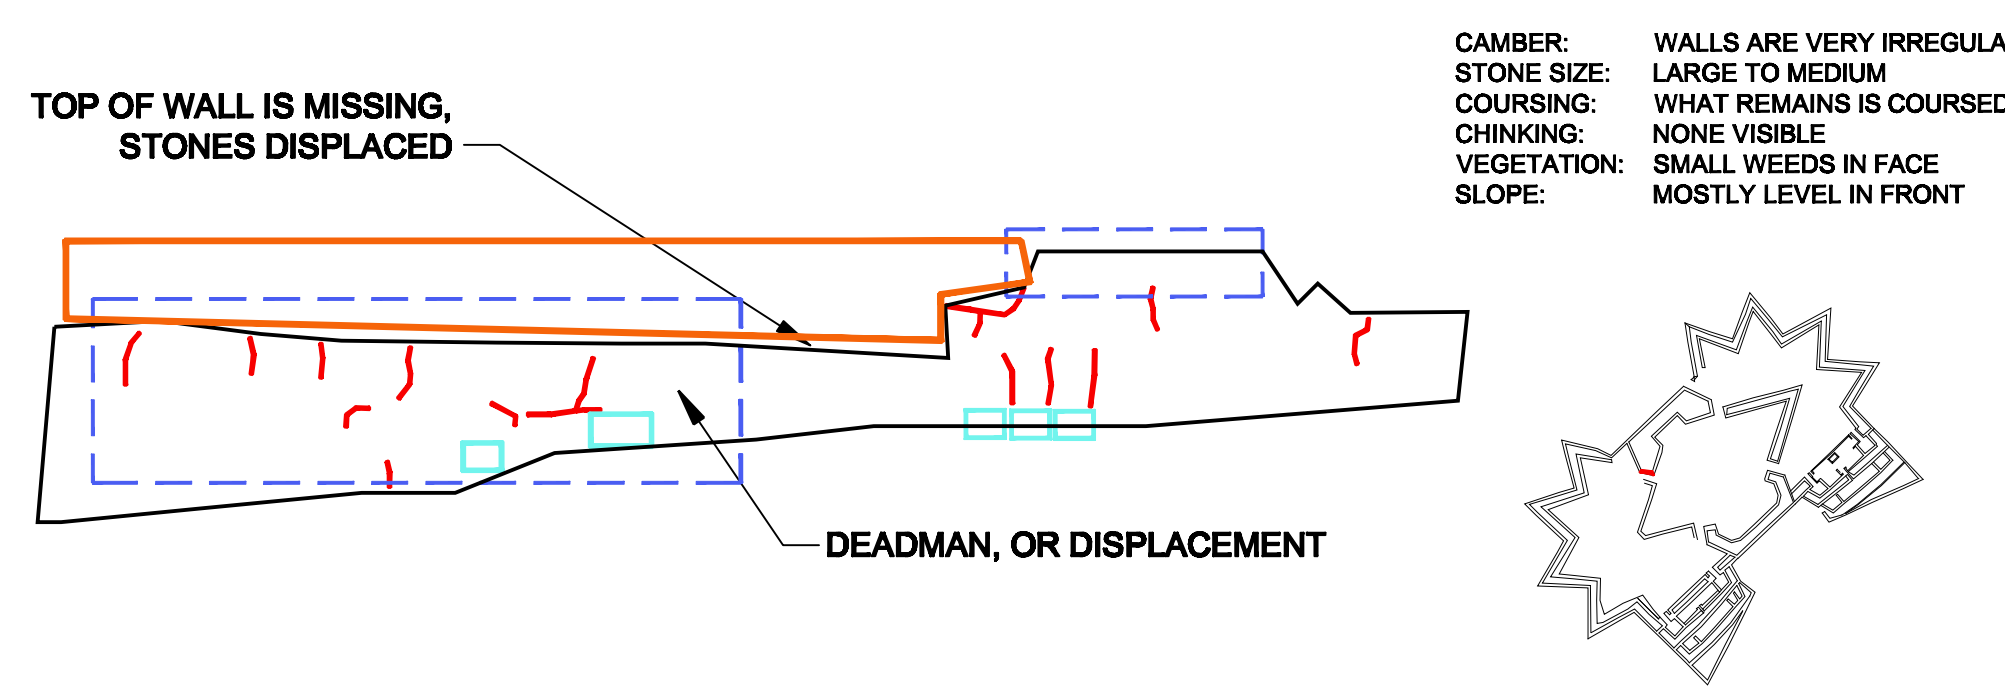
72 NORTH MAIN WORKS - WEST SIDE FACING WEST INNER WORKS
SCALE: 3/8" = 1'-0"
A221

CAMBER: WALLS ARE VERY IRREGULAR
STONE SIZE: LARGE TO MEDIUM
COURSING: WHAT REMAINS IS COURSED
CHINKING: NONE VISIBLE
VEGETATION: SMALL WEEDS IN FACE
SLOPE: MOSTLY LEVEL IN FRONT

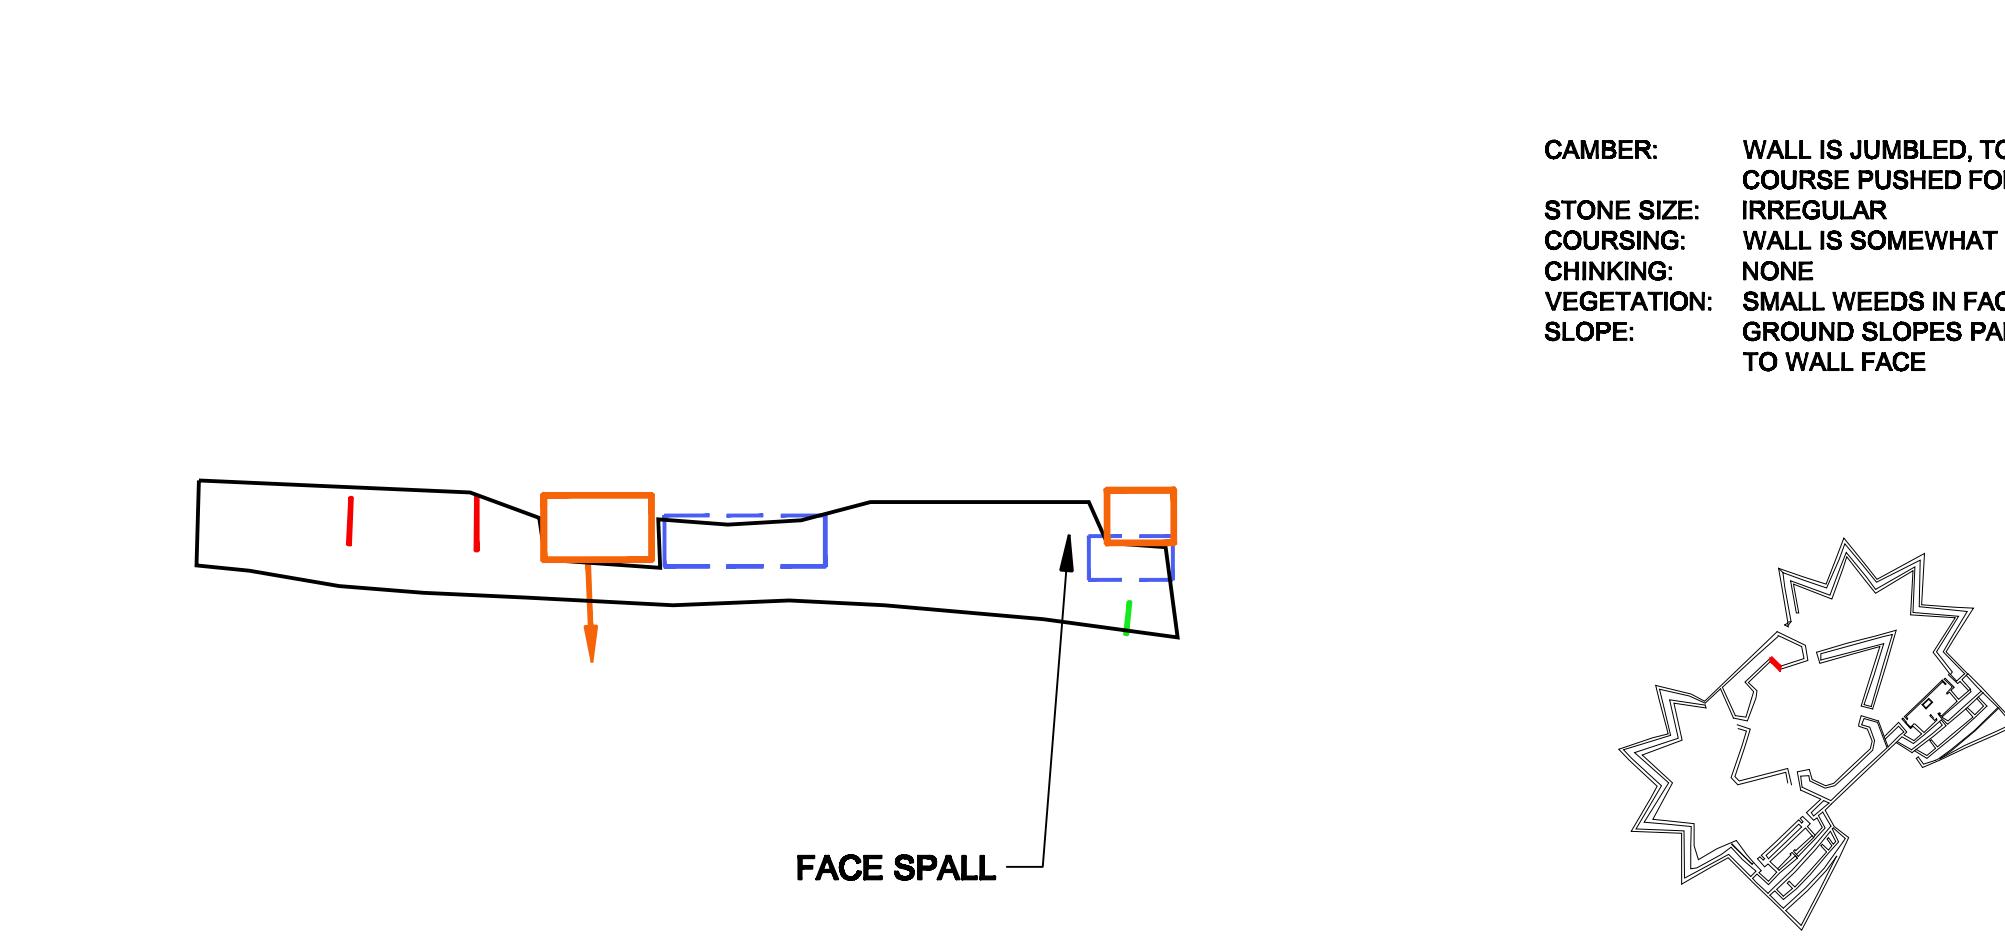
76 NORTH MAIN WORKS - INSIDE MAGAZINE EAST END
SCALE: 3/8" = 1'-0"
A221

CAMBER: WALL IS JUMBLED, TOP
COURSE PUSHED FORWARD
STONE SIZE: IRREGULAR
COURSING: WALL IS SOMEWHAT COURSED
CHINKING: NONE
VEGETATION: SMALL WEEDS IN FACE
SLOPE: GROUND SLOPES PARALLEL
TO WALL FACE
