APPENDIX B

**STRUCTURAL SKETCHES**

Project Title:  
**FORT NEGLEY  
1100 FORT NEGLEY BLVD.  
NASHVILLE, TN 37203**

# FORT NEGLEY (NASHVILLE, TN) FORTIFICATION WALL PROFILE SURVEY

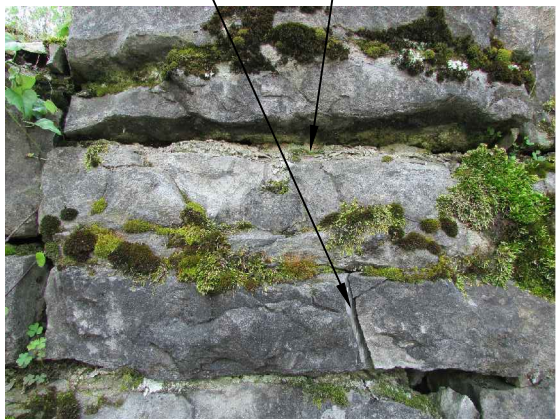
7 BIOLOGICAL GROWTH  
SSK-6 SCALE: N.T.S.

STONE W/ VERTICAL CRACK DUE TO SHEAR FAILURE. STONE FORCED TO SPAN W/ LOSS OF SUPPORT BELOW

STONE DELAMINATION & LOSS, SEE 5/SSK-6.
