APPENDIX C

STRUCTURAL CALCULATIONS

DRY-STACKED STONE GRAVITY RETAINING WALL

Fort Negley (40DV189) Historic Structures Report: Archaeological Investigations

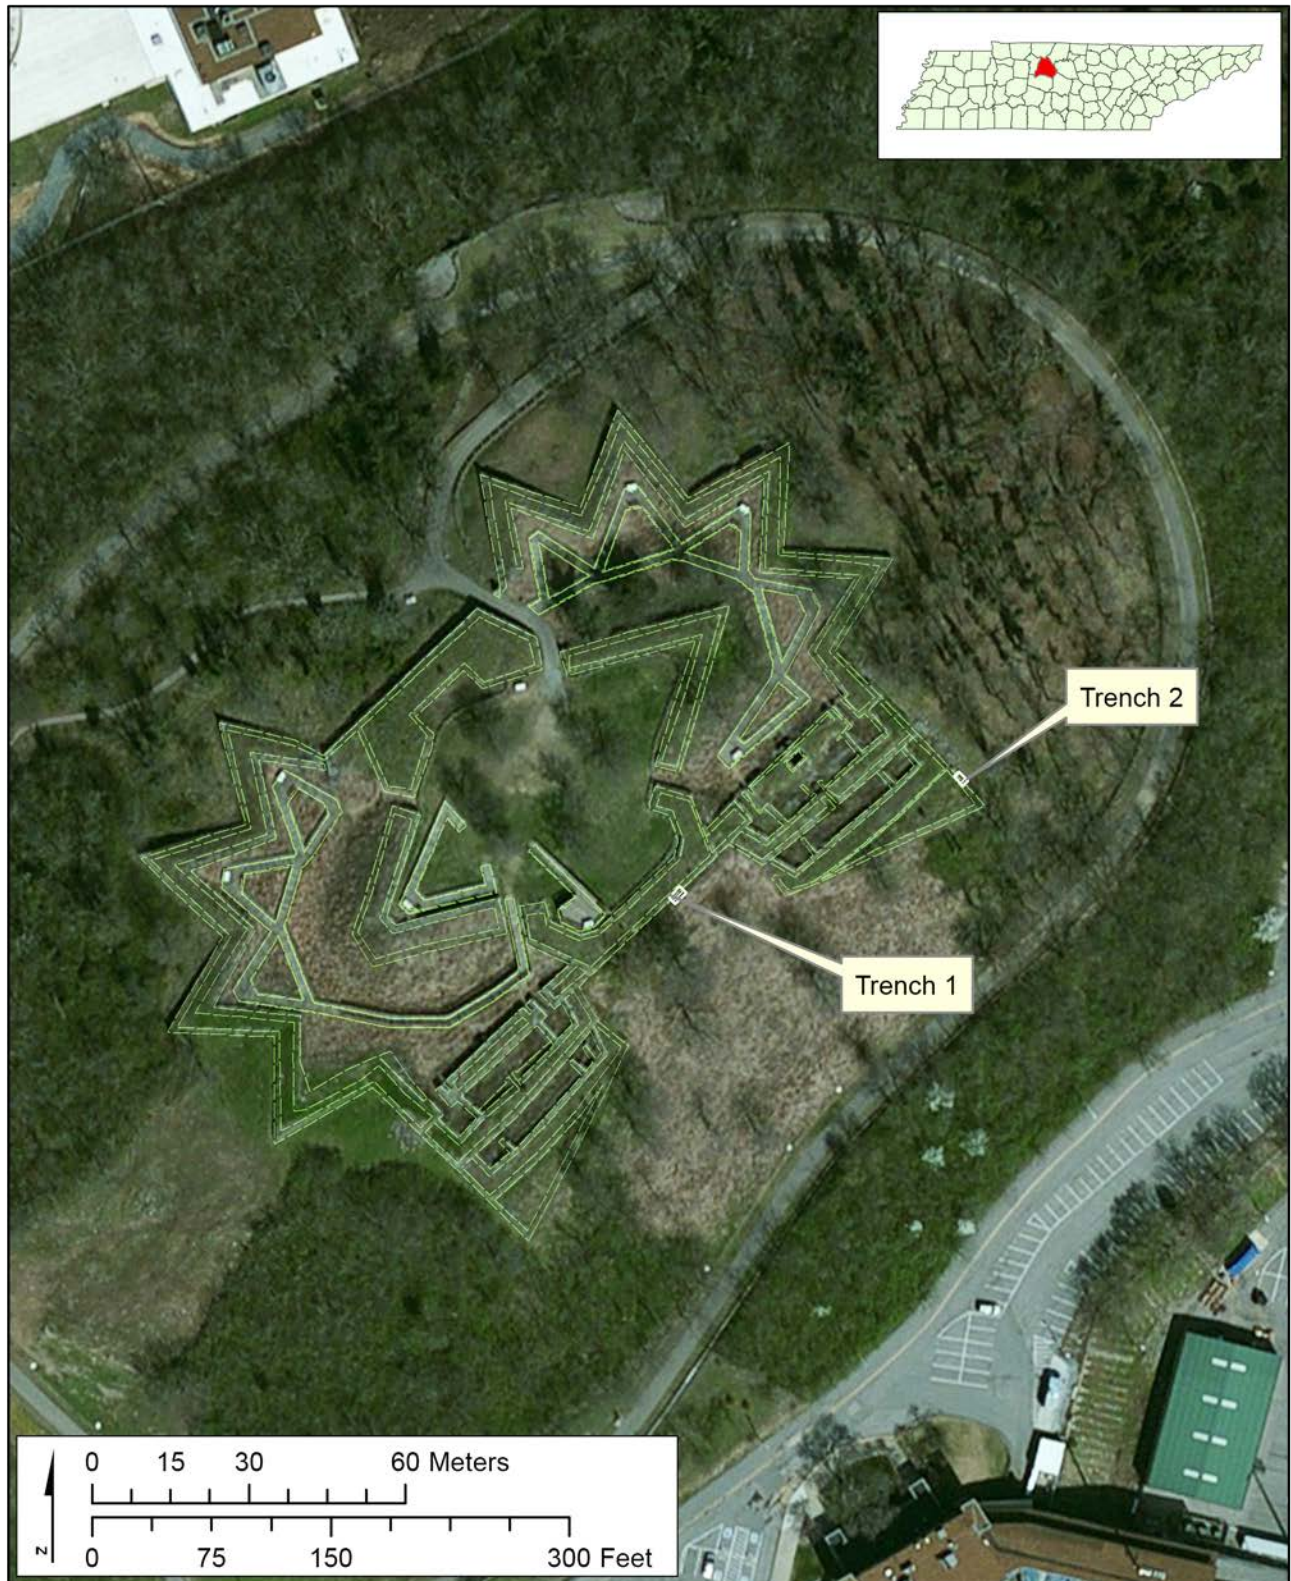
Figure 2.
Map Showing Locations of Trenches 1 and 2

Trench 1 was placed along the south wall of the south main works, roughly halfway between the west and east bastions (see Figure 3a). Trench 1 was aligned perpendicular to the south wall and measured 6x3 feet at the ground surface. Trench 1 was initially established and excavated as two 3x3-foot units: Unit 1 was placed in the north half of the trench, immediately adjacent to and abutting the south wall where it met the ground surface, while Unit 2 was placed in the south half. A third unit, Unit 3, was established to the north of Unit 1 after excavation indicated that the wall sloped inward and away from the excavation unit. Unit 3 was opened four inches below ground surface, measured 0.5x3 feet, and was intended to sample sediments from below a bulging section of the south wall. Units 1, 2, and 3 were excavated to maximum depth of 24, 11, and 24 inches below ground surface, respectively. Excavation of Trench 1 was terminated due to unsafe excavation conditions prior to exposing the wall's foundation; and therefore, the construction method and materials of this foundation were not determined.

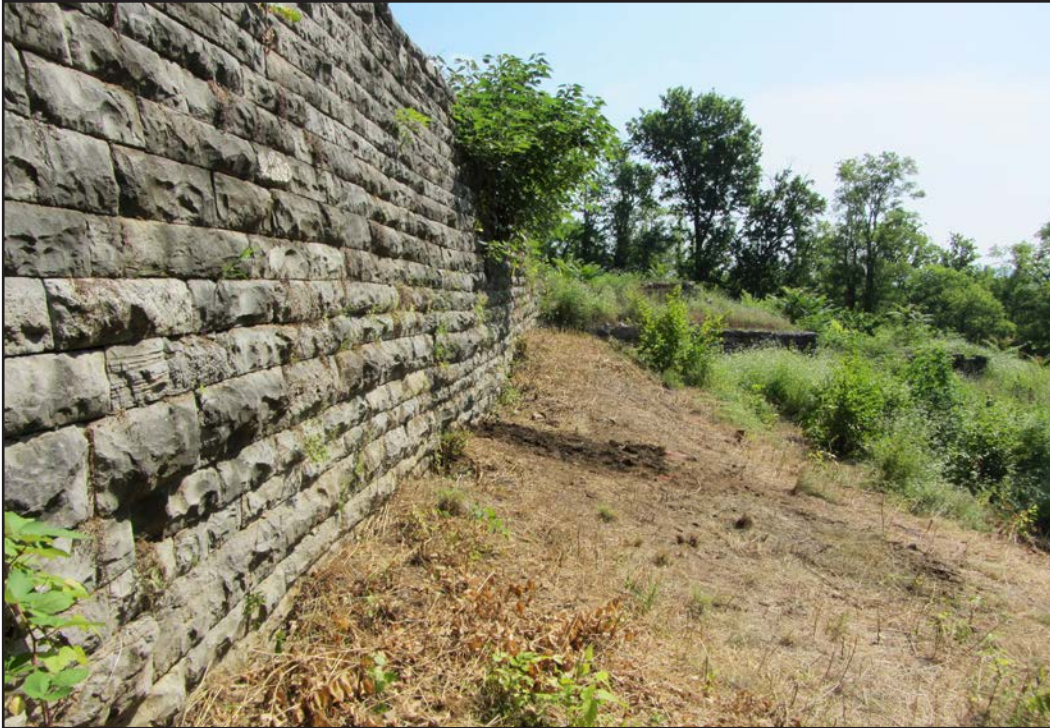
A. Location of Trench 1, Facing East along the South Wall

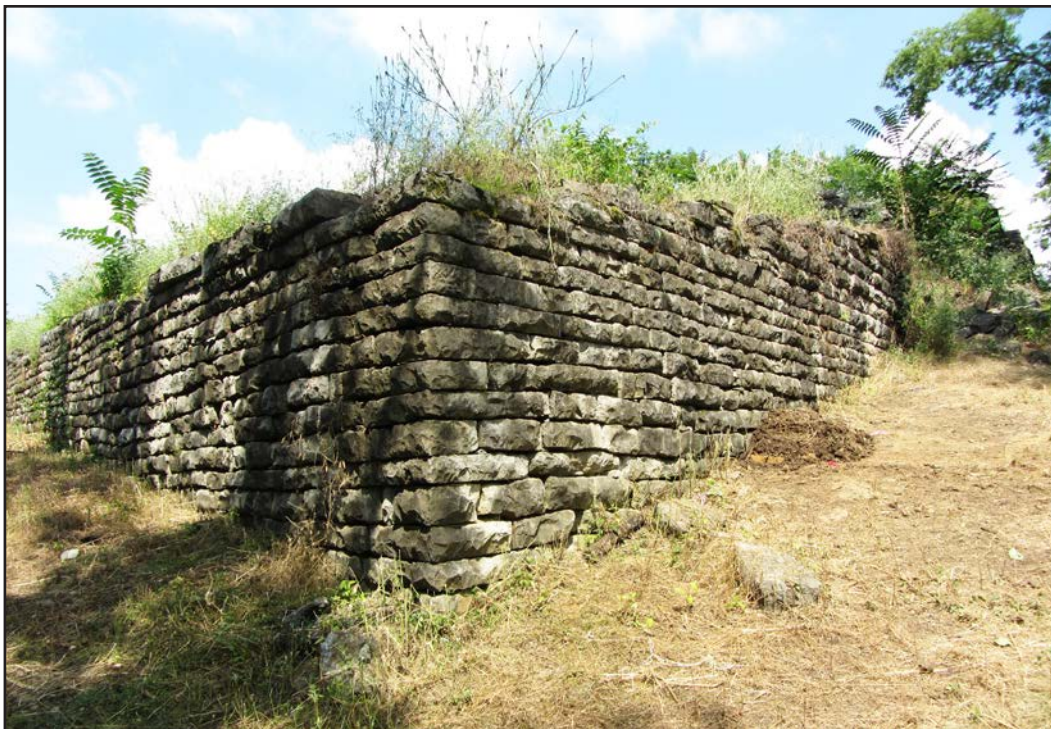
B. Location of Trench 2, Facing Southwest towards the East Bastion.

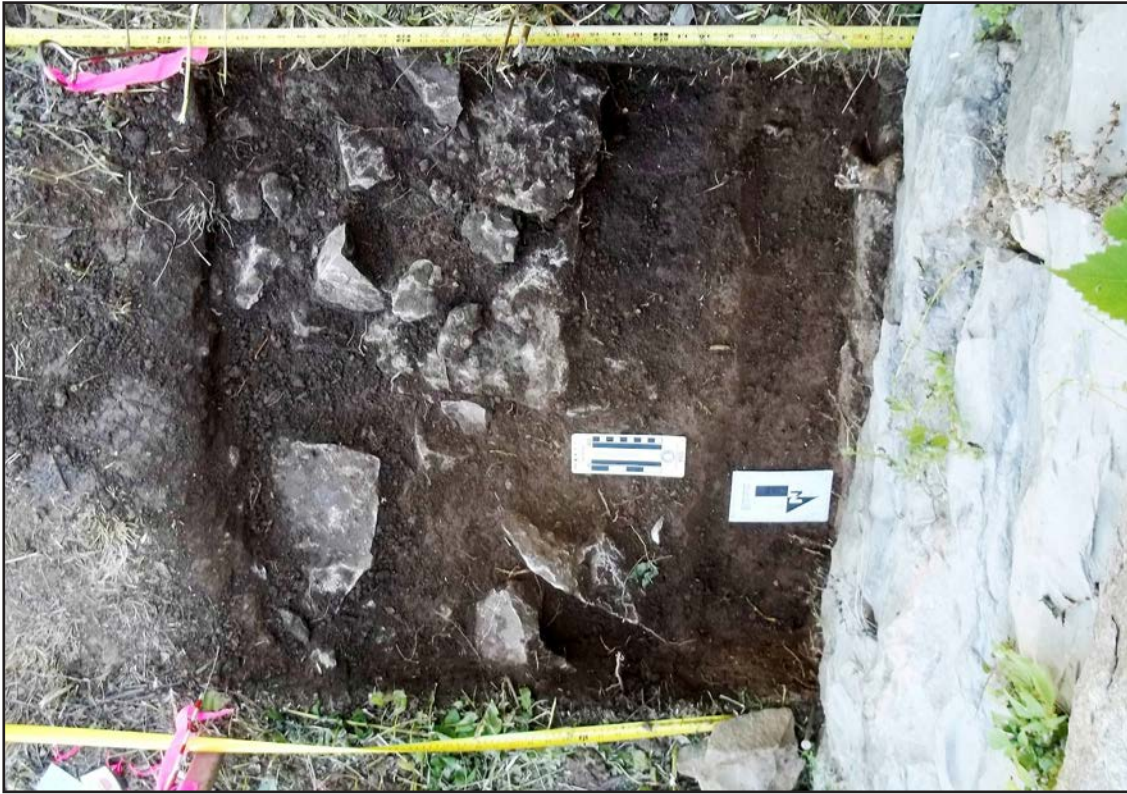
A. Limestone Exposed at Top of Stratum V

the fort. Stratum V was directly below Stratum IV and consisted of a linear deposit of limestone rock that formed the core or base of the berm (Figure 5). Strata IV and V thus were the same matrix, but were distinguished by the deposit of limestone in the lower stratum. Stratum VI was a layer of fill located directly below Stratum II in the northern portion of Trench. The deepest excavation levels of Trench 1 extended into Stratum VI.

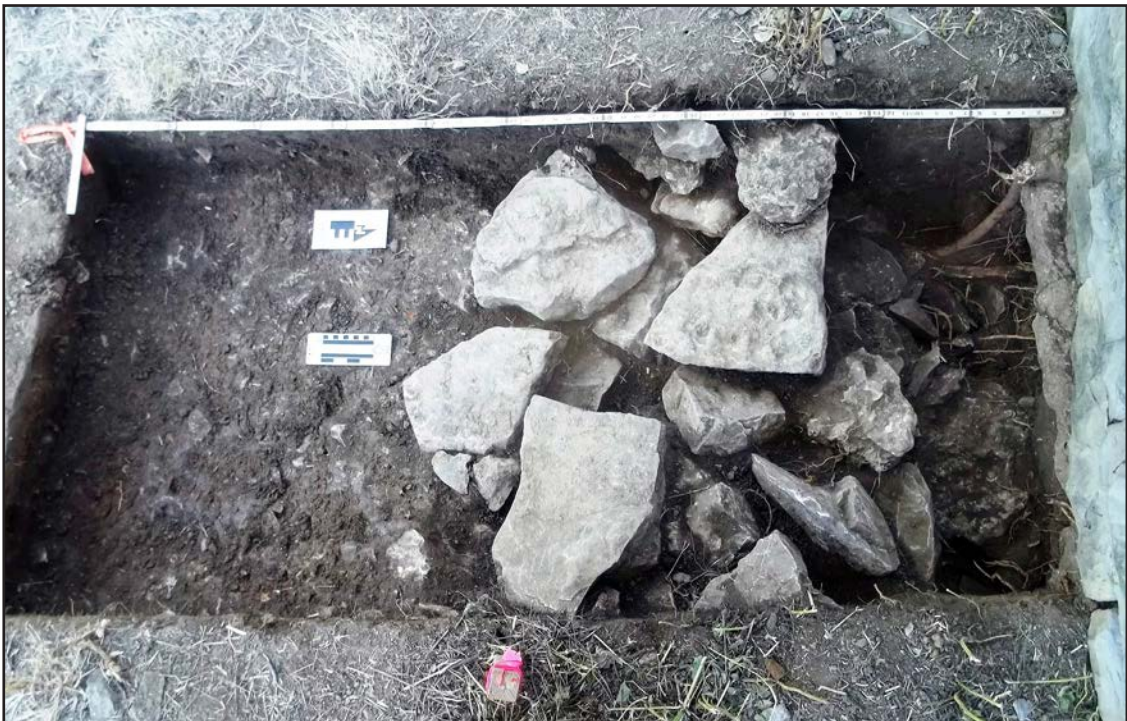
B. Limestone Core of Berm after Excavation

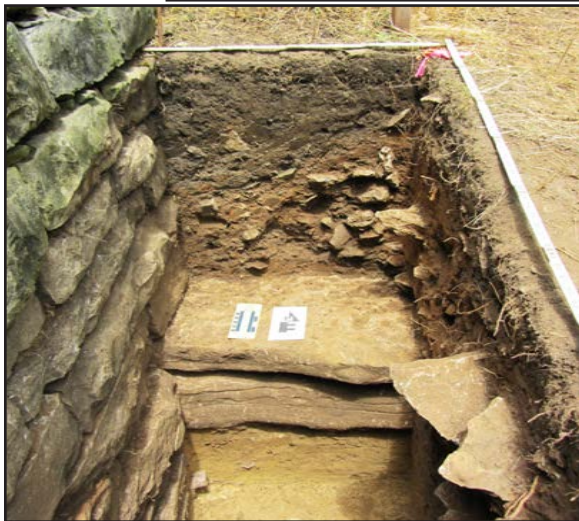
A. North Wall Profile of Trench 2

Trench 2 was placed at the southeast corner of the fort, along the exterior wall of the east bastion (Figure 6) and measured 4x2 feet. The east bastion wall sits on a hillside that slopes to the south. Trench 2 was excavated as one unit, Unit 4, and had a maximum depth of 55 inches below

ground surface. The foundation of the east bastion wall was exposed, and the basal courses of limestone blocks were positioned atop limestone slabs and residuum. It was stepped out to accommodate the southward slope of the hillside.

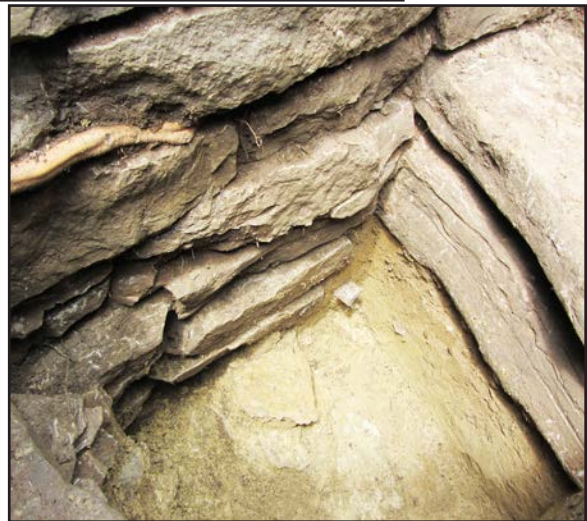
B. West Wall Oblique View of Trench 2 Showing the Basal Course of Cut Stones on a Limestone Slab (Left of Photograph) and Residuum.

The foundation of the east bastion wall was exposed in Trench 2 and the basal courses of limestone blocks were positioned atop limestone slabs (Stratum III) and residuum (Stratum IVD). In addition, the foundation of the east bastion wall was stepped to accommodate the southward slope of the hillside on which it was constructed. Despite exposing the east bastion wall foundation, the temporal affiliation of the stone wall could not be determined. Stratum II in this trench consisted of fill material used to build a berm along the east bastion wall. Stratum I was the A horizon and filled the ditch or depression at the east bastion wall. The artifacts from Strata I and II do not clearly indicate if the fill layers in Trench 2 reflect Civil War era building events or WPA reconstruction. Temporally diagnostic artifacts from both strata have lengthy manufacturing date ranges and do not provide precise dates.
