# WARNER PARKS ALLÉE

STORMWATER & LANDSCAPE  
PLANNING DOCUMENT

## Masonry Condition Assessment Percy Warner Alleé

Masonry Condition Assessment  
Percy Warner Alleé and WW I Memorial, Metro-Nashville Parks & Recreation

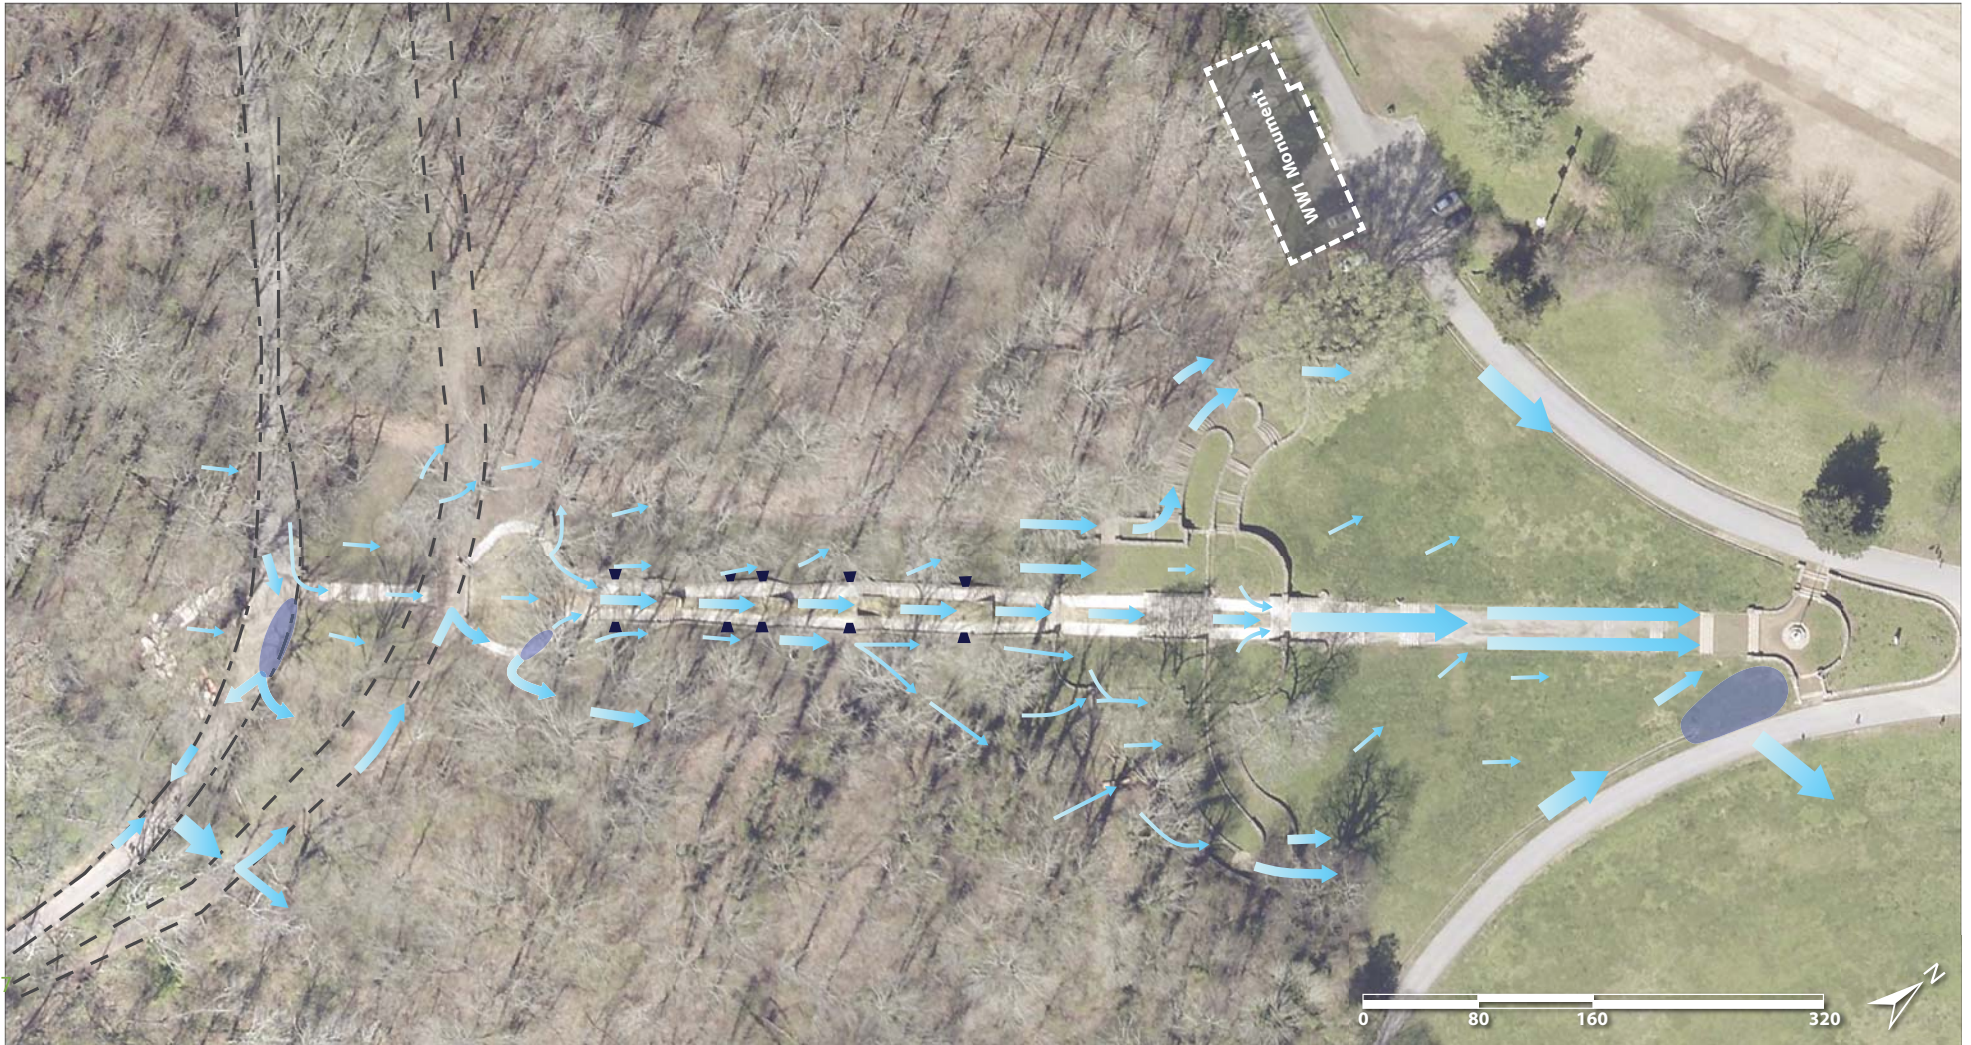
# Stormwater Management Recommendations | Proposed Drainage Solutions - Overview

Throughout the Warner Allée there are consistent issues with poor grading and drainage. This can be seen in sedimentation, erosion, and ponding at various locations around the site. The proposed solutions detailed in this report would reduce the water flow on the stairs by around 70 percent.

4 Note: Original drainage infrastructure and overland flow from the Allée all flows to the area between the Stone Gate Entrance and Percy Warner Golf Course. Water eventually drains across the golf course. Existing conditions at the Allée including sediment accumulation in existing drainage structures has diverted some stormwater runoff toward Page road east of the Stone Gates. Suggested improvements in this document may result in an increase of water draining to the golf course, but is consistent with historical drainage patterns. Drainage issues including standing water and erosion are noted within the golf course and at the Stone Gates. Drainage improvements and study of this area are not included in the scope of work of this document, but a cursory review of this area would suggest that sediment accumulation and generally flat terrain are contributing to ponding in several areas, as well as water draining through the Stone Gates. Vegetative cover at the Stone Gates that is appropriate for solar exposure and soil conditions is recommended to prevent ongoing erosion. Improved grass channels or swales between the Allée and golf course outfall are recommended to eliminate ponding and improve drainage.

- 1 Remove sediment and debris from existing catch basin. Inspect pipe and structure for any damage and repair as necessary. Consider adding velocity dissipation to stone channel such that sediment is removed upstream and can be removed from channel prior to reaching catch basin. Provide cast iron grates at eastern and western most basins.
- 2 Replace existing culvert to convey more water under the road before over topping; rebuild stone headwalls. (Note: this structure is outside of original project scope and replacement calculations have not been provided)
- 3 Remove asphalt pavement and replace with pedestrian walkway to provide a more defined pathway connection between the WWI monument and the entrance path to the Allée. Provide stabilized aggregate paving for all existing grass pathways to match lower section of the Allée.

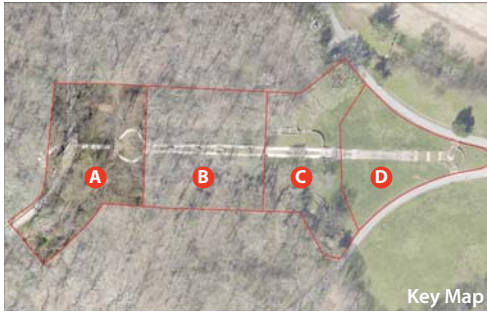
### A. Upper Terrace

The Upper Terrace area consists of the upper park roadway, 15" cross-culvert, Alleé exit stairs, horse trail, and upper terrace. Due to the nature of the existing flow paths, many deficiencies are present in the upper terrace that contribute to uncontrolled runoff, channelization along pathways, erosion, ponding, and sedimentation.

- 1 Ponding at wall east of Alleé exit.
- 2 15" Iron pipe culvert and failing headwall.
- 3 Channelization and erosion along the horse trail.
- 4 Uncontrolled runoff, undermined paver sections, erosion, and ponding.
- 5 Inlet with unknown outlet.

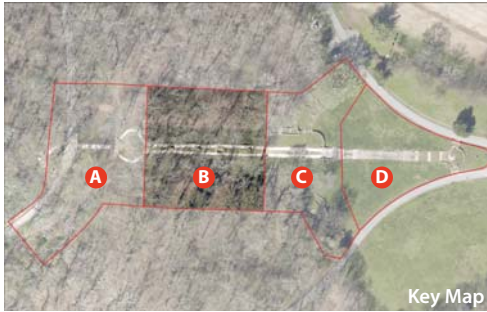
### B. Upper Stairs

The Upper Stairs area consists of the stairs and pathways connecting the upper terrace to the lower terrace. Concentrated stormwater runoff entering the upper stairs, the running grades of the existing paths, and deficient channel grading along to the walls all contribute to the drainage concerns for this area. Deficiencies include sedimentation and inadequate runoff catchment at the scupper drains along the stairs, insufficient channel grading and capacity adjacent to the walls, transportation of sediment to lower areas of the Allée, and uncontrolled discharge leaving this area and entering the lower terrace.

- 6 Scupper Locations
- 7 Deficient channels along walls

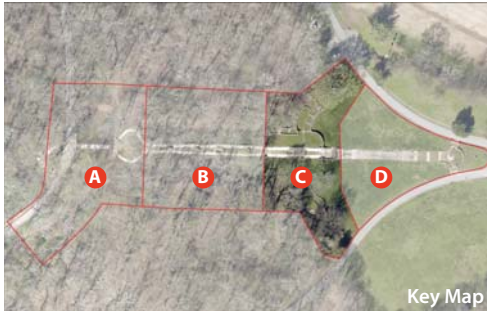
### C. Lower Terrace

The Lower Terrace area connects the upper and lower stairs of the Allée. It consists of the eastern and western exit stairs along with tiered pathways on each side of the main Allée thoroughfare. Concentrated stormwater runoff entering from the upper stairs continues through the lower terrace transporting sediment to the lower stairs. Uncontrolled runoff enters this area over walls, through wall openings, and down stairs. This uncontrolled runoff has created erosion, ponding and sedimentation along the eastern pathways, and erosion at both the eastern and western exit stairs.

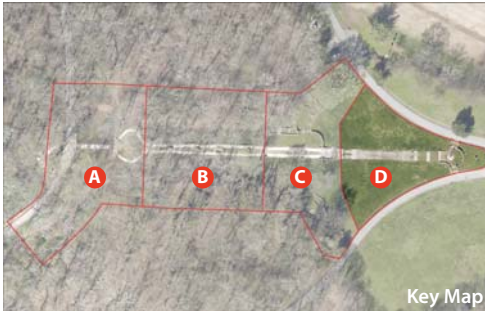
### D. Lower Stairs

The Lower Stairs area connects the lower terrace to the Allée entrance and consists of the stairs, paths, and the grassed areas adjacent to the eastern and western walls of this section. Concentrated stormwater runoff entering from the lower terrace delivers sediment and fine aggregate, which settles along the shallower sloped paver paths. Under high intensity storms, there is potential for concentrated flow to enter the stairs from the east.

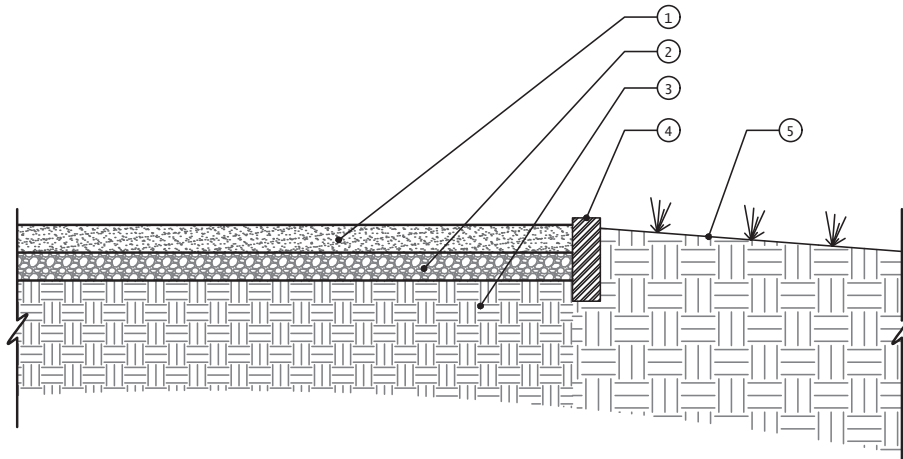
1. 2" Depth Organic-Lock Limestone Fines Pathway Aggregate
2. 2" Mineral Aggregate Base
3. Compacted Subgrade
4. Existing Stone Curb
5. Existing Grass

- Pre-wet Organic-Lock Aggregate Blend is the preferred method of installation, this ensures that Organic-Lock Binder is homogeneously activated by water. If pre-wetting is not done at the quarry, The use of a front-loading tractor and a water source can Pre-wet Organic-Lock Pathway Aggregate on the job site. Slowly add water to the Organic-Lock Pathway Aggregate and turn it over until ~10% moisture content (24 gallons per imperial ton) is achieved.

- If Pre-wetting Organic-Lock Pathway Aggregate prior to spreading is not possible; Spray water after spreading the Organic-Lock Pathway Aggregate at an even rate over the entire surface. 24-45 gallons per 100 square feet is required. Use a moisture probe penetrating the full depth of the Organic-Lock Aggregate layer to ensure complete water saturation.

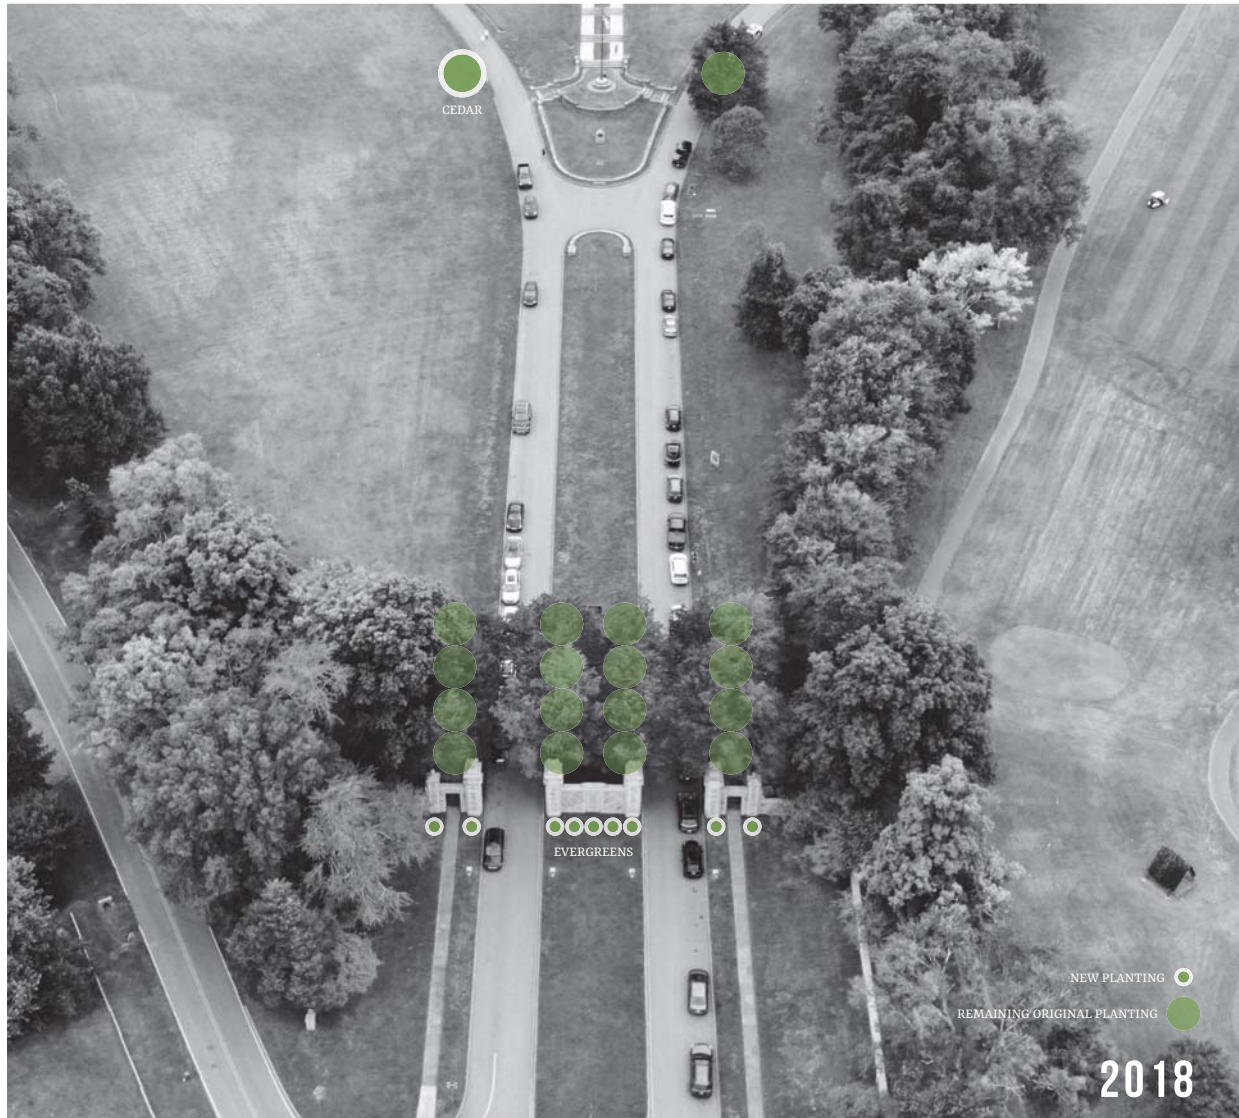
Recommended

The only plants still in existence from the original planting are the junipers behind the gates and one solitary juniper in the top right of the image at left, as evidenced by historic photos. While there were originally more ornamental plantings, we do not recommend replanting for reasons of maintenance. We are proposing the following improvements that consider the original intent and character of the park.

- 1: Add low evergreens to replace historic juniper in front of gate. This planting will help with maintenance and mask light fixtures.
- 2: Repair irrigation at sandstone gates.
- 3: Add one Cedar to mirror original remaining tree.

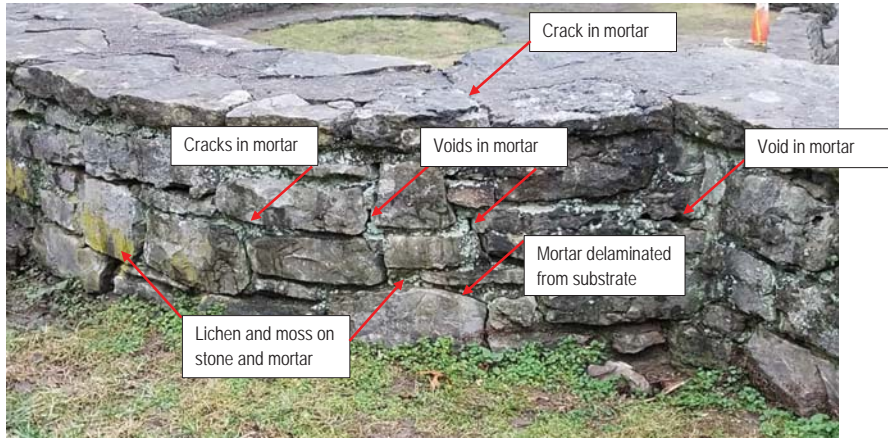
Mortar joints throughout the assemblies appear to be original, in poor shape (eroded, cracked, missing). As mortar is exposed to weather, the wind and rain and freezing conditions combine to generally erode the surface. Over time, fine fissures occur, and these permit tiny amounts of moisture in. This water freezes and thaws cyclically, causing further opening, gradually forming a

Photo 1 – Extent of mortar deterioration typical on site.

- 2) Repoint 100% of all mortar joints. The existing mortar is cracked and deteriorated.
- 3) Clean 100% of all masonry. This will freshen the appearance, but more importantly, prepare the stone to receive a good bond to the new mortar.

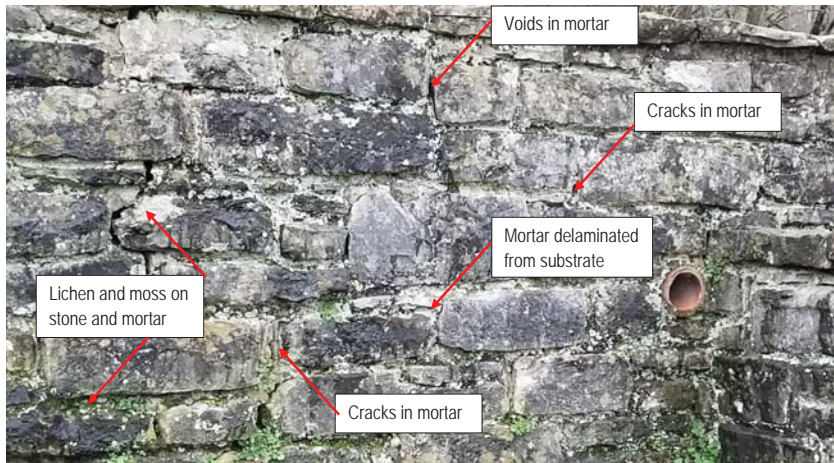
Photo 2 – Extent of mortar deterioration typical on site.

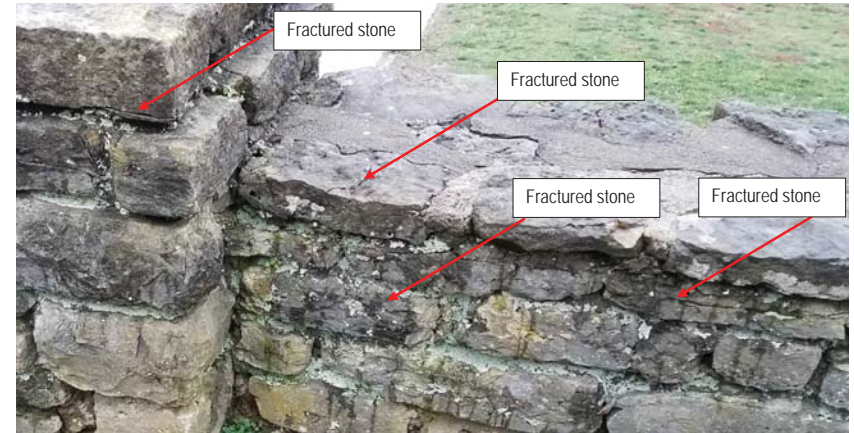
Observation of the stone walls adjacent to the stairs noted presence of soiled conditions throughout wall areas. Stones are random in size and shape, and are in good condition for the most part. There are some stones which have fractured and will need to be replaced when in skyward facing locations. Fracturing of the stone can be caused by inherent weaknesses of the stone which fracture in the weathering process. Fractured stones which survive the mortar removal can remain in place; those that break apart will be salvaged for other uses and replaced in kind. See Photos 3 and 4.

Photo 3 - Example of cracked and fractured stones.

- 4) Reconstruct some walls and some small areas of the Alleé where the masonry is significantly displaced.
- 5) Allow for replacement of existing fractured stones, which will fail in the course of the mortar removal.

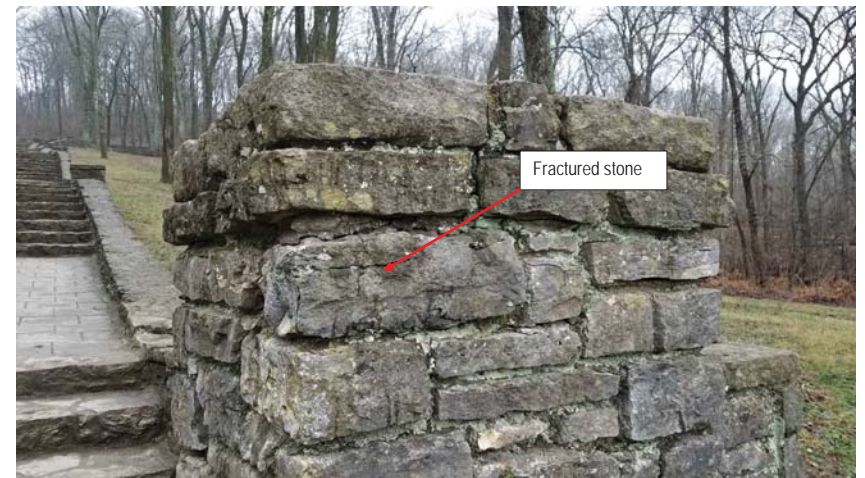
Photo 4 - Example of cracked and fractured stones.

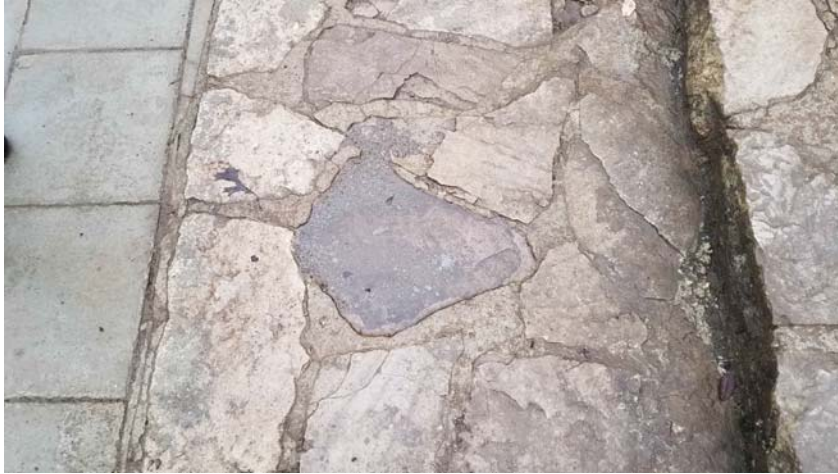
The stairs are comprised of individual stones with a flagstone pattern. The mortar joint is very wide, and typically skyward facing. Where top surfaces are uneven, water can accumulate and lead to icy patches in the winter. Only where stones are missing or severely eroded would these small areas of ponding be addressed. See Photo 5.

In isolated locations, stair treads and the top of the wall at the end pilasters have indentations which are collecting water. It is not known whether these are missing a stone, or the mortar has deteriorated. See Photo 5 and 6.

Photo 5 - Example of skyward surface in need of mortar wash to prevent water accumulation.

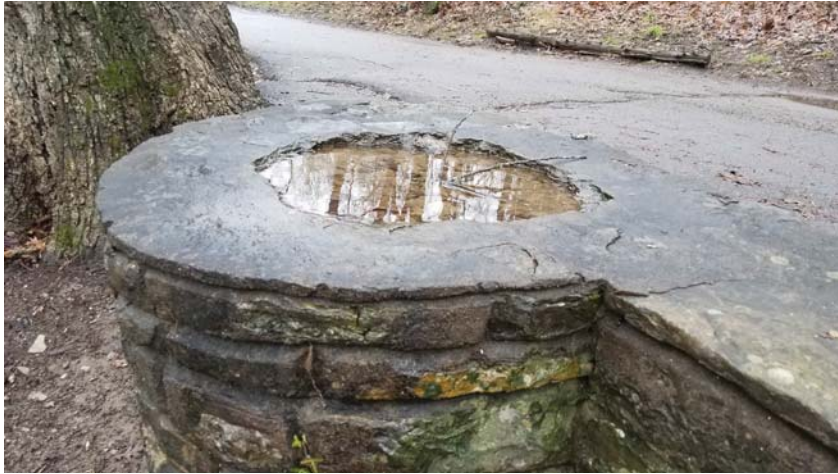
Photo 6 - Example of skyward surface in need of stonework or mortar wash to prevent water accumulation.

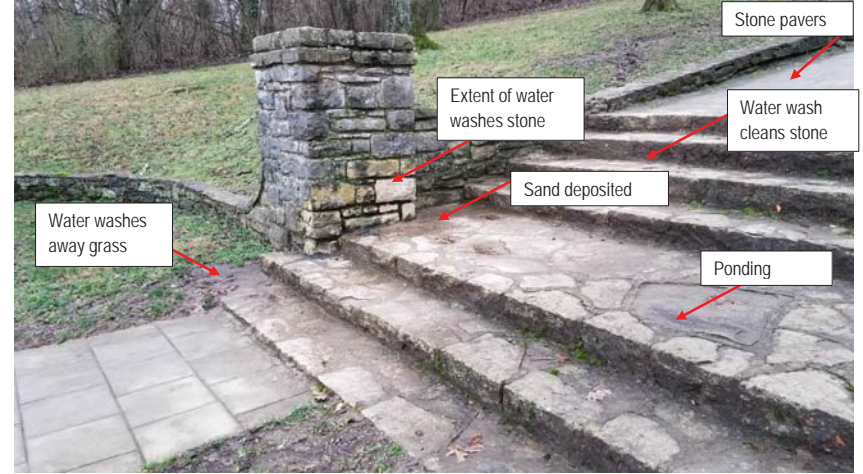
The existing stairs do not comply with the International Building Code 2012 (IBC) which is adopted by the City of Nashville. The stairs are not built in compliance with the rise run and parameters, the risers are not consistent in height in accordance with code, and there is an absence of handrails. With that being said, the implementation of code related upgrades would fundamentally detract from the existing historic appearance of this landscape, and hence upgrades are not recommended. See Photos 7, 10, 20, and 25.

Photo 7 - Area of steps where water washes down, deteriorates mortar, deposits sand and mud, and saturates masonry causing heavy moss growth.

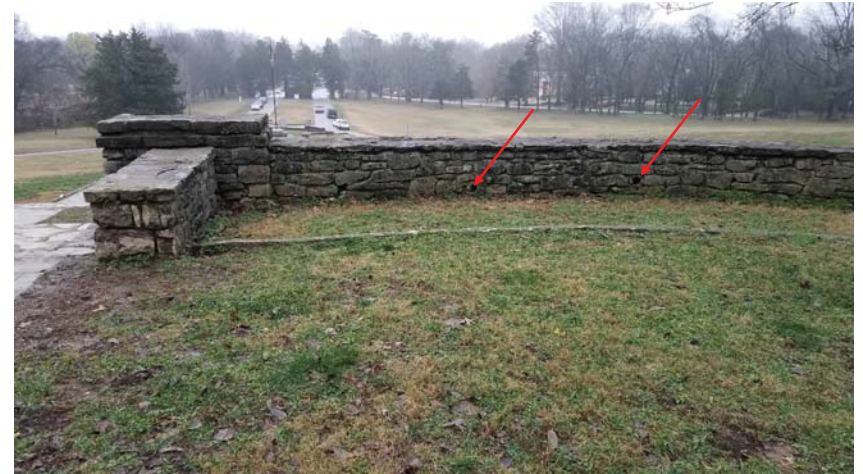
Originally, clay pipe drains were placed at the base of the wall to drain water out of higher areas and onto lower areas. In some of these locations grade has dropped leaving these pipes above the level where they are effective for drainage. It may be possible to lower the pipe in the wall to provide better drainage in certain locations, but it is not recommended to raise the grade, since the natural water table will be below any new fill. See Photo 8.

Photo 8 - Retaining wall where original clay drainage pipes have ended up well above grade level, rendering them ineffective.

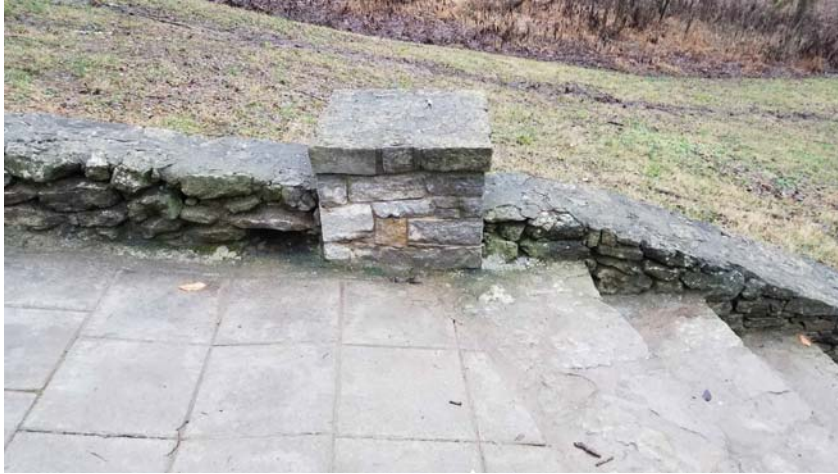
crack, or forcing the mortar away from the stone (debonding). These cracks further deteriorate in the exposed environment, and it cyclically worsens the condition of the mortar. The moisture and cracks form a good substrate, when windborne dust and dirt enter the cracks, resulting in the entire wall being covered in lichen and moss. Biologic growth of this type retains moisture on the surface and cracked and missing mortar joints allow moisture infiltration that accelerates damage to historic masonry assemblies. See Photos 1 and 2. There are select areas of repointing completed on the structure in 2001, but a full repointing was not performed. See Photo 9. These are in good condition, but more work is required, almost twenty years later.

Photo 9 - Pier that was repointed in a previous restoration project in 2001, along with pavers which placed by that project.

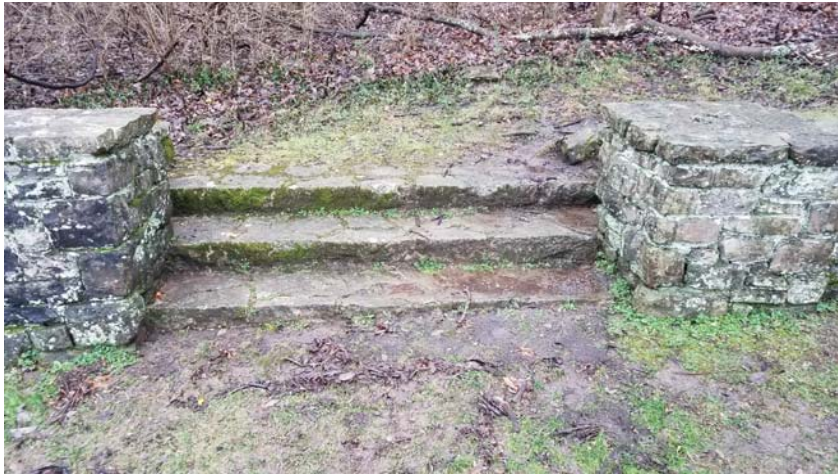
Photo 10 – Steps are comprised of individual stones, in a flagstone pattern, with inconsistent tread depth and riser height, with wide mortar joints skyward facing. Note lack of handrail.

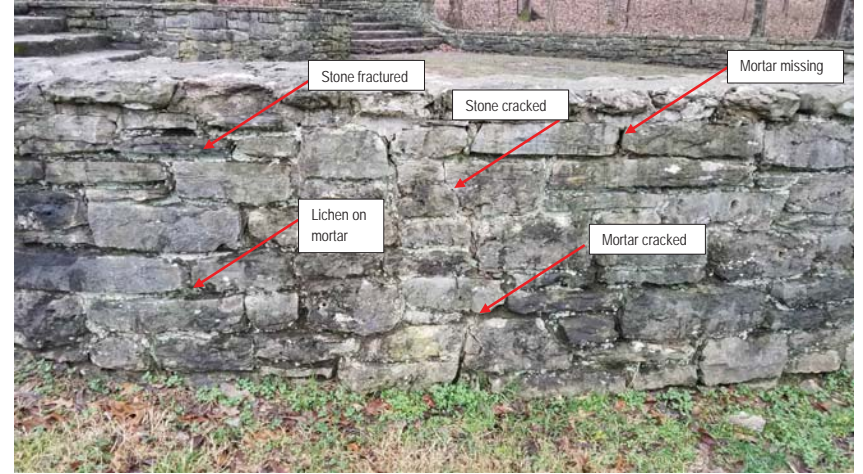
Photo 11 – Mortar is old, covered with lichen and moss, has cracks, and is missing in some cases. Stone is in relatively good condition, but has cracked in some locations, and fractured elsewhere.

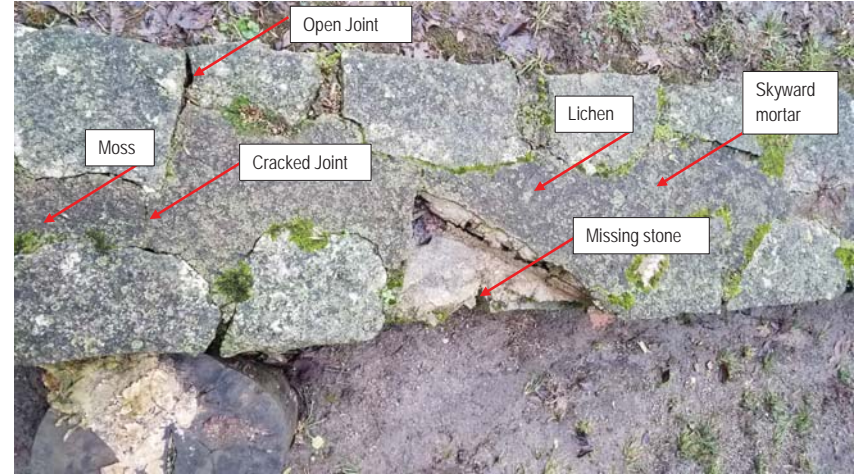
The top of the wall has large areas of skyward facing mortar. Like the face of the wall, the mortar is missing in some places, cracked in others, and covered in moss and lichen. See Photo 12. It is especially important that the top of the wall be maintained, since this is a direct path for water to get into the core of the wall. With freezing and thawing cycles over many winters, this will inflict damage to the core of the wall, resulting in bulging and fracturing. It is likely that freeze / thaw action caused the displacement of the missing stone noted, which was removed from the wall before TTG's site visit and requires replacement.

Photo 12 - The top of the wall with skyward facing mortar, cracks, open joints, moss and lichen.

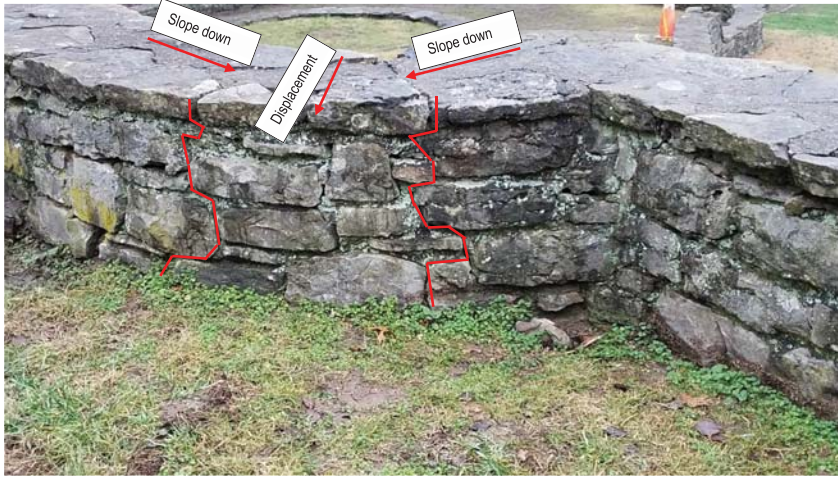
Photo 13 Crack through wall with settlement; Crack to be cut out and repointed

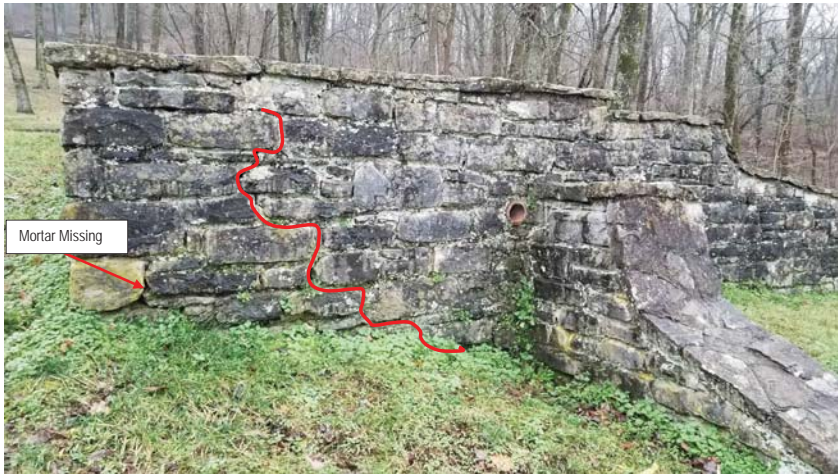
Photo 14 Cracking through wall due to minor differential movement; Crack to be cut out and repointed

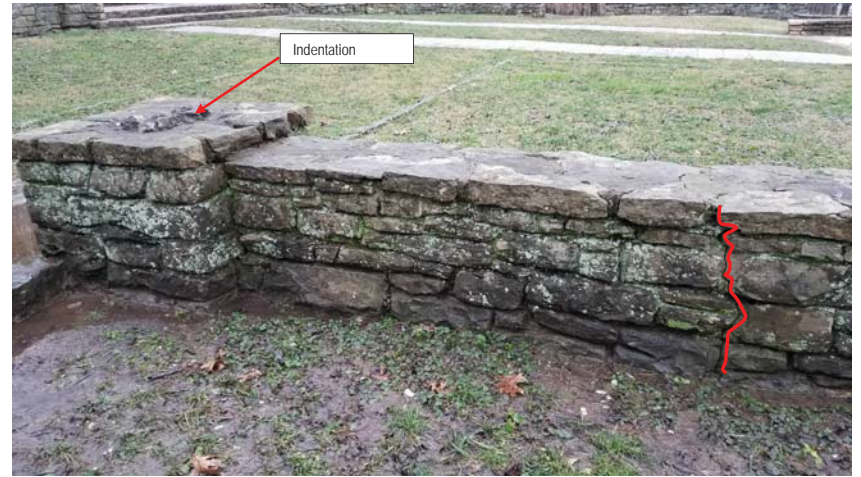
Photo 15 - Wall with differential movement causing crack; Crack to be cut out and repointed. Indentation in top of pier catching water and in need to filling with stone or mortar wash

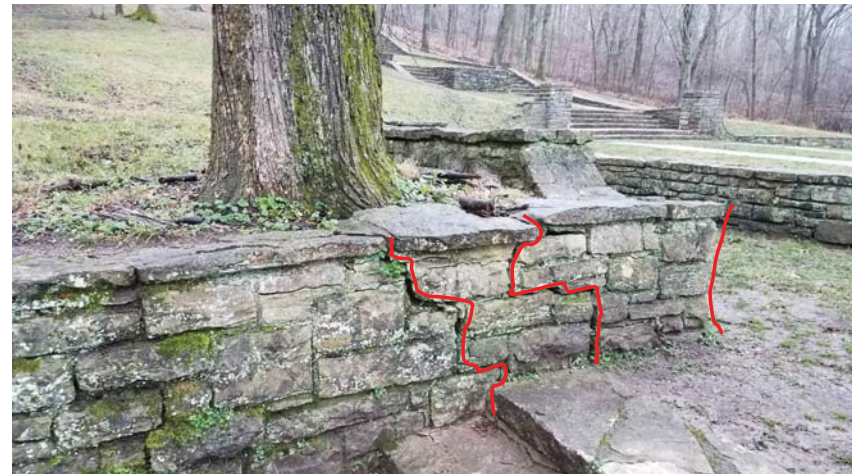
Photo 16 Displacement of wall due to tree roots. This portion of the wall needs to be reset.

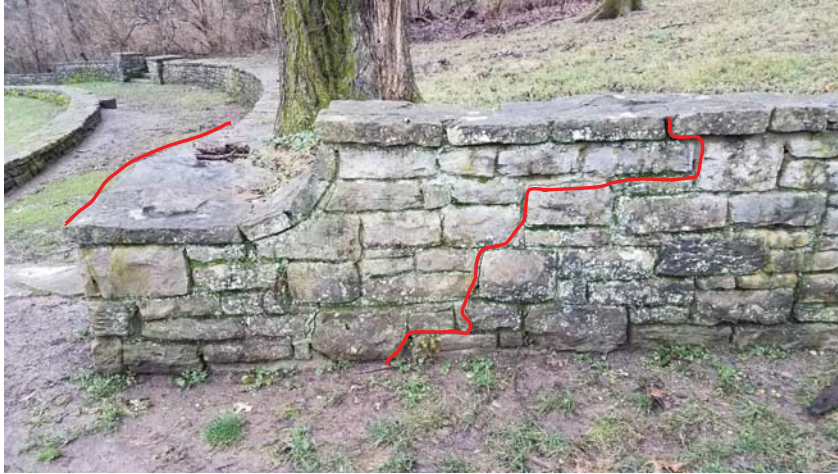
Select locations of wall appear to have some differential movement, due to either the original foundation inadequacy, or caused by the extreme moisture conditions changing the nearing conditions. Regardless, the net effect is that there are cracks through the wall, but the walls are stable. These walls will not be reset but will be repointed to close up the crack against moisture. See Photos 13, 14, 15. In one location, the roots of a large tree has pushed out the wall causing bulging, cracking and displacement. The wall has lost its integrity and needs resetting. See Photo 16 and 17.

Photo 17 Displacement of wall due to tree roots. This portion of the wall needs to be reset.

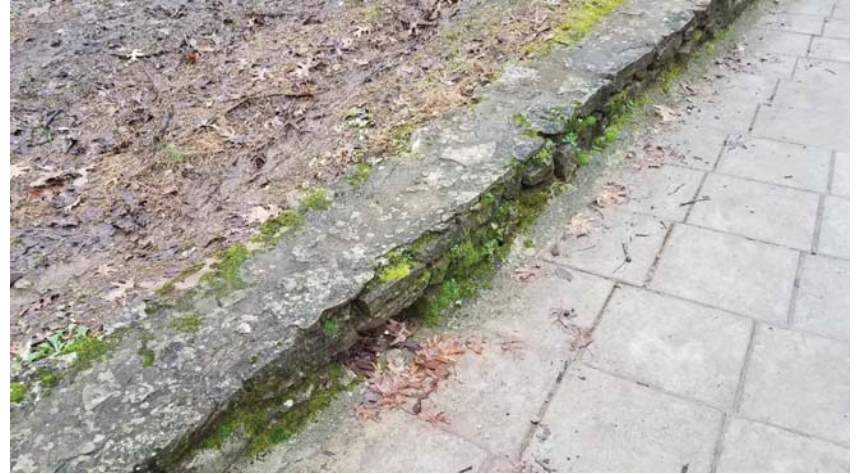
Photo 19 – Low retaining wall to be rebuilt. All mortar has washed out, wall is displacing. Note wash out of soil in lawn adjacent. Water mitigation must be completed before masonry work.

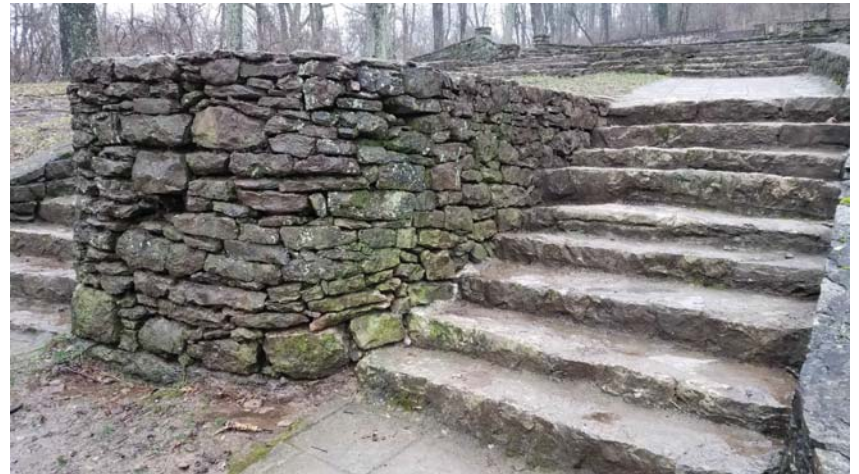
Photo 20 - Retaining wall to be rebuilt. All mortar has washed out, wall is displacing. Note irregular height of treads and lack of handrails and guard rails.

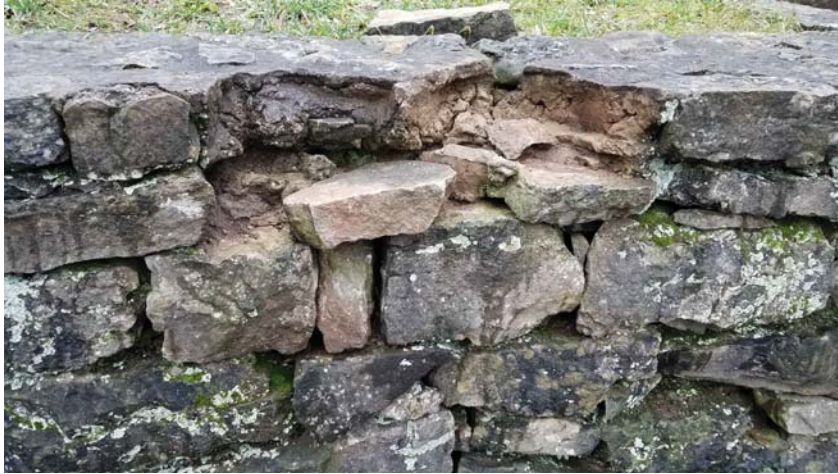
Photo 21 - Retaining wall to be rebuilt. All mortar has washed out, wall is displacing.

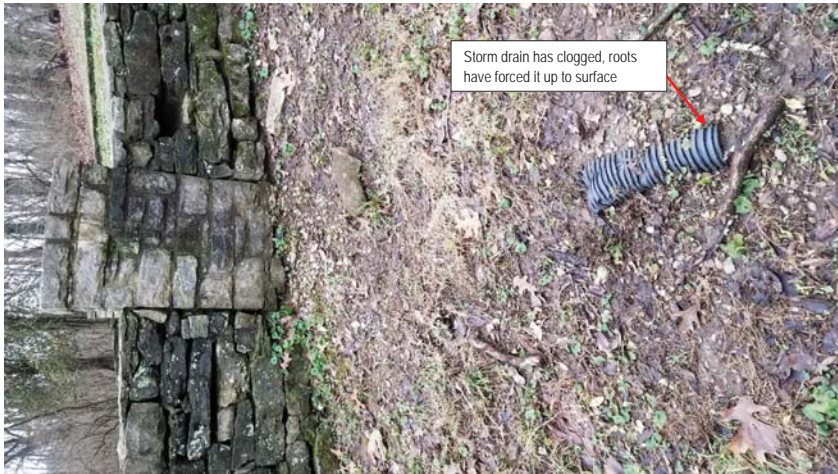
Photo 22 - Storm drainage placed to west of previous photo has failed.

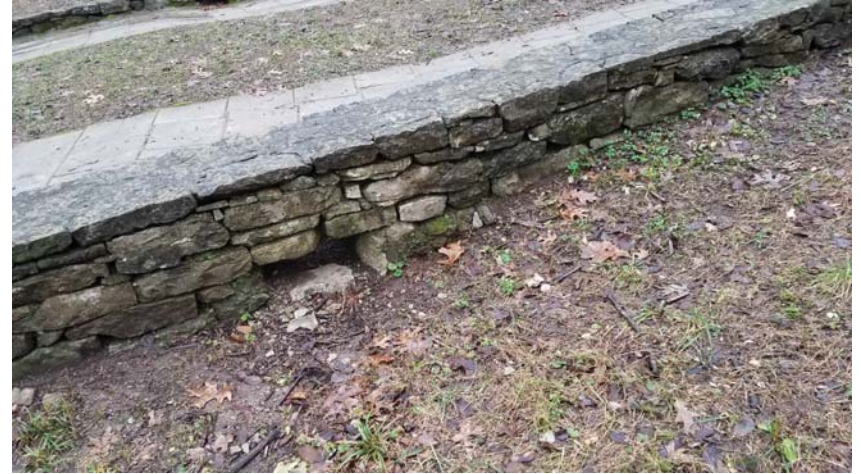
Photo 23 - Sidewall where all mortar has washed out and required rebuilding. Moisture from lawn side of wall back washing into scupper due to slopes.

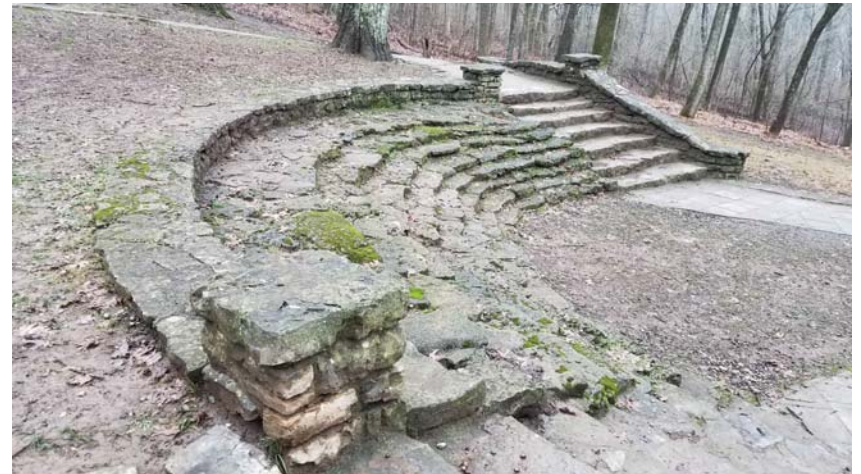
Photo 24 - Crescent area of steps / seating that has displaced and is washing out due to saturation from surface groundwater

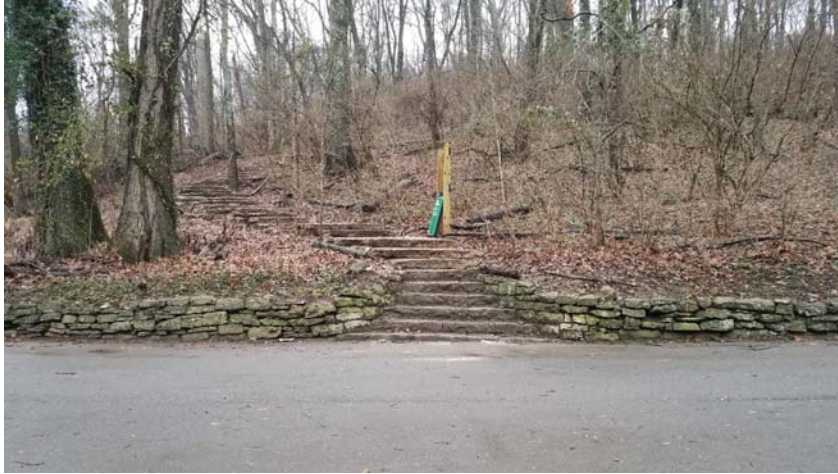
The retaining wall at south side of south roadway at top of stairs was dry stacked and has displaced with the amount of water flowing down the slopes in the area. As a result of the water, freeze thaw action has displaced the dry stacked stones, resulting in the wall being out of plumb and some stones getting out of position. See Photo 25.

Photo 25 - Retaining wall at south side of roadway at top of stairs was dry stacked and has displaced. Proposal to reset wall with mortar.

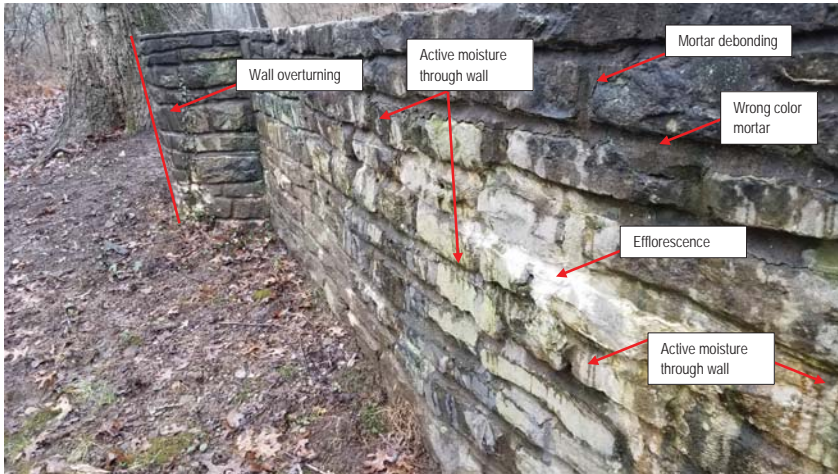
Photo 26 - Retaining wall at north side of roadway at top of stairs exhibiting efflorescence due to moisture passing straight through wall. Civil water mitigation may reduce effect in future.

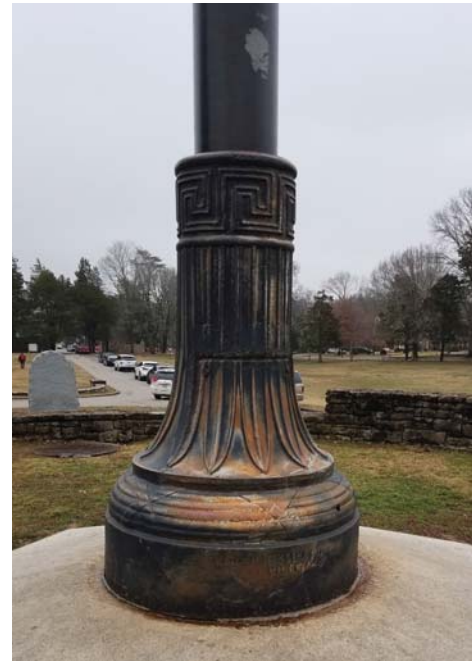
Photo 29 - Flagpole is not in scope, but paint film has weathered, and substrate exposed.

Based on the above identified conditions, it is recommended to refinish the metal base and flagpole. The materials of the flagpole and base will be identified, and the paint tested for lead. Based on the findings, a suitable refinishing process will be selected. Once the substrate is clean, a new exterior grade industrial paint film will be applied, of a type which can be field-repaired in the future.

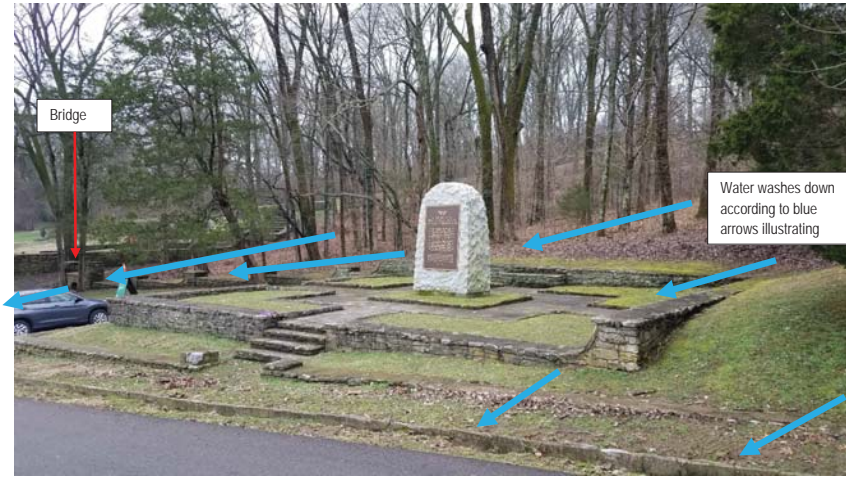
Photo 30 - World War I Memorial context view with path of water marked.

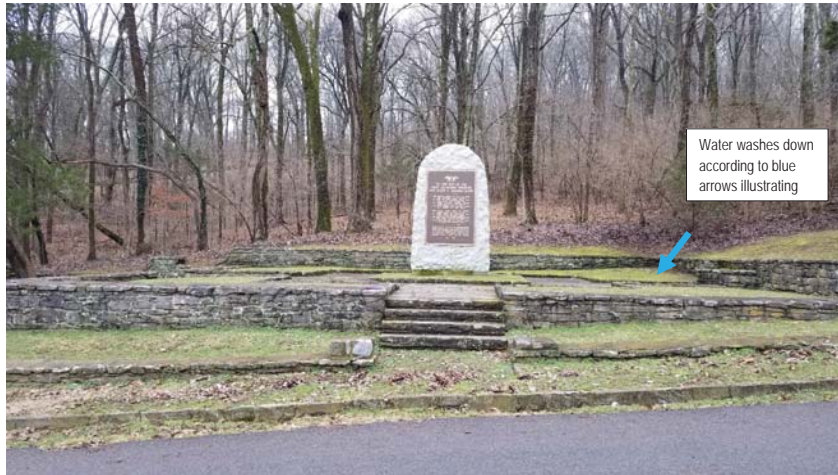
There is a large slope above the memorial, from which water flows into the corner of the memorial, washing away grasses, and depositing silt which has changed grade in the SE corner. See Photo 31 and 32. Other water from the slope above comes to the back of the retaining wall, which blocks its passage, and silt is deposited to the back side of the wall, and it washes to the east. See Photos 34 and 35.

Photo 31 - World War I Memorial general view, with specific water issue in SE marked.

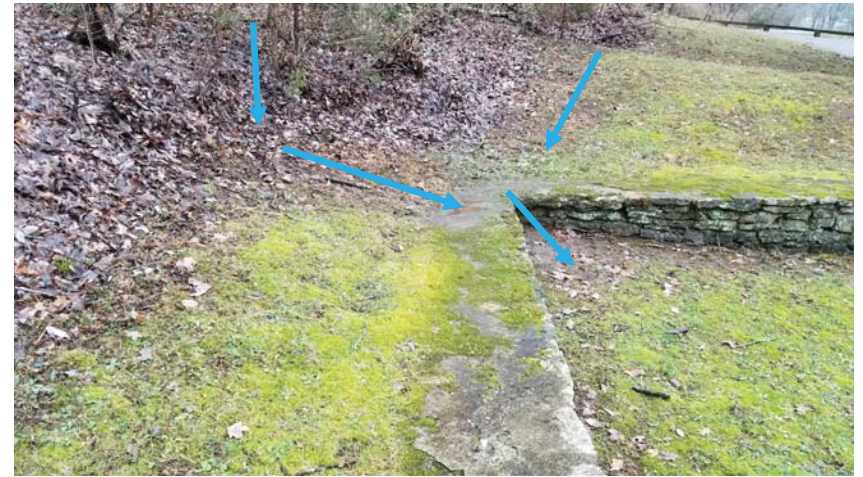
Photo 32 - World War I Memorial path of water SE corner

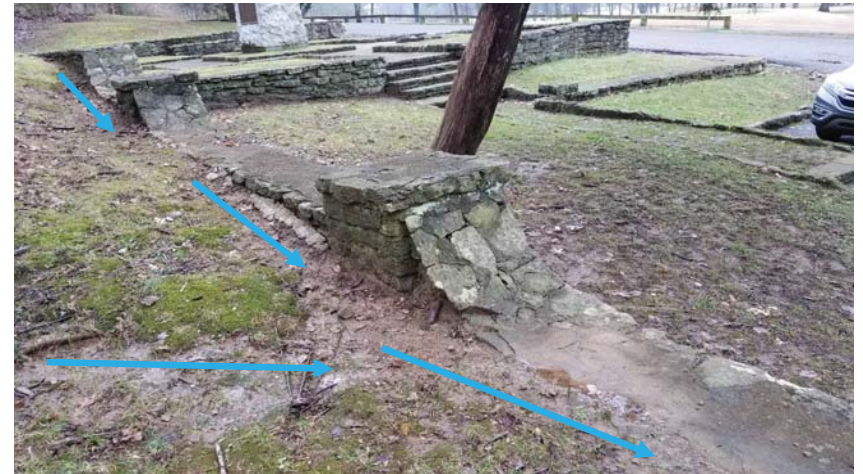
Photo 33 - World War I Memorial path of water from south, moving east, carrying silt

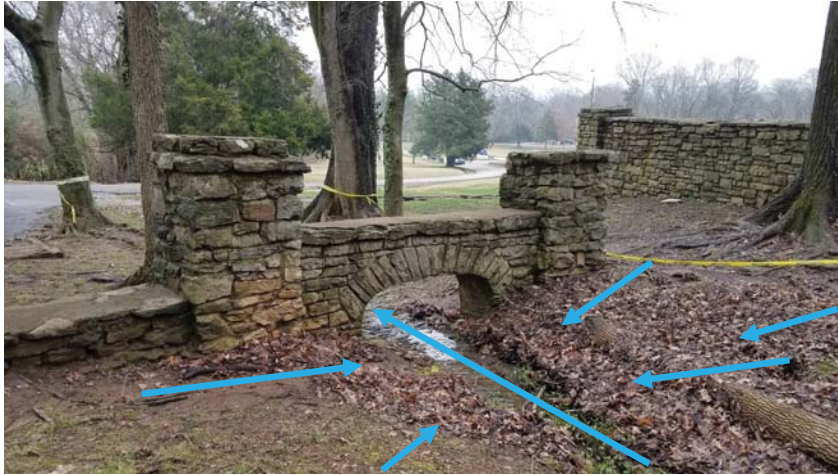
Photo 34 - World War I Memorial back of bridge, with path of water from south, moving east - quantity of water in the recent storm event resulted in overwhelming the storm drainage, and deposition of debris.

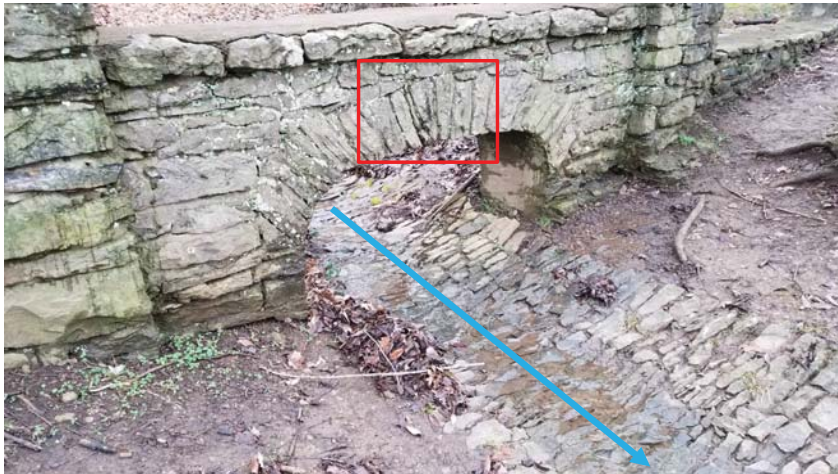
There is a small bridge at the east end of the Memorial. See Photos 35 and 36. It is displaying the same level of deterioration as the rest of the stonework. However, it additionally has a crack adjacent to the keystone. See Photo 37. Since there is no displacement of the keystone, it can be repointing in situ.

Photo 35 - World War I Memorial front of bridge with area of concern marked (see next photo)

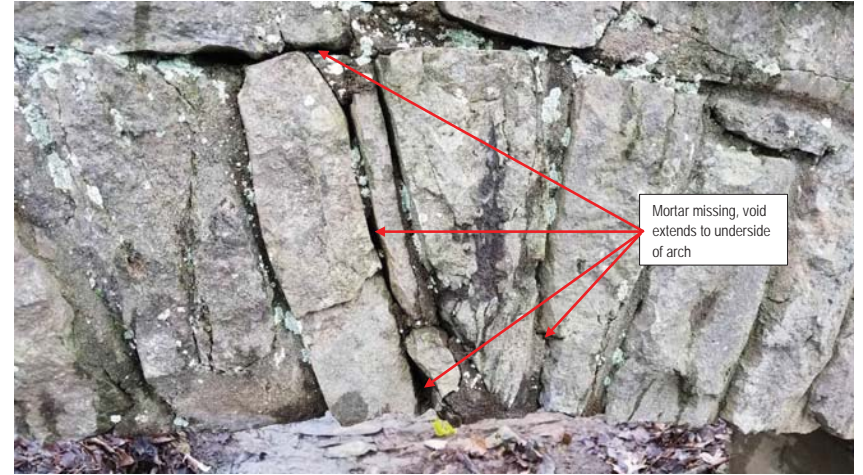
Photo 36 - World War I Memorial keystone arch (area of concern) is missing mortar, and has large crack passing down face and under arch. Study of structure is required.

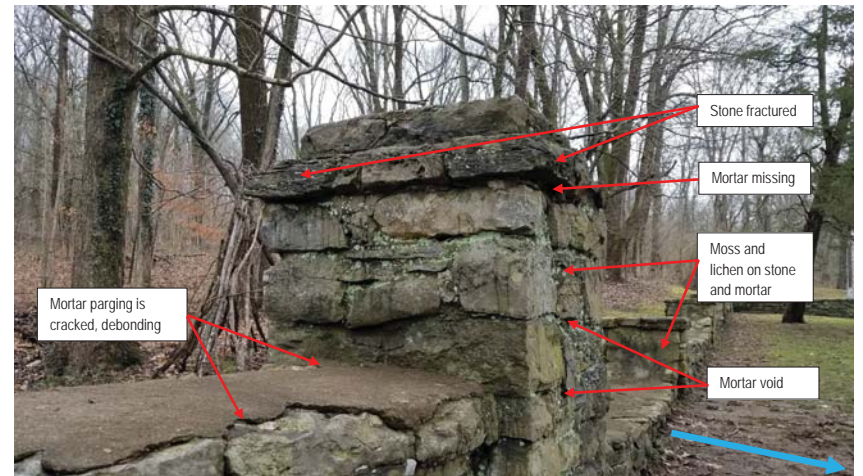
Photo 37 - World War I Memorial west side of bridge. Note spalling stones, poor condition of mortar, typical of the memorial.
