# WARNER PARKS ALLÉE

STORMWATER & LANDSCAPE  
PLANNING DOCUMENT

## Masonry Condition Assessment Percy Warner Alleé

Masonry Condition Assessment  
Percy Warner Alleé and WW I Memorial, Metro-Nashville Parks & Recreation

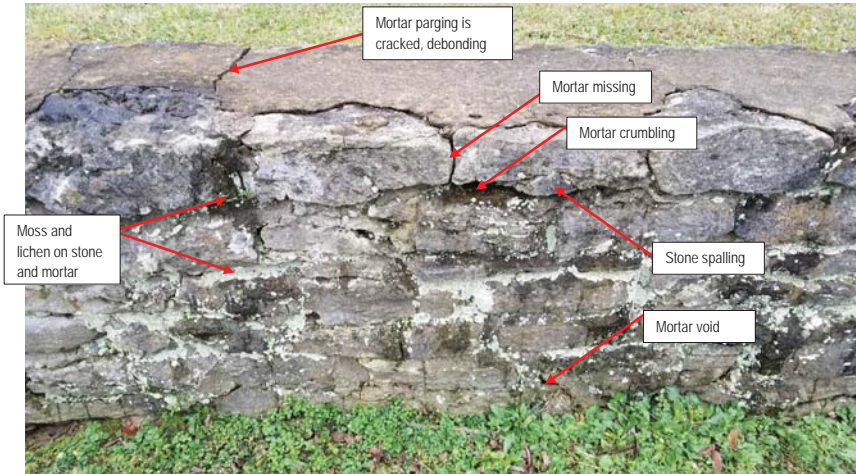
**Photo 38 - World War I Memorial typical wall. Note spalling stones, poor condition of mortar, typical of the Memorial.**

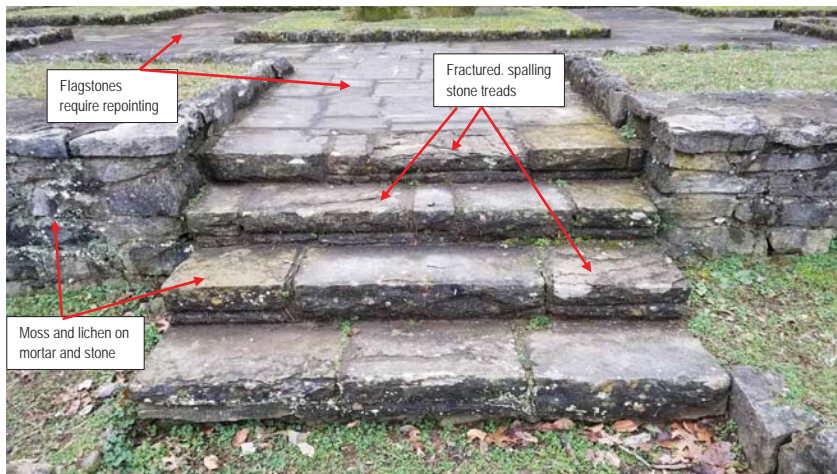
**Photo 39 - World War I Memorial front steps conditions, typical of all areas of steps and flagstones on the Memorial.**
