# Richland Creek Watershed Management Plan

Prepared by Metro Water Services Stormwater Division

12/20/2016

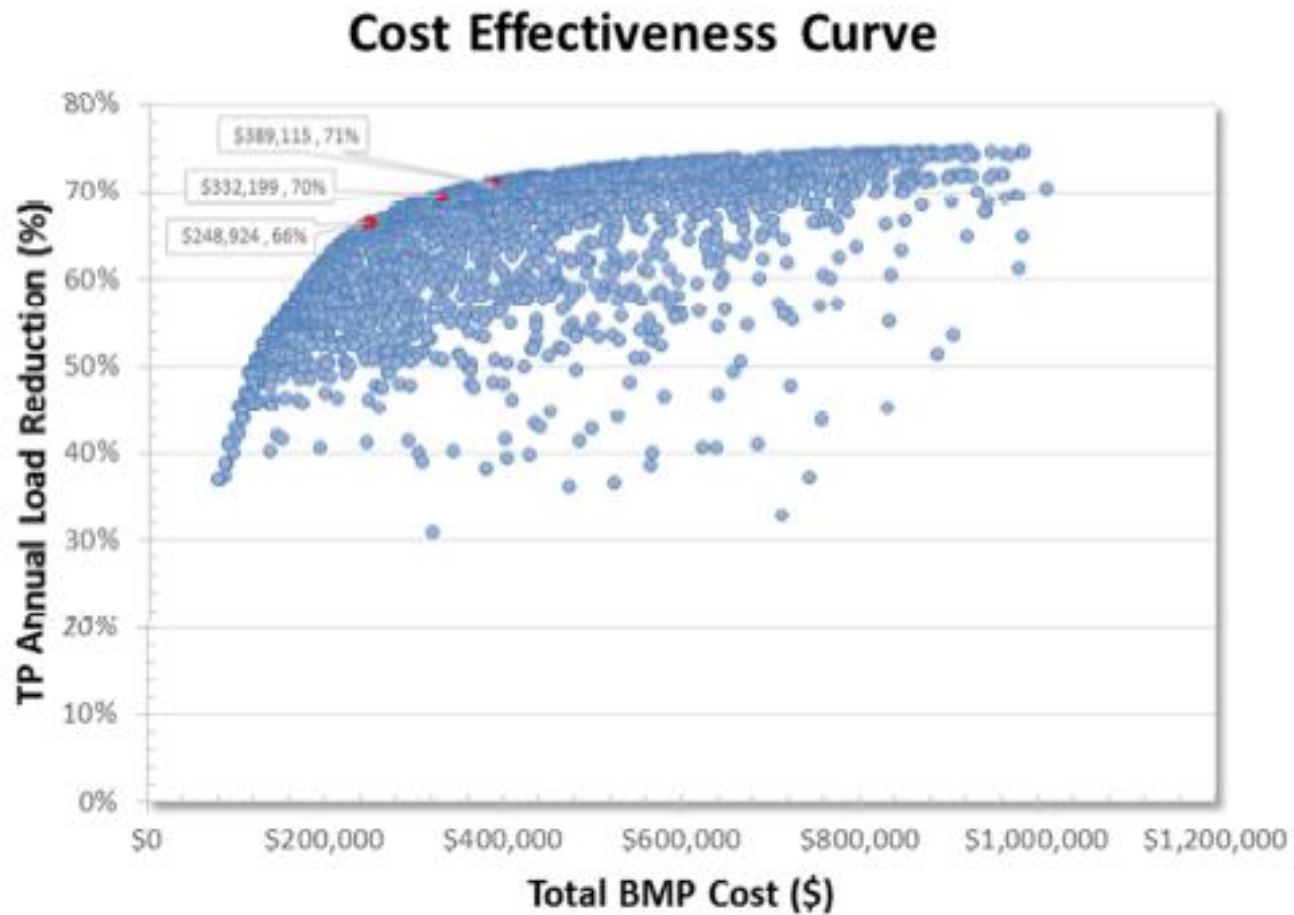
**Figure 31.** Cost effectiveness curve for potential bmp combinations.

Three best solutions were selected on the frontier of the curve by the SUSTAIN pilot to demonstrate the cost versus percent TP load reduction benefits (Figure 31). However, this application must be accompanied by an intimate understanding of the study area and the identification of influential factors that affect the decision making to achieve Stormwater management goals. For example, the Best Solution 1 chosen by the SUSTAIN model would cost \$389,115 to achieve an estimated 71% TP annual load reduction, whereas the Best Solution 2 chosen by the model would cost \$56,916 less than Best Solution 1 but will still achieve 70% load reduction. Best Solution 3, however, costs 36% less (\$140,191) than Best Solution 1 with only 5% less load reduction. The small reduction in nutrients may not be worth the additional cost, which in this case is equal to \$28,000 per additional percent in TP load reduction.

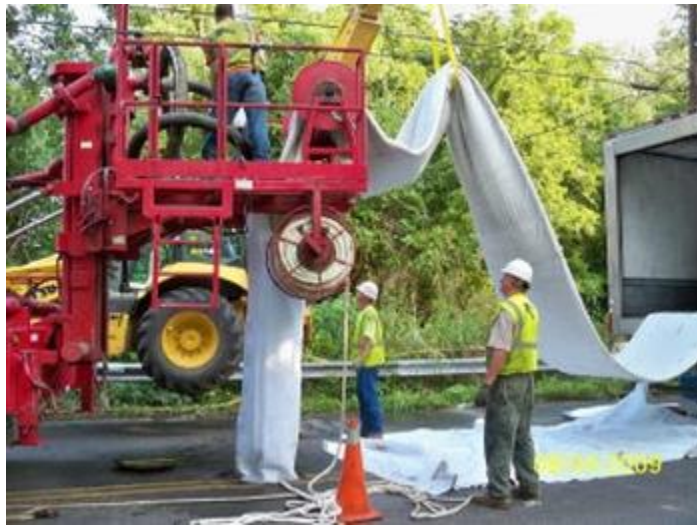
**Figure 32.** This picture shows a sewer lining project that is used to reduce infiltration into the sewers.

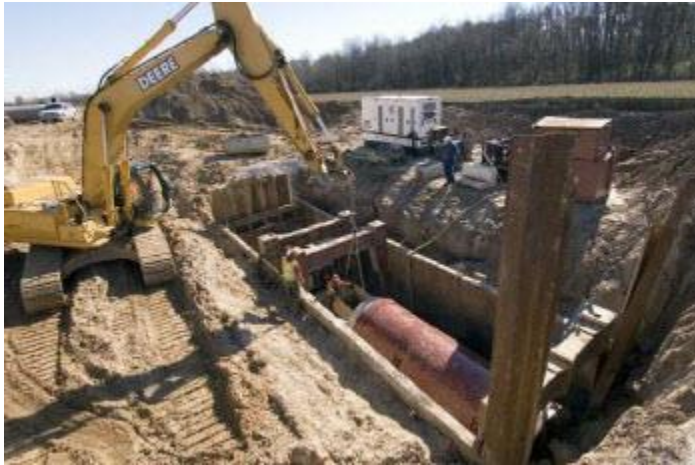
**Figure 33.** This picture shows a new conveyance being installed that will increase carrying capacity of undersized sewer mains.

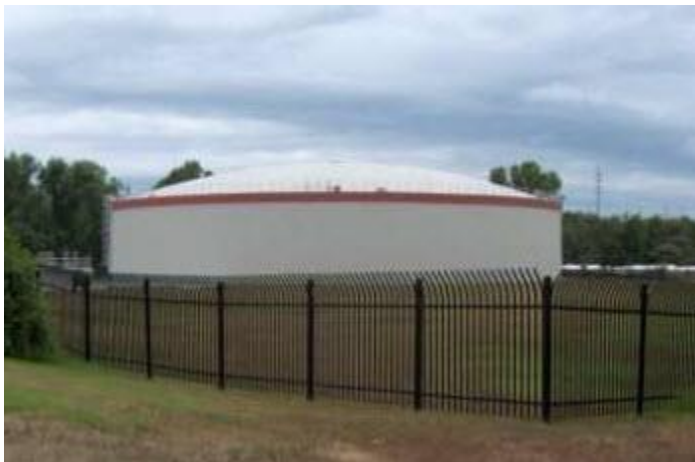
**Figure 34.** This equalization basin was installed to store sewer during times of peak flow and when sewer capacity is at a maximum.

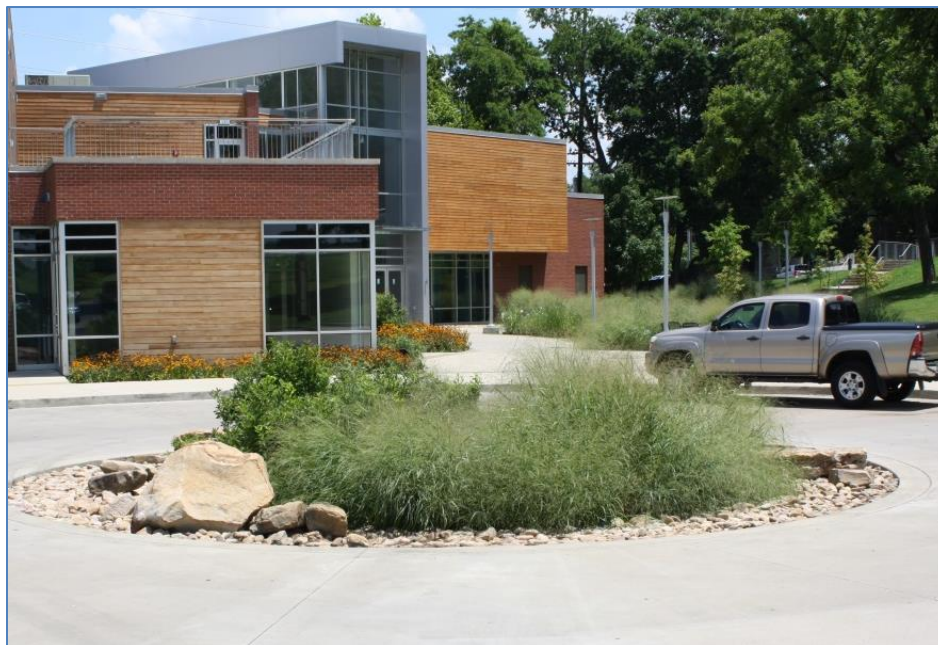
**Figure 37.** Installation of bioretention at McCabe Community Center.

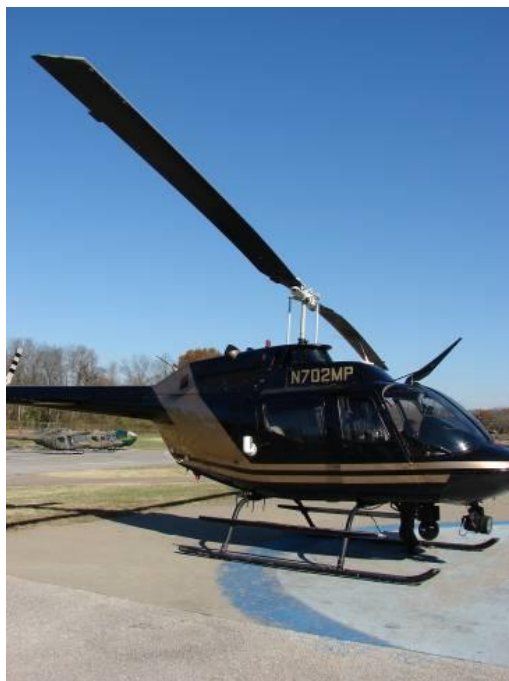
**Figure 38.** MNPD helicopter with FLIR camera

The Thermograph Program uses infrared cameras to detect heat signatures in water bodies that could signify pollutants entering streams/rivers. Metro Nashville Police Department's helicopter (Figure 38) is equipped with a FLIR camera and flies with an NPDES employee who maps the flight. The video is reviewed and anomalies are mapped using ArcGIS.

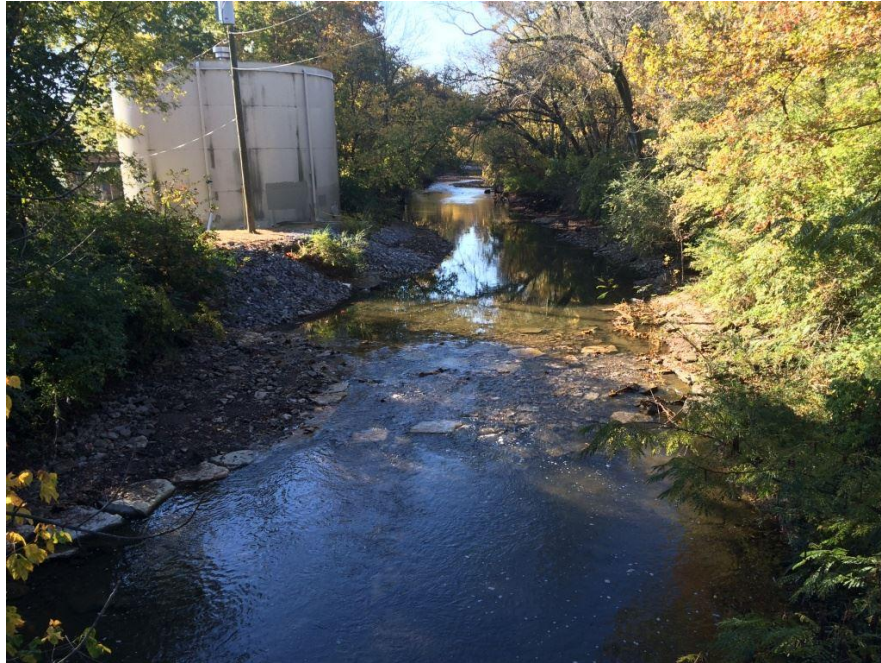
**Figure 41.** Richland Creek following dam removal.

There have been numerous water quality improvement projects as a result from the Stewardship Plan. One major project within the Richland Creek watershed was the removal of a low-head dam within the main stem of Richland Creek. This dam was initially installed to aid in the withdrawal of water for Metro owned McCabe Golf Course. It created a fish barrier, decreased dissolved oxygen within this stretch of the stream, and assumedly lowered the biodiversity of aquatic life due to the lack of natural substrate. Following removal of the dam, the stream banks were stabilized with rock and vegetation (Figure 41). The stream will naturally create habitat over time.

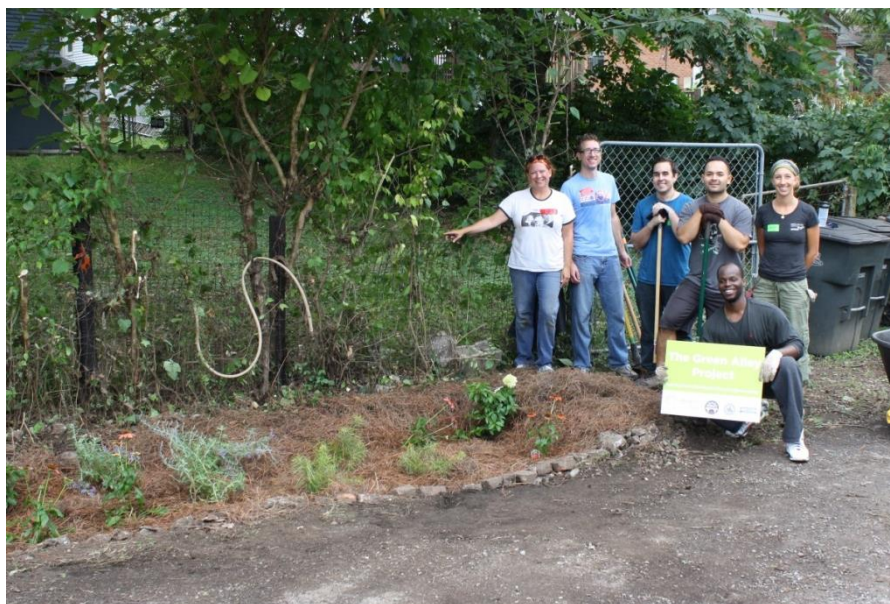
**Figure 42.** Volunteers working on installation of a Green Alley rain garden

The Green Alley Project is located within the Nations neighborhood. 100 rain gardens were built within alleyways of this neighborhood which is located within the lower portions of Richland Creek (Figure 42). It is estimated that each rain garden infiltrates 42,000 gallons of rain water each year. The project as a whole treats 4,200,000 gallons of rain each year.

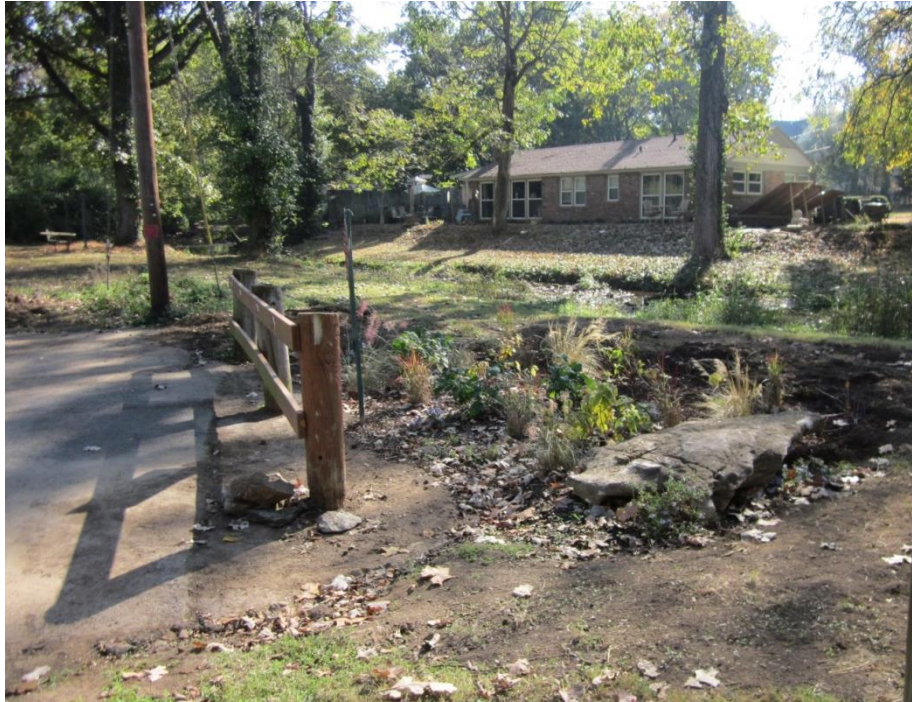
**Figure 43.** Recent installation of a rain garden at the end of Hilldale Drive.

One large rain garden project has been planted along Sugartree Creek at the end of Hilldale Drive. This project is part of the implementation phase of the SUSTAIN model. As shown in the picture (Figure 43), it will provide treatment for the stormwater runoff before the water enters the stream.
