HISTORIC STRUCTURE REPORT
FORT NEGLEY
Nashville, Tennessee

FINAL REPORT (CORRECTED)
January 31, 2014

CHAPTER I.3 – CONDITION ASSESSMENT

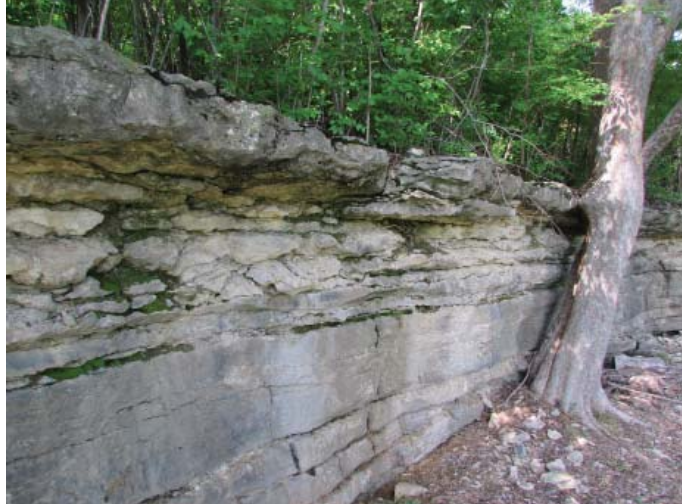
Stone delamination and associated material loss at Fort Negley is a direct result of the material's sedimentary formation. The locally-quarried Ordovician limestone is relatively soft and easily friable (Figure 65). Some of the stones can be readily seen to be delaminating along layers, or "bedding planes," of stone and sand. Deterioration appears to be ongoing throughout the natural bedrock in Fort Negley Park and in the fortification walls without regard to the sizes of the stones (Figures 66 and 67). In other instances, where the sedimentary materials are not well bonded due

Figure 66. Various stages of delamination in exterior facing stones (1200AE, 2013).

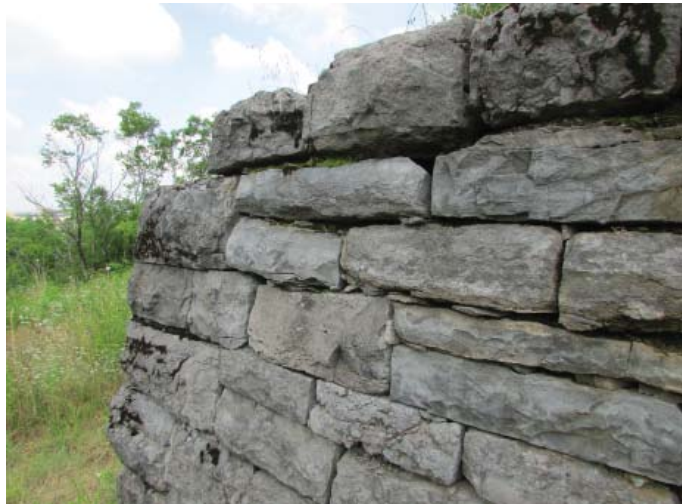
Figure 67. Advanced decomposition in exterior facing stones and loss of material (1200AE, 2013).

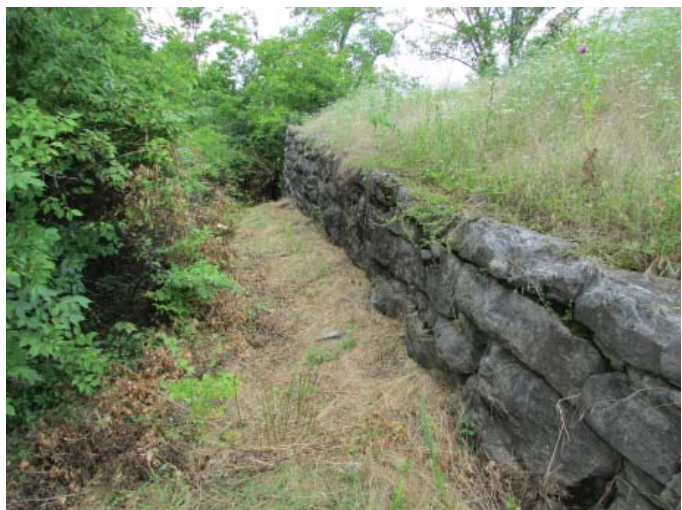
Capstone Loss or Dislocation. Many areas of the fortification walls, especially noticeable at the interior parapet walls, also exhibited a loss or dislocation of capstones at the tops of the walls (Figures 70 and 74). This loss is likely due to the growth of ground vegetation, heaving due to freeze and thaw of the upper two feet of soil along the back face of the wall, and possibly (though not observed) human traffic and/or vandalism. Capstones in many areas have been pushed forward out of the vertical wall plane below and have often fallen forward onto the ground below. In many instances, stones are missing where one stone has fallen or even entire long rows are missing. This loss of capstone units reduces the overall weight of the gravity retaining wall to resist lateral soil pressure and enables water to infiltrate the interior of the masonry walls which, in addition to the deterioration mechanisms described above, also leads to the loss of fill material.

Figure 74. Localized wall displacement and missing capstones (JMA, 2013).

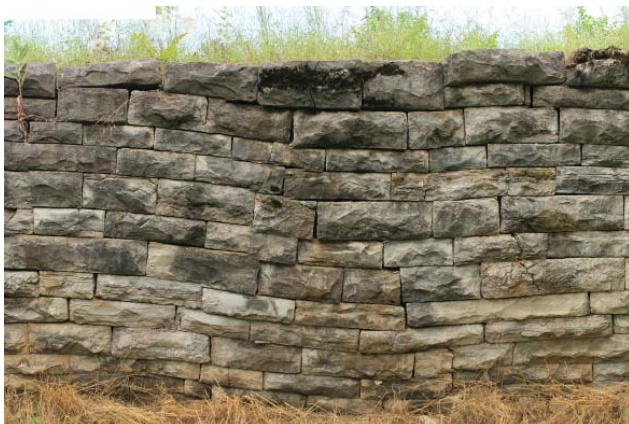
Figure 76. Sagging wall, possibly due to poor soils, animal burrows, or undermining (JMA, 2013).

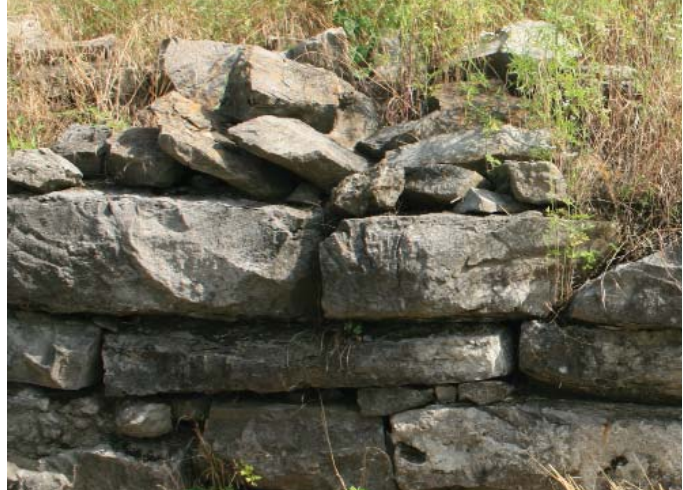
Dry-stacked stone walls are strengthened by installing “deadmen” — stones set at right angles to extend back into the rubble or soil behind the wall. These stones tie the wall to the backup using friction to limit movement. At Fort Negley, deadmen are often small and rectangular in section. Some of these have been “edge bedded” with the deposit layers in the stone laid vertically (Figure 75), increasing their susceptibility to water saturation and delamination. Stone coursing at several locations around the fort also appears to be sagging, probably due to settlement or compaction of soils (Figure 76). Large piles of rubble on the berms at the tops of some walls have also increased loads acting on these walls (Figure 77).

Figure 77. Stone rubble piled on top of wall (JMA, 2013).

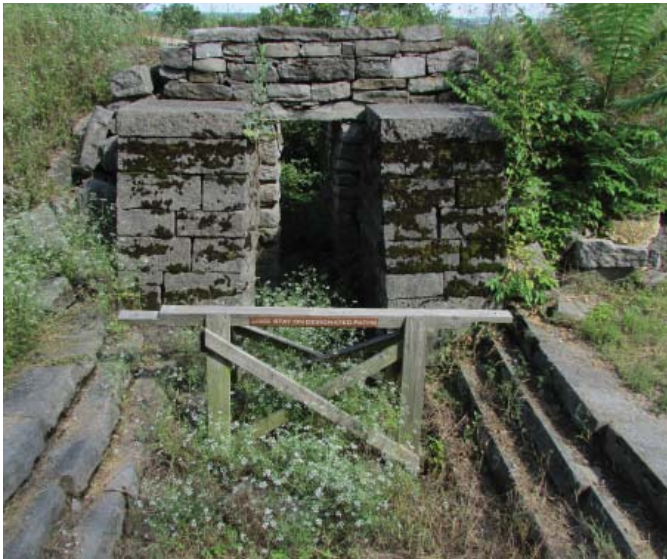
Figure 86 (above). West Sally Port linking inner works to West Ravelin ditch (Redan No. 4 beyond) (1200AE, 2013).

Note tapered wall height at left and limited wall height to right. Dead-end of boardwalk beyond. Yellow arrow represents area of stone delamination.

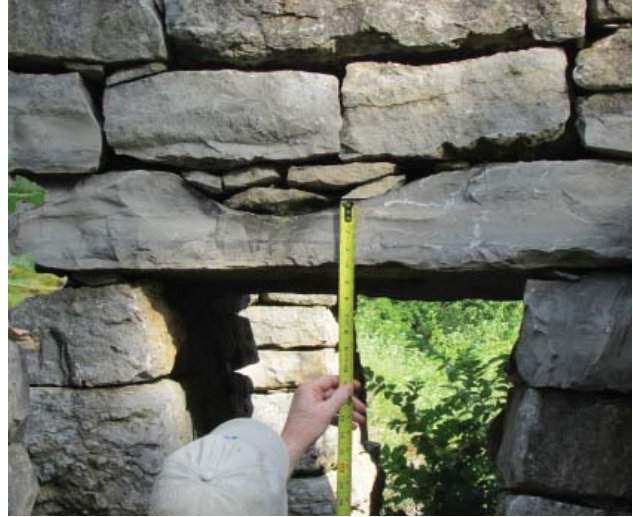
Figure 90 (above right). East Bastion tunnel with notched lintel (1200AE, 2013).

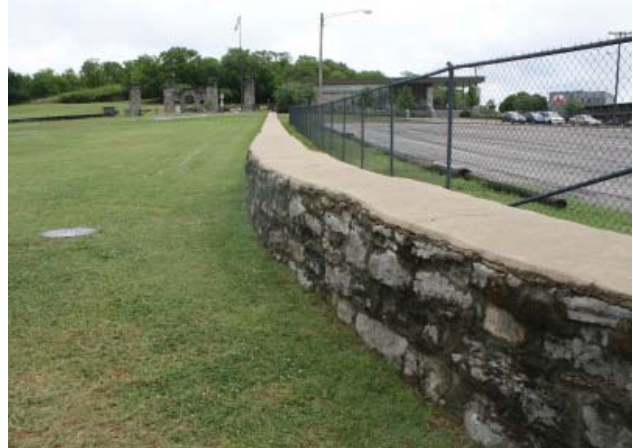
Figure 103. Northern pier of the northwest wing wall at entrance gate, looking west (JMA, 2013).

Damage includes missing mortar joints, inappropriate repairs, cracked and displaced masonry units, bleaching from landscape chemicals, and biological growth.

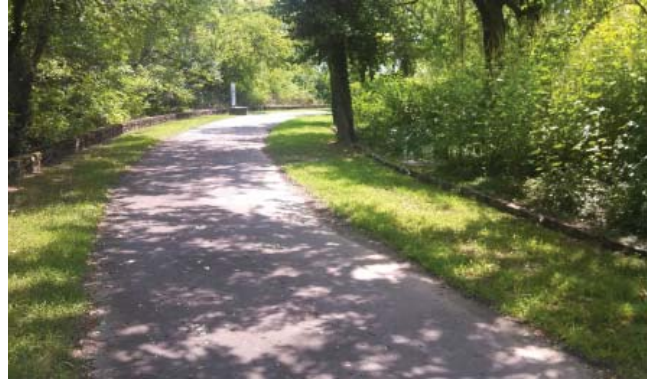
Figure 108. Damp road surfaces at edge indicate locations of ponding (LEA, 2013).

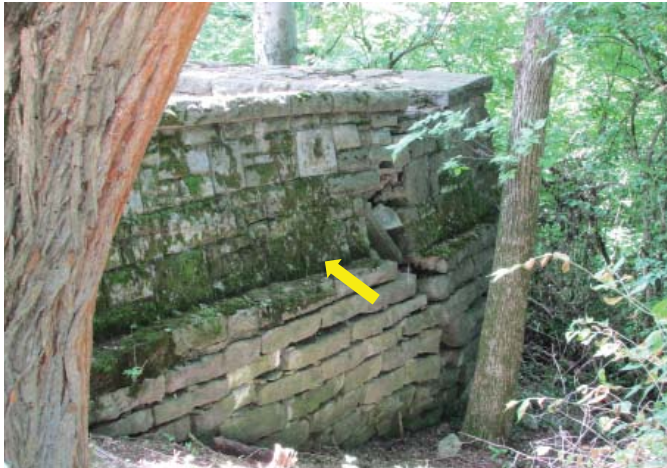
Areas of structural distress are mostly isolated to the east and west ends of the lower retaining wall and parapet (Figures 110 through 112, and see also Appendix B, diagram SSK-1). Vertical and diagonal cracks were observed at both ends of the retaining wall, and diagonal cracks have also developed, apparently due to out-of-plane sliding displacement (Figure 113). A complete collapse has occurred at the northwest corner of the retaining wall and the parapet above, approximately 12 linear feet (see Figure 111). Partial collapses have also occurred at the ends of the parapet return walls. It appears that gravel has been placed to stabilize the soils along the top surface of the parking lot. The formation of hinge points, cracks, and areas of collapse negatively effects the tie action of the parapet to resist out-of-plane forces, and future movement should be anticipated.

Figure 112. Parapet wall construction on top of dry-stacked stone wall (yellow arrow) and collapse at NW corner of wall due to sliding of corner down the hill (1200AE, 2013).

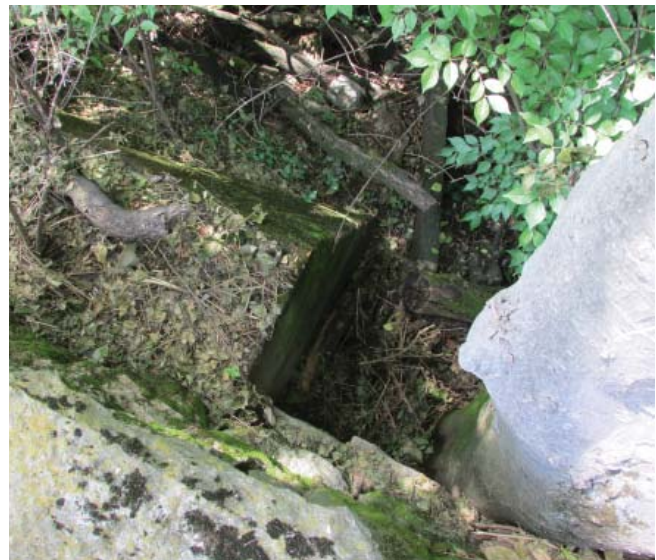
Four large concrete buttresses constructed along the toe (downhill) side of the dry-stack gravity retaining wall below were likely installed in an attempt to stabilize the wall against additional lateral movement (Figure 115). Three buttresses are positioned on the eastern half of the wall length and the remaining buttress is positioned within the western half of the wall. In this configuration, the buttresses act as primary lateral supports and the masonry retaining wall spans horizontally between them. As a result, two hinge points were observed in the top of the wall (Appendix B, diagram SSK-1) at the easternmost and western buttresses. The buttresses appear to be restricting movement in the center portions of the retaining wall allowing out-of-plane displacement (sliding) to occur at the northeast corner and along the western half of the wall.

Figure 115. Loss of capstone units and delamination of exterior surface of stones. (1200AE).

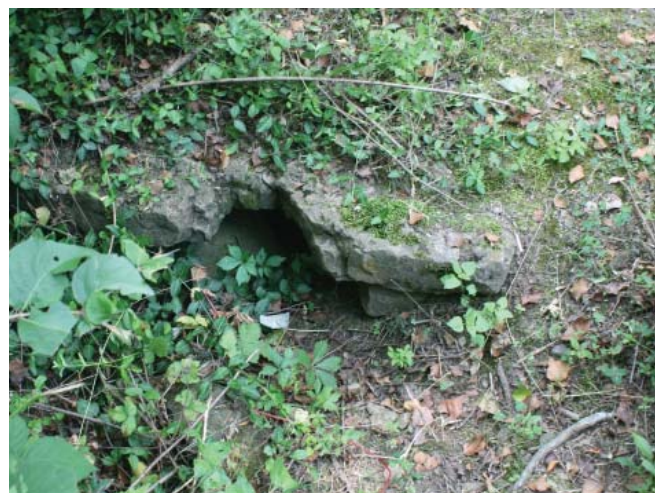
Original limestone slab caps protecting drop inlets were set up on low limestone rubble corner blocks to allow water flow into the culvert (Figure 116). Some of the limestone slabs collapsed into the inlets or have been replaced with concrete slabs (see Figure 42 in Chapter I.2) incompatible with the rustic design. Some of the inlets were not visible for investigation.

Figure 116. Partially-buried limestone drop inlet cover (JMA, 2013).

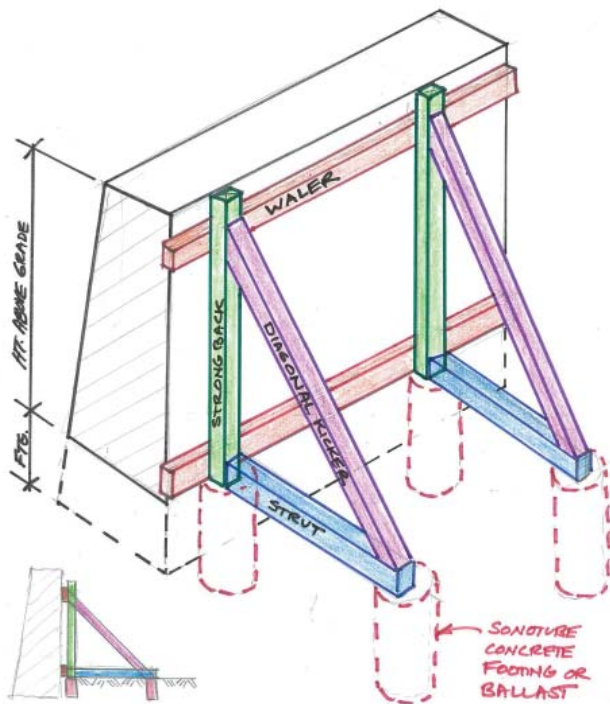
Figure 120. Temporary shoring concept (1200AE).

- *First*, temporarily shore or brace bastion tunnels to address the immediate threats to life safety and then shore or brace walls exhibiting bulges and out-of-plane displacements to maintain the existing wall construction wherever there is a high probability of further collapse;
- *Second*, stabilize walls with grouted stainless steel soil and masonry anchors.

Bracing to resist lateral earth pressure consists of horizontal “walers” set tight to the wall surface and spanning between timber buttresses set at regular 10- to 15-foot intervals. These buttresses would be constructed in a triangulated fashion of vertical “strong-backs,” laid flush against the walers, and diagonal “kickers” (rakers) with horizontal struts, similar to Figure 120 (above left). The bases of the strong-backs and the diagonal kickers would be set on small isolated concrete footings, poured in place, to resist horizontal and vertical forces. Alternatively, ballast or large precast concrete slabs could be placed on top of the soil surface to minimize disturbance to the subgrade and associated archaeological remains.

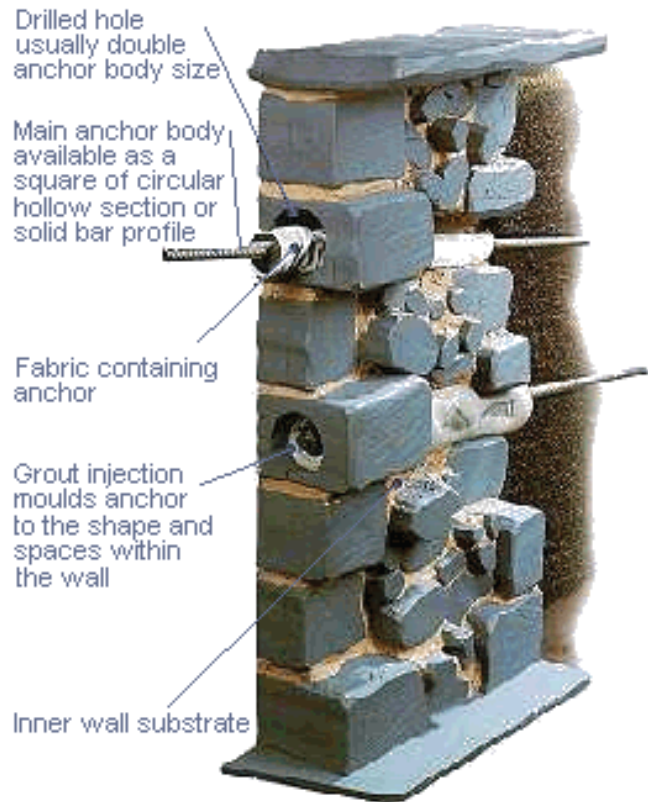
Figure 121: Components of grouted masonry sock anchoring (reproduced courtesy of Cintec Worldwide).

An oversized hole is pre-drilled in the wall structure using a diamond coring bit which operates at low speed to minimize harmful vibration. A stainless steel anchor body (hollow pipe or tube) surrounded by a fabric sock is inserted and, following insertion, a low-pressure cementitious

grout is injected through the middle of the anchor. The grout passes through a series of clearance holes into the fabric sock, inflating the entire assembly like a balloon from the rear of the anchor forward and keying into the natural void areas of masonry, rubble infill and soils (Figure 121).

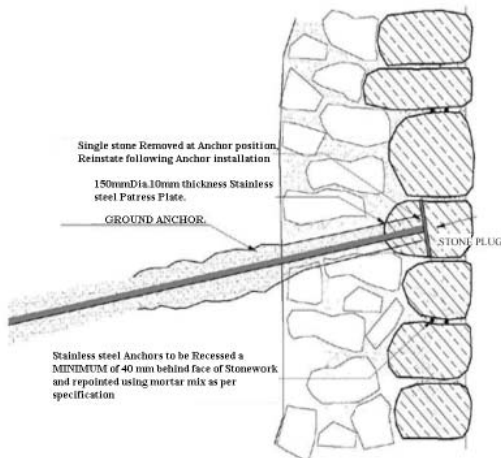
Figure 122. Grouted soil sock anchor through various substrates including dressed stone, rubble fill and soil substrates (reproduced courtesy of Cintec Worldwide).

This method improves the interconnection of different structural materials, providing a mechanical connection between interstitial layers where the grout enables formation of a light chemical bond between surfaces (Figure 122). If reversibility is required, the anchors can be removed by over-coring with a slightly larger bit.

The stone anchoring system (as shown in Figures 122 and 123) can be adapted to serve as soil anchors (tie-backs) by extending the reinforcement beyond the failure planes as required by the given soil conditions. To resist out-of-plane displacement in the dry-stacked stone retaining walls, the grouted anchors would be positioned at the upper half of wall. Similar to the installation of buttresses, the anchors enable the gravity wall to span (arch) horizontally between anchor locations.

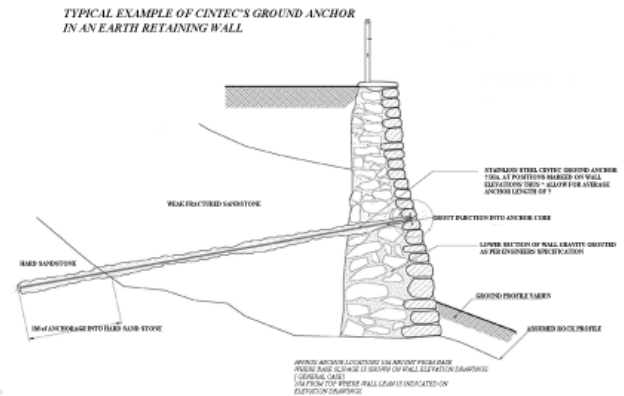
Figure 123. Example of grouted soil anchor for lateral restraint of existing rubble gravity retaining wall (reproduced courtesy of Cintec Worldwide).
