METROPOLITAN GOVERNMENT OF NASHVILLE AND DAVIDSON COUNTY

STAFF RECOMMENDATION
1830 5th Avenue North
January 20, 2021

Application: Demolition
District: Salemtown Neighborhood Conservation Zoning Overlay
Council District: 19
Map and Parcel Number: 081 08 0M 002.00
Applicant: Jeff Zeitlin
Project Lead: Paul Hoffman, paul.hoffman@nashville.gov

SUBJECT: Feasibility Opinion Letter
1830 5th Avenue N, Nashville, TN
SE&I Project No: 20-1316

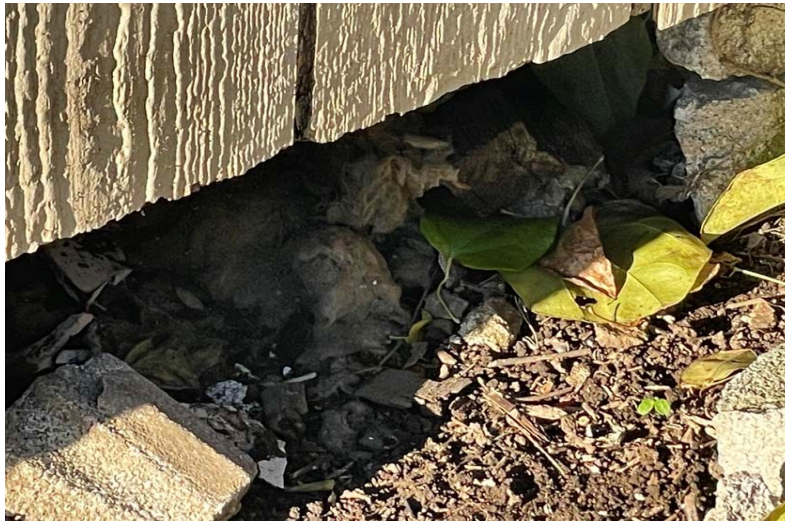
View of Crawl Space Access (9"x18")

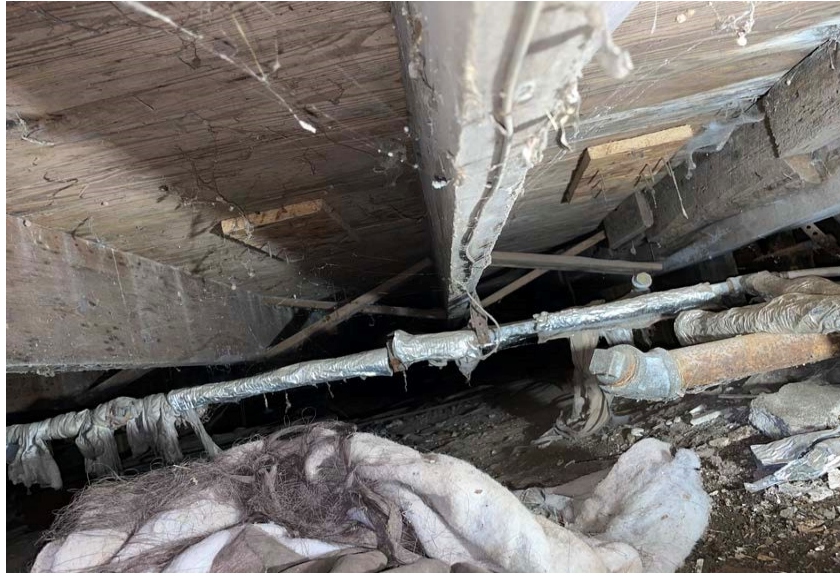
View of Crawl Space – No accessibility; No vapor barrier
