METROPOLITAN GOVERNMENT OF NASHVILLE AND DAVIDSON COUNTY

STAFF RECOMMENDATION
1204 Russell Street
March 17, 2021

Description of Project: The applicant requests demolition of a contributing building, arguing for economic hardship.

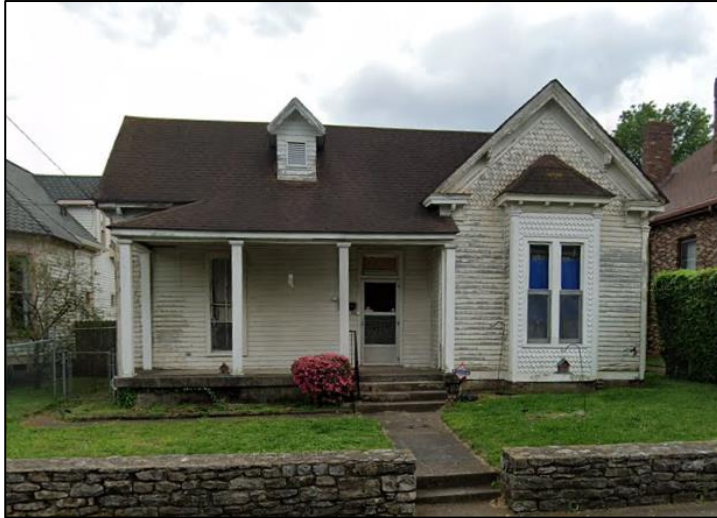
Figure 1: 1204 Russell Street.

Background: 1204 Russell Street was built circa 1890 and is a contributing building in the Lockeland Springs-East End Neighborhood Conservation Zoning Overlay (Figures 1 and 2).

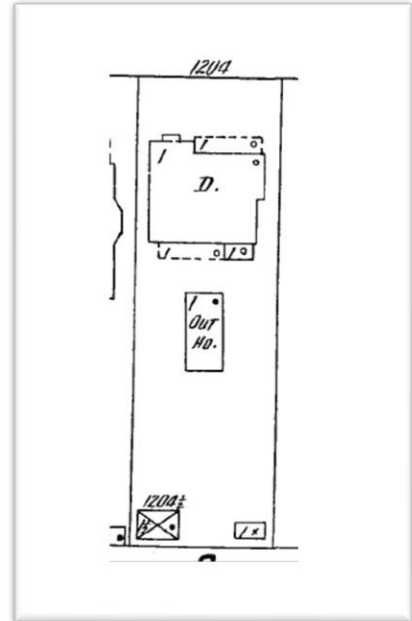
Figure 2: 1914 Sanborn map. “Outhouse” has been connected to the house at an unknown time.

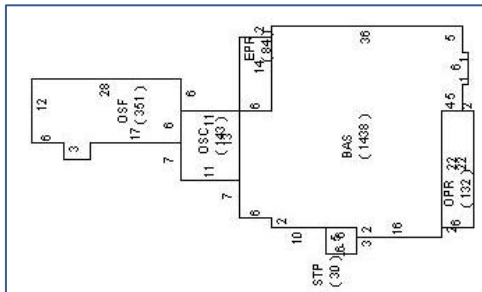
The cost of exterior repairs of the historic portion of the building alone is not clear. (Please also see analysis of #4.) The rear wall of the historic portion of the building is thirty-six feet (36’) back from the front wall. Anything beyond that rear wall would be approvable for demolition and so repair of that section of the house would not be a factor in the commission’s determination of compliance.

Figure 3: The area indicated approximates the historic footprint of the home. Portions of the home beyond the original rear wall could be removed.

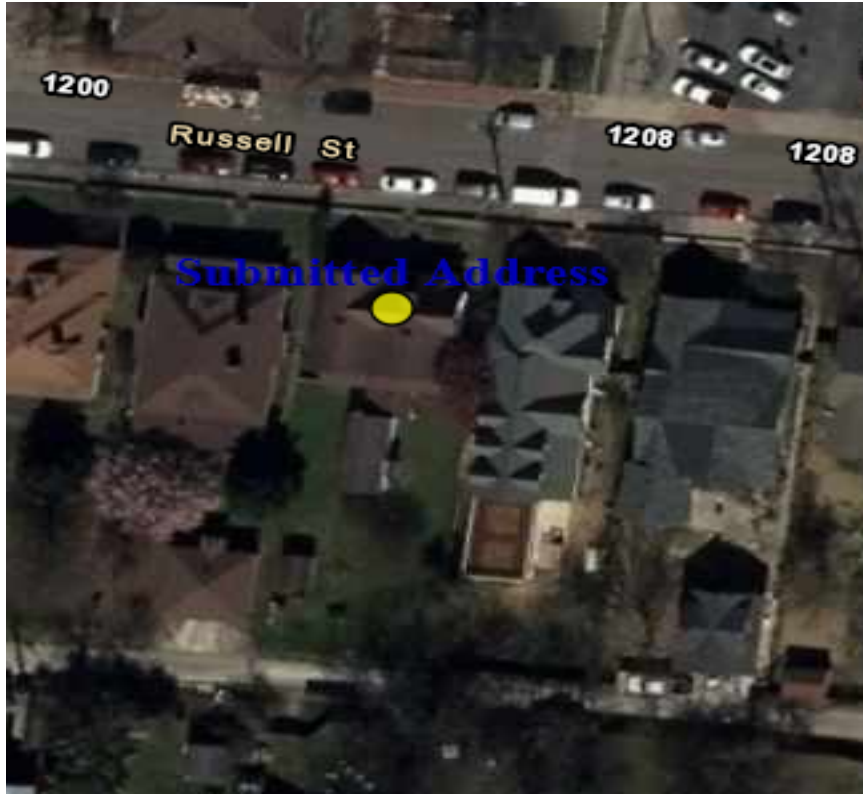
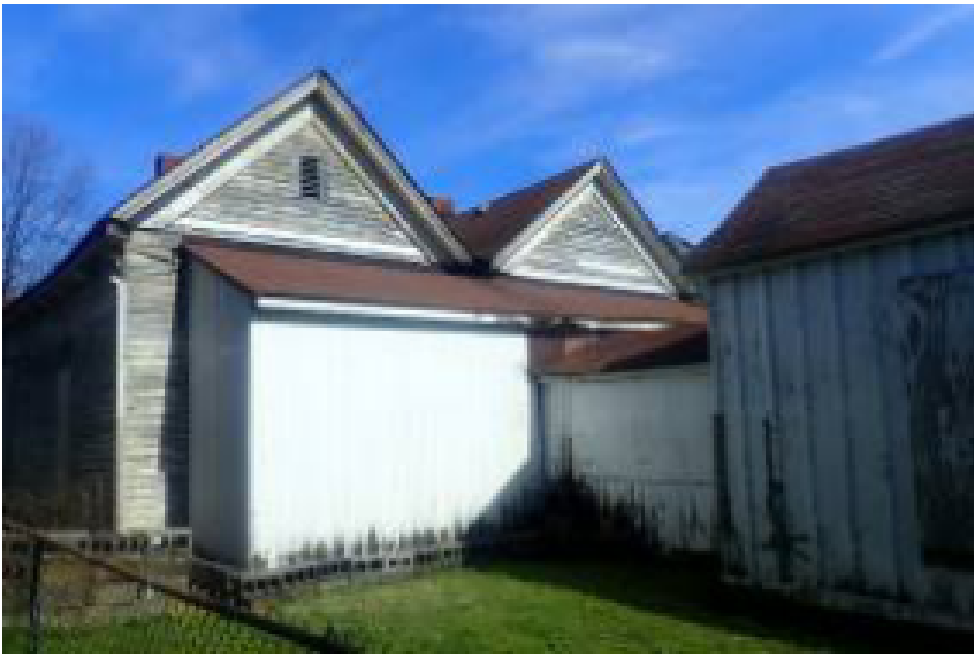
The two additions are also proposed to be removed. These structures do not contribute to the architectural or historical significance of the district, and that their demolition meets Section II.B.2 for appropriate demolition.

Figure 2. Two additional add ons to the building.

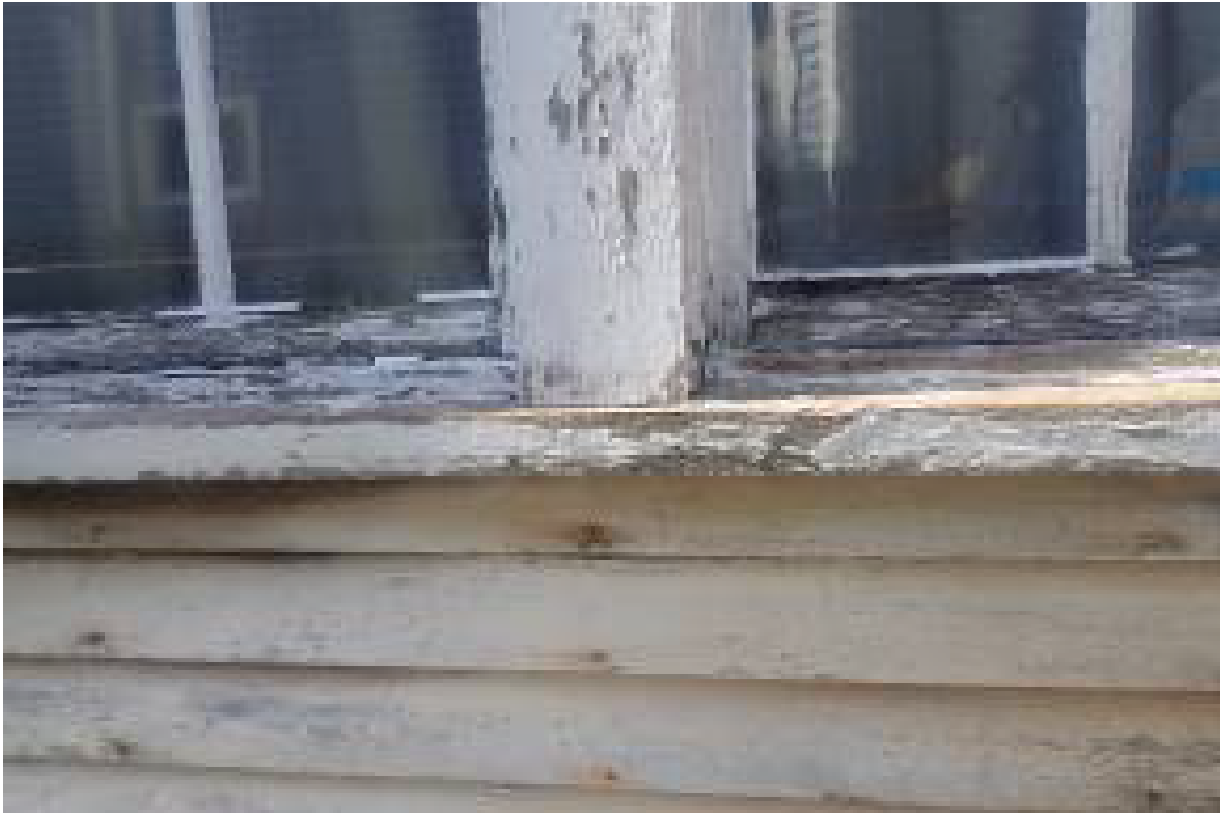
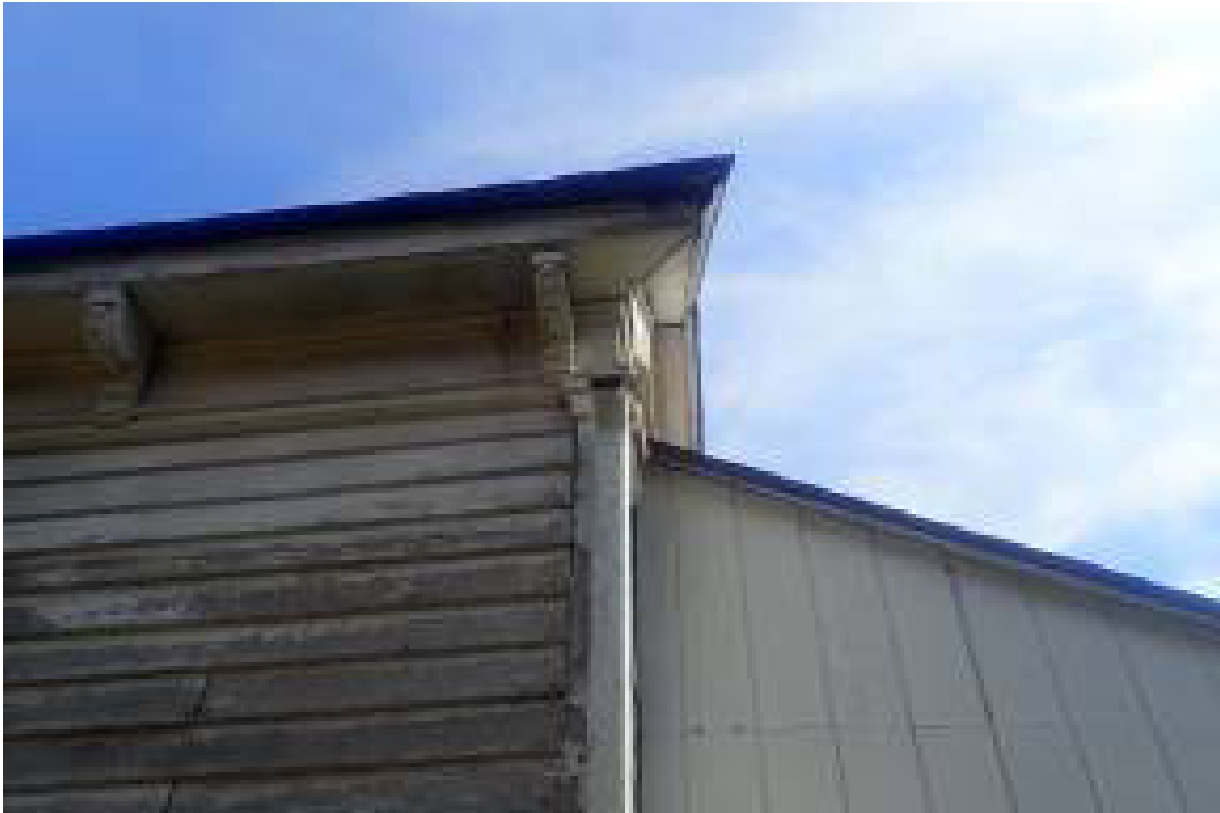
EXTERIOR DEFICIENCIES (Cont'd)

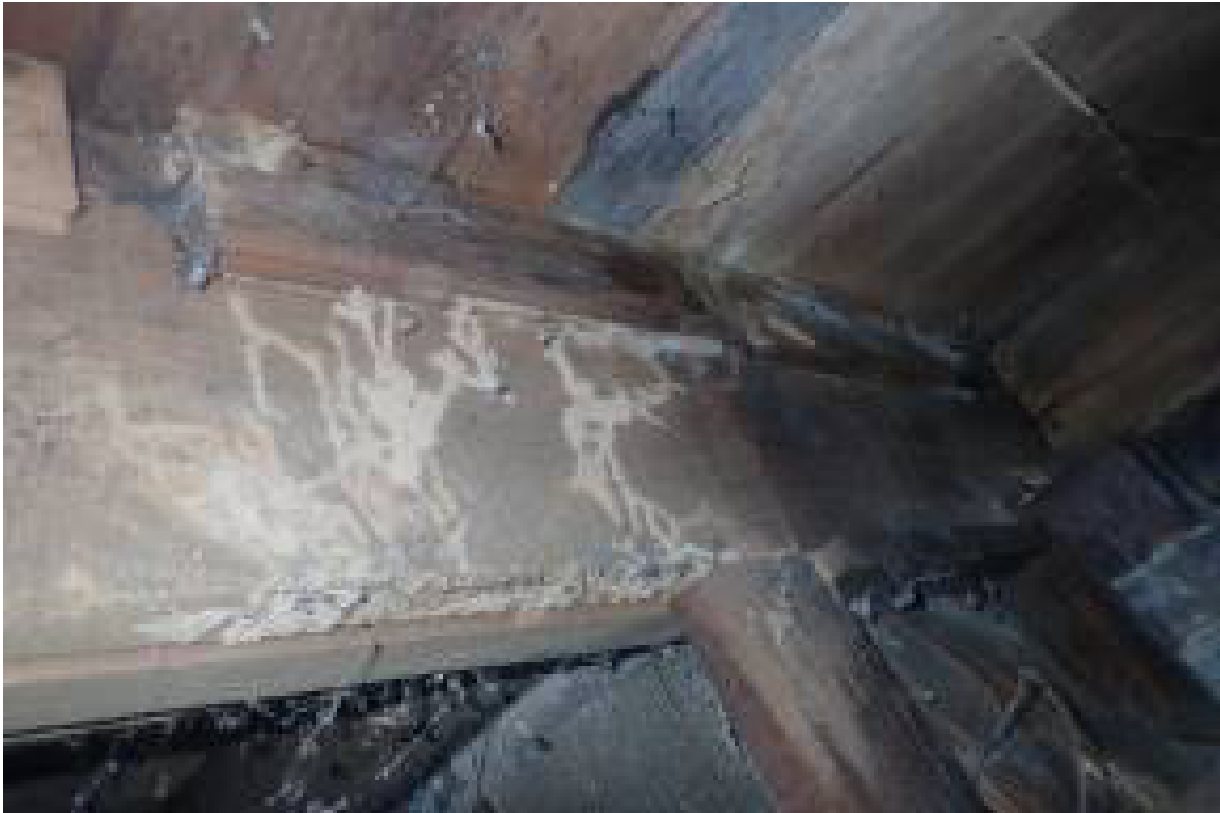
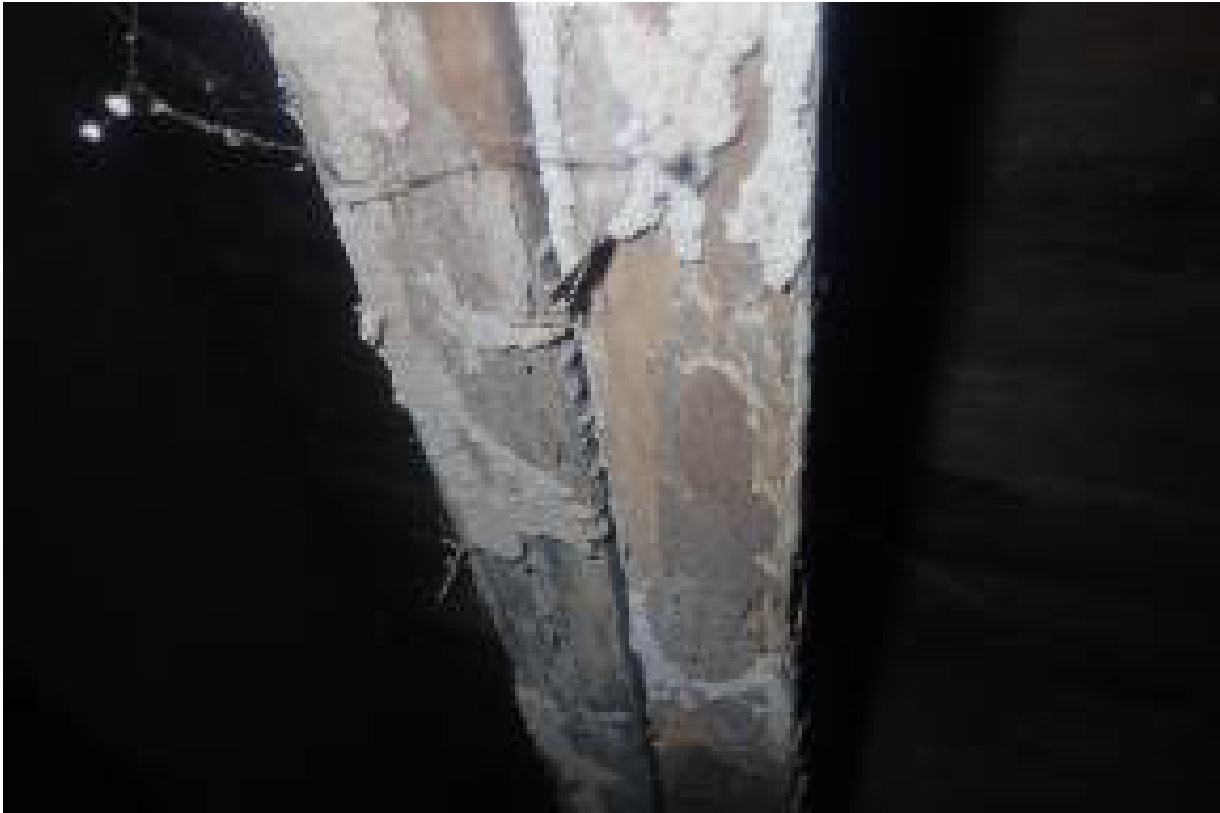
CRAWLSPACE DEFICIENCIES

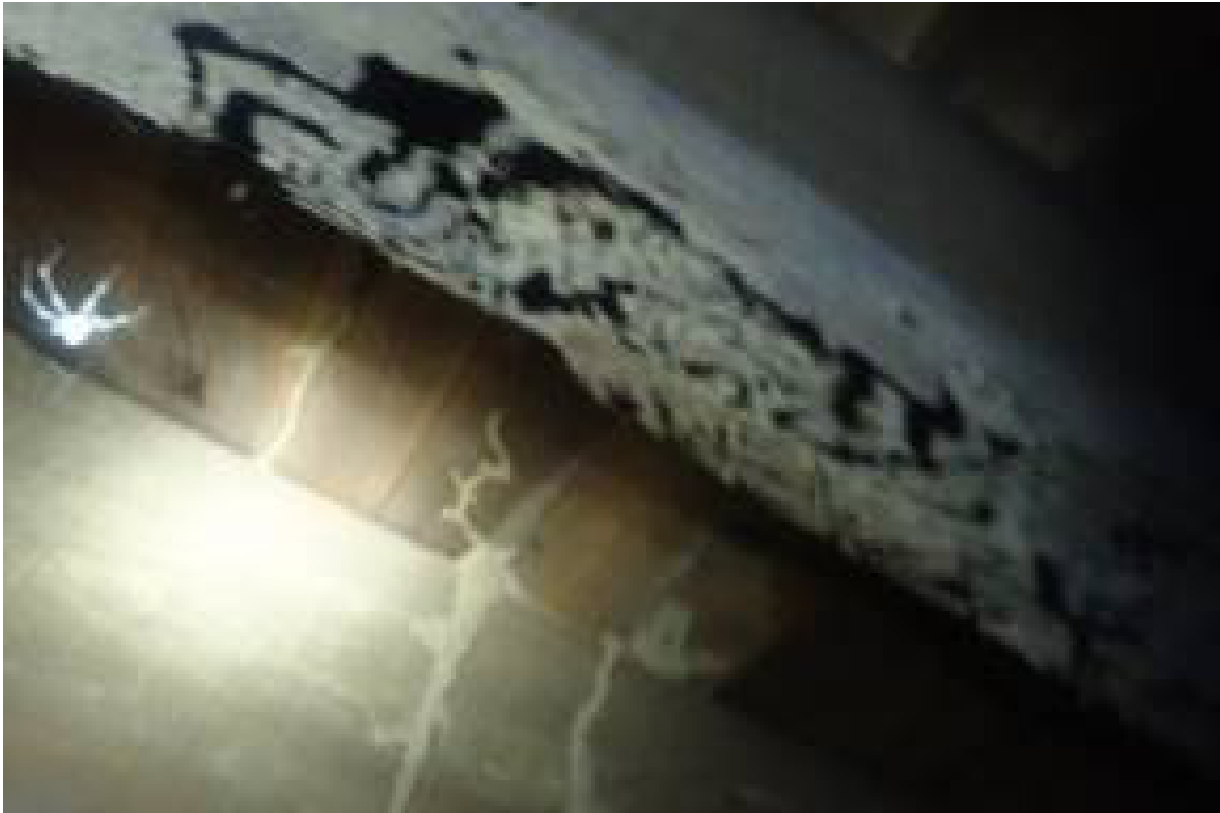
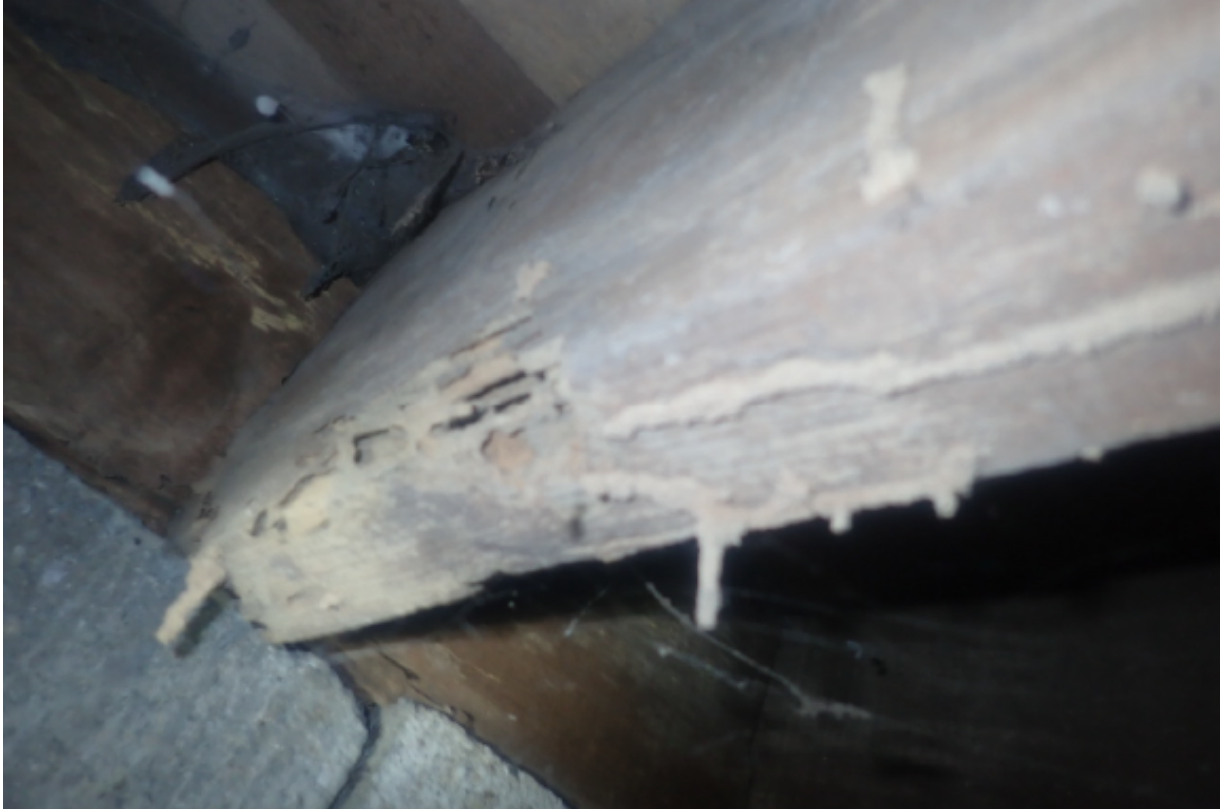
CRAWLSPACE DEFICIENCIES (Cont'd)

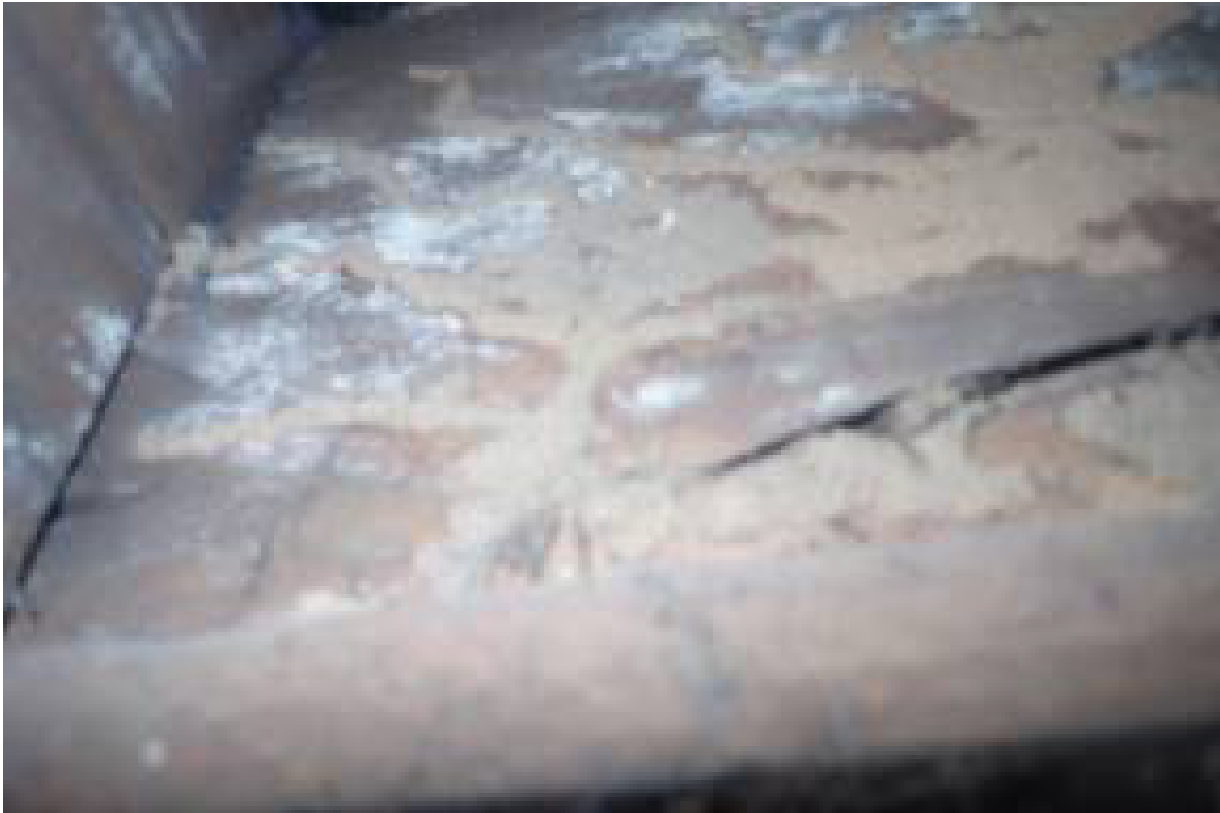
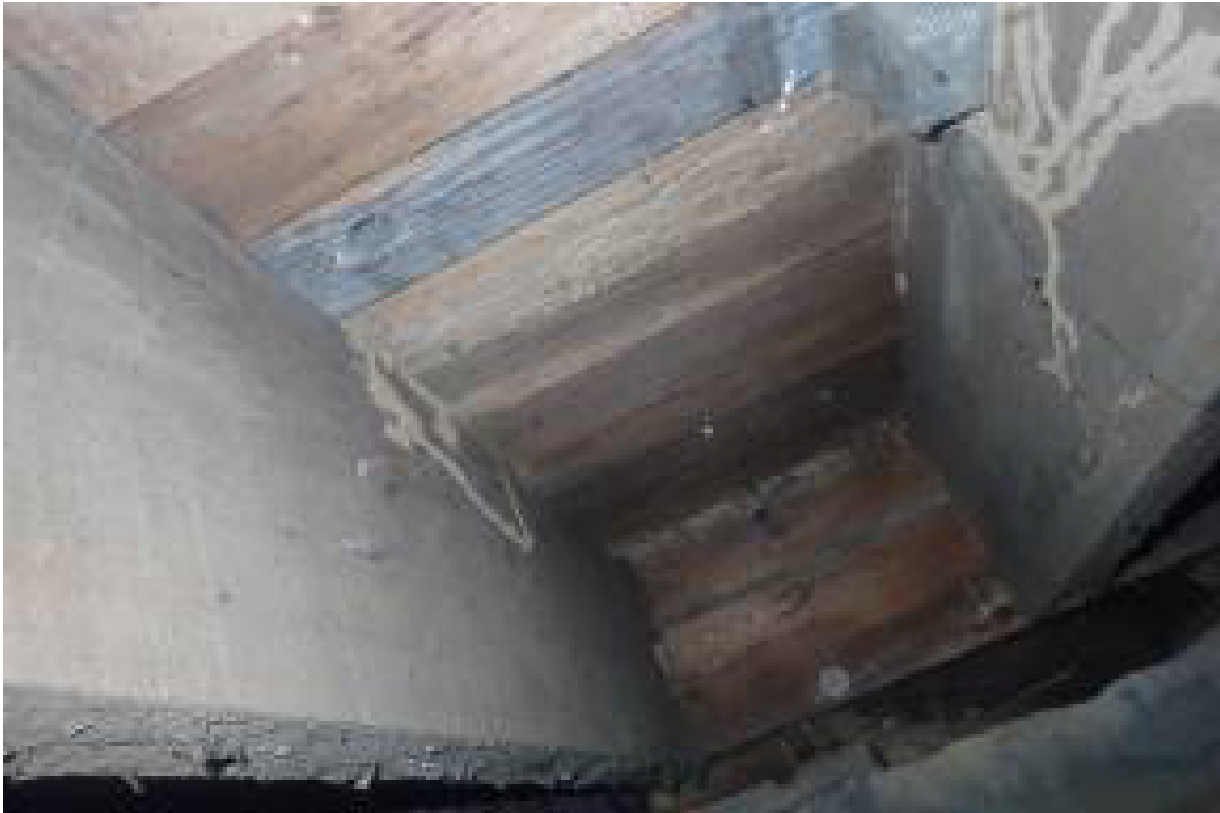
CRAWLSPACE DEFICIENCIES (Cont'd)

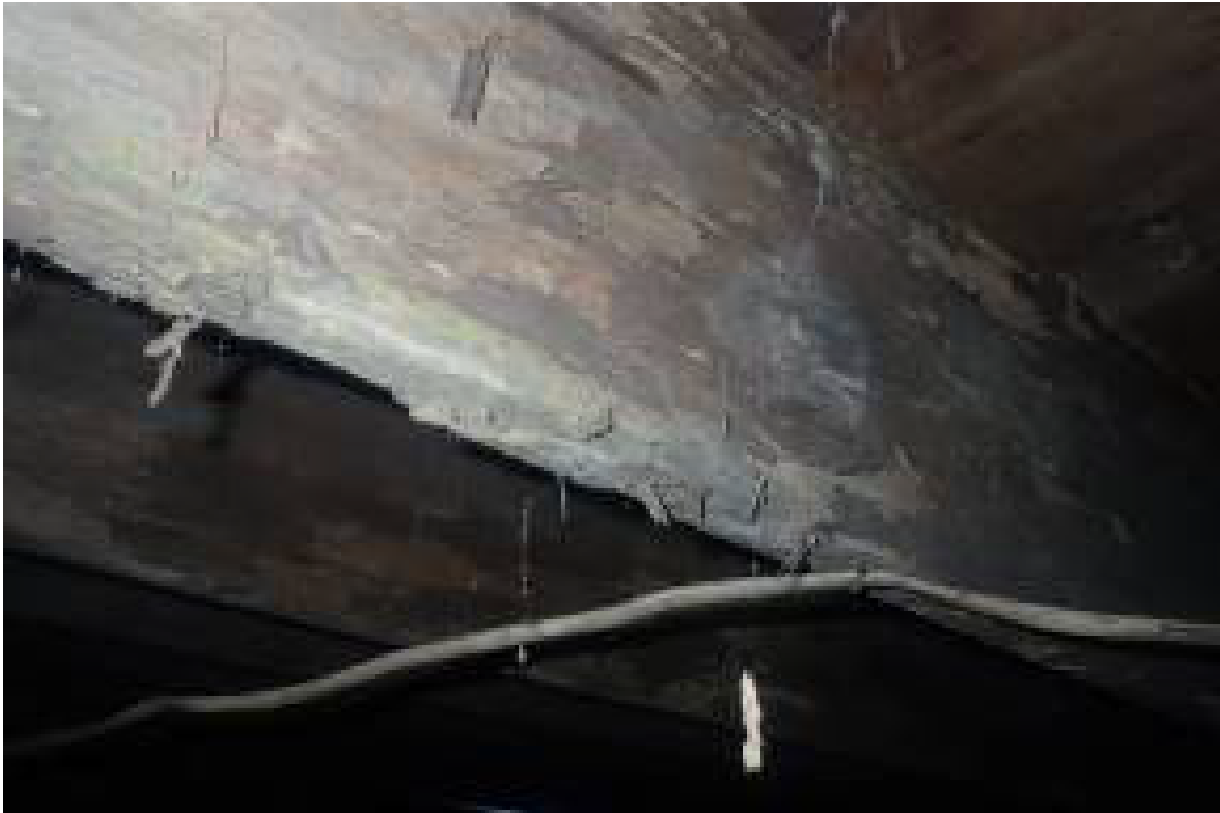
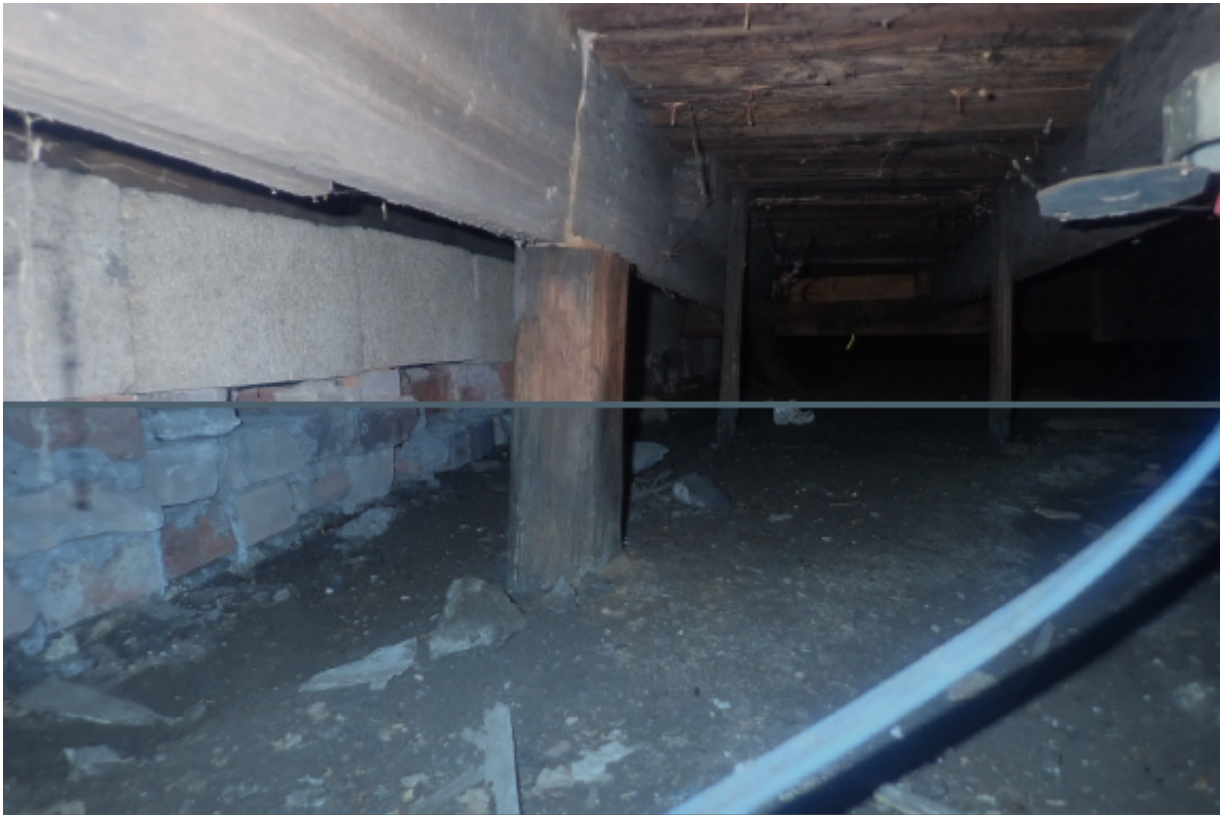
CRAWLSPACE DEFICIENCIES (Cont'd)

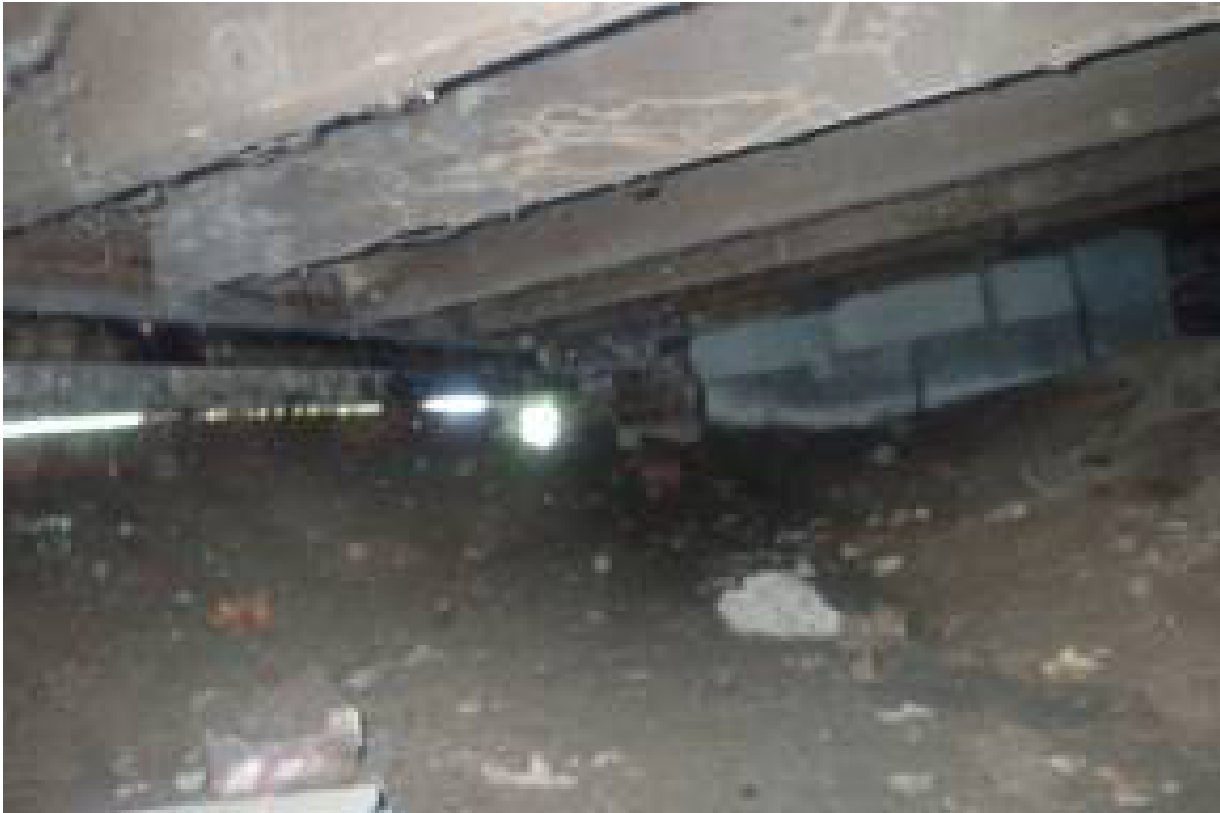
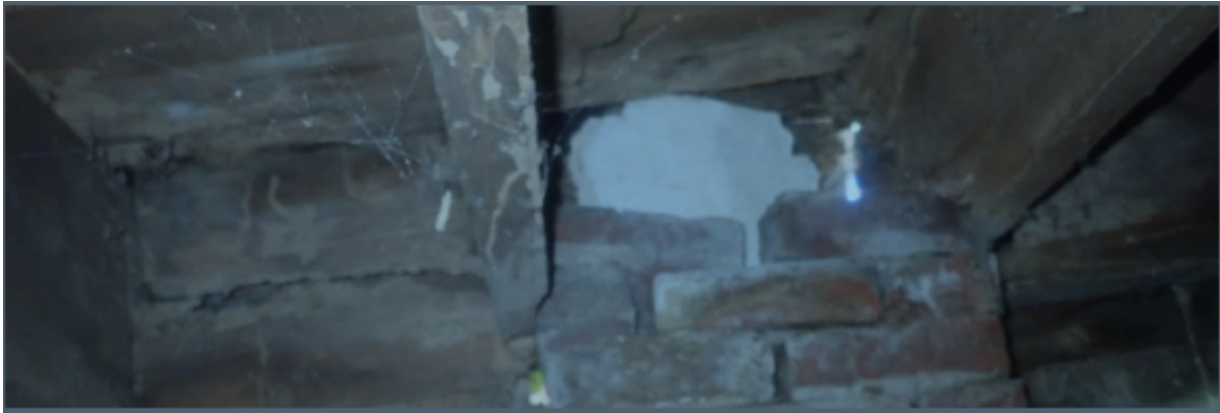
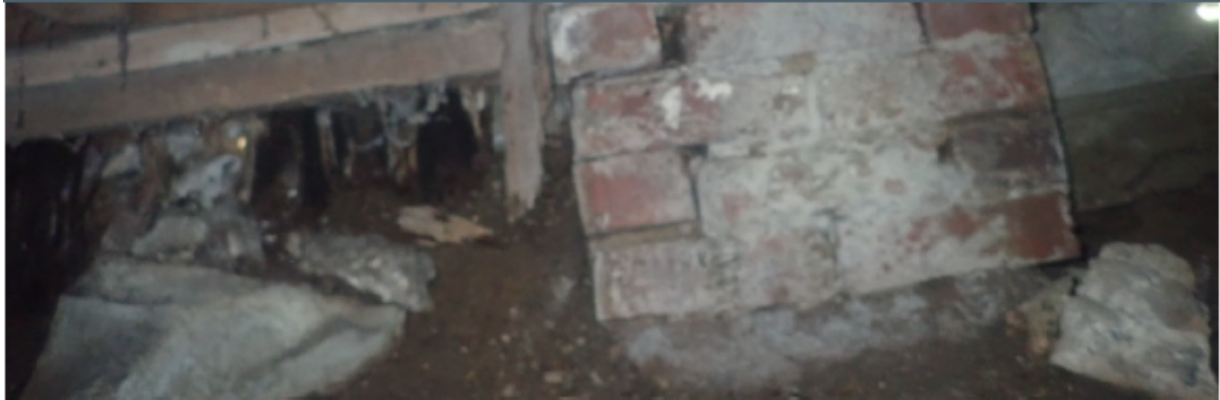
CRAWLSPACE DEFICIENCIES (Cont'd)

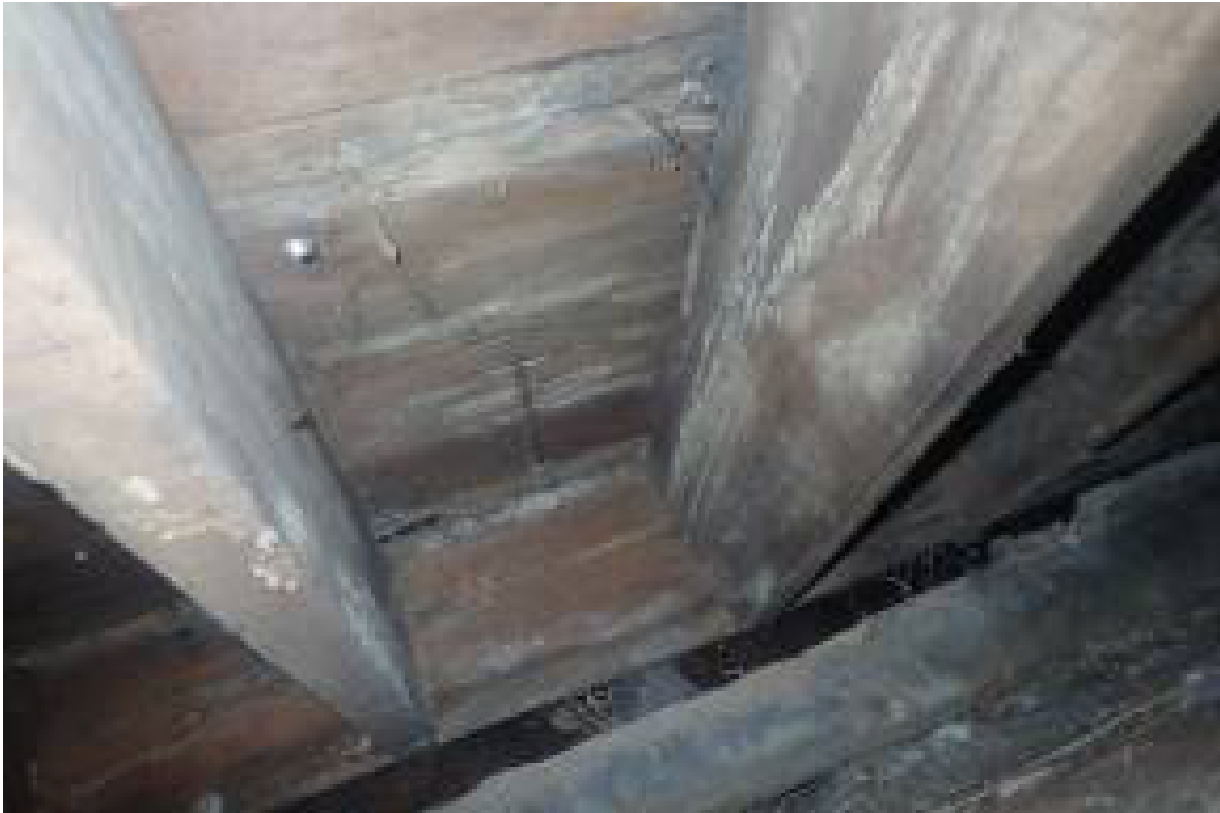
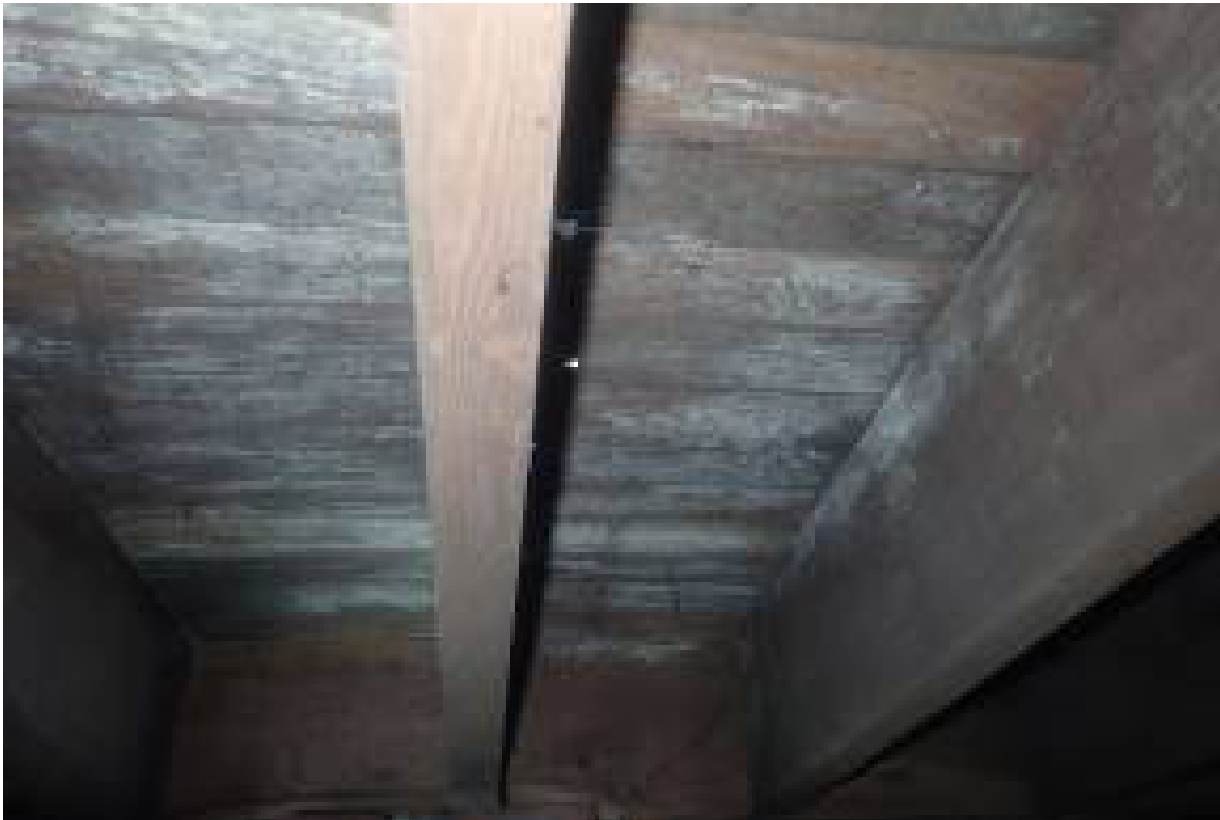
CRAWLSPACE DEFICIENCIES (Cont'd)

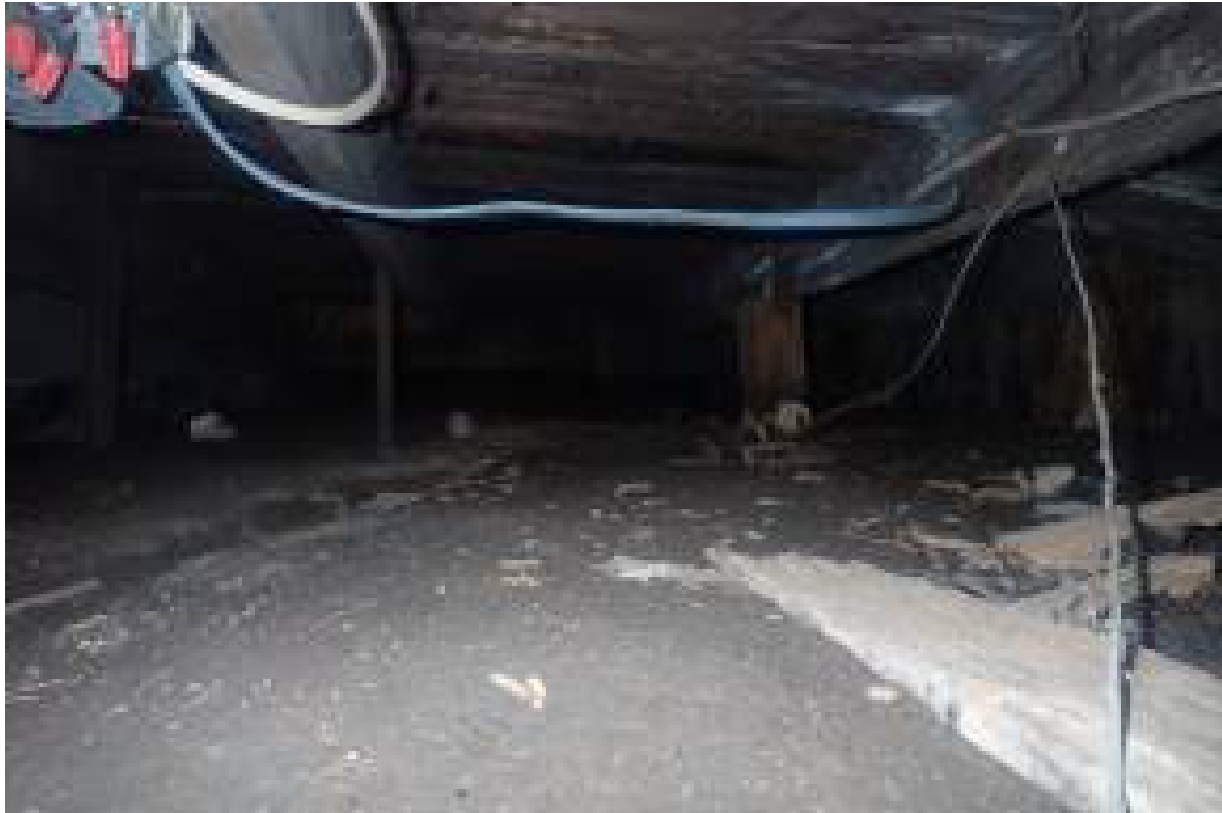
CRAWLSPACE DEFICIENCIES (Cont'd)

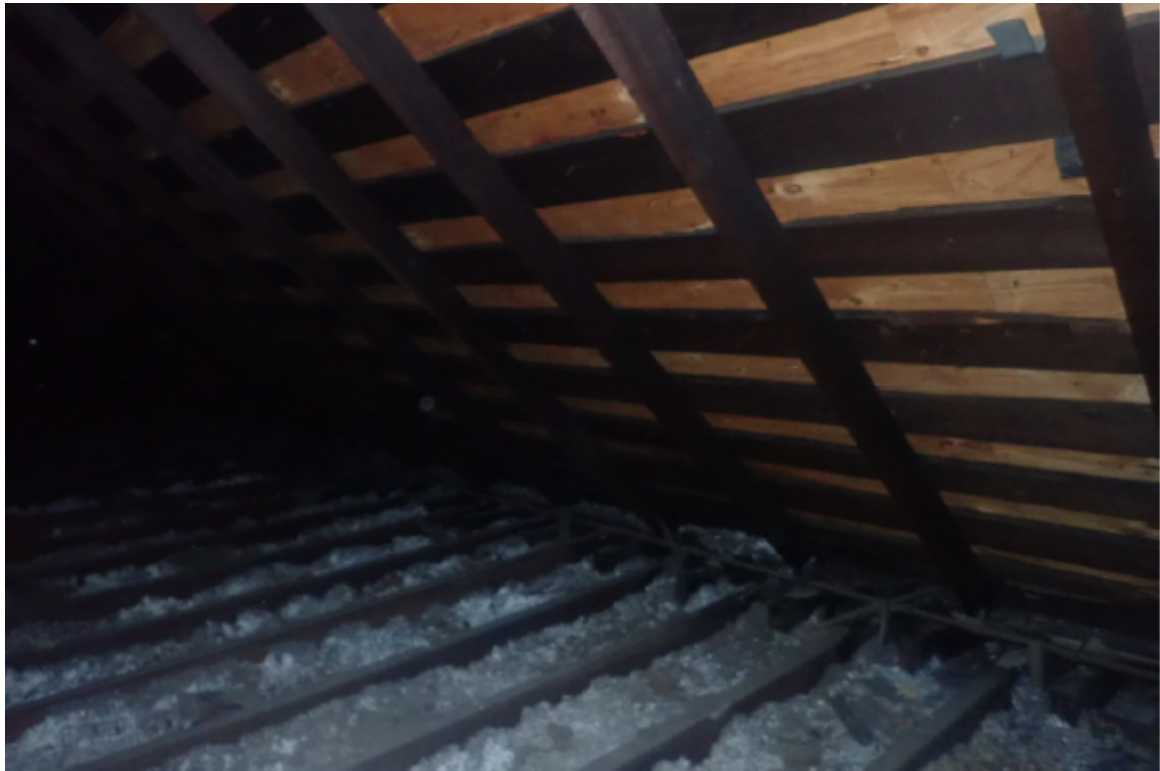
ATTIC DEFICIENCIES:

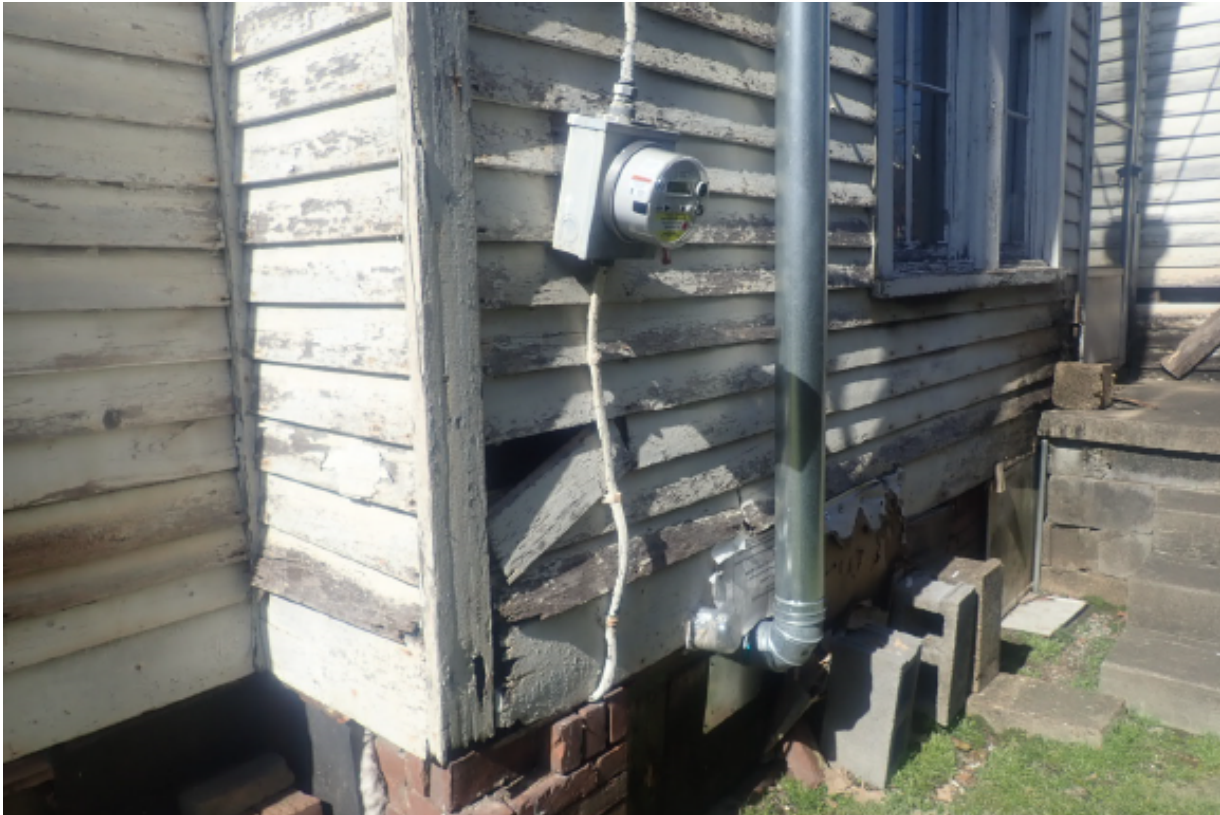
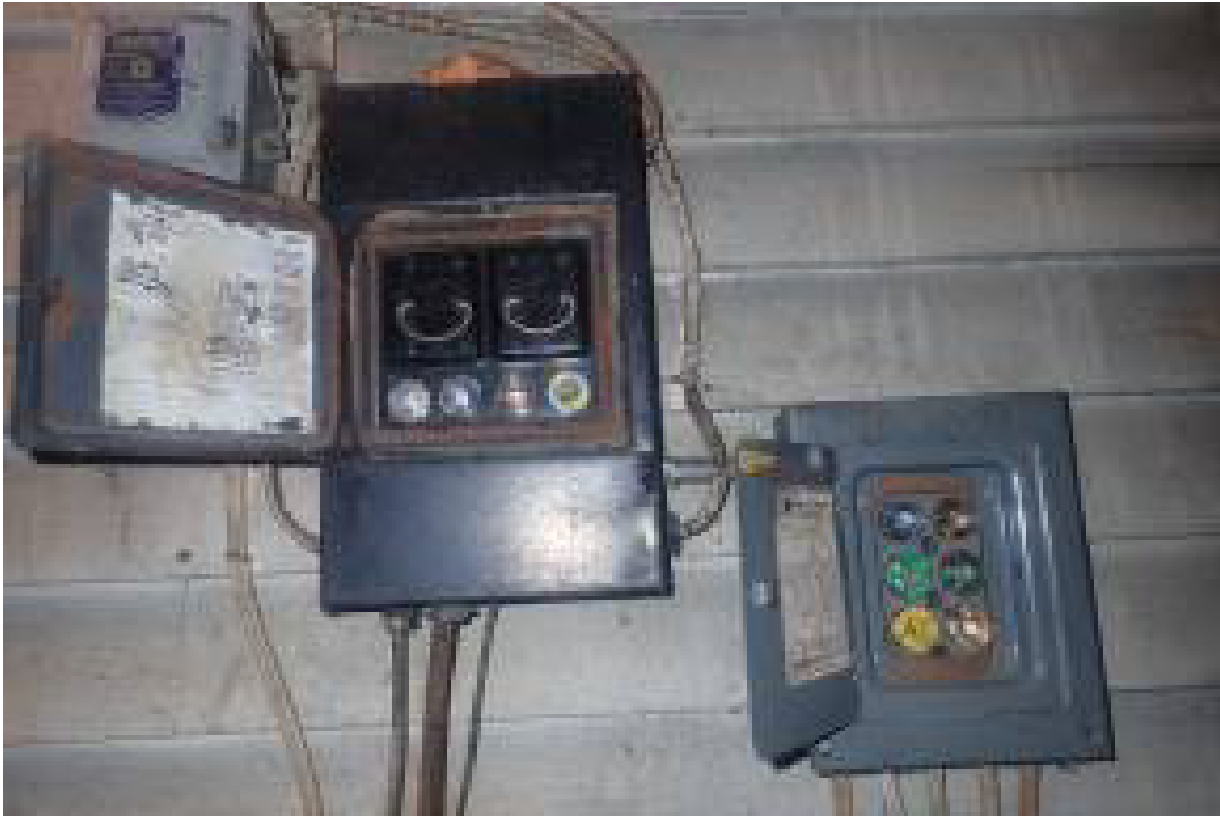
ELECTRICAL DEFICIENCIES

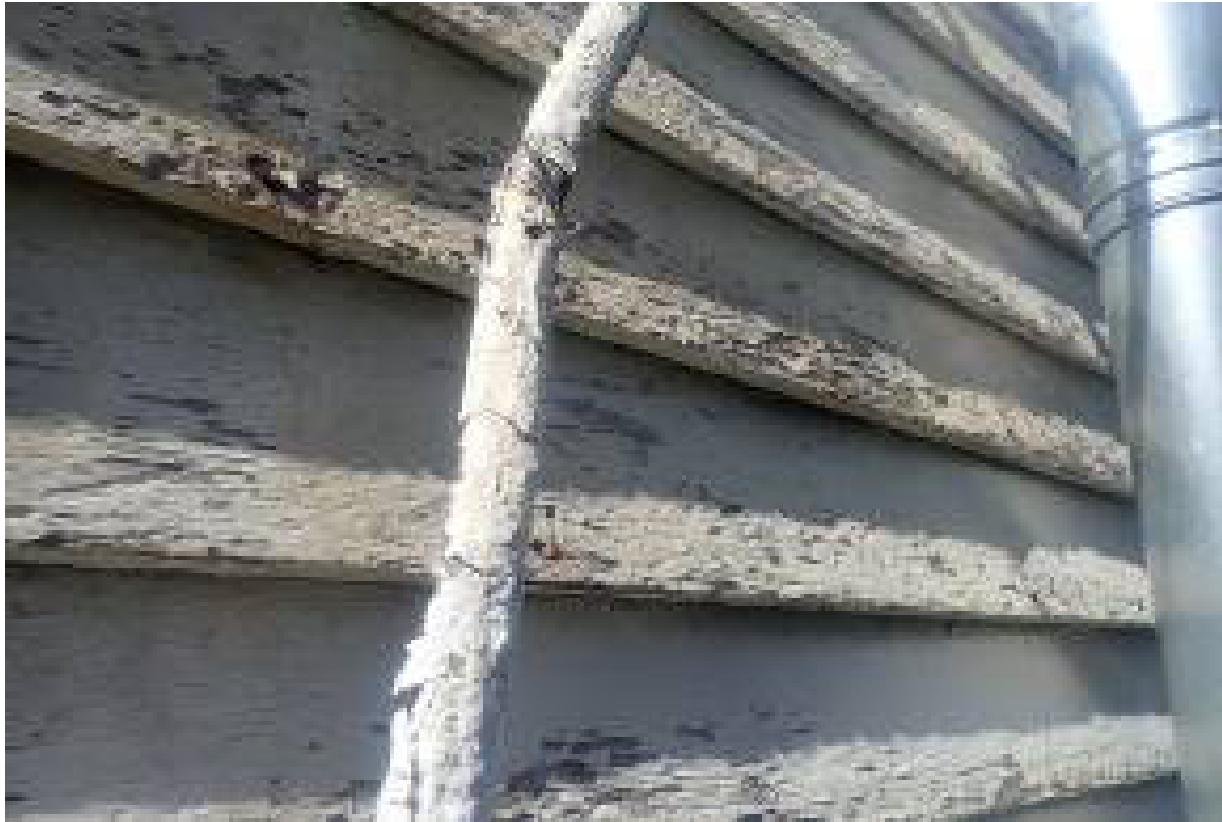
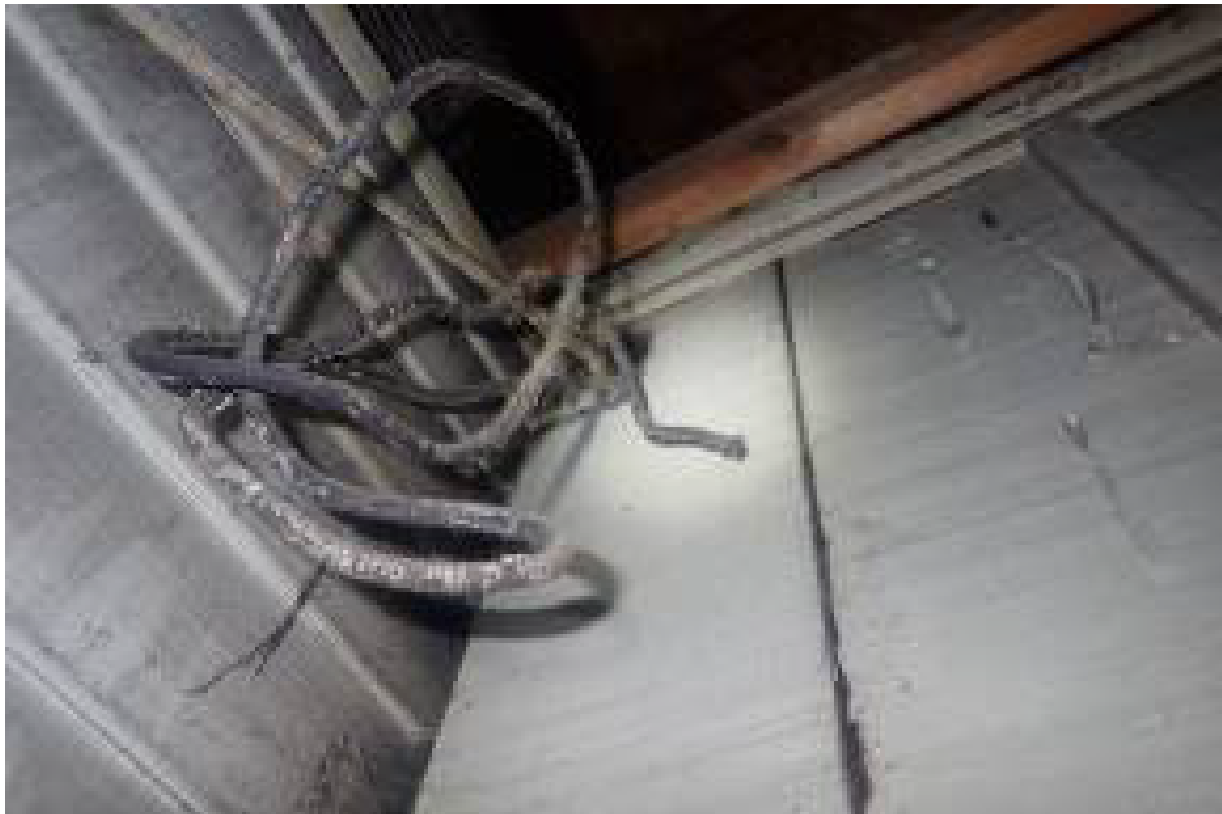
ELECTRICAL DEFICIENCIES (Cont'd)
