METROPOLITAN GOVERNMENT OF NASHVILLE AND DAVIDSON COUNTY

STAFF RECOMMENDATION
1204 Russell Street
March 17, 2021

Description of Project: The applicant requests demolition of a contributing building, arguing for economic hardship.

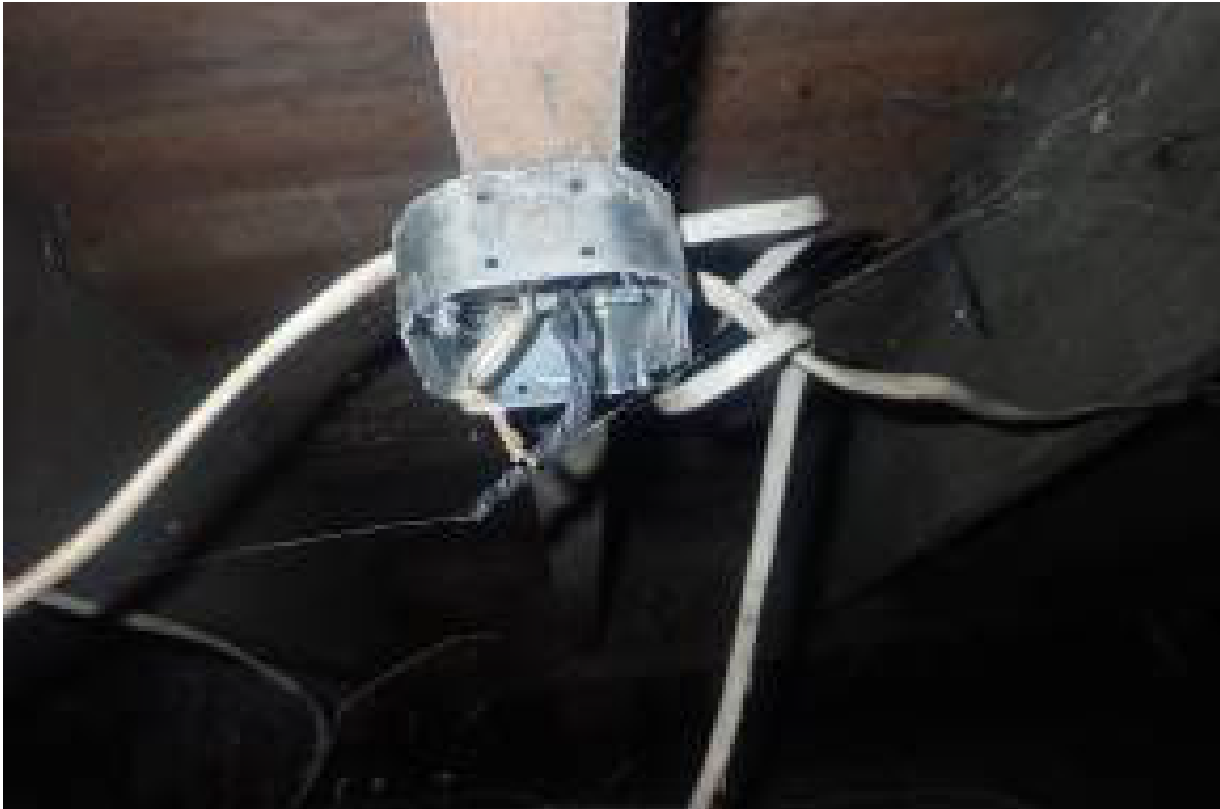
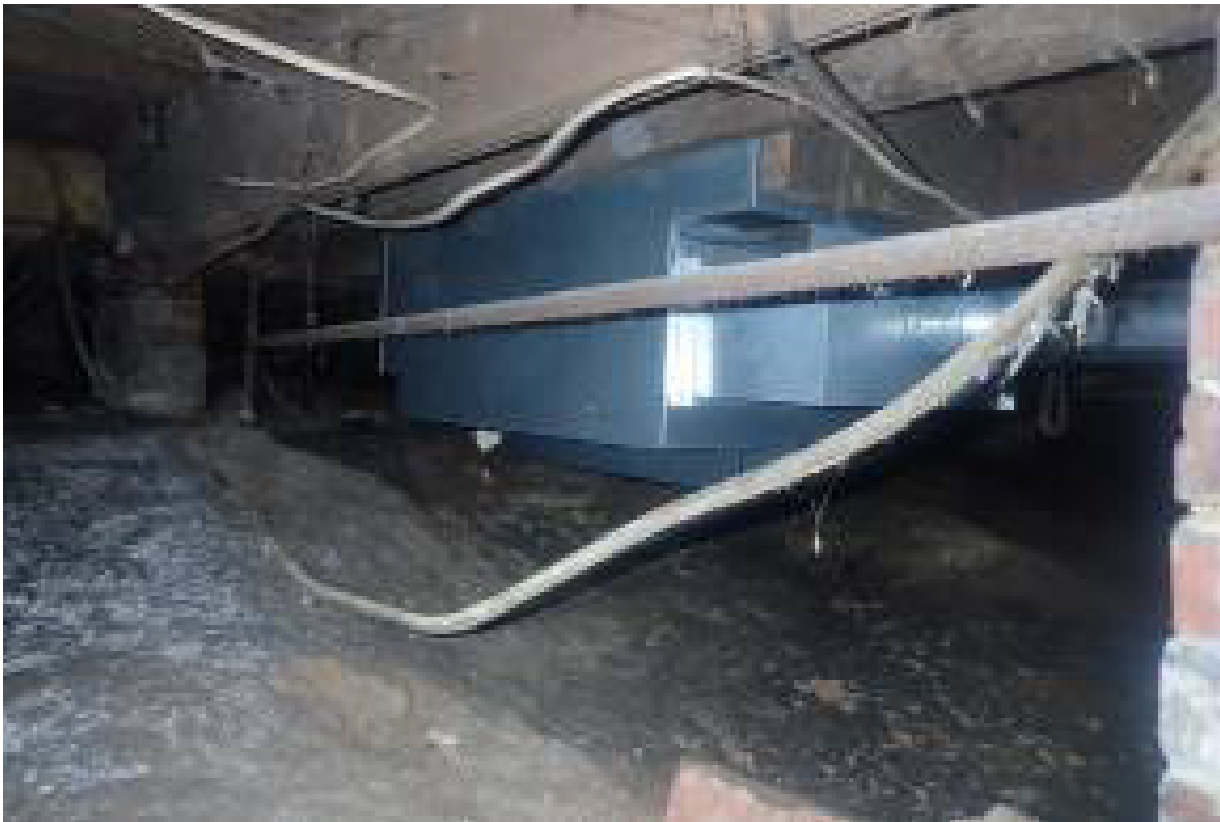
ELECTRICAL DEFICIENCIES (Cont'd)

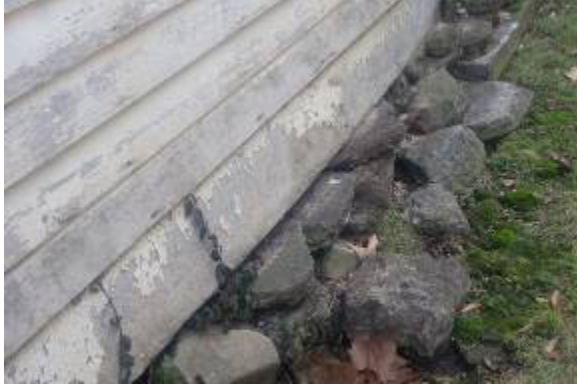
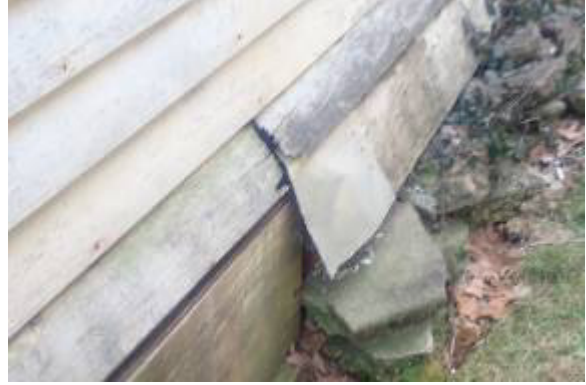
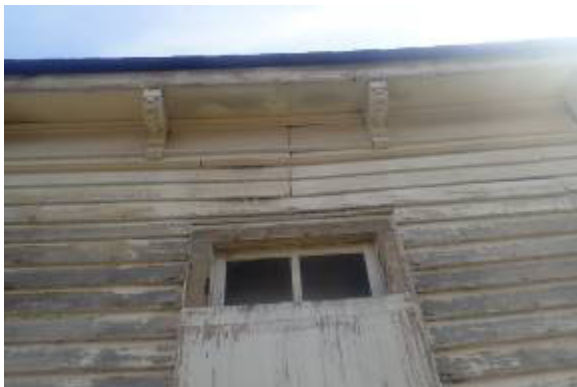
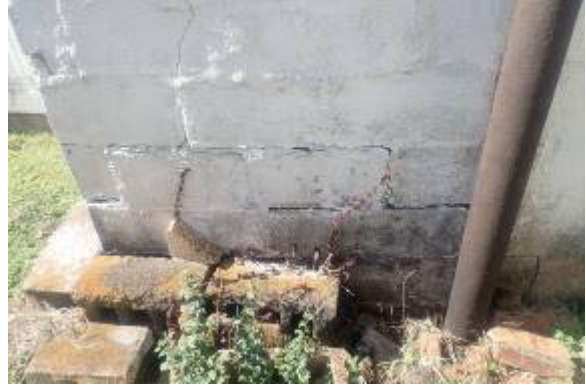
1. Areas of bowed walls and deteriorated masonry was noted around perimeter of the home. Areas of wood on grade construction were noted in several areas of the exterior. It is recommended to consult a licensed structural repair contractor for further examination of the home with repairs completed as needed.

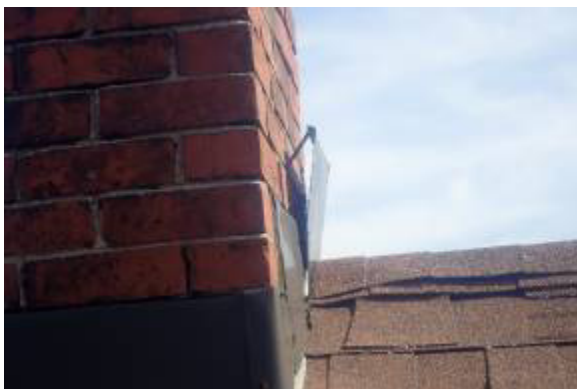
2. It is recommended to repair the detached flashing along the brick chimney structure to limit the potential for water intrusion. Evidence of previous leaking was noted inside the interior of the attic and roof structure. Consult a qualified masonry contractor for further examination of the chimney with repairs completed as needed.

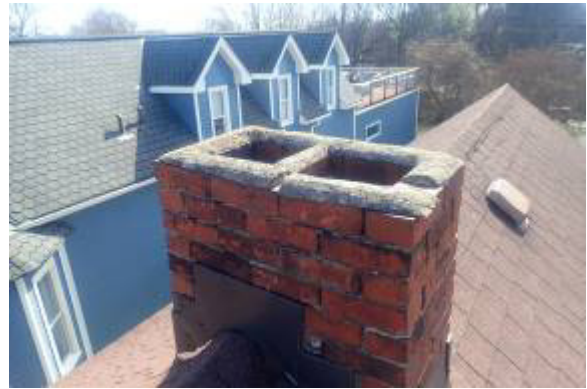
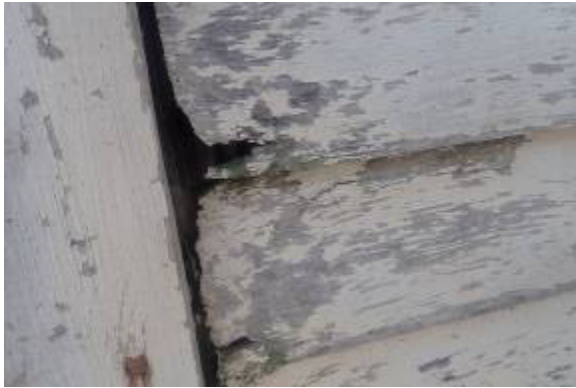
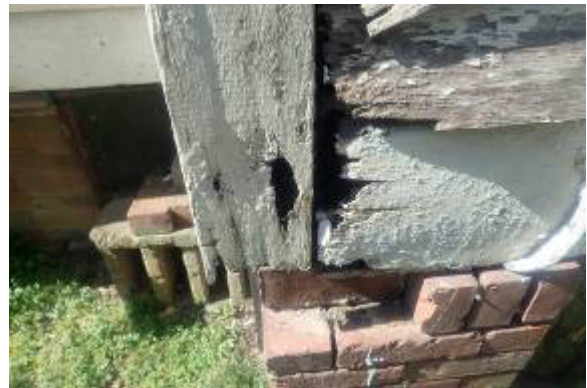
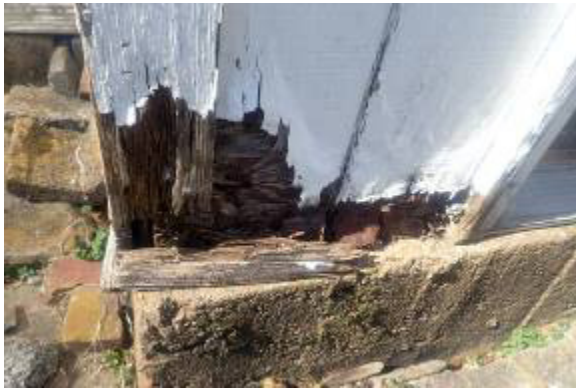
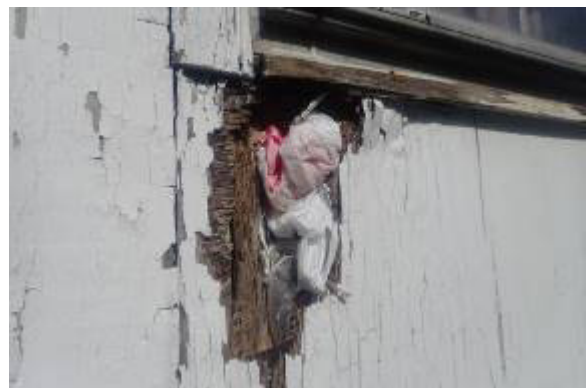
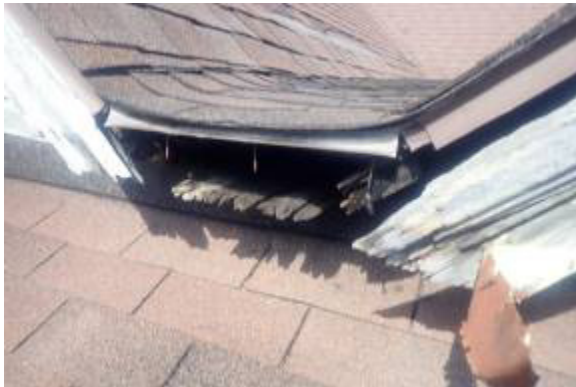
4. Areas of extensive wood rot were noted around the perimeter walls of the home. Gaps and openings in the exterior walls were noted around the home. It is recommended to consult a qualified contractor for further examination of the home with repairs completed as needed.

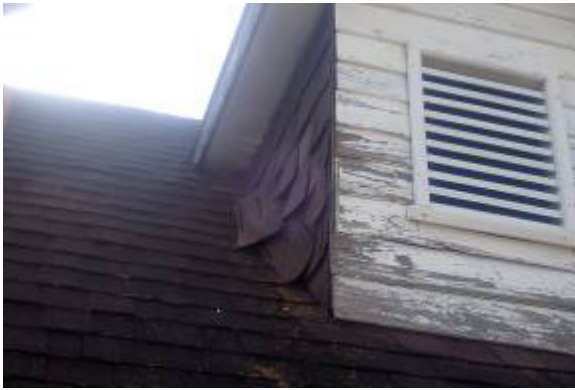
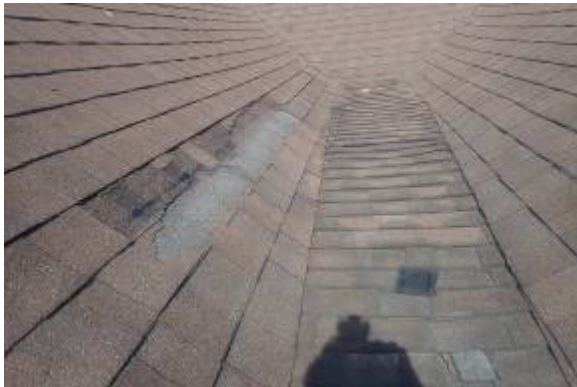
5. Areas of detached shingles and inadequately sealed shingles were noted at the front center roof dormers, front roof structure and rear center roof structure. It is recommended to consult a licensed roofing contractor for repair.

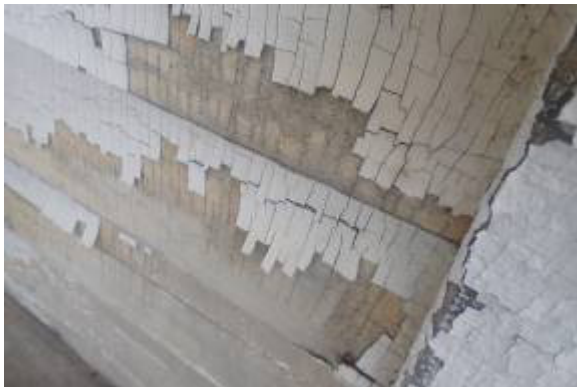
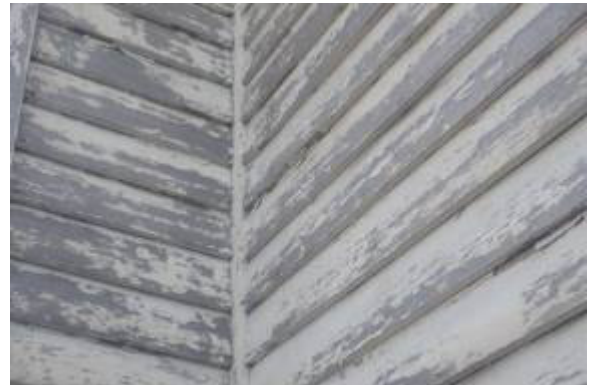
6. Evidence of deteriorated paint was noted on the exterior wood siding, eave decking, and trim around the property. The exterior wood surfaces appeared to be at a point of requiring caulking and paint maintenance as well. Due to the age of the home, it is likely that lead paint may be present around the home. All repairs and or remodeling should be conducted with regard for lead base paint exposure. Consult a licensed general contractor for evaluation and repair options. Consult www.epa.gov for more information regarding lead paint exposure and removal.

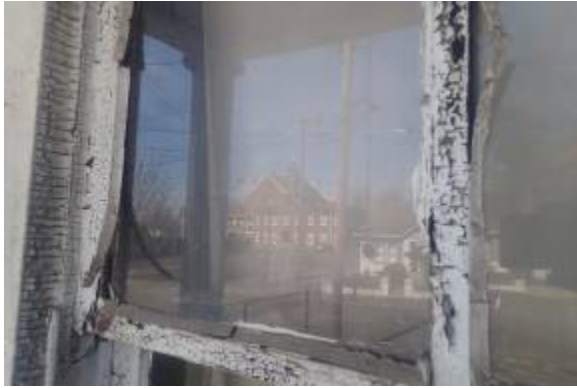
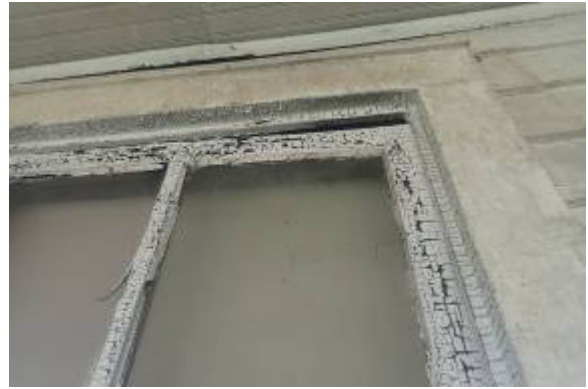
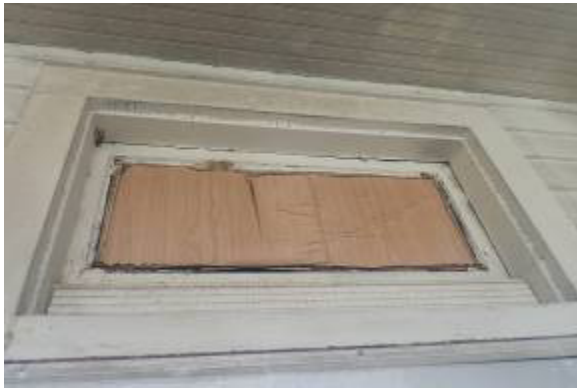
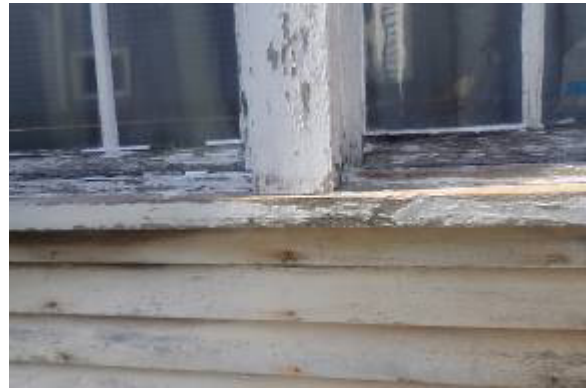
7. The window systems around the home were in poor condition. Wood rot and broken glass were noted. The window glazing around the home is in a state of deterioration and requires repair and or replacement to limit air and moisture intrusion or detachment of the glass panes. The windows are nearing a point of requiring replacement. Consult a qualified contractor for replacement options.

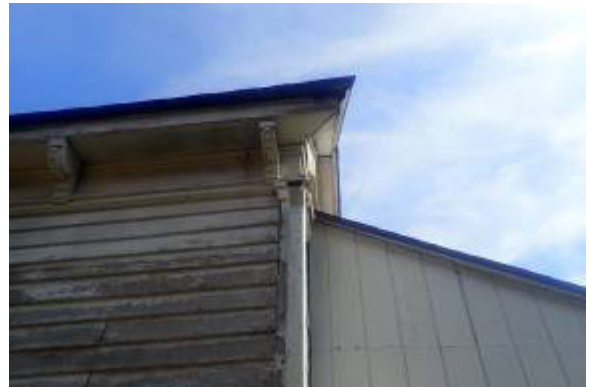
8. It is recommended to repair all detached and misaligned gutter downspout and drain piping around the home. Evidence of points of active water intrusion was noted at the rear right corner of the home. Maintenance of the gutter and drain systems is of high priority in limiting moisture around the foundation walls.

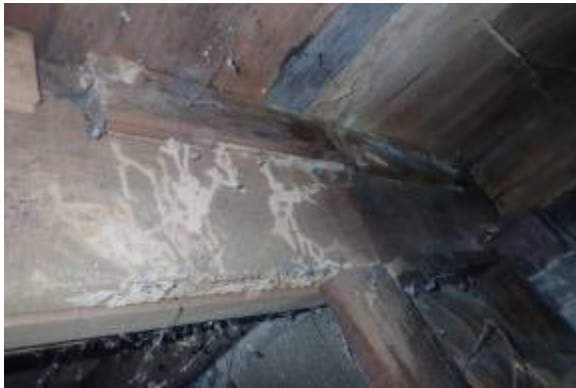
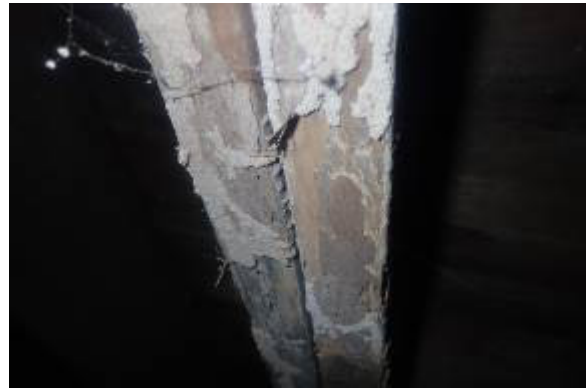
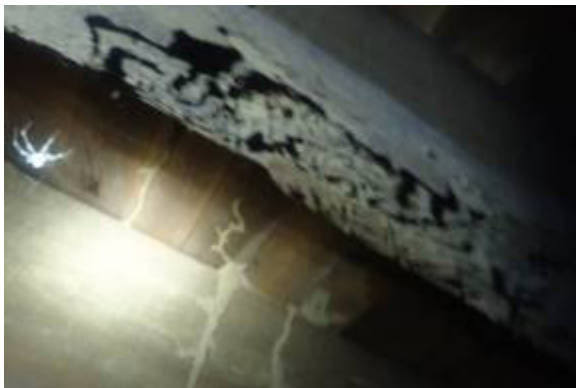
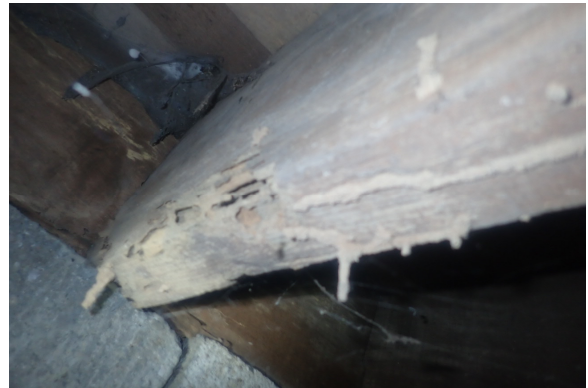
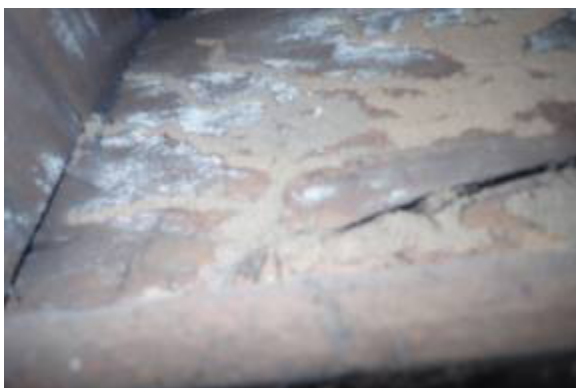
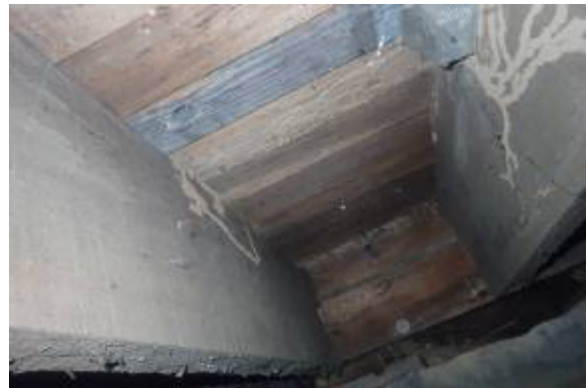
9. Evidence of termite shelter tubes and extensive damage was noted on the floor structure under the crawlspace. It is recommended to consult a qualified general contractor for repair of the damaged wood. It is recommended to consult a licensed termite and or pest control contractor for further examination of the home with treatment completed as needed.

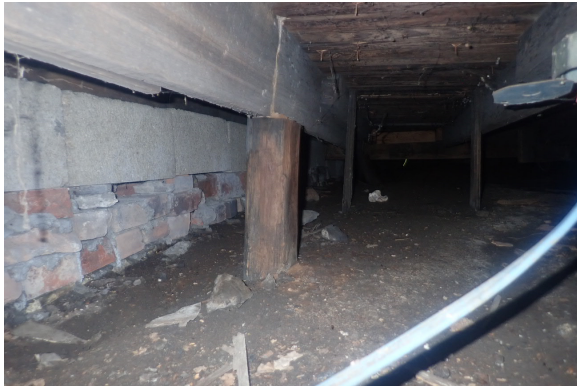
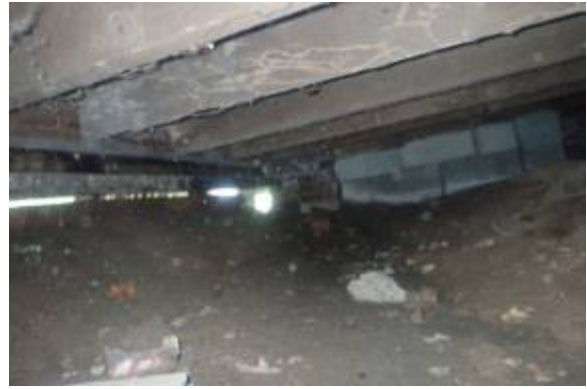
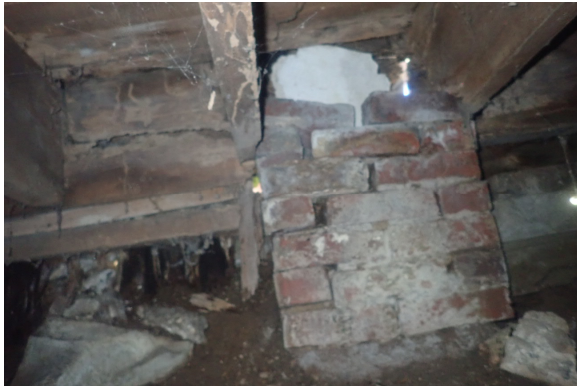
10. Evidence of wood on grade construction was noted around the perimeter walls of the crawlspace and foundation. Areas of rot and termite damaged wood were noted. It is recommended to consult a qualified contractor for further examination of the structures with repairs completed as needed.

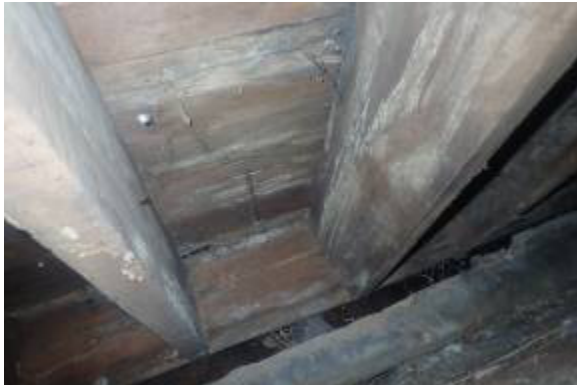
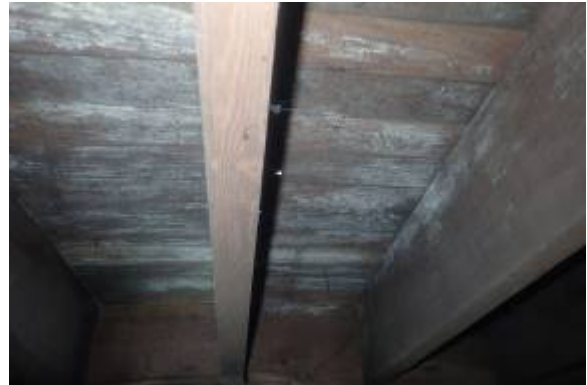
11. Evidence of suspicious fungal growth was detected on the wood floor structures throughout the crawlspace. It is recommended that a licensed environmental services contractor be contacted to perform an evaluation of the structures and or remediation in these areas. Determination of mold is outside the scope of this inspection.

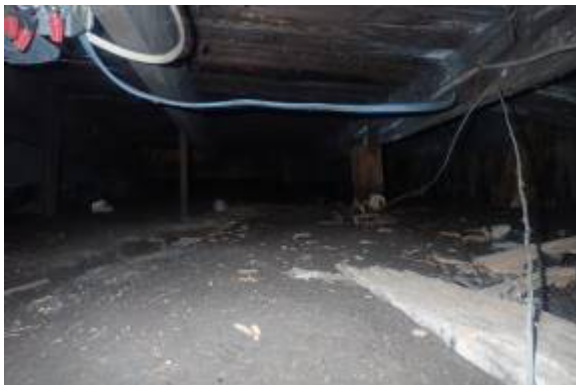
12. No vapor barrier was noted on the crawlspace dirt floor. A continuous vapor barrier is recommended to reduce condensation buildup in the crawlspace.

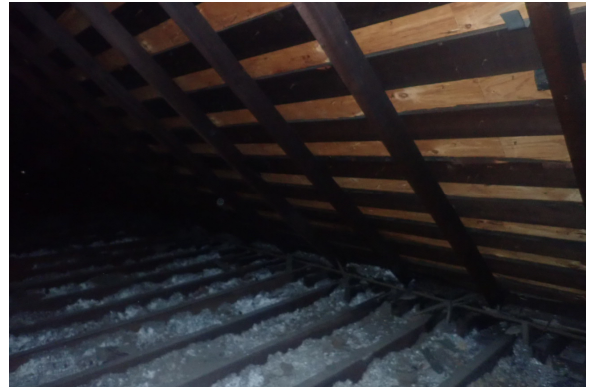
13. Settled and missing insulation was noted in several areas throughout the attic space. Additional insulation is recommended to reduce heat loss. Further investigation is recommended by a qualified professional with corrections made as needed.

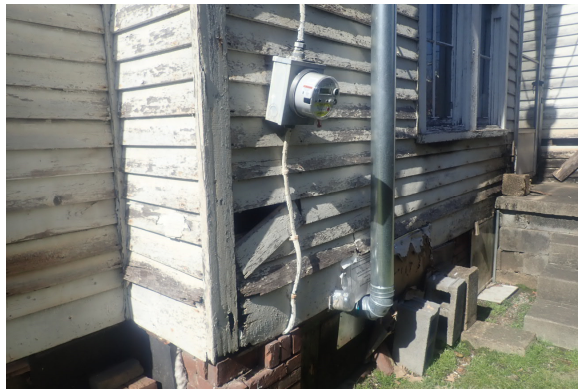
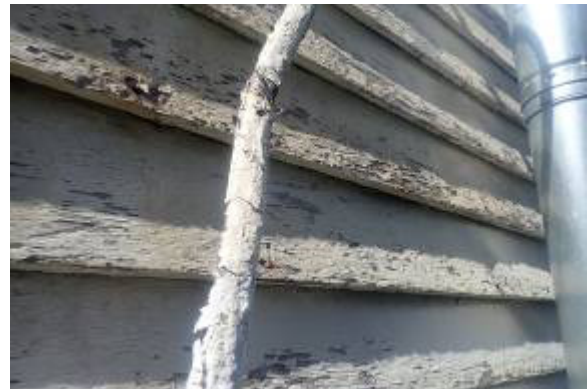
14. The electrical meter is detached from the exterior wall. Evidence of deteriorated wire insulation was noted at the service entry and meter connection. It is recommended to consult a licensed electrician and or utilities provider for further examination of the meter and wiring with repairs completed as needed.

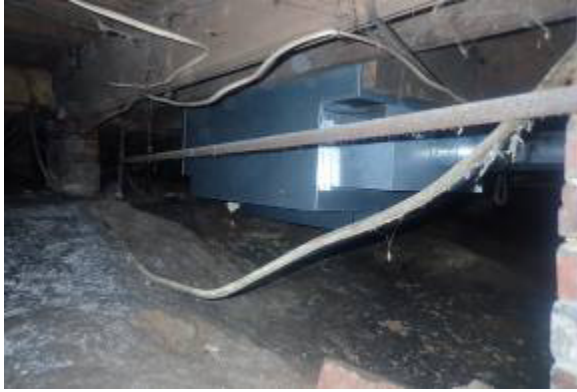
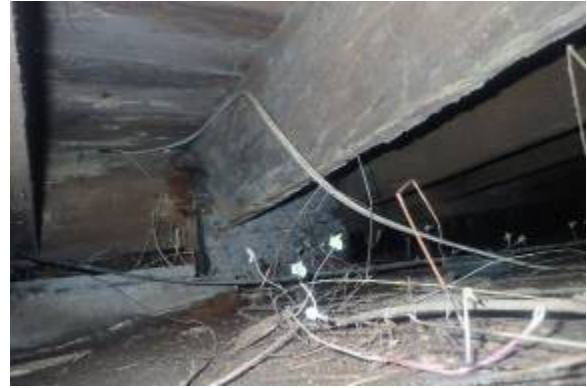
15. Evidence of wire splices outside of approved junction boxes and open air wire splice was noted in several areas of the crawlspace and in the utility electrical shed. It is recommended that all wire splices be installed inside of a closed and mounted electrical junction box. Consult a licensed electrical contractor for repair.

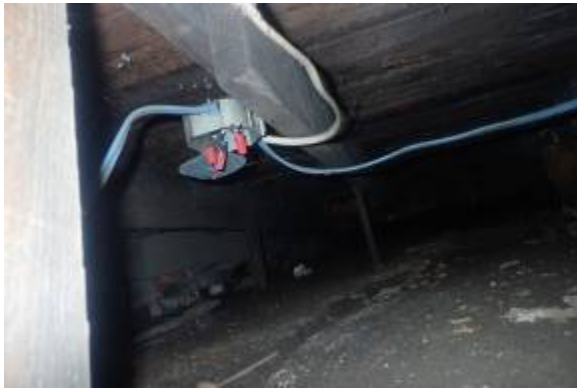
16. It is recommended to properly anchor or staple the loose electrical wiring under the home to the floor joists to limit the potential for contact with the ground and moisture. Consult a licensed electrician for repair.

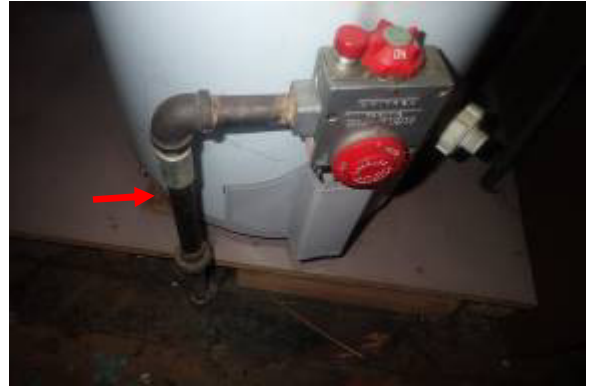
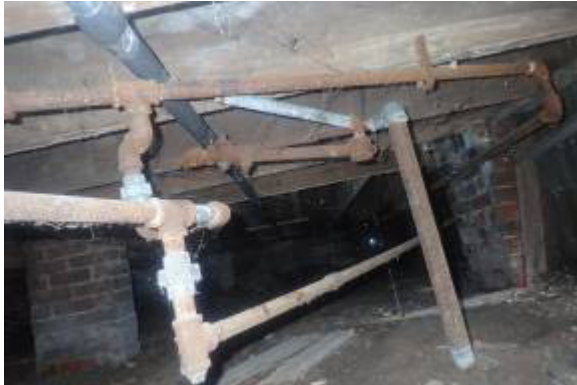
19. No sediment trap or drip leg was noted at the gas line. The sediment trap is a capped section of the gas line that is installed in such a manner to allow moisture or debris in the gas line to be collected in the trap prior to entering the appliance. It is recommended to consult a licensed mechanical or plumbing contractor for further examination of the gas line with repairs completed as needed.

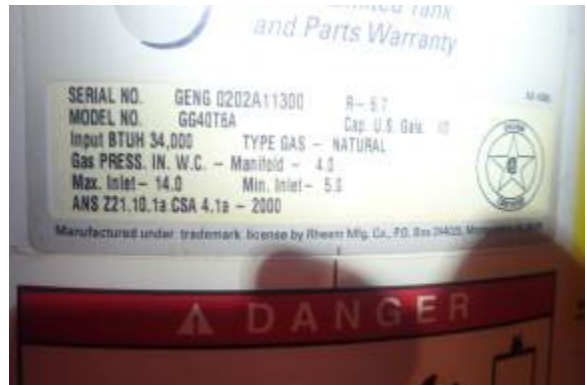
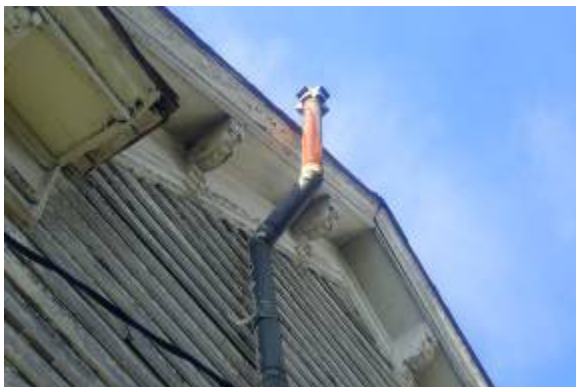
21. The water heater is nearing 18 years of service. The average life expectancy of a water heater is approximately 6-10 years. The water heater was functioning adequately at the time of the inspections. Repairs/replacement should be expected in the future.

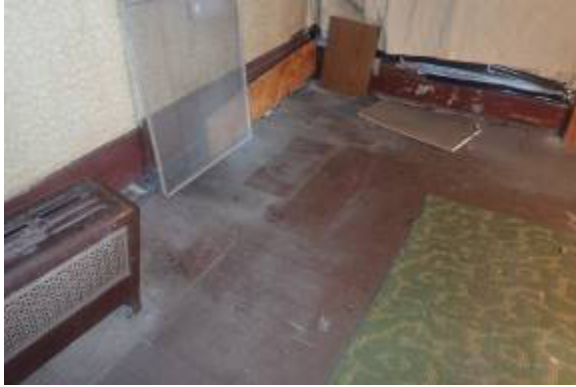
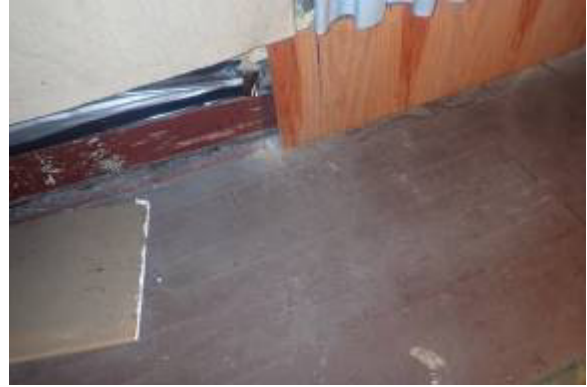
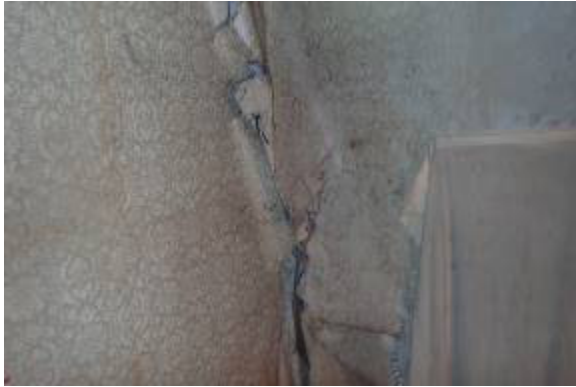
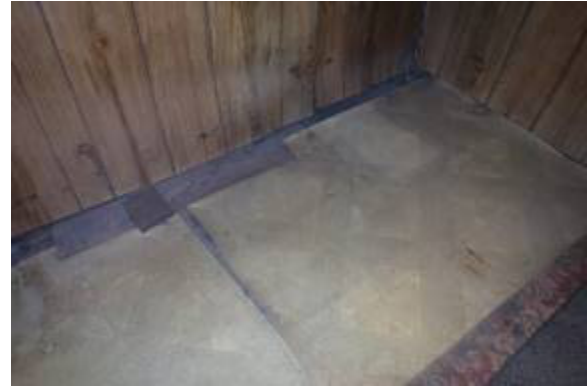
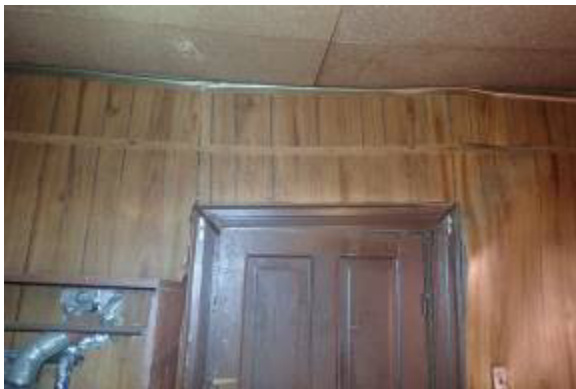
23. Evidence of floor deflection was noted throughout the home. Areas of termite damaged floor structure were noted. Additionally, several areas of cracking were noted in the plaster ceiling and walls. It is recommended to consult a licensed general contractor for an evaluation of the interior structures with recommendations for leveling the floors and repair of the interior wall surfaces.

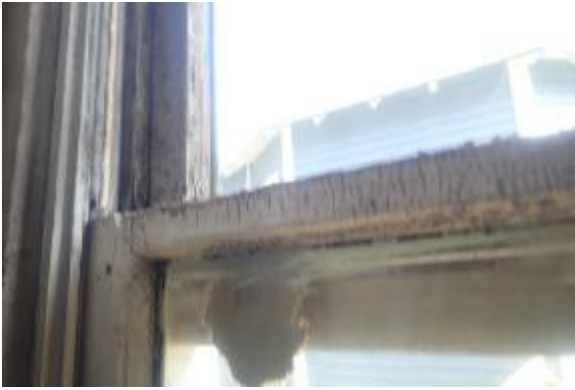
24. Several windows throughout the home did not open when tested. It is recommended that at least one window in each room with no exterior door open properly to maintain egress in case of emergency.

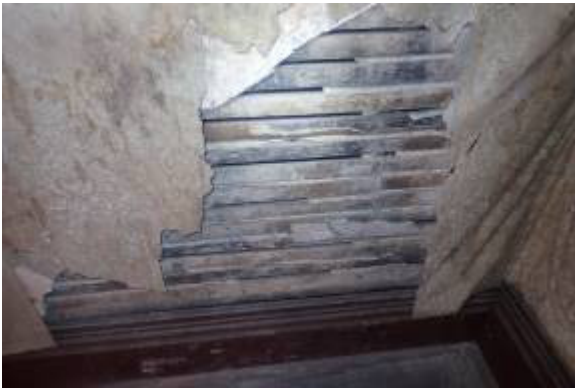
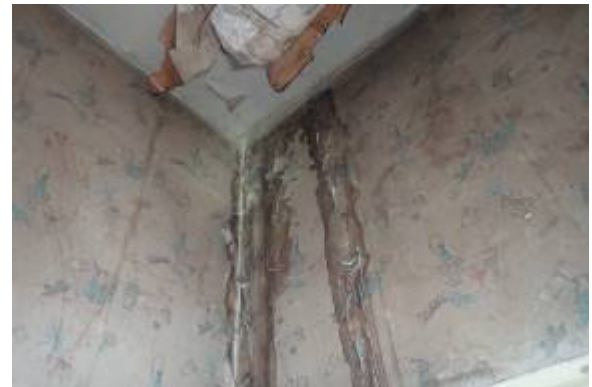
25. Evidence of previous leaking stains and suspicious fungal growth were noted in several areas of the interior. It is recommended to consult a qualified contractor for further examination of the home with repairs completed as needed.

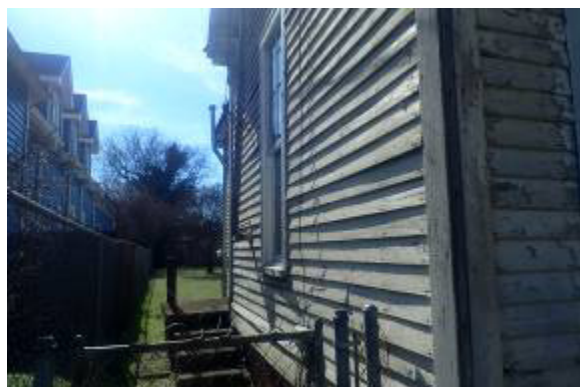
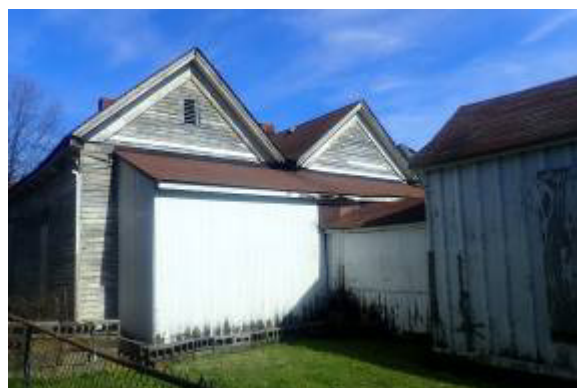
SLOPE: Areas of negative slope and grading were noted.
