# HISTORIC STRUCTURE REPORT

## **FORT NEGLEY**

### **Nashville, Tennessee**

FINAL REPORT (CORRECTED)  
January 31, 2014

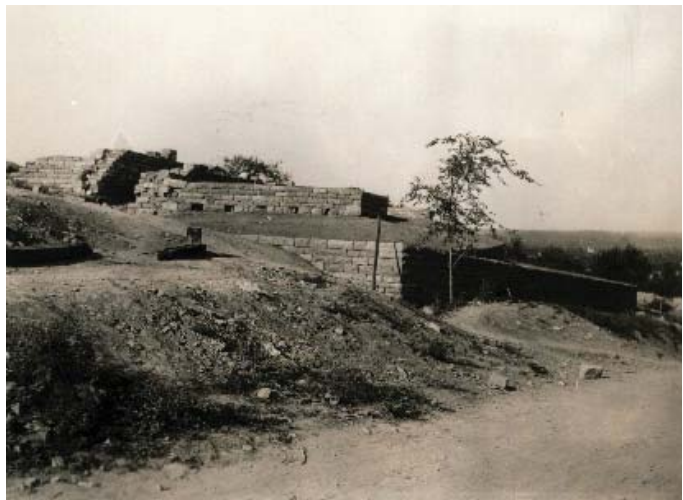
**Figure 6a.** East Bastion, 1930's. Photo in Tennessee State Library and Archives (FNVC).

Note temporary construction access road in foreground (also visible in Figure 7) and quantity of rubble or fill between bastions (in front of South Main Works) which appears to have been subsequently removed or regraded.

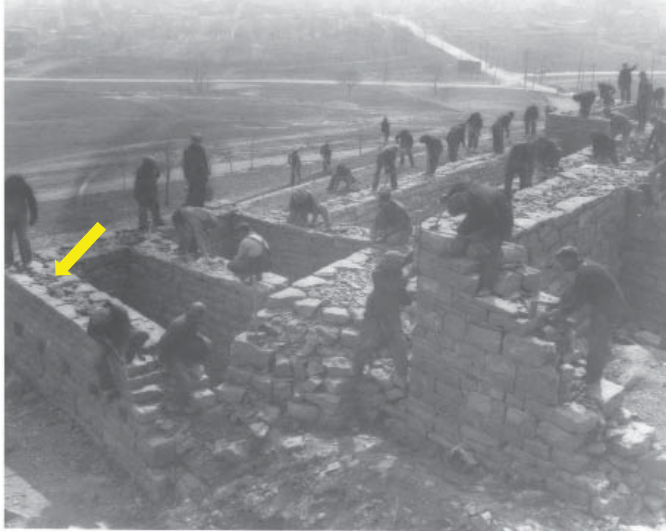
**Figure 6b.** WPA work crew, March 1936. National Archives (FNVC).

Note use of ashlar exterior stone coursing and interior rubble fill (yellow arrow).

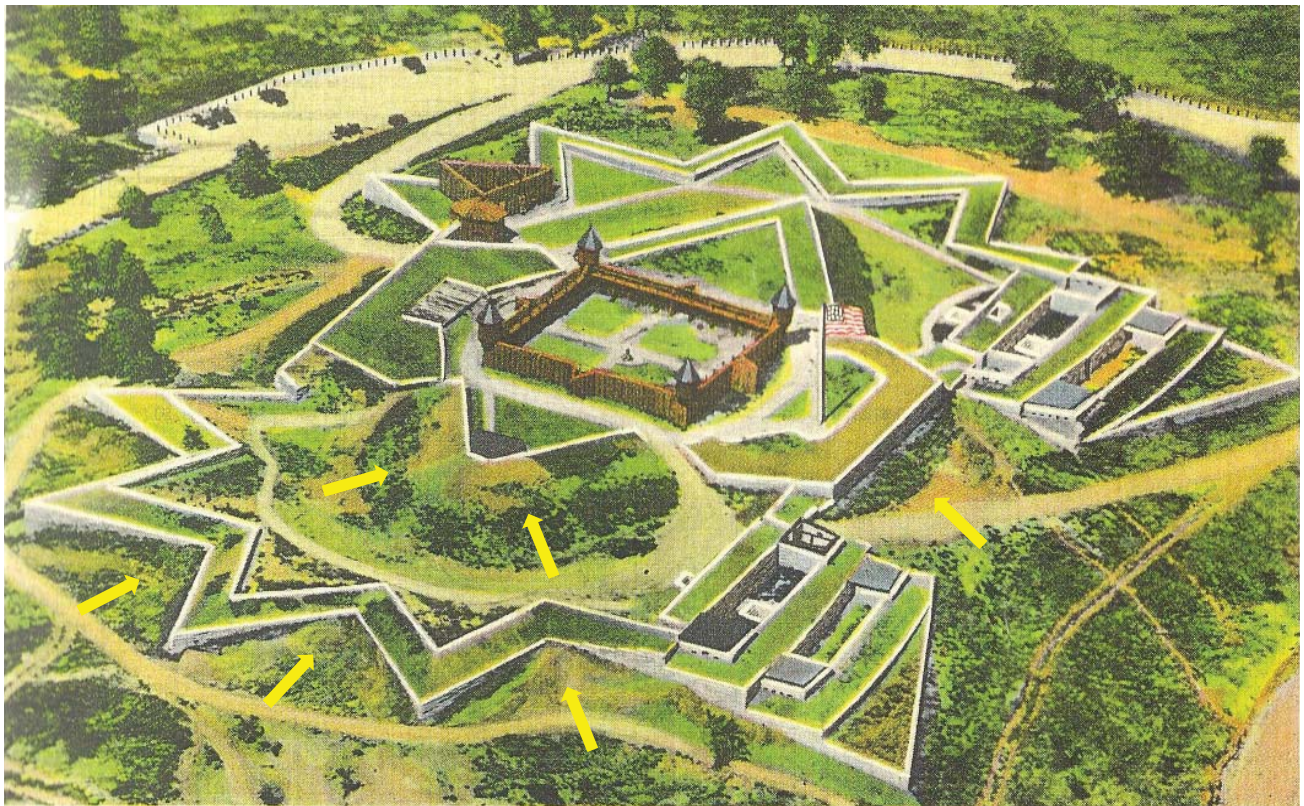
**Figure 7 (below).** Fort Negley as restored and landscaped by WPA including the reconstructed stockade, a flagpole inside the South Main Works, and roofed circular stockade gatehouse with adjacent triangular stockade at the Main Sally Port. Postcard from Michael Emrick Collection (FNVC).

Note bollards or posts at perimeter of parking area and loop road. Note also the scarps (steeply sloped earth fill) between redans, bastions, and at the West Ravelin (yellow arrows).

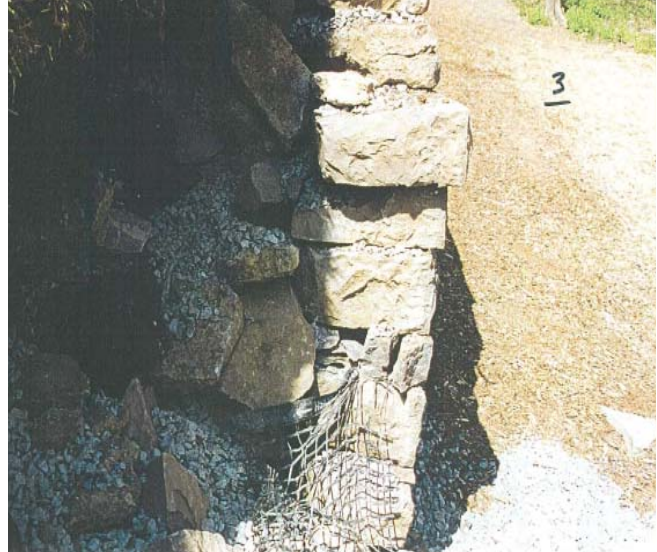
**Figure 12.** Wall stabilization failure from Geologic Engineering Consultants March 28, 2000, report to Metro Parks and Recreation Board (FNVC).

Filter fabric at left installed over existing rubble fill, new gravel fill behind stone masonry, and horizontal geogrid intended to tie the stone back to the fill.

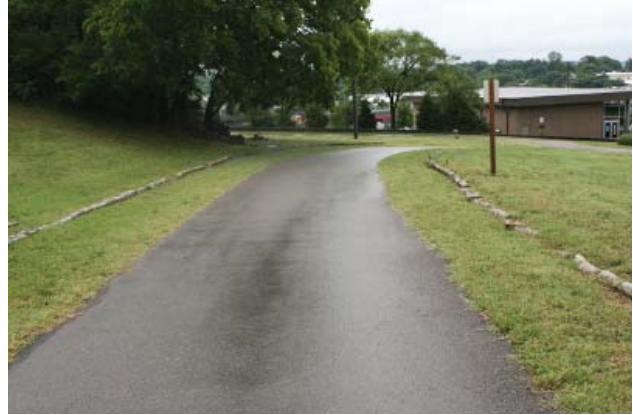
**Figure 28.** Fort Negley loop road looking toward Visitor Center (JMA, 2013).

10-foot wide asphalt travelway functions primarily as walking path and maintenance access road—original gravel paving ranged from 10 to 14 feet and extended to limestone curbing on either side

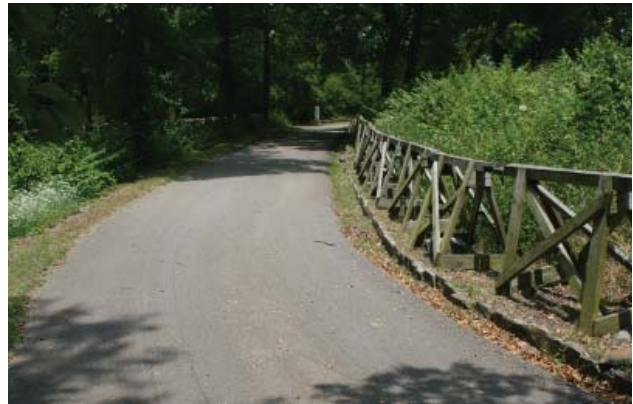
**Figure 29.** Fort Negley loop road on north side of fort curving eastward toward parking area (JMA, 2013).

Original road narrowed in this stretch, evident in the closer spacing of the limestone curbs.

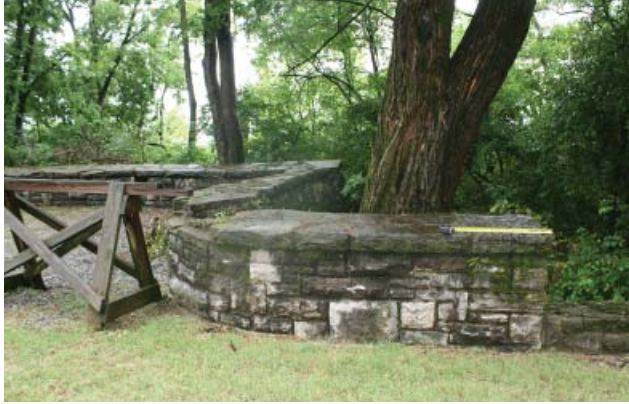
**Figure 32.** South end of parking area wall (JMA, 2013).

End of wall also marks end of loop road retaining wall at right.

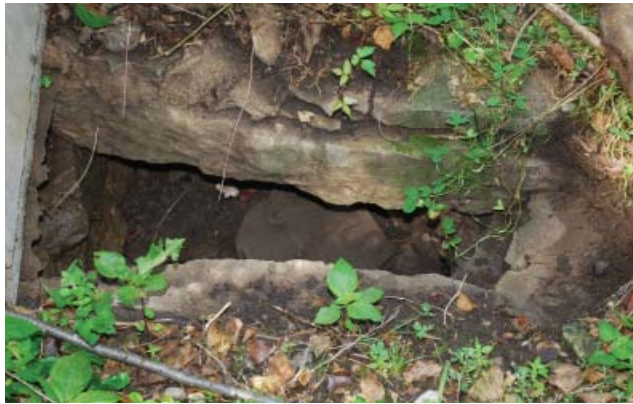
**Figure 42.** Interior of stone culvert (JMA, 2013).

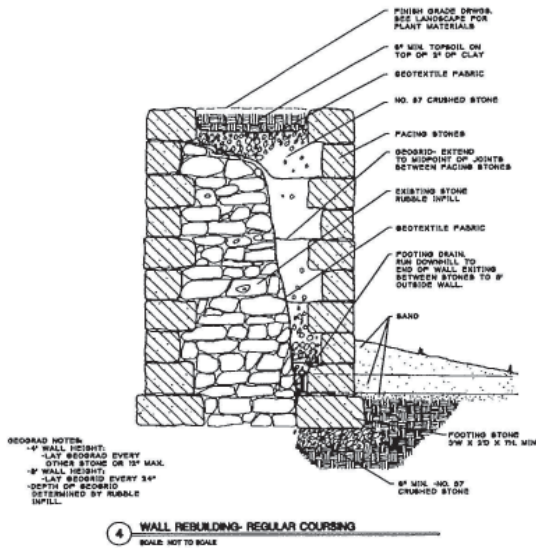
Project meeting minutes and inspection reports indicate these structural repairs began to fail in localized areas as construction neared completion in 1999. GEC, a geotechnical consultant, was retained in early 2000 to perform an investigation of the collapses. The reported findings of the geotechnical investigation appear to be comprehensive and sound. Investigators concluded that the primary factor of wall collapse was tie pull-out failure due to the limited embedment lengths of geogrid ties beyond the soil failure plane and their lack of connection to the face stones. This lack of tension reinforcement and/or wall ties to the internal rubble substrate beyond provided minimal restraint against lateral earth pressure and forced the relatively narrow facing stones along the exterior wythe to serve as a gravity retaining wall.

**Figure 84.** 1999 structural repairs detail. Hickerson Fowlkes (FNVC). Note geogrid horizontal ties extend from facing stone to face of rubble and geotextile filter fabric.

Preliminary calculations show the designed wall configuration provides insufficient support to the adjoining soils by a significant margin. The polymer reinforcement materials are also currently exposed to the sun at the areas of present collapse and at openings. These materials deteriorate rapidly due to ultraviolet radiation and may result in continued distress and subsequent collapse.

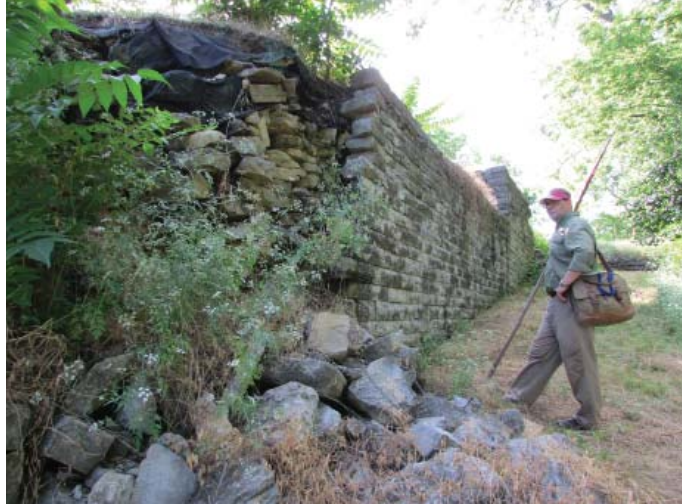
Twenty-three locations of wall collapse occur around the perimeter fortification walls. The most dramatic forms of collapse occur at areas of elevated wall heights, including the bastions and South Main Works walls (Figures 61 and 62), but the amount of collapse appears to be uniformly distributed throughout all areas of the outer walls including the lower redan walls (Figure 63).

**Figure 63.** Collapse area at Redan No. 7 retaining wall (1200AE, 2013).

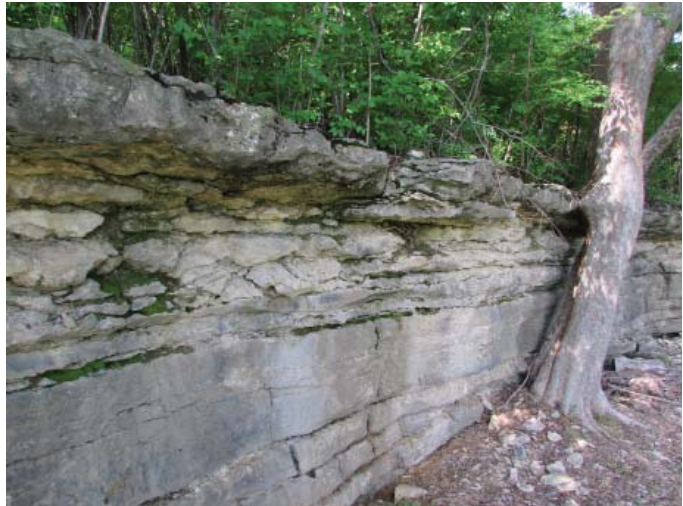
Stone delamination and associated material loss at Fort Negley is a direct result of the material's sedimentary formation. The locally-quarried Ordovician limestone is relatively soft and easily friable (Figure 65). Some of the stones can be readily seen to be delaminating along layers, or "bedding planes," of stone and sand. Deterioration appears to be ongoing throughout the natural bedrock in Fort Negley Park and in the fortification walls without regard to the sizes of the stones (Figures 66 and 67). In other instances, where the sedimentary materials are not well bonded due

**Figure 66.** Various stages of delamination in exterior facing stones (1200AE, 2013).

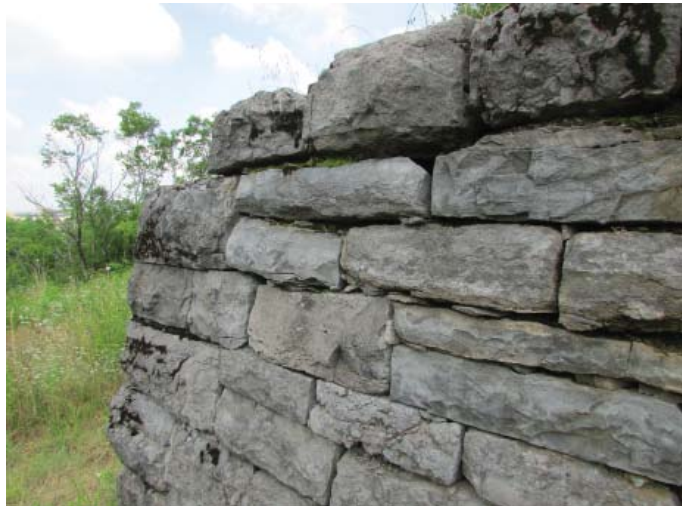
**Figure 67.** Advanced decomposition in exterior facing stones and loss of material (1200AE, 2013).

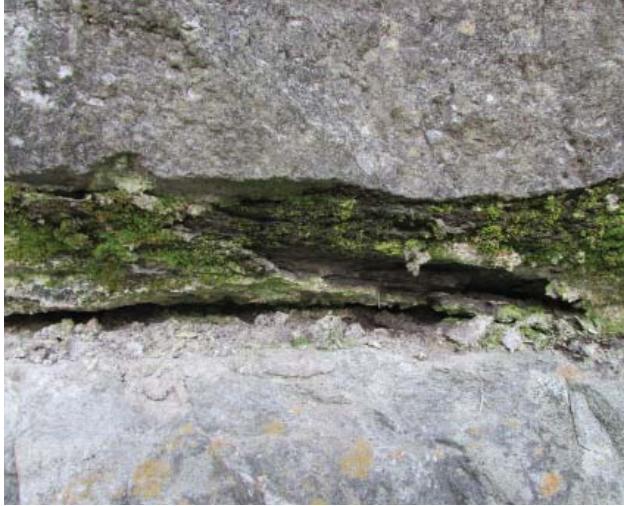
**Figure 68.** Initial stages of delamination and exfoliation in exterior stones (1200AE, 2013).

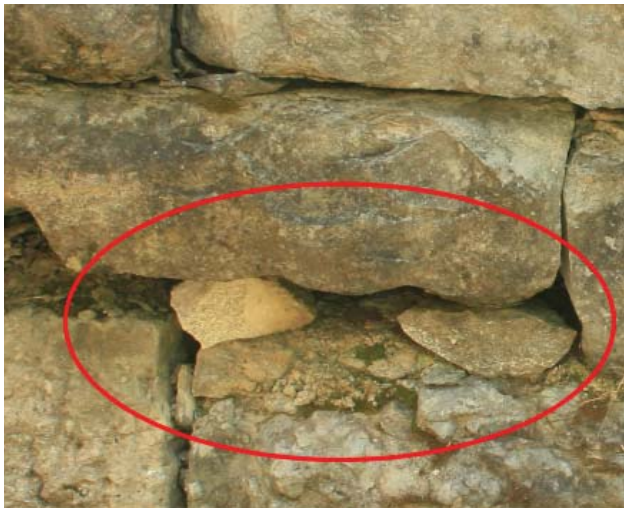
**Chinking Loss.** Two forms of chinking are visible in many fortification walls: long, thin, very flat stones placed in the wall during construction to maintain course alignments, and “face chinking” consisting of small stones set or driven into the face of a finished wall to level and stabilize large stones. There are many instances where thin chinking stones—poorly consolidated during formation and containing high levels of clay—have completely eroded (Figure 69) thereby allowing the stones above to span the resulting void between adjacent stones. At other walls, face-chinking has eroded or fallen out due to thermal expansion of the wall, destabilizing the stone above and allowing it to rotate in the wall, extending the area of instability further into the stone courses above.

**Figure 69.** Chinking loss (JMA, 2013).

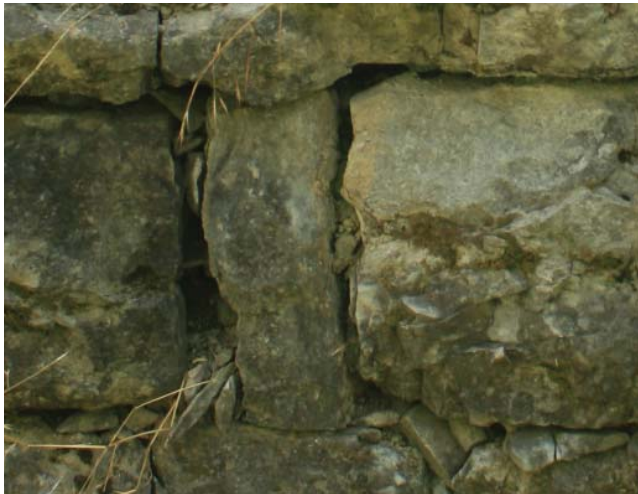
Dry-stacked stone walls are strengthened by installing “deadmen” — stones set at right angles to extend back into the rubble or soil behind the wall. These stones tie the wall to the backup using friction to limit movement. At Fort Negley, deadmen are often small and rectangular in section. Some of these have been “edge bedded” with the deposit layers in the stone laid vertically (Figure 75), increasing their susceptibility to water saturation and delamination. Stone coursing at several locations around the fort also appears to be sagging, probably due to settlement or compaction of soils (Figure 76). Large piles of rubble on the berms at the tops of some walls have also increased loads acting on these walls (Figure 77).

**Figure 75.** Edge bedded (bedding planes vertical) deadman (JMA, 2013).

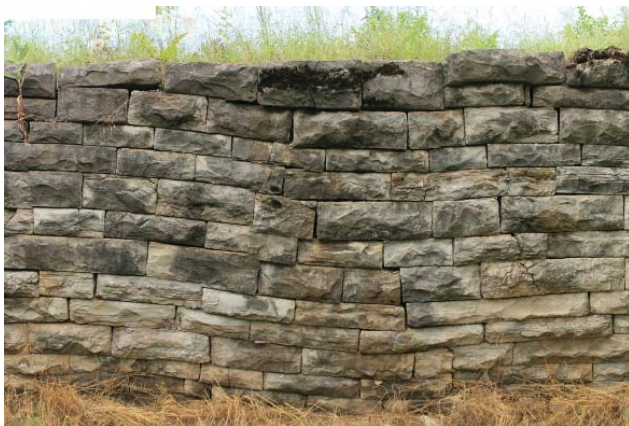
**Figure 76.** Sagging wall, possibly due to poor soils, animal burrows, or undermining (JMA, 2013).

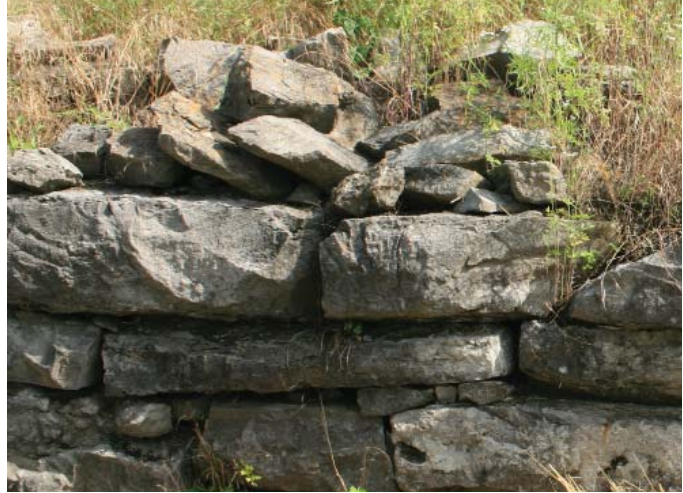
**Figure 77.** Stone rubble piled on top of wall (JMA, 2013).

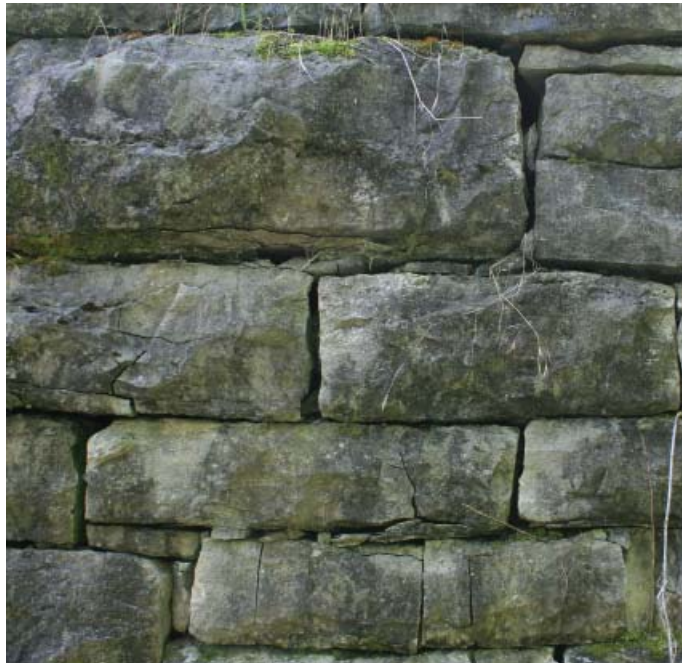
Redan walls, in particular, were laid with a range of medium, large, and giant stones instead of stones of nearly uniform size. Frequently, these giant stones are placed in the upper half or third of a wall instead of lower in the wall (Figure 78), in some cases causing crushing or cracking of the stones below by their weight and in other cases raising the center of gravity of the wall section and contributing to overturning.

**Figure 78.** Large stones laid in top half of wall alter the center of gravity, promoting wall overturning and crushing stones in wall below (JMA, 2013).

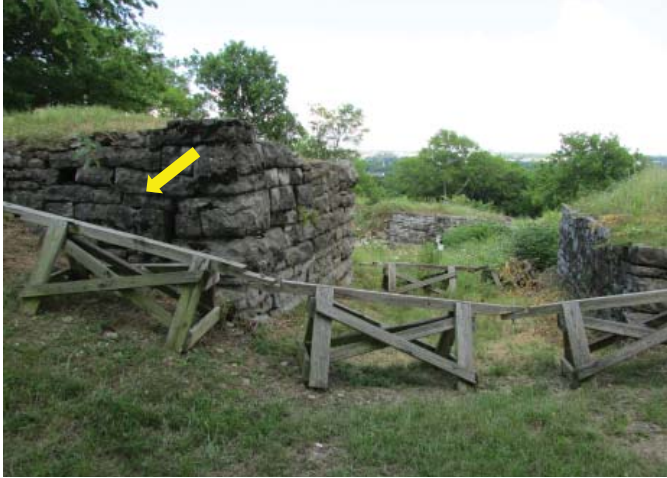
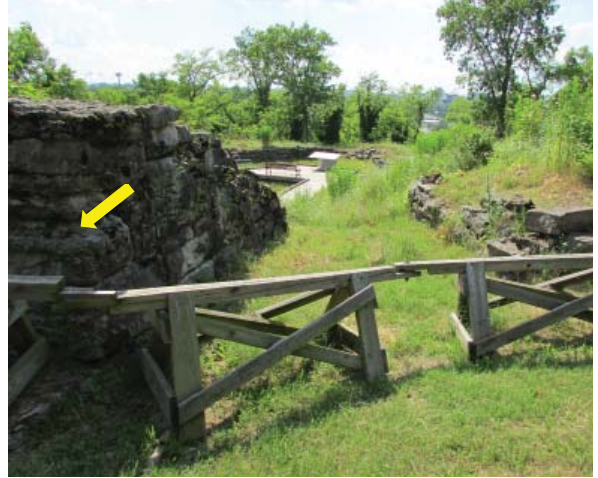
**Figure 85 (above left).** East Sally Port linking inner works to East Ravelin ditch and East Bastion beyond (1200AE, 2013).

Note relative soil height difference between south and north walls (left and right respectively). Note horizontal displacement in south wall of East Inner Works (yellow arrow).

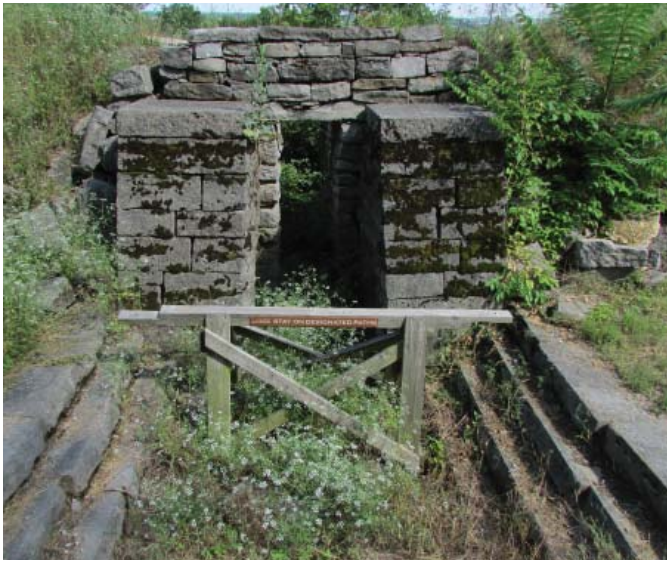
**Figure 86 (above).** West Sally Port linking inner works to West Ravelin ditch (Redan No. 4 beyond) (1200AE, 2013).

Note tapered wall height at left and limited wall height to right. Dead-end of boardwalk beyond. Yellow arrow represents area of stone delamination.

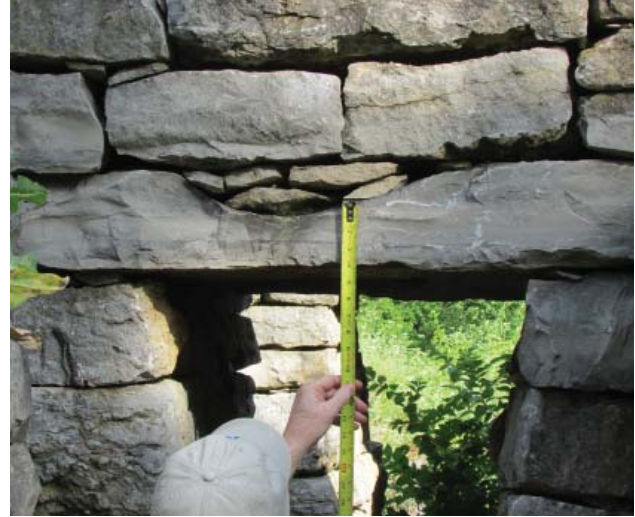
**Figure 90 (above right).** East Bastion tunnel with notched lintel (1200AE, 2013).

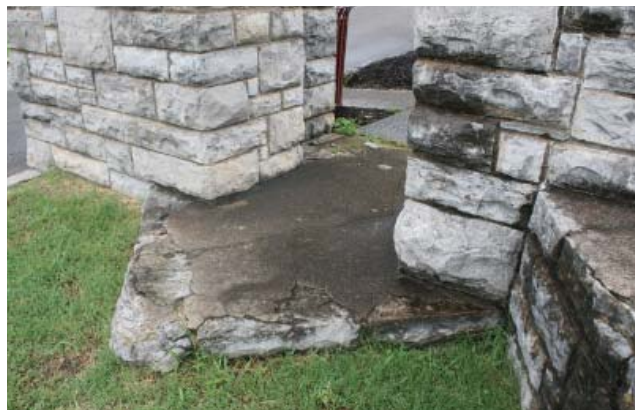
**Figure 98.** Cracked and broken mortar skim coat on limestone platforms at openings in entrance gate central screen wall, completely missing in some places (JMA, 2013).

Water can infiltrate between units and may lead to displacement.

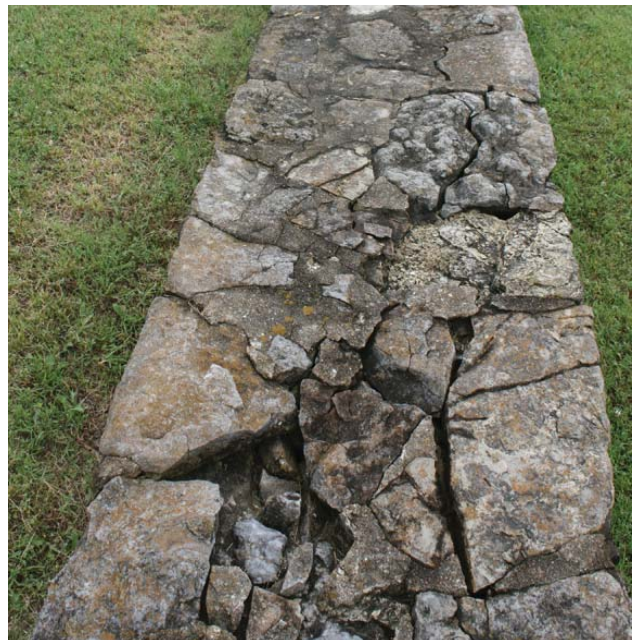
**Figure 105.** Damage to top surface of northwest wing wall of entrance gate structure caused by water infiltration and failure of post previously mounted into top of wall (JMA, 2013).

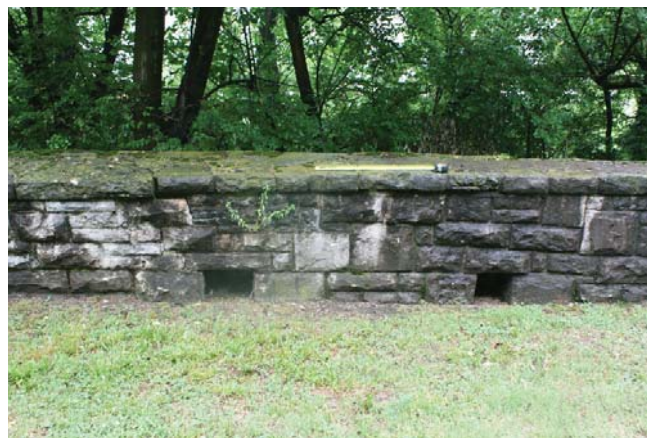
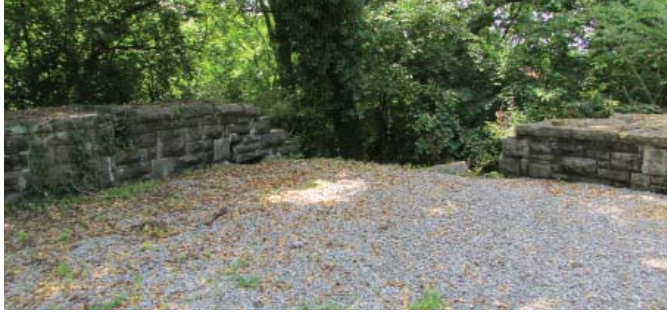
Areas of structural distress are mostly isolated to the east and west ends of the lower retaining wall and parapet (Figures 110 through 112, and see also Appendix B, diagram SSK-1). Vertical and diagonal cracks were observed at both ends of the retaining wall, and diagonal cracks have also developed, apparently due to out-of-plane sliding displacement (Figure 113). A complete collapse has occurred at the northwest corner of the retaining wall and the parapet above, approximately 12 linear feet (see Figure 111). Partial collapses have also occurred at the ends of the parapet return walls. It appears that gravel has been placed to stabilize the soils along the top surface of the parking lot. The formation of hinge points, cracks, and areas of collapse negatively effects the tie action of the parapet to resist out-of-plane forces, and future movement should be anticipated.

**Figure 111.** Collapse at southwest corner of wall (1200AE, 2013).

- *First*, temporarily shore or brace bastion tunnels to address the immediate threats to life safety and then shore or brace walls exhibiting bulges and out-of-plane displacements to maintain the existing wall construction wherever there is a high probability of further collapse;
- *Second*, stabilize walls with grouted stainless steel soil and masonry anchors.

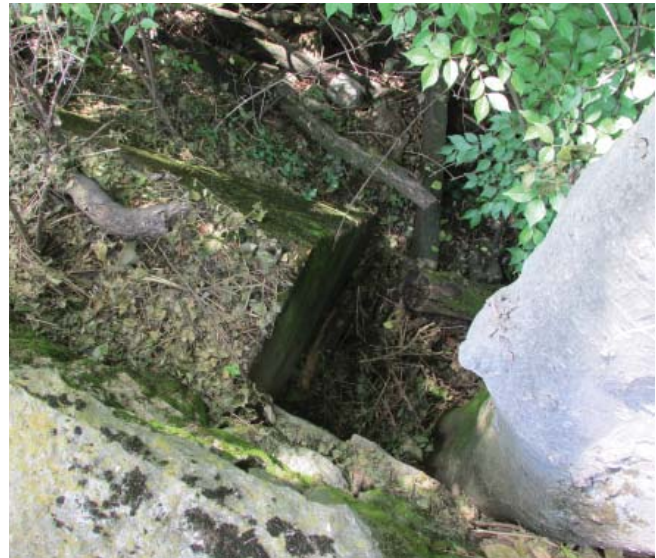
**Figure 115.** Loss of capstone units and delamination of exterior surface of stones. (1200AE).

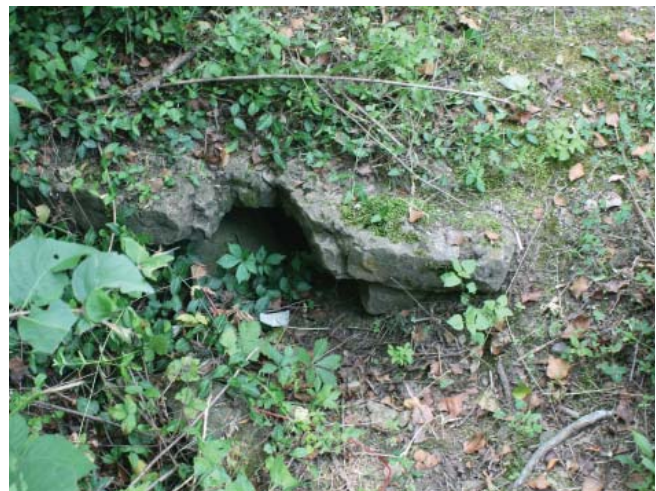
Original limestone slab caps protecting drop inlets were set up on low limestone rubble corner blocks to allow water flow into the culvert (Figure 116). Some of the limestone slabs collapsed into the inlets or have been replaced with concrete slabs (see Figure 42 in Chapter I.2) incompatible with the rustic design. Some of the inlets were not visible for investigation.

**Figure 116.** Partially-buried limestone drop inlet cover (JMA, 2013).
