Operations Monitoring Report

Second Quarter FY15

**Thermal Engineering Group, Inc.
105 Hazel Path Court, Ste 2
Hendersonville, TN 37075**

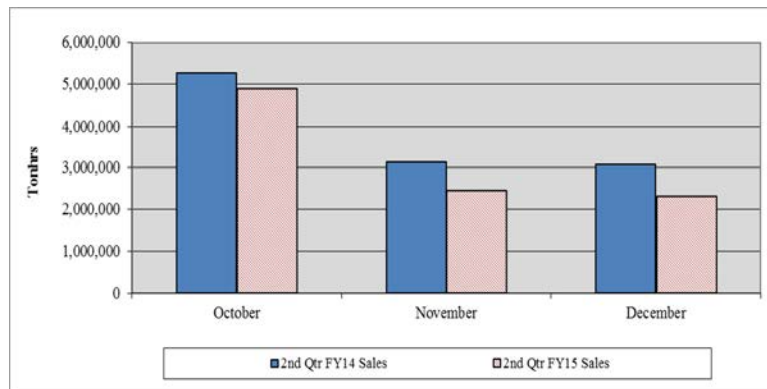
A comparison for the Second Quarter chilled water sales is shown in Figure 1. This data reflects a 15.9% decrease in sales for the current quarter over the same quarter of the previous fiscal year.

Figure 1. Second Quarter FY15 Sales Comparison

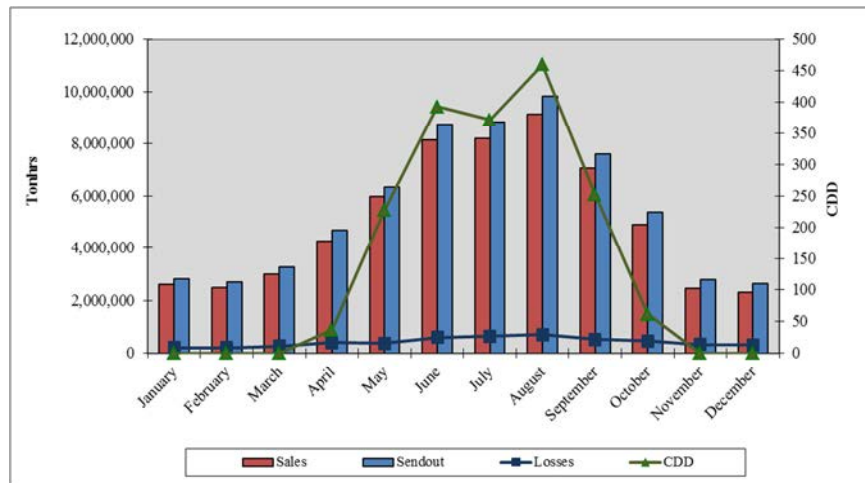
Figure 2 shows the chilled water sales, sendout and losses for the previous twelve months. The losses on this figure are defined as the difference in tonhrs per month between the recorded sendout and sales values and represent the total energy loss for chilled water in the EDS. The number of cooling degree days per month are also tracked for comparison.

Figure 2. Chilled Water Sales, Sendout, Losses and CDD for the Previous Twelve Months

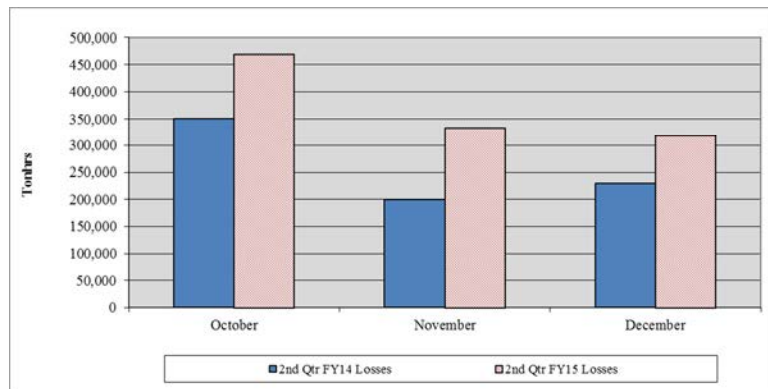
A comparison of the total, chilled water energy losses in the EDS for the Second Quarter is shown in Figure 3. These losses are the difference in chilled water sendout and sales.

Figure 3. Chilled Water System Loss Comparison for the Second Quarter FY15

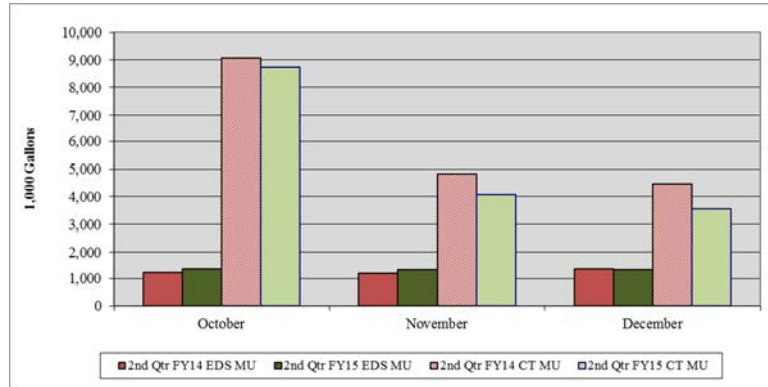
experienced a 34.7% decrease during the current quarter. The overall city water make-up comparison for the chilled water system is shown in Figure 4.

Figure 4. Chilled Water System City Water Usage Comparison

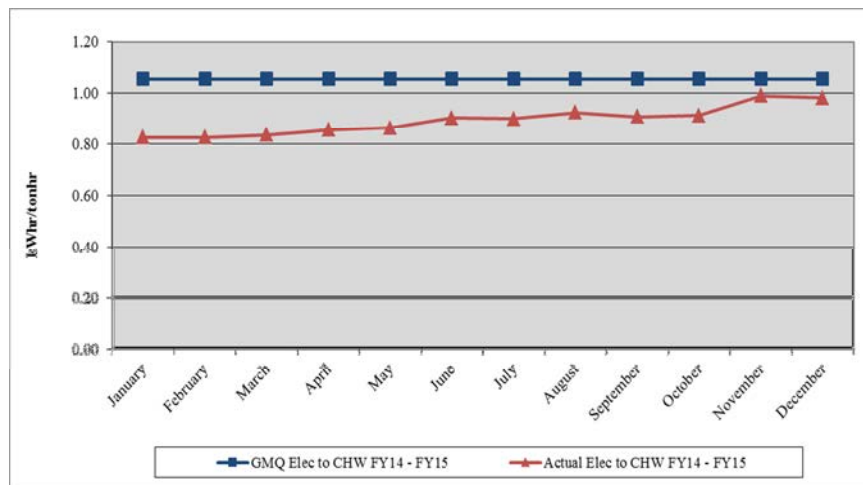
The performance of the chilled water aspect of the EGF is presented by the following two charts, Figures 5 and 6, for the previous twelve months. Under the management of CNE, the System Performance Guarantee levels as described in the ARMA are being achieved quite satisfactorily.

Figure 5. Chiller Plant Electric Performance Guarantee Comparison for the Previous Twelve Months

The chilled water allocation of the electric consumption falls under the GMQ limit of 1.055 kWhr per tonhr for the current quarter, and no excursion is reported for the current fiscal year. However, the chiller plant electric usage continues to show a steady increase over previous years. This increase is believed to be due, in part, to a change in operation of the chiller plant adopted by CNE during the First Quarter that was to be addressed during the Second Quarter. The electric usage per unit of sales increased approximately 14.3% over the Second Quarter for FY14 (Figure 5). The Second Quarter FY15 saw the two lowest efficient months in the DES operational history.

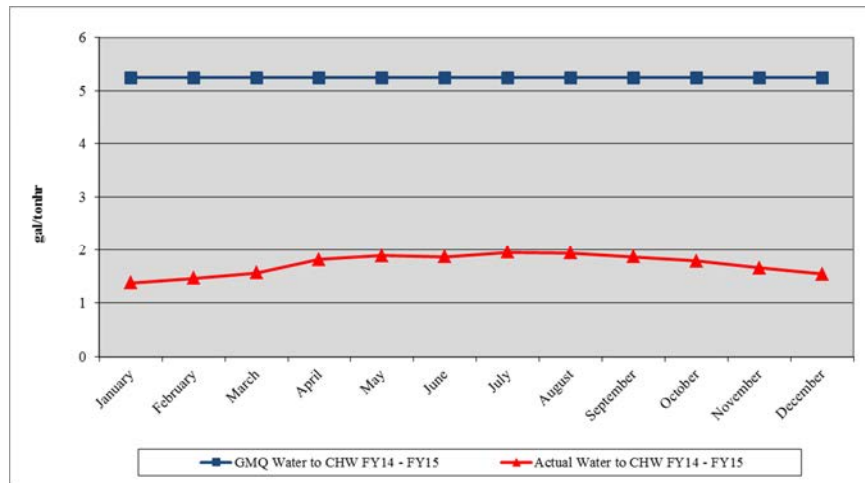
Figure 6. Chiller Plant Water Consumption Performance Guarantee Comparison for the Previous Twelve Months

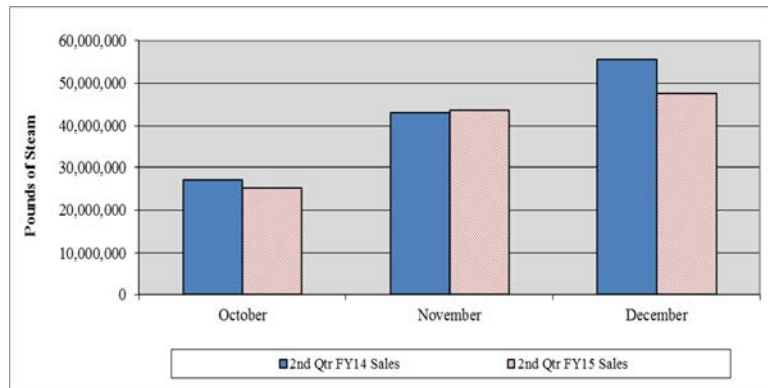
The steam sendout decreased by approximately 6% over the previous Second Quarter (FY14), and the sales also decreased by approximately 7%. The number of heating degree days decreased 1.6% over the previous Second Quarter. The steam system losses increased 15% over the previous Second Quarter. A comparison for the Second Quarter steam sales is shown in Figure 7.

Figure 7. Steam Sales Comparison for the Second Quarter FY15

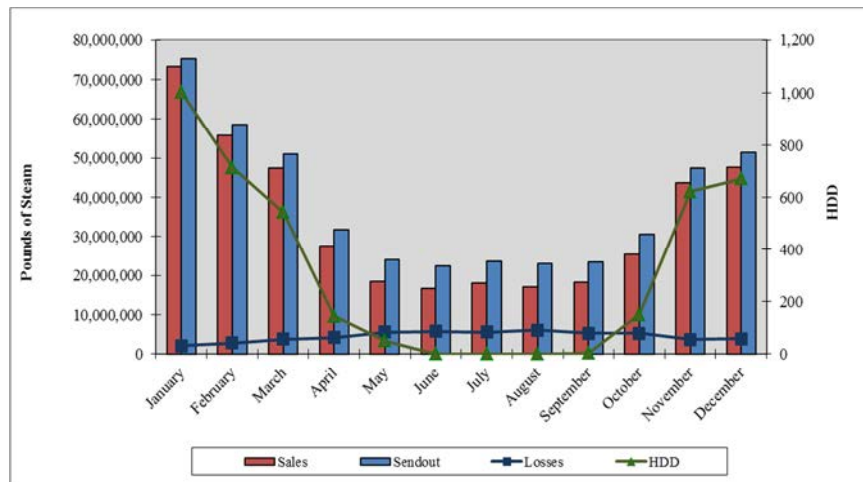
Figure 8 shows the steam sales, sendout and losses for the previous twelve months. The losses on this figure are defined as the difference in pounds per month between the recorded sendout and sales values and represent the total mass loss in the EDS between the EGF and the customer meters.

Figure 8. Steam Sales, Sendout, Losses and HDD for the Previous Twelve Months

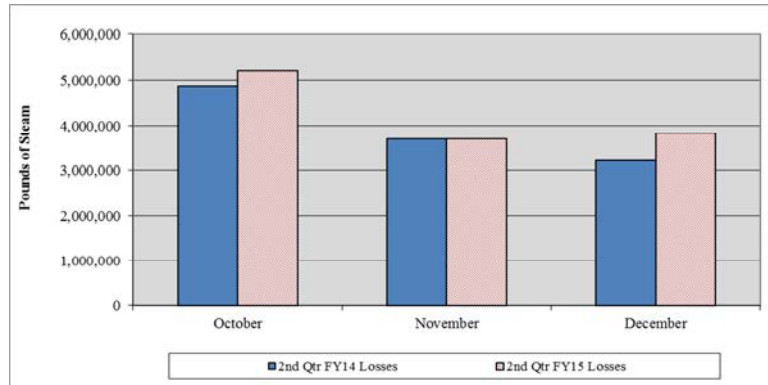
A comparison of the total steam mass losses in the EDS for the Second Quarter is shown in Figure 9. The mass loss is caused by the heat loss in the EDS between the EGF and the customer meters, resulting in a mass loss at steam traps. Faulty traps, steam leaks or meter error could also be a contributing cause of these losses.

Figure 9. Second Quarter FY15 Steam System Losses

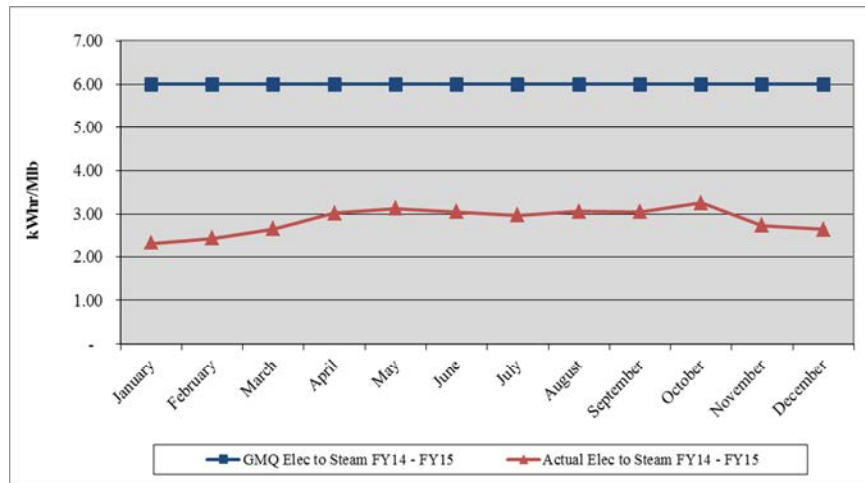
The performance of the steam system aspect of the EGF is presented by the following three charts, Figures 11, 12 and 13. Under the management of CNE, the System Performance Guarantee levels as described in the ARMA are being achieved satisfactorily.

Figure 11. Steam Plant Electric Performance Guarantee for the Previous Twelve Months

The current quarter experienced a marginal increase in the steam plant electric consumption while experiencing a 9.3% increase in the electric conversion factor. The water consumption for the steam plant increased 31.9% this quarter as compared to the previous Second Quarter. The fuel consumption per unit of steam sales is relatively constant throughout the year and when compared to the historic data. The boiler plant fuel efficiency decreased 0.56% for the current quarter.

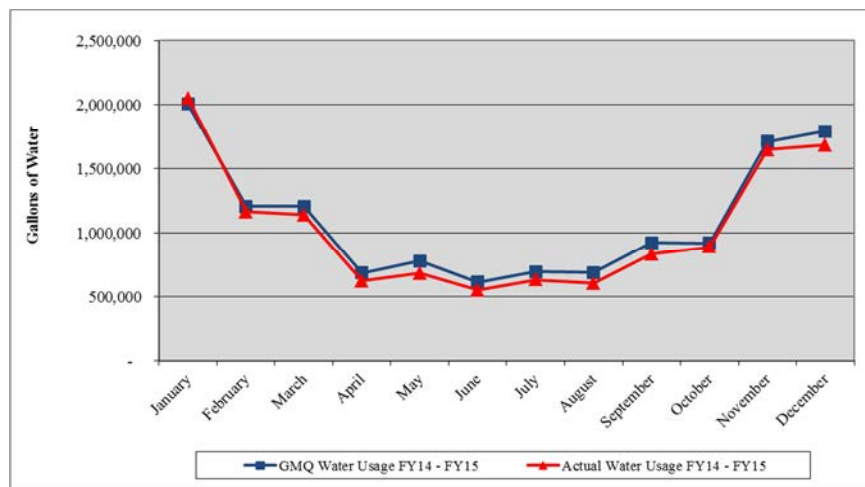
Figure 12. Steam Plant Water Performance Guarantee for the Previous Twelve Months

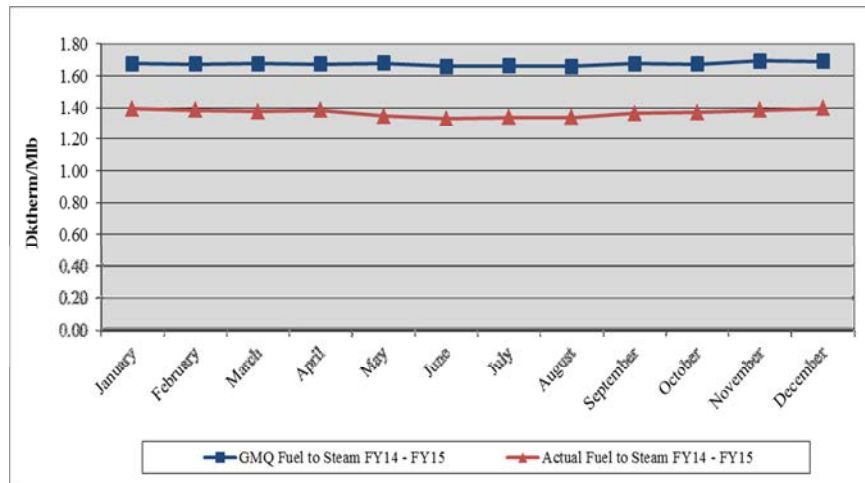
Figure 13. Steam Plant Fuel Performance Guarantee for the Previous Twelve Months
