Operations Monitoring Report

Second Quarter FY19

**Thermal Engineering Group, Inc.
105 Hazel Path Court, Ste 2
Hendersonville, TN 37075**

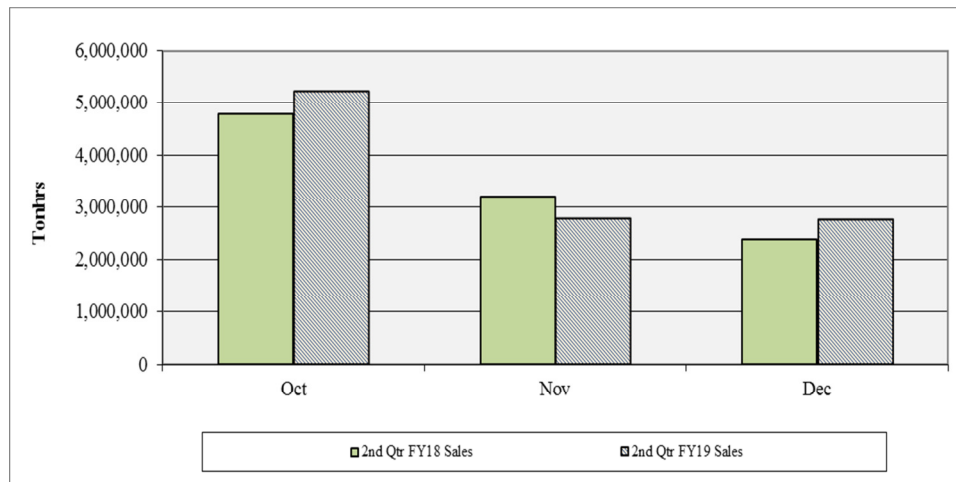
A comparison for the Second Quarter chilled water sales is shown in Figure 1. This data reflects a 3.6% increase in sales for the current quarter over the same quarter of the previous fiscal year.

Figure 1. Chilled Water Sales Comparison

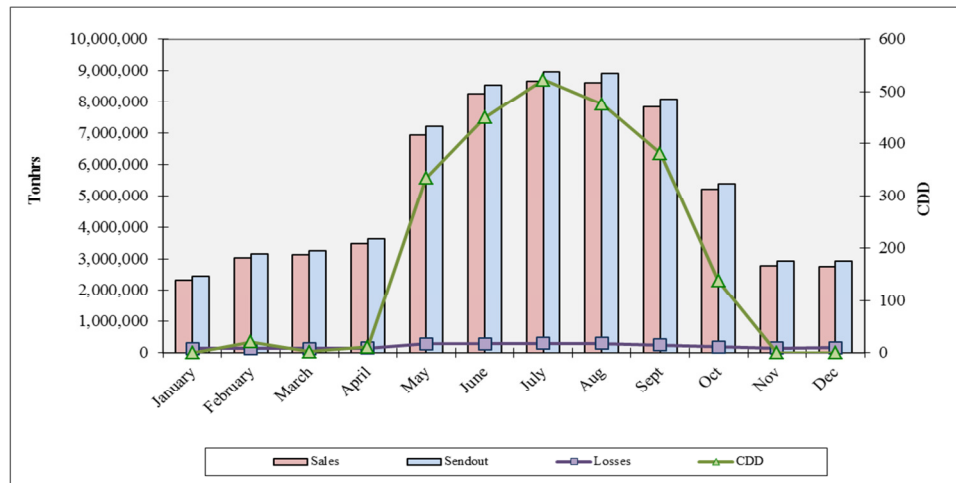
Figure 2 shows the chilled water sales, sendout and losses for the previous twelve months. The losses on this figure are defined as the difference in tonhrs per month between the recorded sendout and sales values and represent the total energy loss for chilled water in the EDS. The number of cooling degree days per month are also tracked for comparison.

Figure 2. Chilled Water Sales, Sendout, Losses and CDD for the Previous Twelve Months

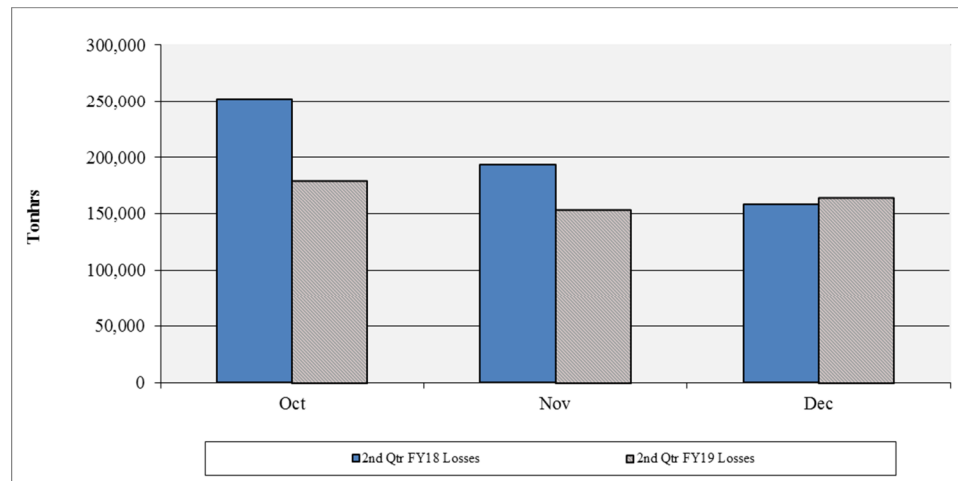
A comparison of the total, chilled water energy losses in the EDS for the Second Quarter is shown in Figure 3. These losses are the difference in chilled water sendout and sales.

Figure 3. Chilled Water System Loss Comparison

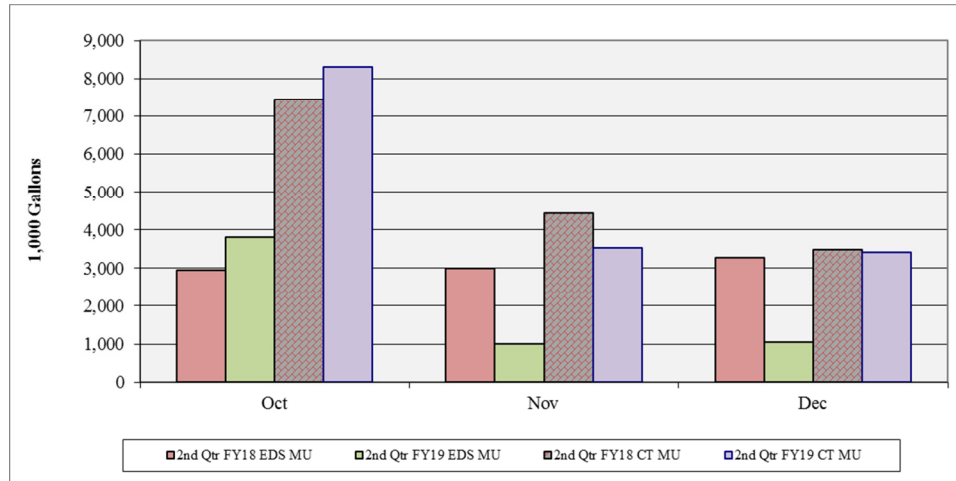
The make-up to the cooling towers decreased approximately 0.8% during the quarter. The number of cycles of concentration in the condensing water circuit experienced a 31.3% decrease during the current quarter. The overall city water make-up comparison for the chilled water system is shown in Figure 4.

Figure 4. Chilled Water System City Water Usage Comparison

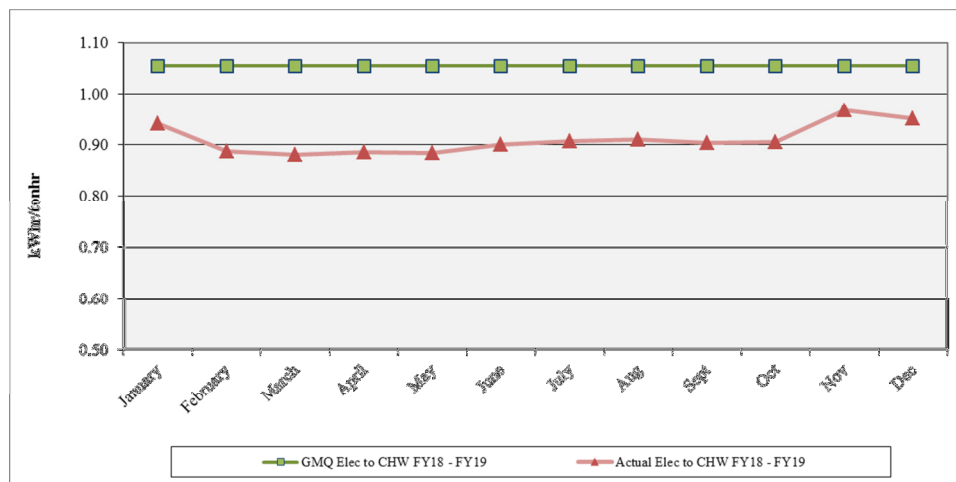
The performance of the chilled water aspect of the EGF is presented by the following two charts, Figures 5 and 6, for the previous twelve months. Under the management of CNE, the System Performance Guarantee levels as described in the ARMA are being achieved satisfactorily.

Figure 5. Chiller Plant Electric Performance Guarantee Comparison for the Previous Twelve Months

The chilled water allocation of the electric consumption falls under the GMQ limit of 1.055 kWhr per tonhr for the current quarter, and no excursion is reported for the current fiscal year. The electric usage per unit of sales increased 2.5% over the previous Second Quarter.

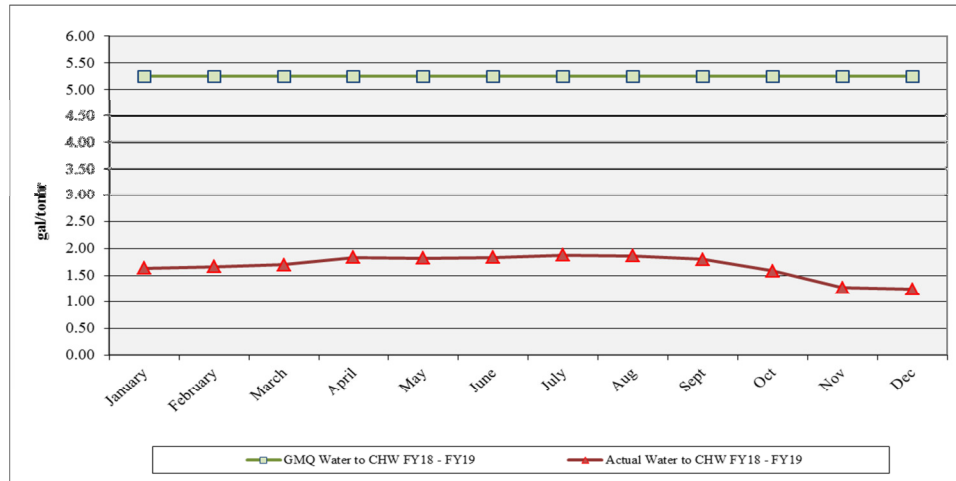
Figure 6. Chiller Plant Water Consumption Performance Guarantee Comparison for the Previous Twelve Months

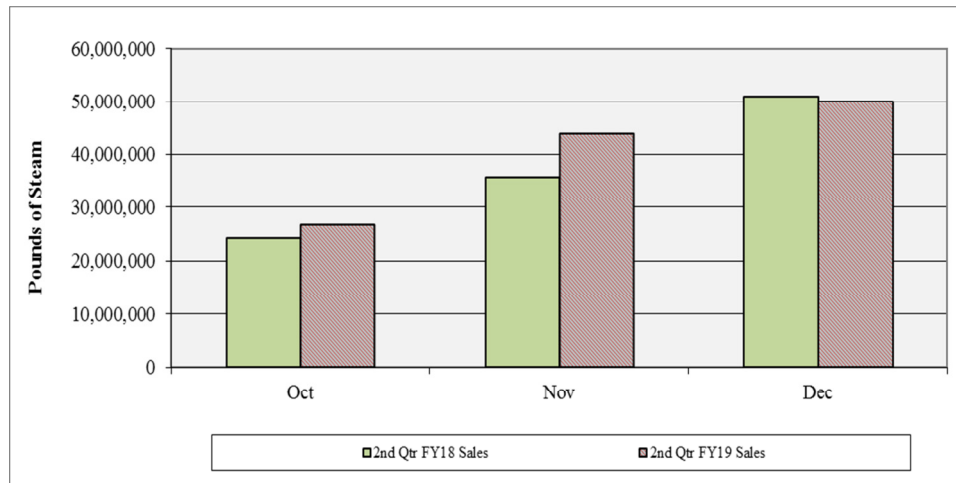
The steam sendout increased by approximately 6.2% over the previous Second Quarter (FY18), and the sales also increased by approximately 9.2%. The Quarter experienced a 2.6% increase in the number of heating degree days. The steam system losses decreased 16.3% over the previous Second Quarter. A comparison for the Second Quarter steam sales is shown in Figure 7.

Figure 7. Steam Sales Comparison

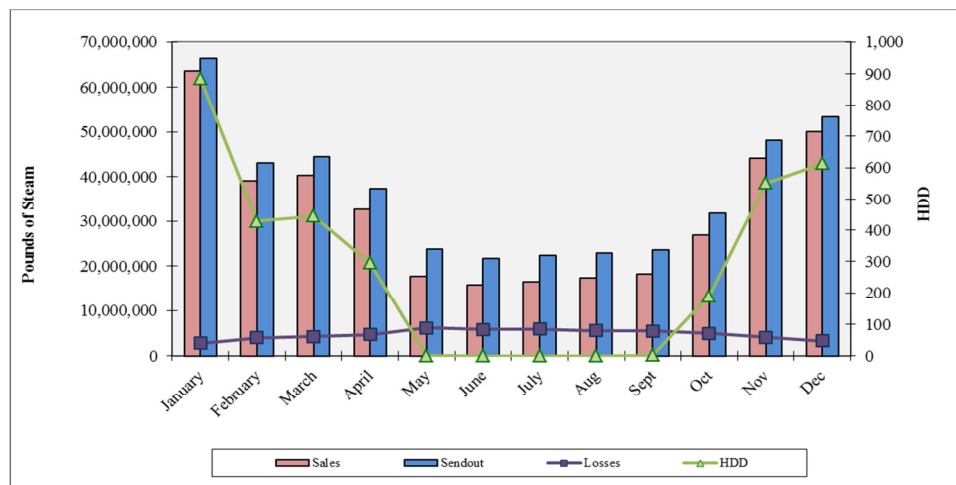
Figure 8 shows the steam sales, sendout and losses for the previous twelve months. The losses on this figure are defined as the difference in pounds per month between the recorded sendout and sales values and represent the total mass loss in the EDS between the EGF and the customer meters.

Figure 8. Steam Sales, Sendout, Losses and HDD for the Previous Twelve Months

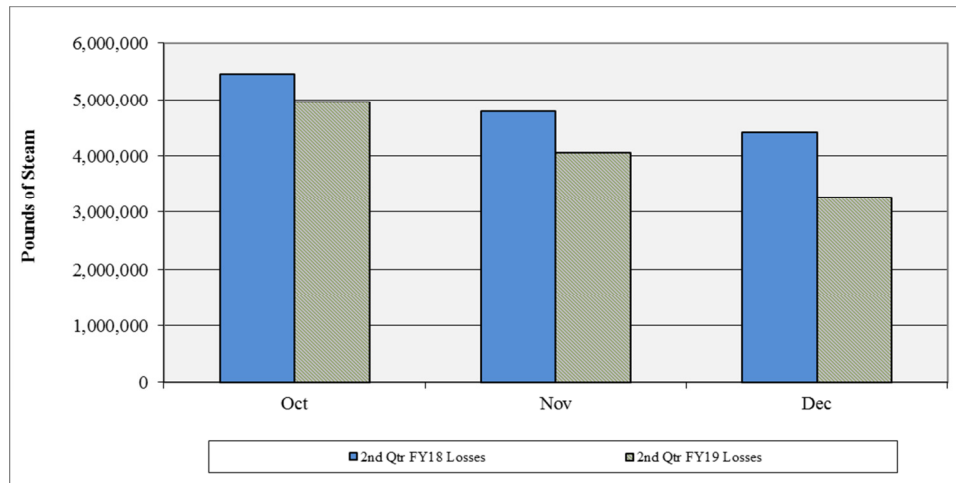
A comparison of the total steam mass losses in the EDS for the Second Quarter is shown in Figure 9. The mass loss is caused by the heat loss in the EDS between the EGF and the customer meters, resulting in a mass loss at steam traps. Faulty

traps, steam leaks or meter error could also be a contributing cause of these losses. Whenever steam sales decrease from the previous quarter, the percent of system losses can be expected to increase since the majority of these losses are based on a near constant heat loss of the system.

Figure 9. Steam System Losses

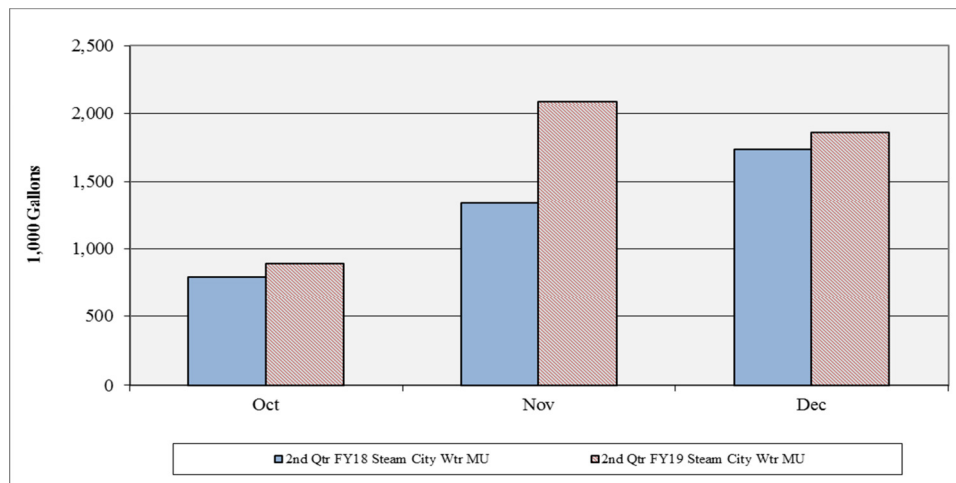
The amount of city water make-up (MU) to the steam system consists of the loss in mass between the EGF and the customers, in the condensate return from the customers to the EGF and losses at the EGF. This data is shown in the comparison of Second Quarter data in Figure 10.

Figure 10. Steam System City Water Make-up Comparison

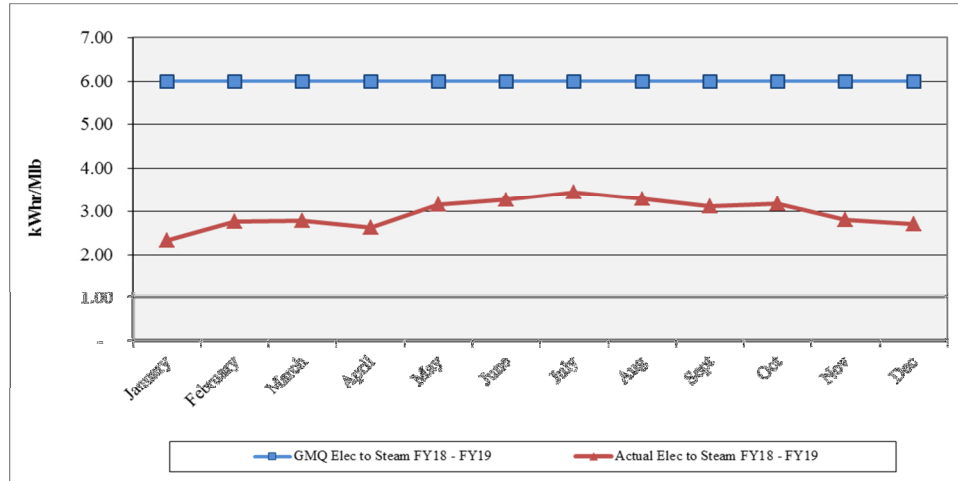
The performance of the steam system of the EGF is presented by the following three charts, Figures 11, 12 and 13. Under the management of CNE, the System

Figure 11. Steam Plant Electric Performance Guarantee for the Previous Twelve Months

The current quarter experienced a 14.8% increase in the steam plant electric consumption while experiencing a 5.1% increase in the electric conversion factor. The water consumption for the steam plant increased 25.1% this quarter as compared to the previous Second Quarter. The fuel consumption per unit of steam sales was 0.3% higher than in the previous Second Quarter.

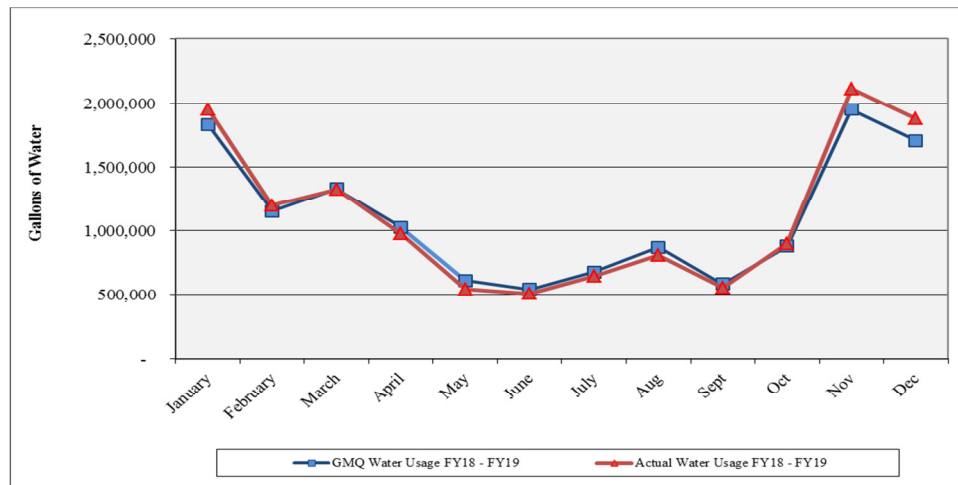
Figure 12. Steam Plant Water Performance Guarantee for the Previous Twelve Months

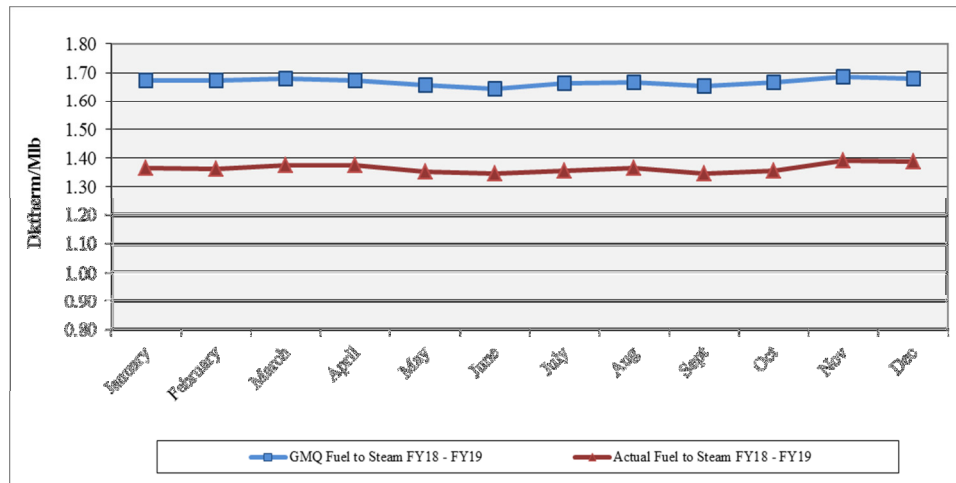
Figure 13. Steam Plant Fuel Performance Guarantee for the Previous Twelve Months
