STAFF RECOMMENDATION

**118 South 11th Street
March 17, 2021**

Application: New Construction—Infill
District: Lockeland Springs-East End Neighborhood Conservation Zoning Overlay
Council District: 06
Base Zoning: MUL-A
Map and Parcel Number: 08309022600 and 08309022500
Applicant: Gina Emmanuel, Centric Architecture
Project Lead: Melissa Baldock melissa.baldock@nashville.gov

Description of Project: Applicant proposes to construct infill on a vacant lot due to the March 3, 2020 tornado.

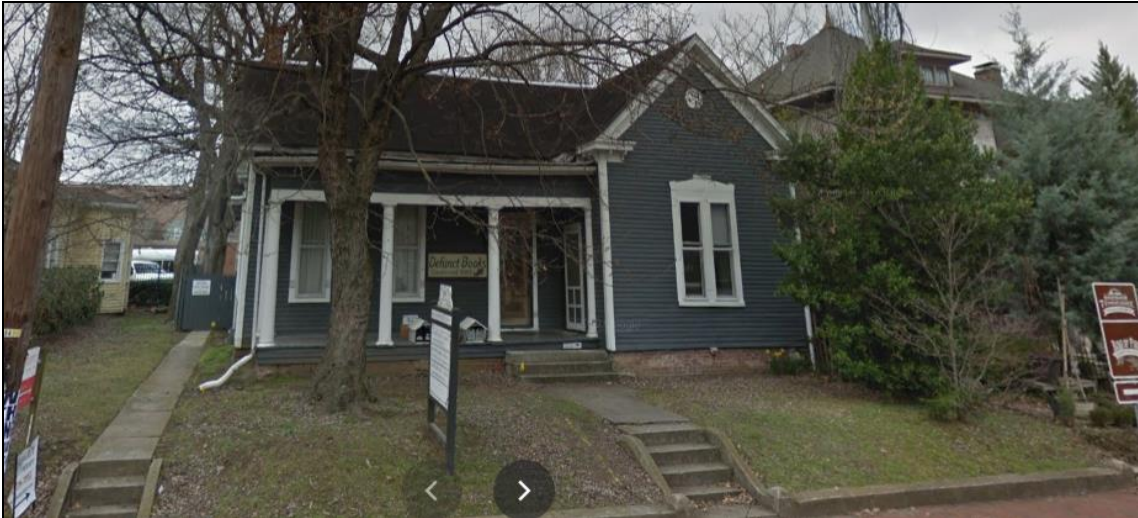
Figure 1. 118 South 11th Street prior to the March 3, 2020 tornado

Background: 118 South 11th Street was a c. 1895 one-story folk Victorian house (Figure 1). The house was significantly damaged in the March 3, 2020 tornado (Figures 2 & 3). In March 2020, MHZC staff issued an emergency demolition permit under the Rules of Order and Procedure VI.C.2.c, which allow for administrative issuance of demo permits for any structure that has become a major life-safety hazard and based on engineer's findings that the buildings were not reparable.

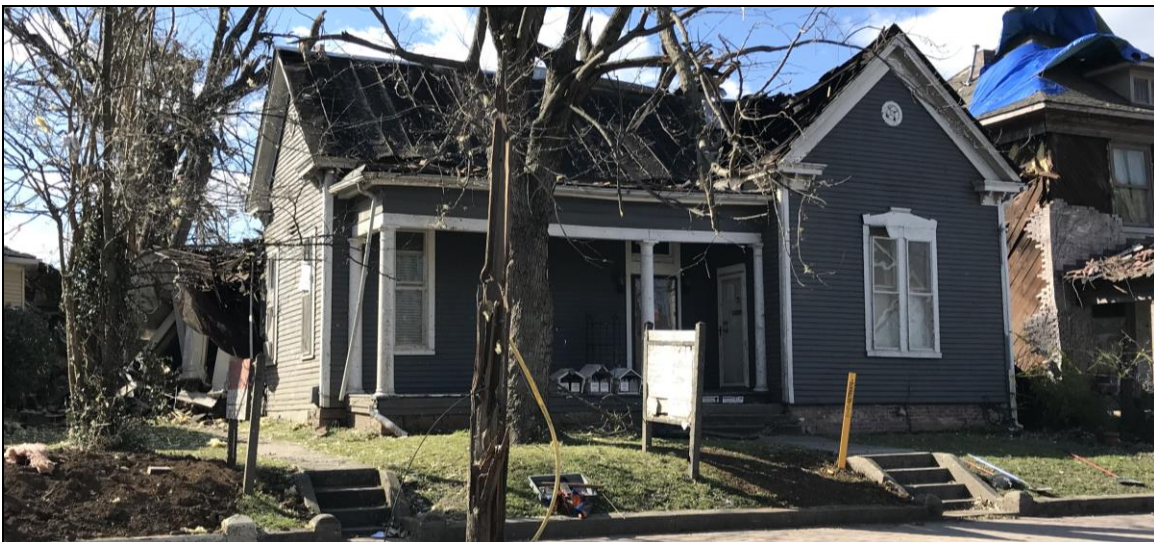
Figure 2. The tornado damage

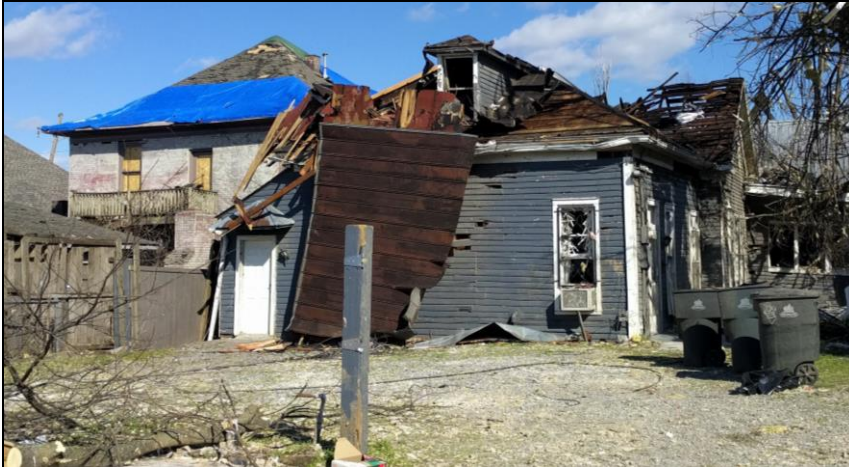
Figure 3. The tornado damage from the rear.

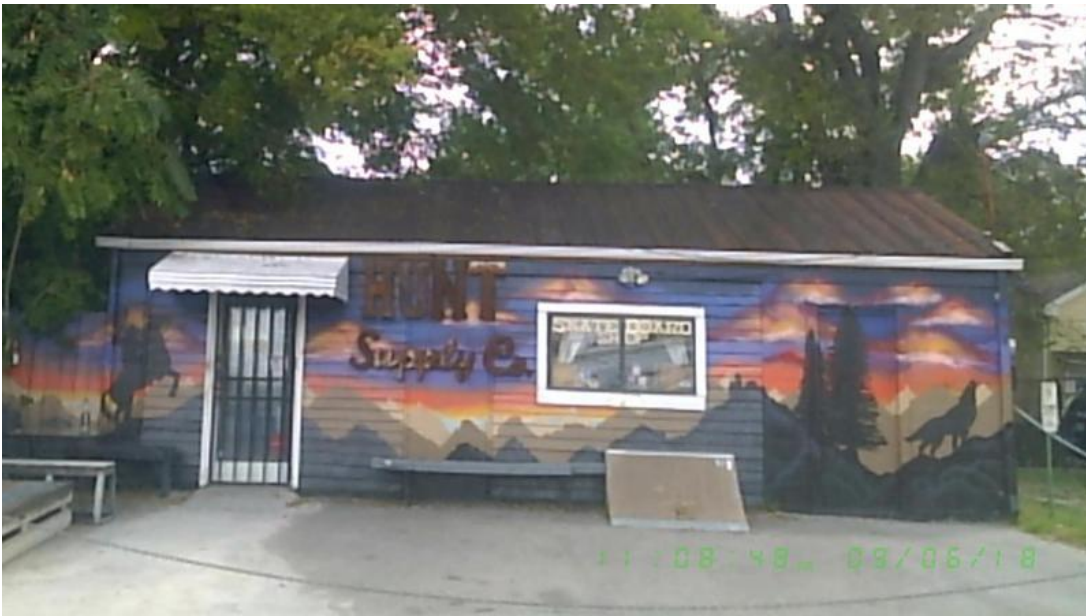
Figure 4. Rear building prior to the 2020 Tornado.

The site also included a one-story outbuilding at the rear (Figure 4). The Metro Property Assessor dates this outbuilding to 1956. Regardless of its date of construction, the structure's concrete block construction, materials, design, and location at the rear of the lot rendered it non-contributing. The structure was destroyed in the March 3, 2020 tornado (Figure 5).

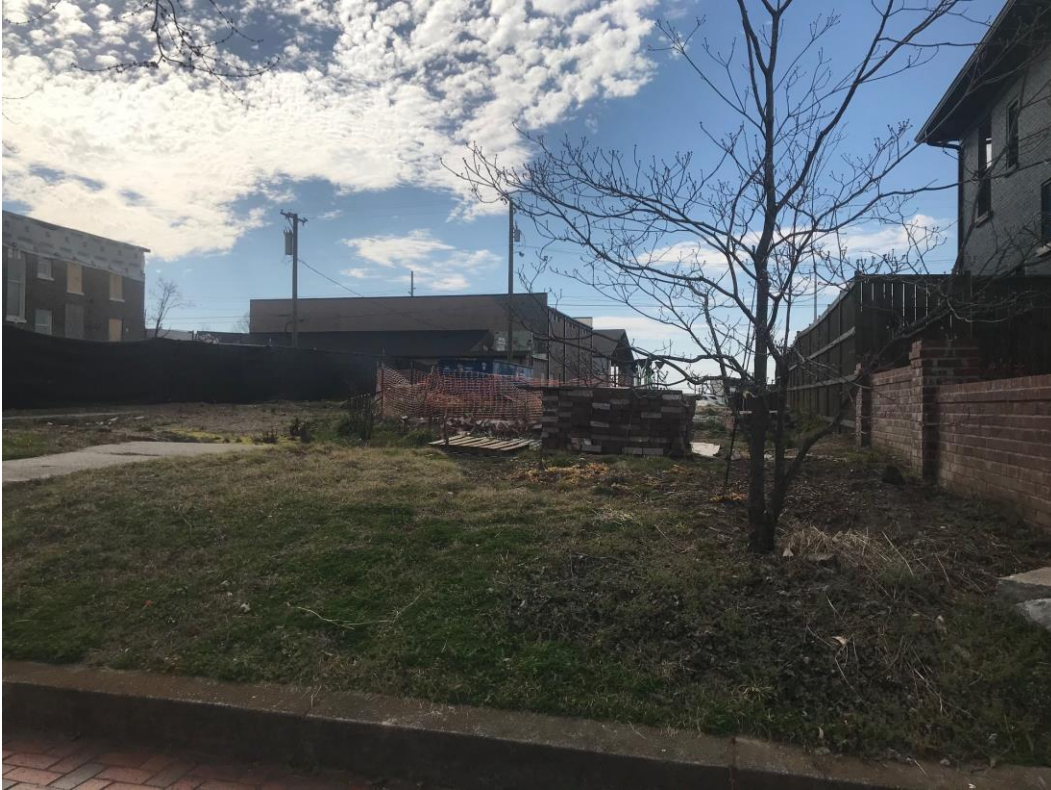
Figure 5. 118 South 11th Street in March 2021

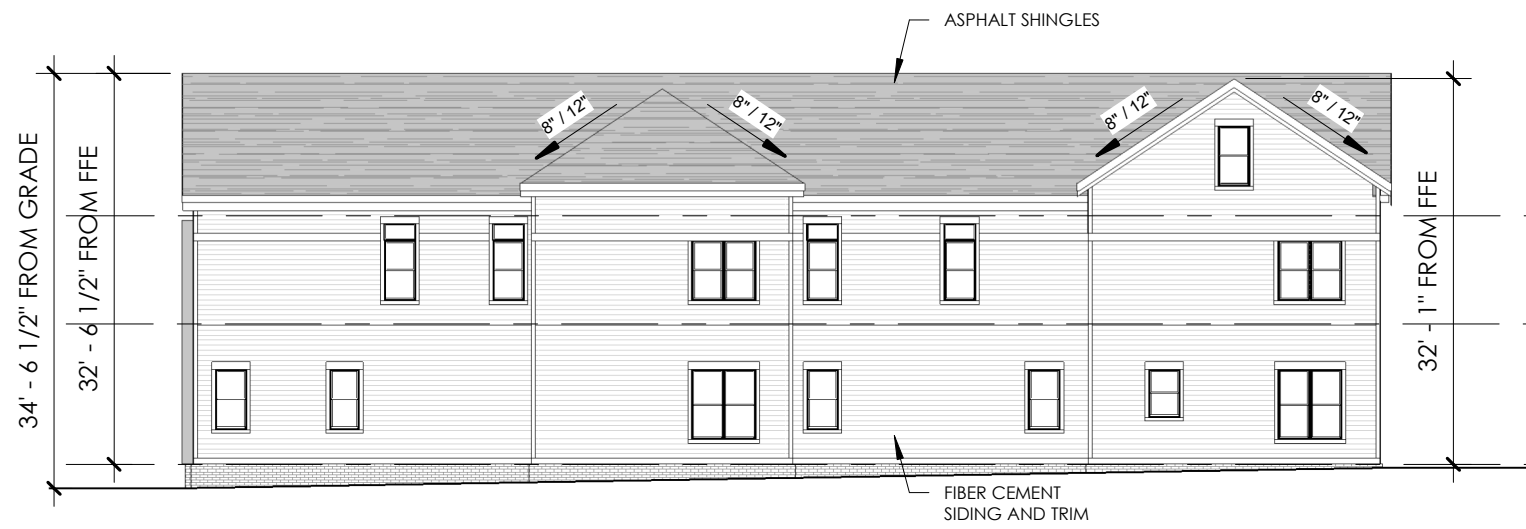
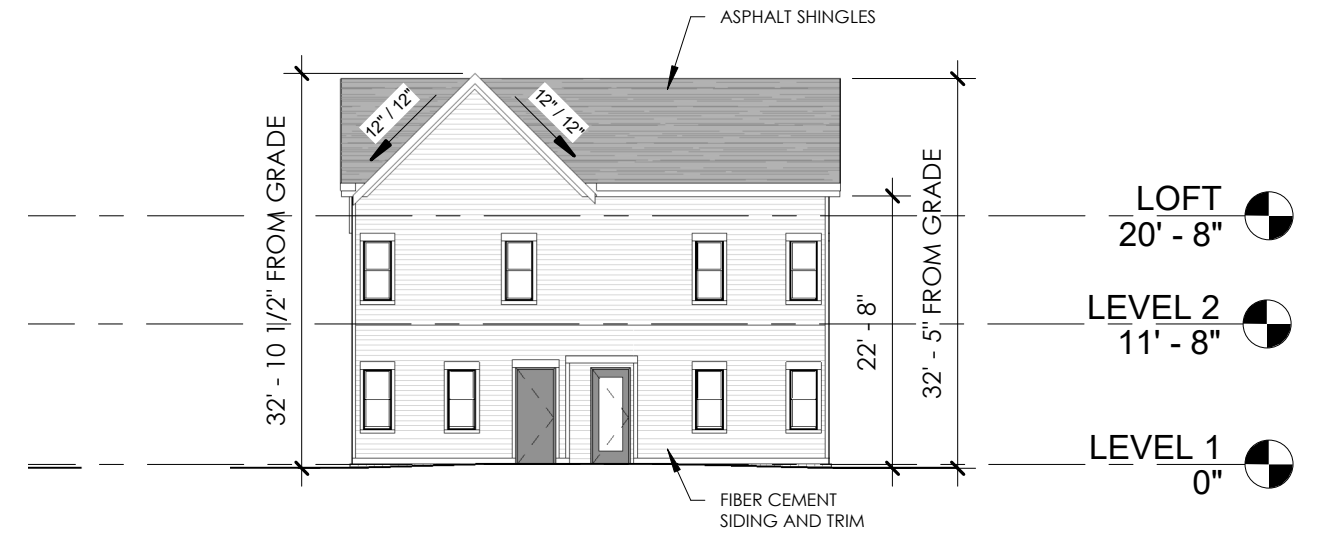
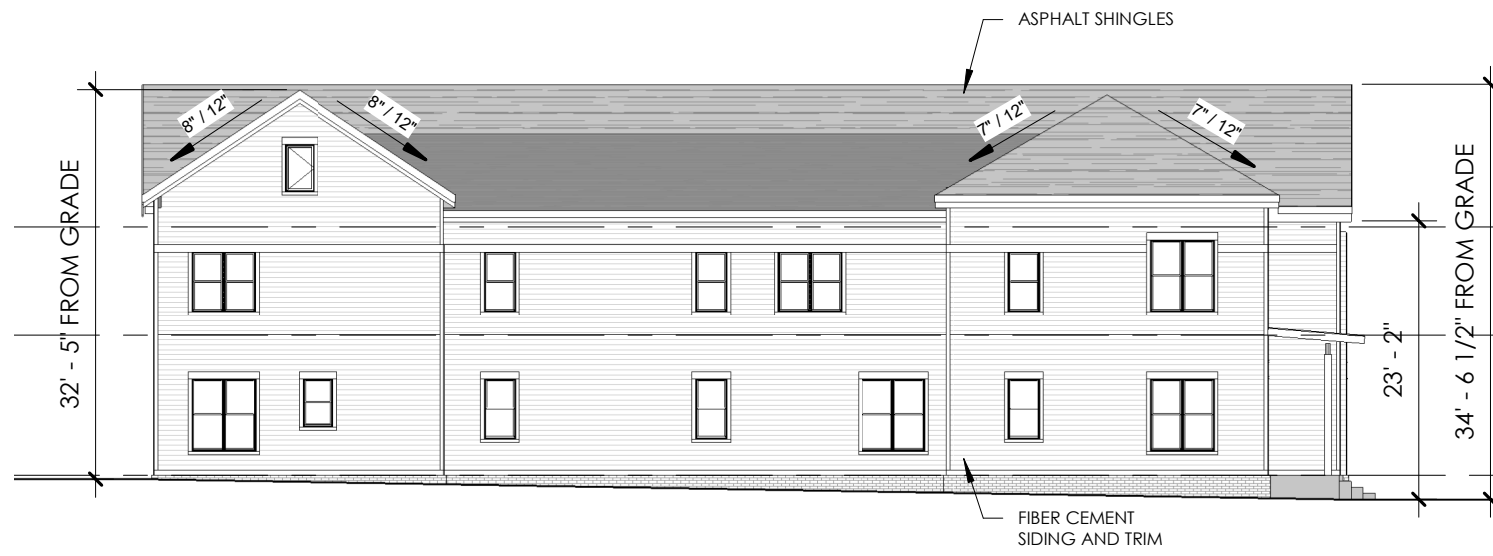
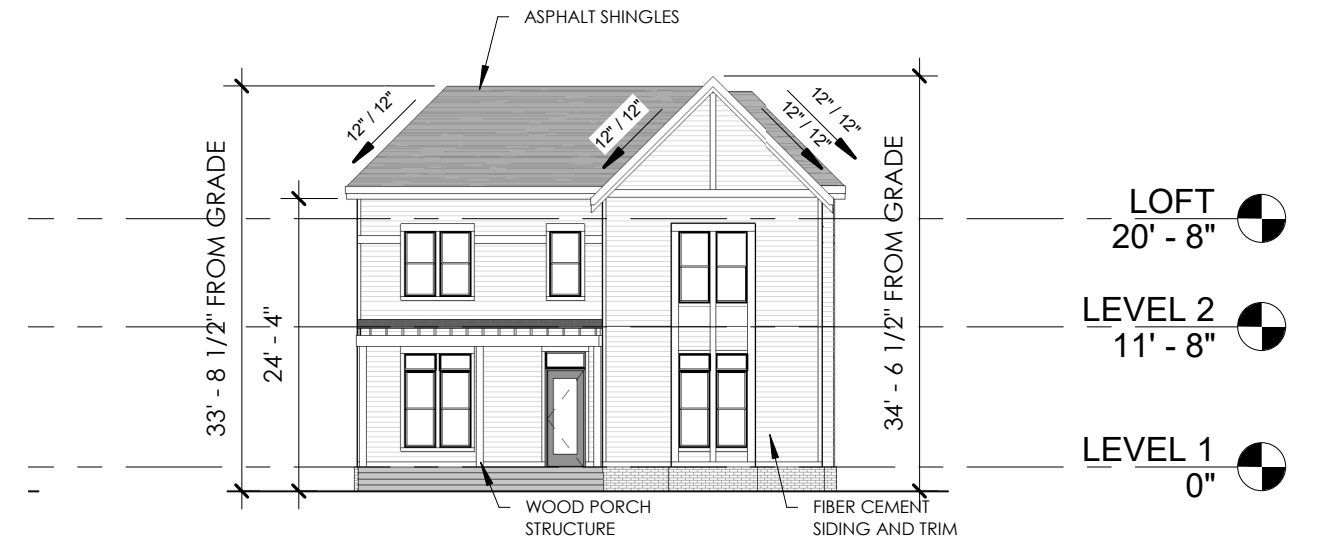
* HEIGHTS FROM GRADE
ARE APPROXIMATE

Although the height and scale are similar to houses in the immediate context, staff finds that the infill's depth and overall scale are not. The infill has a depth of ninety-eight feet, six inches (98'6"), which is significantly deeper than the other two story houses in the immediate vicinities, which have depths ranging from forty feet to sixty-two feet (40'-62'). The depth does not meet section II.B.2. for its mass in relationship to open spaces. The fact that the entire depth is a full two stories makes the overall scale incompatible with the immediate historic context. Staff recommends that a condition of approval be that the rear twenty feet (20') have a one or one-and-a-half story form and a lower height.

Roof form: The infill's primary roof form is a gabled-ell, with a front facing gable and a hip. Such a roof form is found in the immediate historic context on 1103 Holly Street and 205 South 12th Street, and staff finds it to be appropriate. The front facing gable will have a 12/12 pitch and the hip will have a 7/12 and a 12/12 pitch. The side facades incorporate 8/12 gables to break up their long depths. Staff finds that these gable forms do not go far enough to reduce the overall scale of the infill. Staff therefore recommends that the back twenty feet (20') of the infill have a one or one-and-a-half story roof form.
