METROPOLITAN GOVERNMENT OF NASHVILLE AND DAVIDSON COUNTY

STAFF RECOMMENDATION
1830 5th Avenue North
January 20, 2021

Application: Demolition
District: Salemtown Neighborhood Conservation Zoning Overlay
Council District: 19
Map and Parcel Number: 081 08 0M 002.00
Applicant: Jeff Zeitlin
Project Lead: Paul Hoffman, paul.hoffman@nashville.gov

SUBJECT: Feasibility Opinion Letter
1830 5th Avenue N, Nashville, TN
SE&I Project No: 20-1316

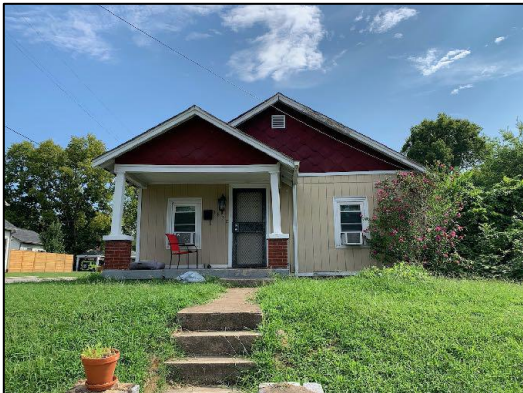
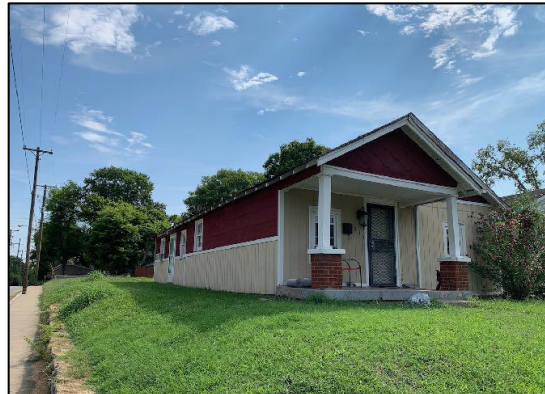
Figures 1-2. 1830 5th Avenue North

Background: 1830 5th Avenue North is a contributing building in Salemtown constructed circa 1925.

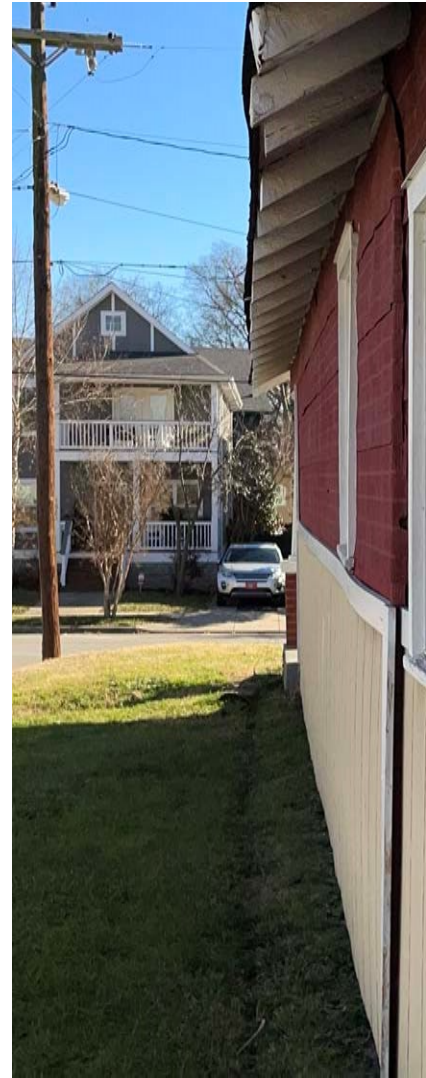
View of 2x4 rafters, poorly installed siding

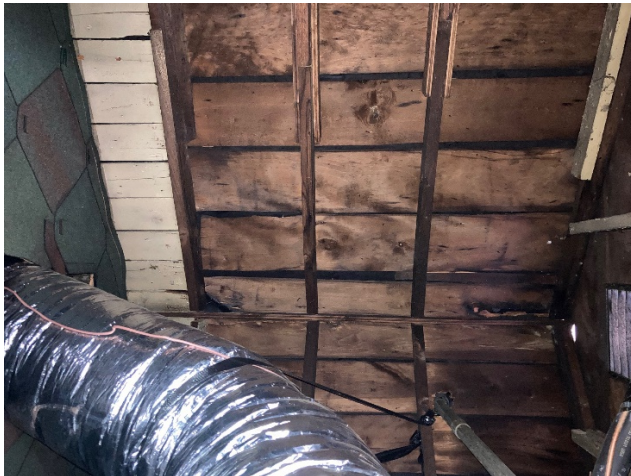
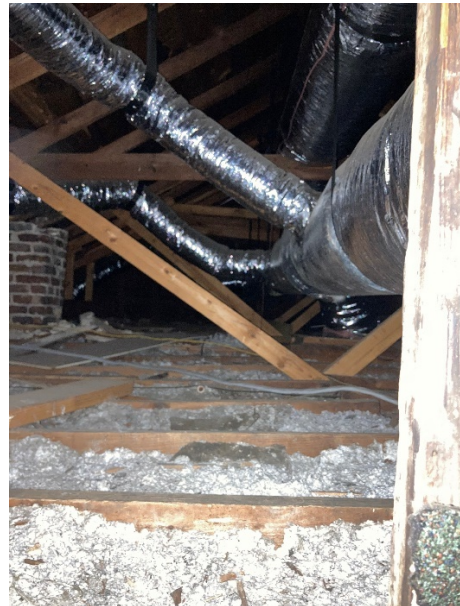
**View of Rafters, Roof Framing and ceiling joists
(Note diagonal and horizontal bracing)**

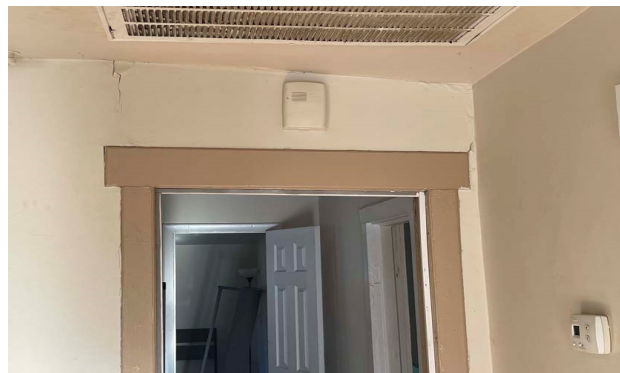
1-inch difference in door frame below

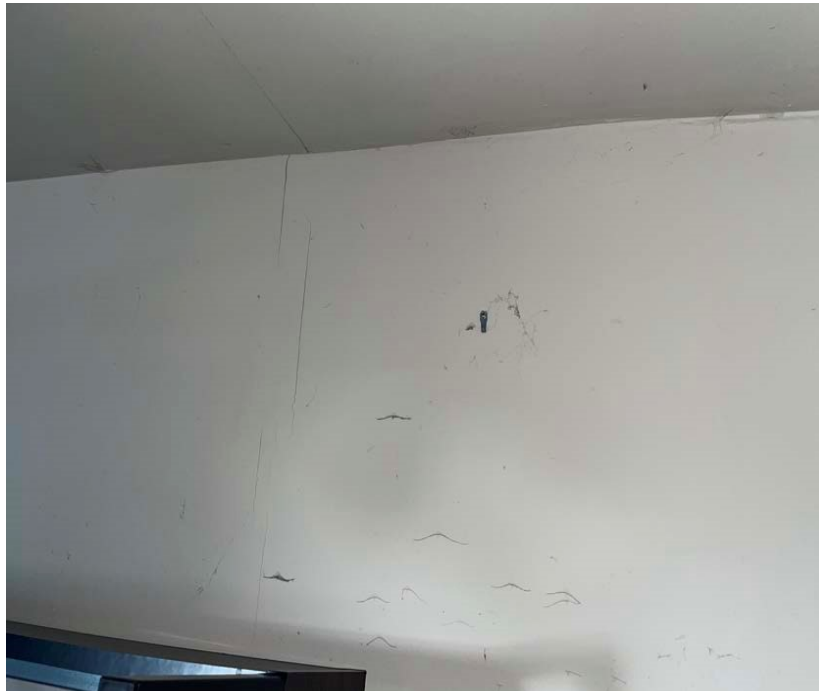
Typical cracks in drywall throughout
